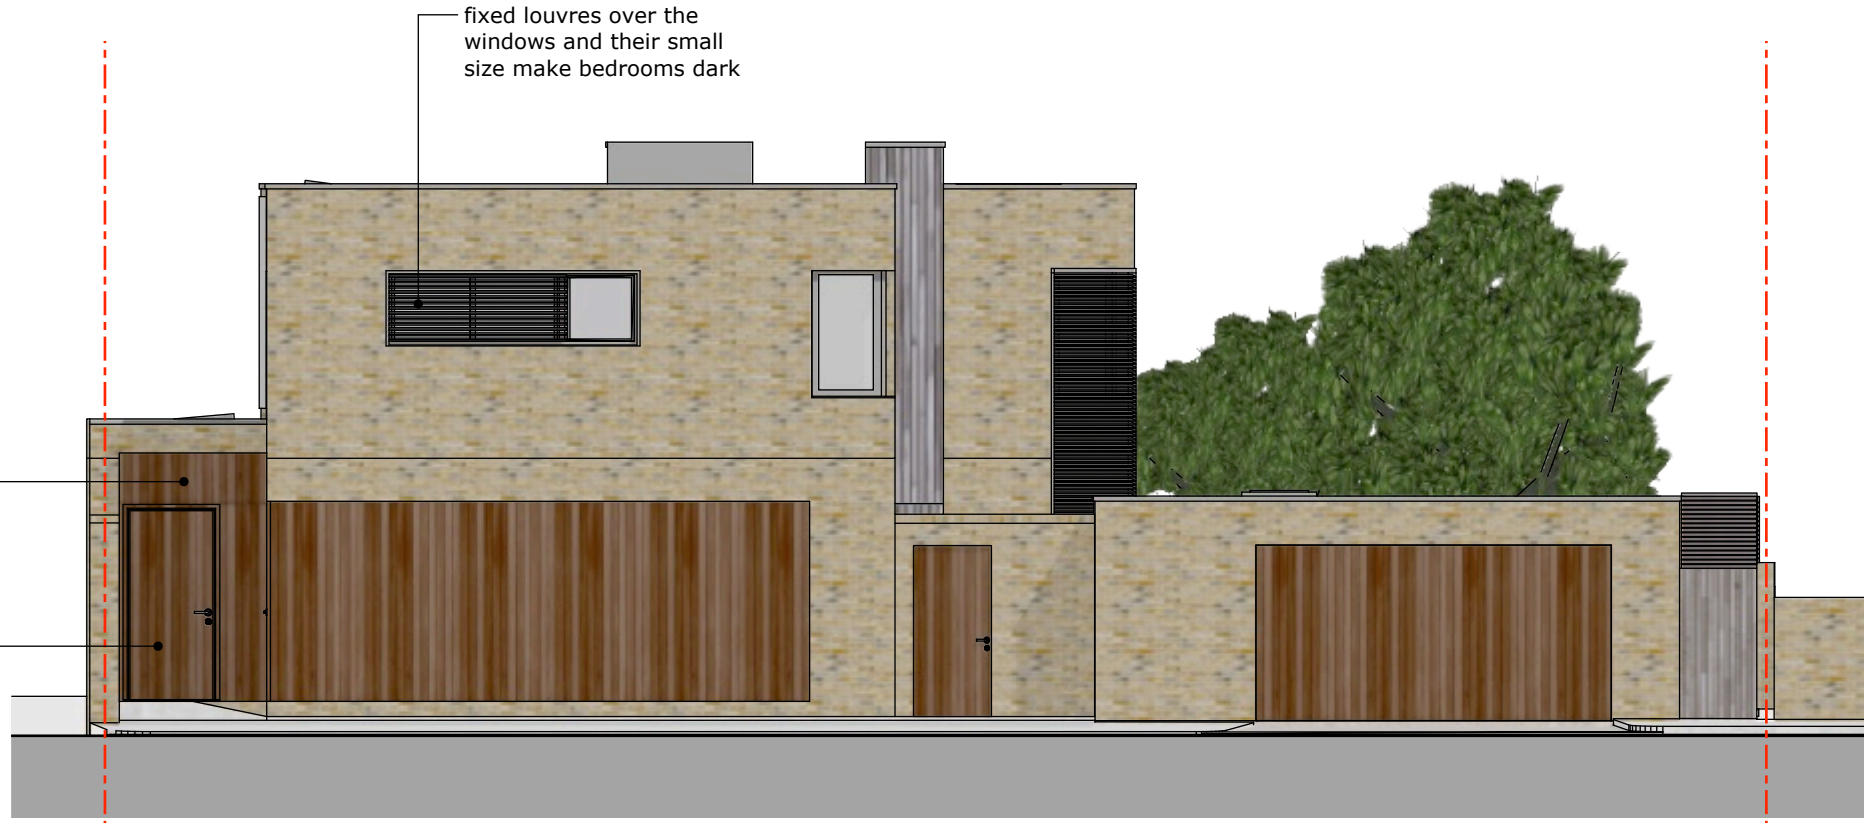
front elevation has no windows at ground floor, leading to a 'cold' appearance from the street

the existing timber cladding has aged, is rotting and falling away from the building in places

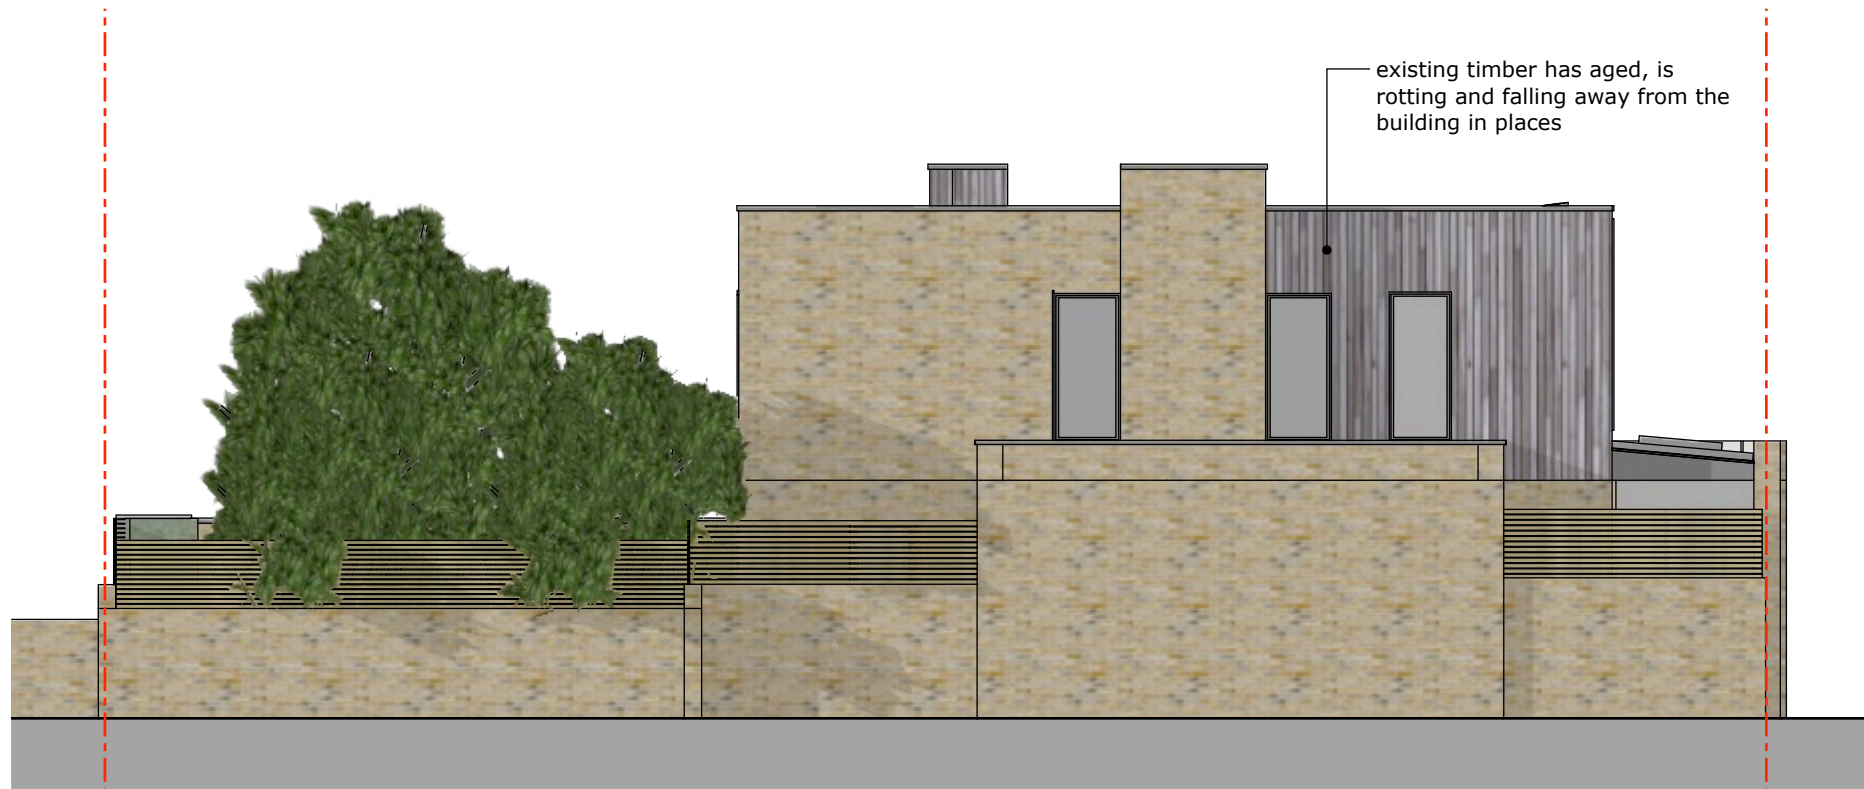
rear elevation

existing timber has aged, is rotting and falling away from the building in places
