STOKES HOUSE, HAM STREET

Design and Access/Heritage Statement

Planning Application

Stokes House
Ham Street,
Richmond
TW10 7HR

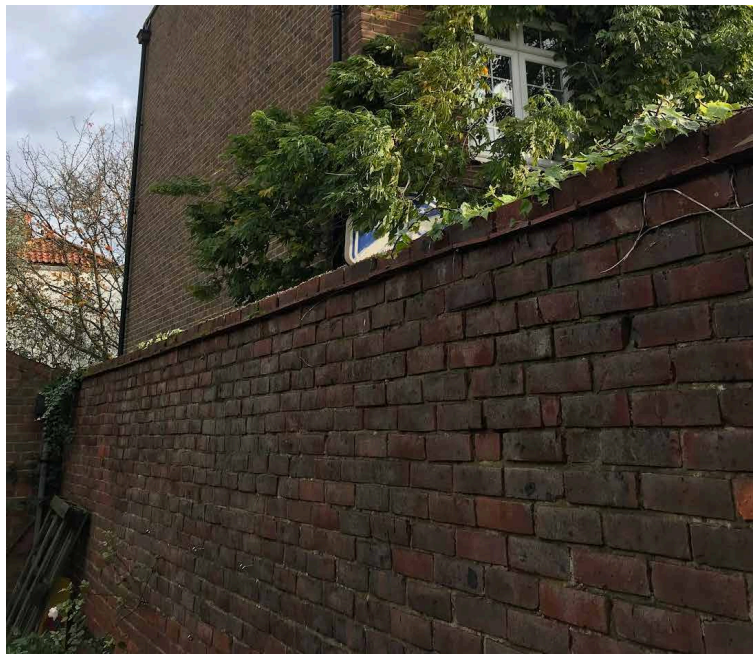
- This wall is constructed in a single skin stretcher bond (4 inches thick), with a single layer creasing tile at high level and a single stretcher course capping above.

- The brick is a dark red brick.
- It's possible that this section of wall was built at the same time as The Bench next door, or later when the car port or storage buildings at Stokes House were modified.

- The wall is not in bad condition, and appears in keeping with its surroundings, but because of the single skin construction the wall is not of the highest construction quality when compared to other boundary treatments around the site.

Photograph of existing southern boundary wall

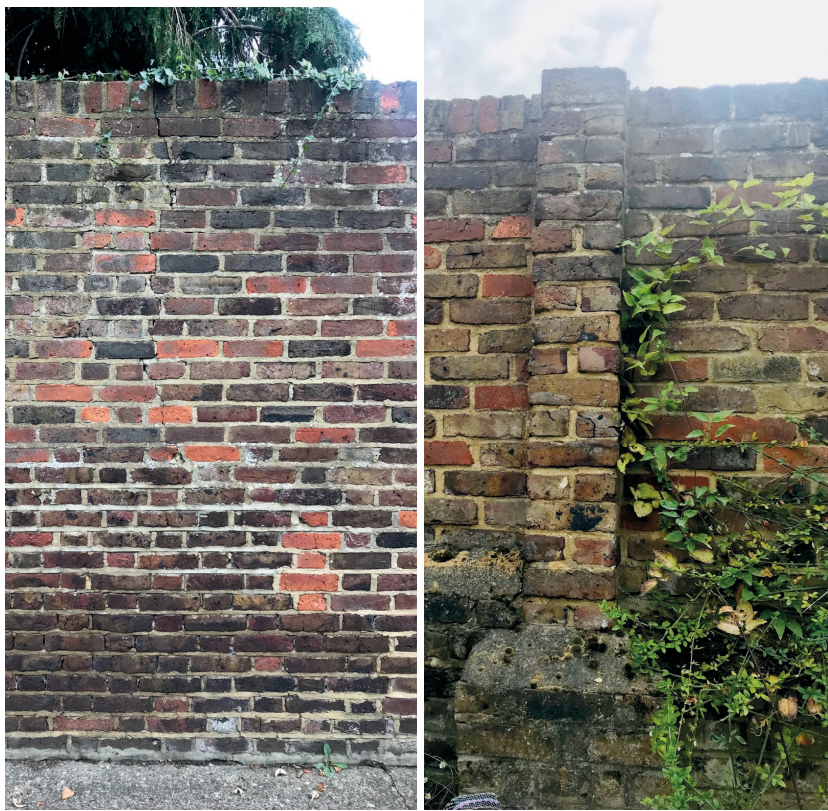
- It's possible that this section of wall has been demolished and rebuilt at some point in the history of the house. This is clearly evident internally due to the change in thickness of the wall, but is less obvious from outside because the single skin of brickwork in the upper section has been built to align with the external face. The only evidence being the change from flemish bond at the bottom section to stretcher bond in the top section, and a slightly different tone of brick.

Left hand image is the outside view of western boundary wall, note the slight change in brick appearance and bond pattern part way up the wall.

Right hand image is the internal view of the same wall, note the change in brick appearance and step in the wall where it becomes a single skin, along with the reduction in pier width.

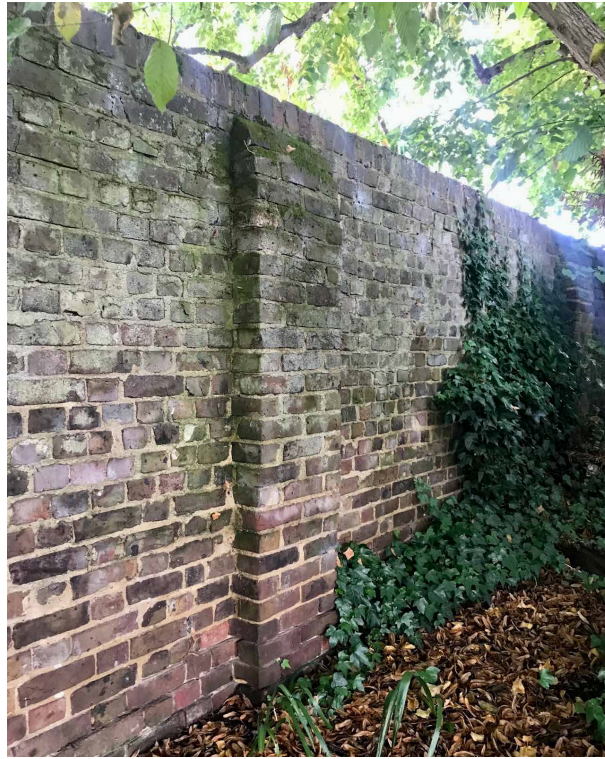
The wider piers, with less regular spacing with curved tops are thought to be earlier. Note the brick on edge along the top of the wall.

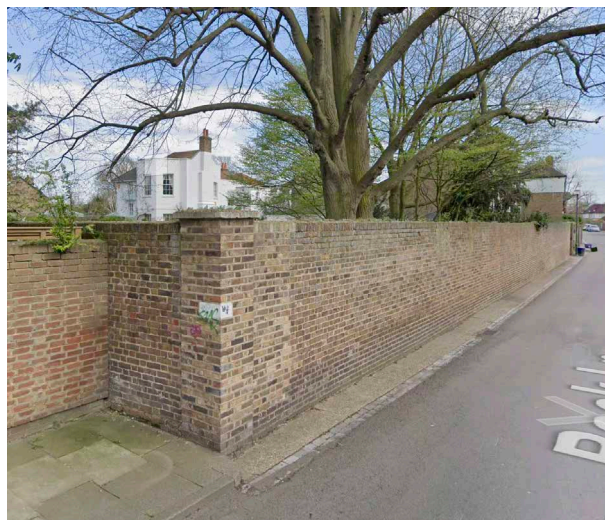
- The corner pier at the end of this wall, at the north western corner of the site is of a different design, projecting up above the general height of the wall, with a flat modern concrete coping on top. The slight difference in tone of the brickwork and mortar around this corner pier suggest it has been rebuilt more recently than the rest of the wall, therefore it is not known what the exact format of the earlier wall would have been in this area. There is a cornerstone halfway up the wall, but due to erosion it is not possible to read any inscription.

Corner pier in the northern corner looks to have been rebuilt.

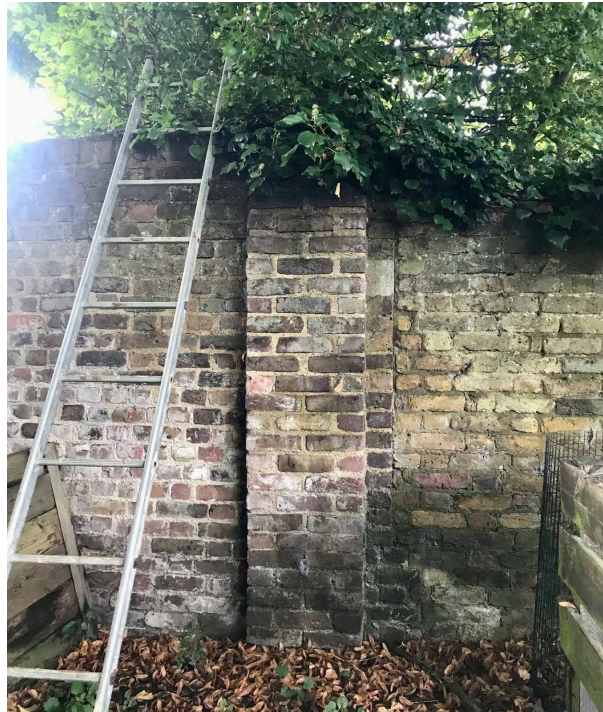
- Along the northern boundary the brick wall continues, dividing Stokes House from 57 Ham Street. Along this boundary the wall is approximately 2m high.
- After the first pier, the brick colour changes significantly to more of a yellow stock, piers are also narrower again, more akin to the modern construction of the upper section of wall along the western boundary, but this wall appears to be 9 inches thick, and still has the brick on edge capping.

Brick wall change on northern boundary

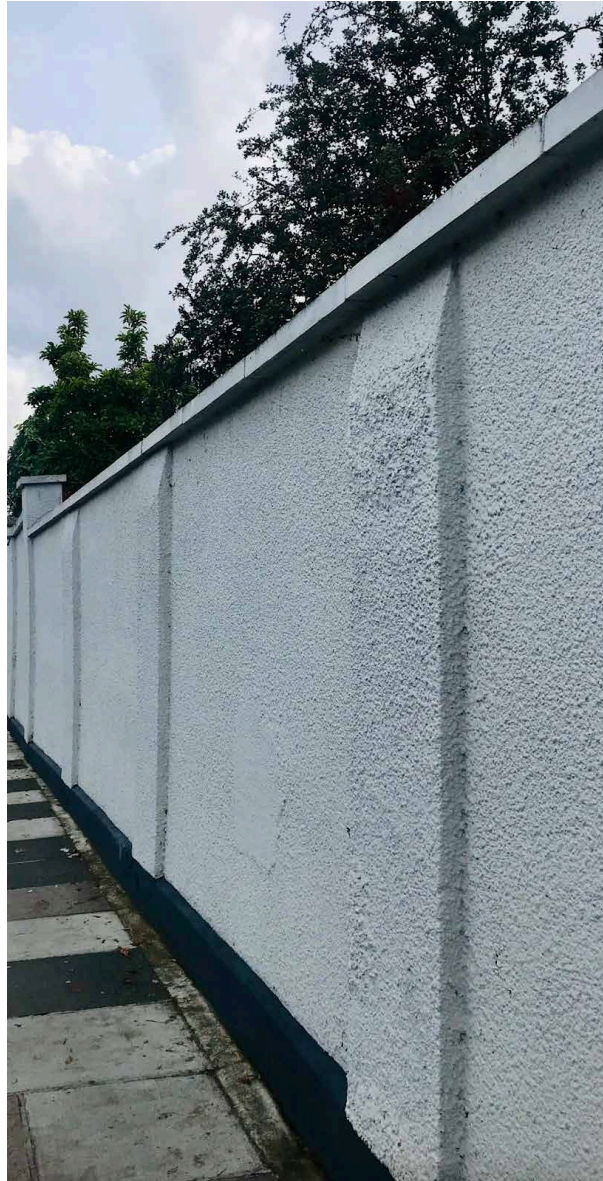
- From here, the first four bays of the eastern boundary wall seem to mimic the design of the older parts of the northern and western boundary walls. The piers are a similar width and projection, and have curved tops tapering back into the wall. A key difference is that the piers are visible both inside and outside the garden.
- Further to this, there is no brick on edge coping above the curved top of the pier, and the outer facing side has been rendered in a thick, very coarse render with a bright white paint.

Northernmost 4 bays of the eastern boundary wall

- Where modern generic concrete copings have been removed, capping treatments will be as follows:
 - A double layer of creasing tiles and a brick on edge coping detail above the four bays of wall at the northern end, where the piers are tapering at the top. This is the lowest and most simple part of the boundary wall which just encloses the garden, and should therefore be treated with a similar coping detail to the rest of the garden.

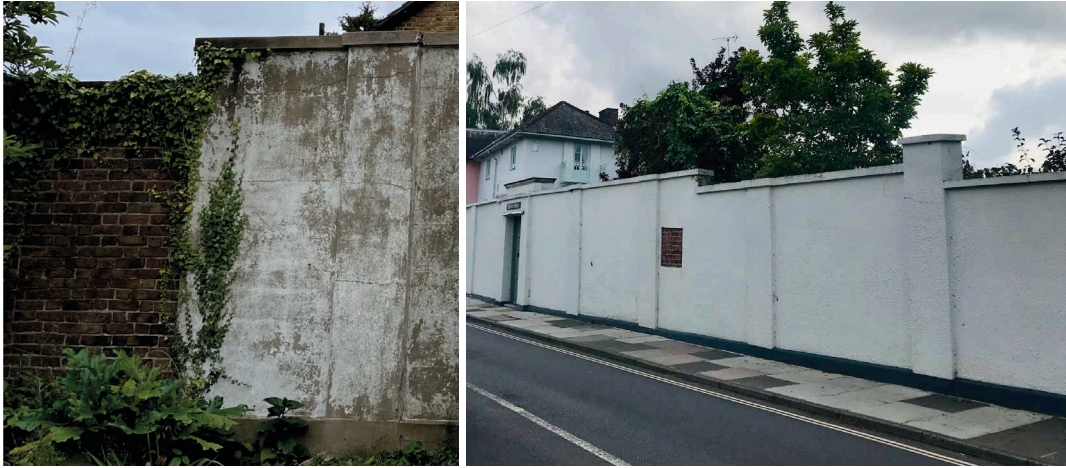
- Following the taller pier, there are four bays in the wall before the Ham Street entrance to Stokes House. Half way along the second bay the wall steps up awkwardly. The step in this location in the wall feels unnatural as it does not align with the piers. This suggests that the position of the step has been modified at some point since the wall was originally built. A theory that is further supported by the presence of a render finish on the internal side of this part of the wall, which stops in line with the awkwardly positioned step. It is likely that at some stage a building was built in the garden against this section of the wall. The smooth render with straight lines cut into it to give the effect of ashlar stonework suggests this is likely to have been an orangery or other type of glazed leisure building.

Eastern boundary wall steps up as it moves towards the house.

- Two awkwardly positioned steps in the height of the wall will be repositioned to align with the existing piers and the awkward detail adjacent to the Ham Street entrance will be removed and aligned properly with the wall.

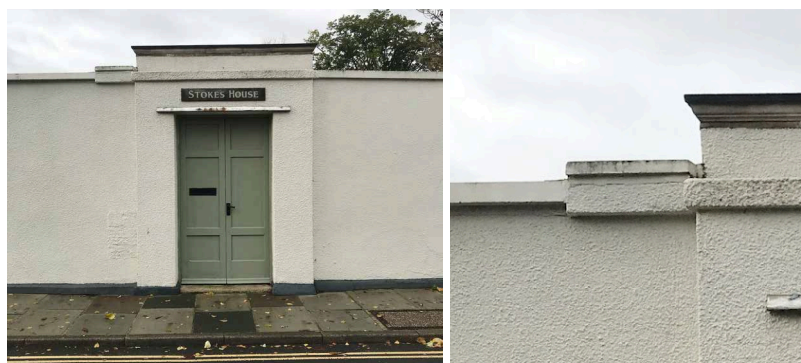
- The entrance to Stokes House from Ham Street is located in the centre of this section of the wall. It consists of a pair of narrow doors with a rendered surround that is taller than the section of wall in which it sits. A straight pediment is visible above the doorway, but appears undersized, likely due to the fact that the thickness of the modern render has reduced its projection and visual prominence. A projecting rendered band runs above the door, in line with the height of the adjacent wall, and there is an awkward step present in the top of the wall to the left of the door surround, the origins of which are puzzling.

The Stokes House entrance on Ham Street, and the unusual adjacent detail.

- Finally, a new front door will be made to replace the dilapidated existing timber doors in the existing door opening facing Ham Street. The design of the new door is based on the original, but will have enhanced thermal, acoustic and security performance.

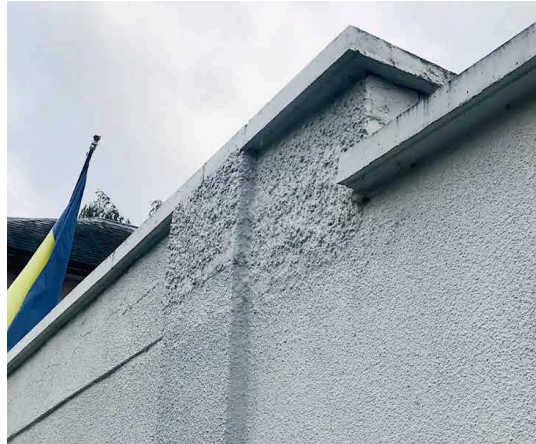
- South of the doorway, four more bays of the same design of wall are present. In the last bay of these four the wall once again steps up awkwardly before the pier.

Awkward step up not aligned with pier

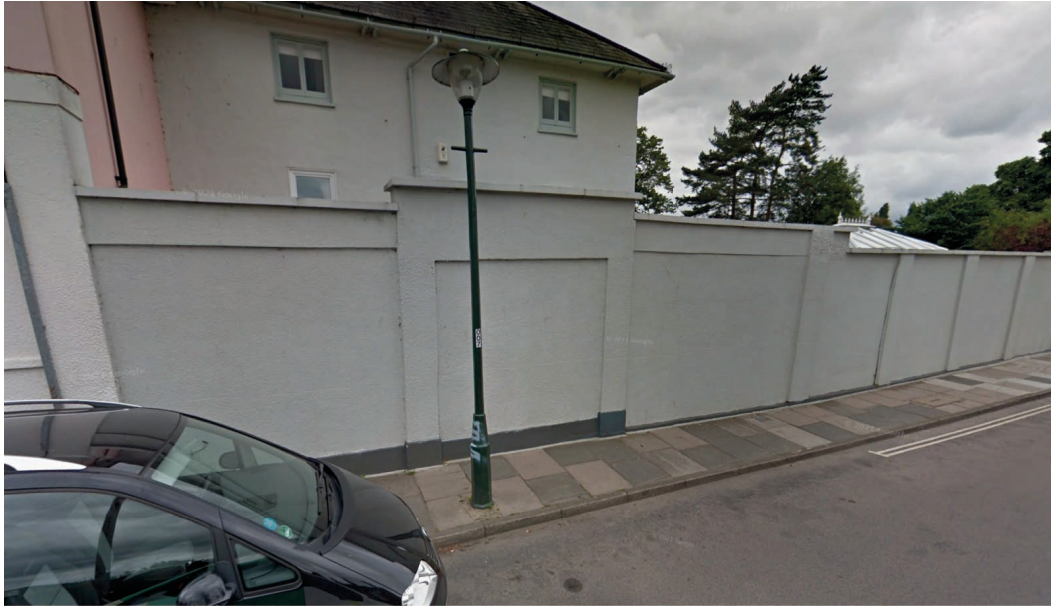
been introduced just past the right hand pier. Note also that the height of the darker plinth has been reduced in the right hand bay of this taller section, introducing asymmetry around the raised section.

More recent image of the same section of wall

- The taller section of the dark coloured plinth will be extended one bay further along, to create more symmetry around the taller section of the wall, tidying up the appearance.

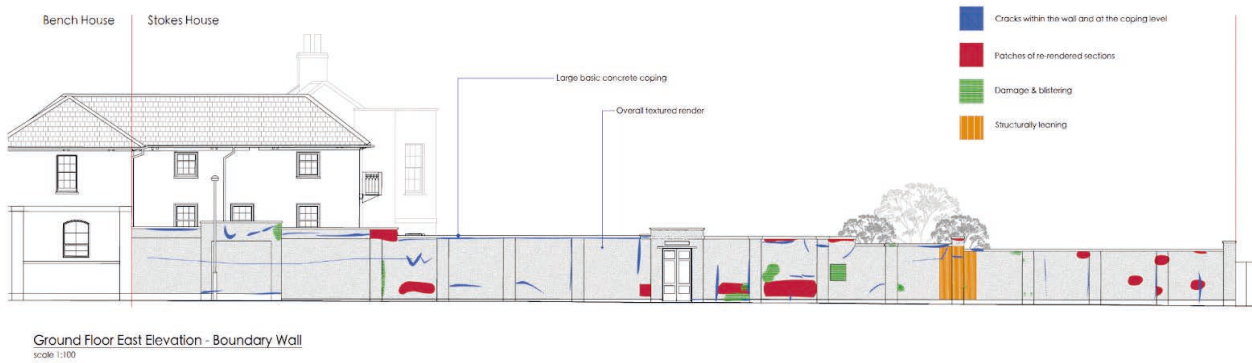
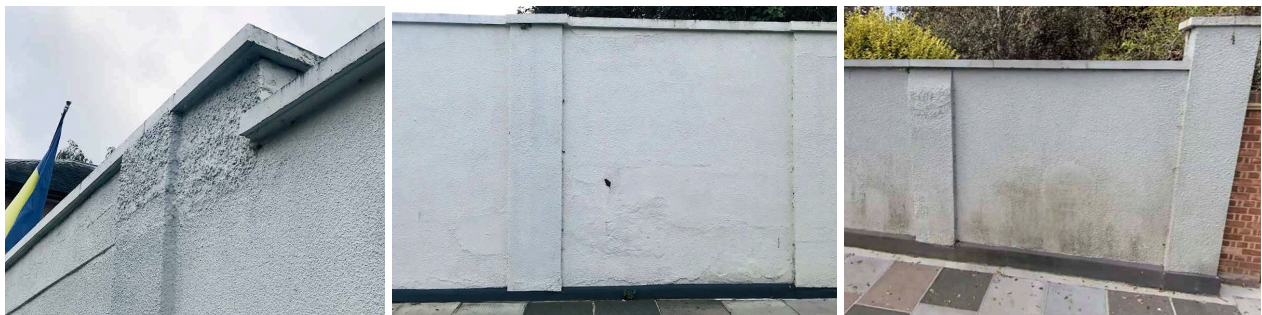
Existing eastern boundary wall - diagram showing wall condition

Various photographs showing examples of the condition of the rendered wall.

- The above diagram and photographs show the result of our visual inspection of the eastern boundary wall, it shows the significant amount of cracking and damage, the patchwork of repairs in the surface finish and damaged areas in need of repair, it also shows sections of the wall that are significantly out of level and in need of some structural attention.

- Firstly, the modern spray on non-breathable render and masonry paint need to be removed to reduce the potential for damage caused by inflexibility, and reduce the potential for trapped moisture and long term decay.
- The modern generic concrete copings will also be removed, along with the unsuitable pediment above the entrance.

- Once modern render and copings are removed, the wall will then be carefully inspected and any essential structural repairs carried out, such as bed reinforcement or ties between walls and piers, to ensure the long term structural stability and soundness of the wall is maintained.

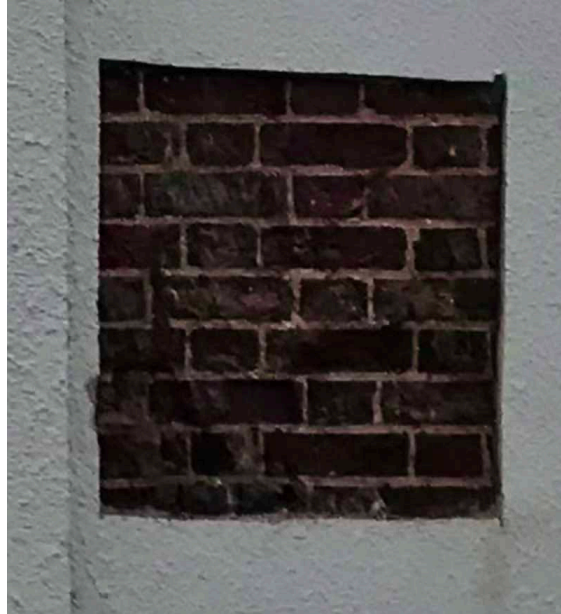
Removed patch of render reveals an attractive red brick

- A removed section of render has revealed an attractive red stock brick substrate, in flemish bond with a durable cream coloured lime mortar, that appears consistent with the walls surrounding the rest of the garden.

- Unfortunately, the existing render has a very strong adhesion to the original bricks, and therefore cannot be removed without causing damage to the brick face, meaning that it will not be possible to remove the render and leave the original stock brick as the finish.

- In other locations modern generic concrete copings will be replaced with more traditional, cast stone copings, pier caps and straight pediments.
- Once the render is removed, the original brickwork is likely to have a damaged face, which will be unsightly and too porous to be left exposed, and so a new breathable lime render finish is proposed. This finish will conceal historic damage, along with any repairs and strengthening, and give the wall a refreshed and more traditional appearance. The lime render finish will be thinner than the existing modern textured cement based render, and therefore pier widths, and depths, along with other details in the wall will appear more elegant and closer to their original design intent.
