**Arboricultural and
Development Scope Report**

**St. Mary's College,
Waldegrave Road,
Strawberry Hill,
Twickenham,
London, TW1 4SX**

ARBORICULTURAL REPORT

LOCATION	St. Mary's College, Waldegrave Road, Strawberry Hill, Twickenham, London. TW1 4SX	REF: AR/1419/te
CLIENT	Colvin and Moggridge Landscape Architects, 4 Bourlet Close, London. W1W 7BJ	DATE OF REPORT 12 th April, 2007
REPORT PREPARED BY	J. Quaife, Registered Consultant Dip.Arb.(RFS), F.Arbor.A.	DATE(S) OF INSPECTION 13 th March, 2007
SURVEY INSPECTOR(S)	Tim Scott-Ellis MICFor Dip Arb (RFS), F Arbor A	SHEET No. 1 of 6

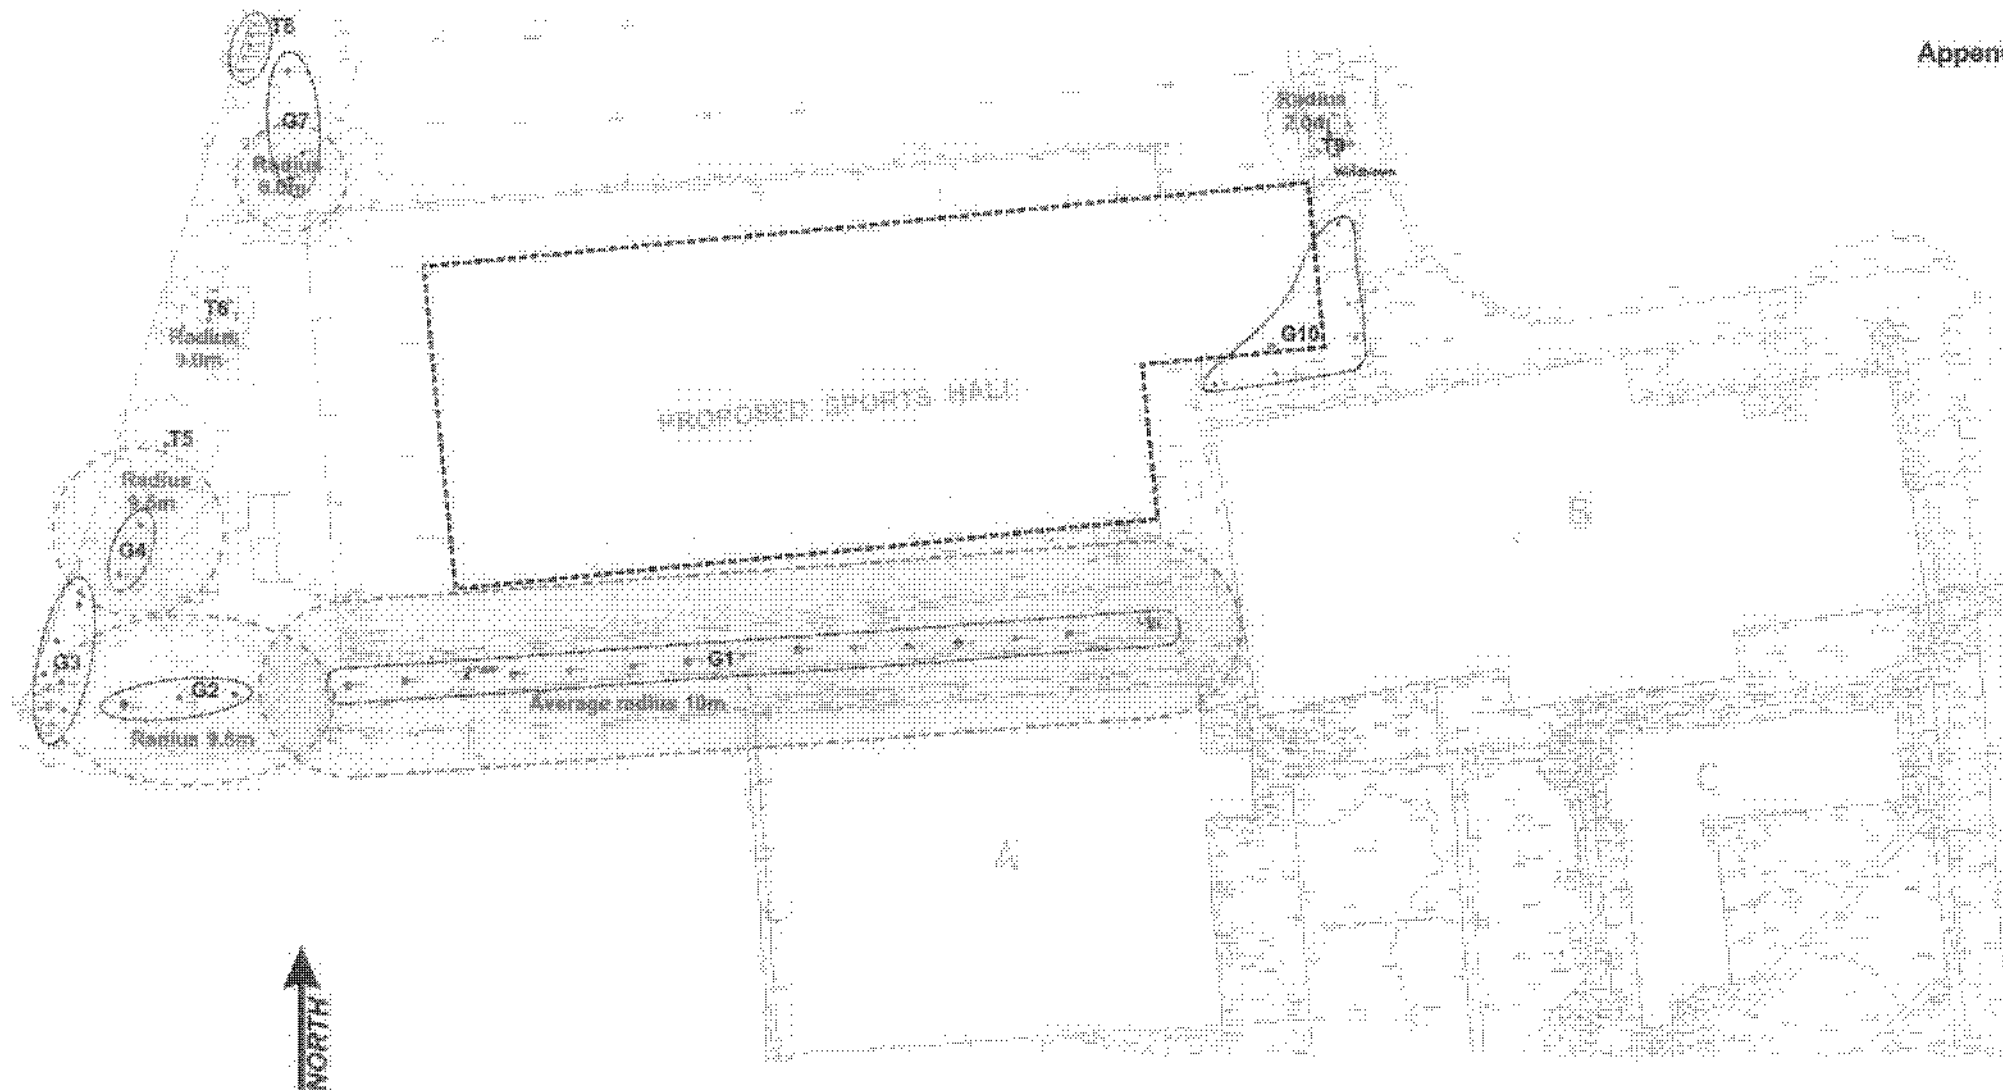
Quail Woodlands Arboricultural Survey AR/1419/06
St. Mary's College, Waldegrave Road, Twickenham, TW1
 Site Plan - Arboricultural Development Scope Plan April 2007
 Scale: approximately as per bar
DO NOT SCALE FROM DRAWING

- 6.1 The sketched position of the new hall (dotted black line at Appendix A) will be outside the combined RPA of G1. This avoids the need to use a supported foundation which would have implications for the slab level of the building.

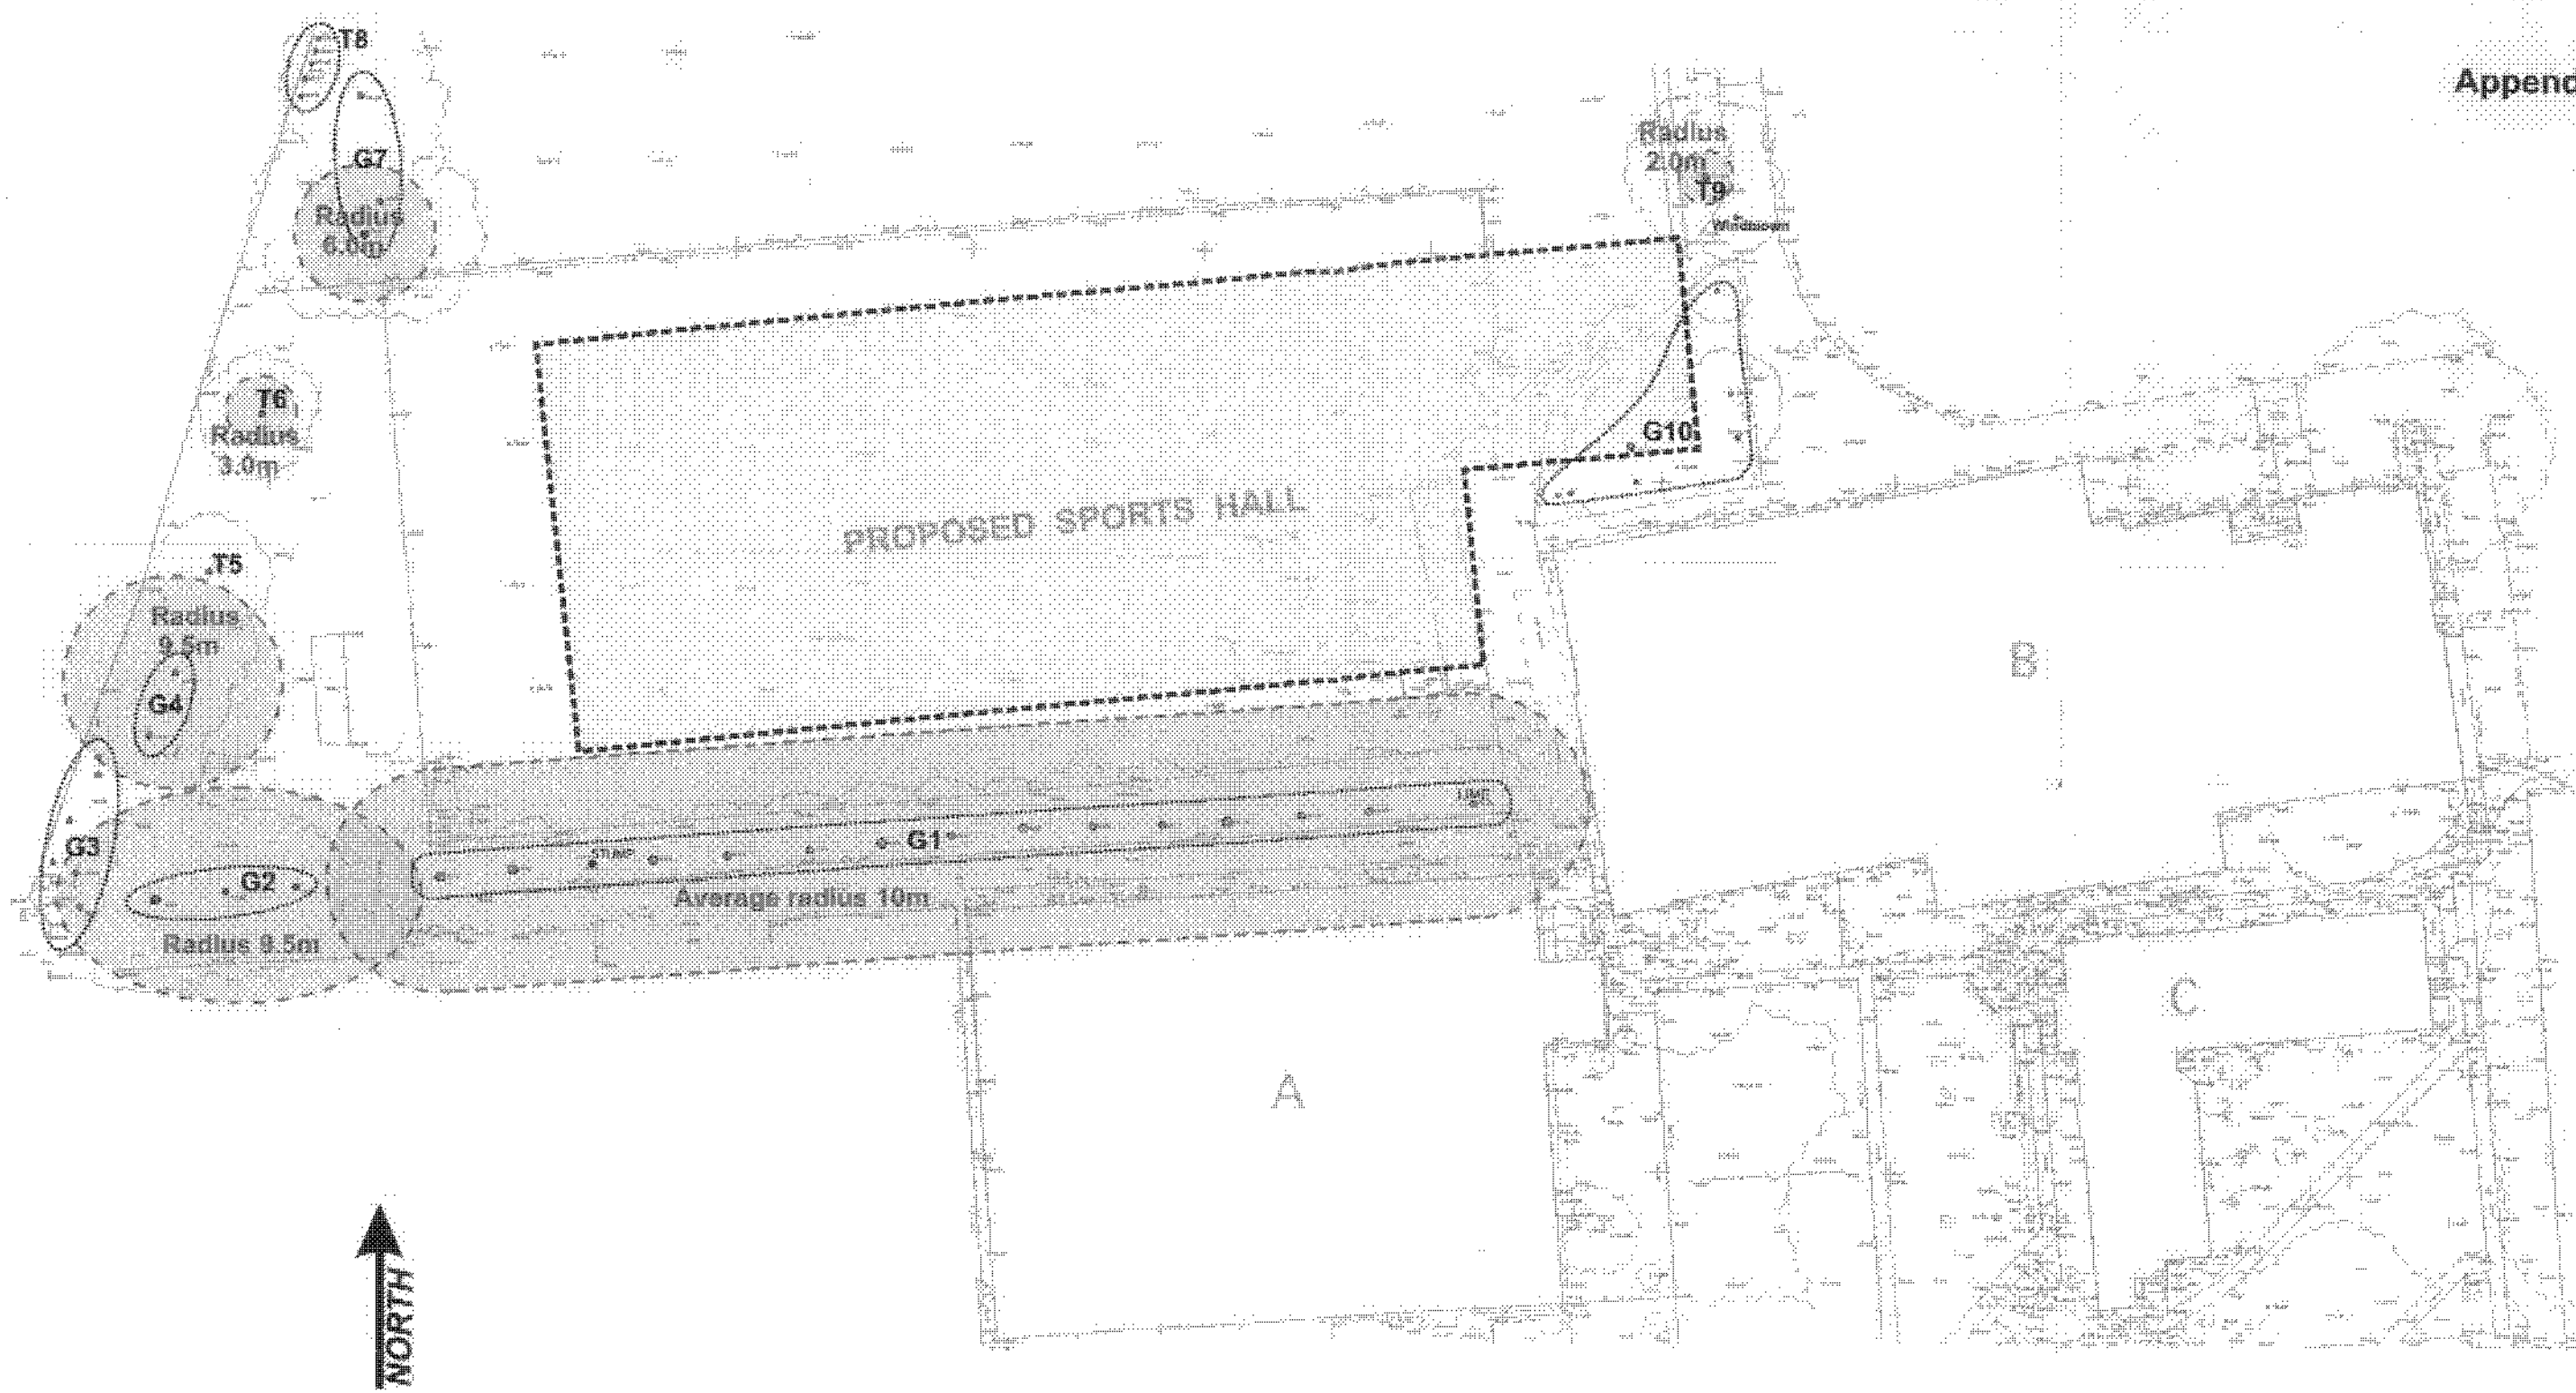
Quaife Woodlands Arboricultural Survey AR/1419/te
 St. Mary's College, Waldegrave Road, Twickenham, TW1
 Site Plan - Arboricultural Development Scope Plan April 2007
 Scale: approximately as per bar
DO NOT SCALE FROM DRAWING

- 5.5 The RPA radii are included at Appendix B and are annotated at Appendix A. Where there is a range of RPA radii the largest has been used. With group G1 the range of RPA radii is from 6.5 metres to 11 metres. I have taken regard of the site and growth circumstances and for a line of trees such as this the root systems will have extended laterally much the same distance due to growth competition. Realistically therefore I have used an average radius of 10 metres as I do not believe that the RPA has a scalloped edge.

- 6.2 The edge of the building footprint is outside the RPA, but the area required for scaffolding along that elevation can be protected in accord with Figure 3 of BS5837 (see Appendix E).

- 8.2 The trees that should be removed (G10) for the development are of little merit and overall the landscape impact of the scheme is neutral.
- 8.3 There is scope to enhance the arboreal landscape with new planting.
