DESK STUDY AND CONCEPTUAL SITE MODEL
for the site at
FORMER EXPRESS DAIRIES SITE, ORCHARD ROAD,
RICHMOND, TW9 4LZ
on behalf of
HAREPATH LLP

Title: DESK STUDY AND CONCEPTUAL SITE MODEL
Project: FORMER EXPRESS DAIRIES SITE, ORCHARD ROAD, RICHMOND, TW9 4LZ
Client: HAREPATH LLP
Date: 23 SEPTEMBER 2011
Reference: LS0360
Version: V2 – development proposals revised

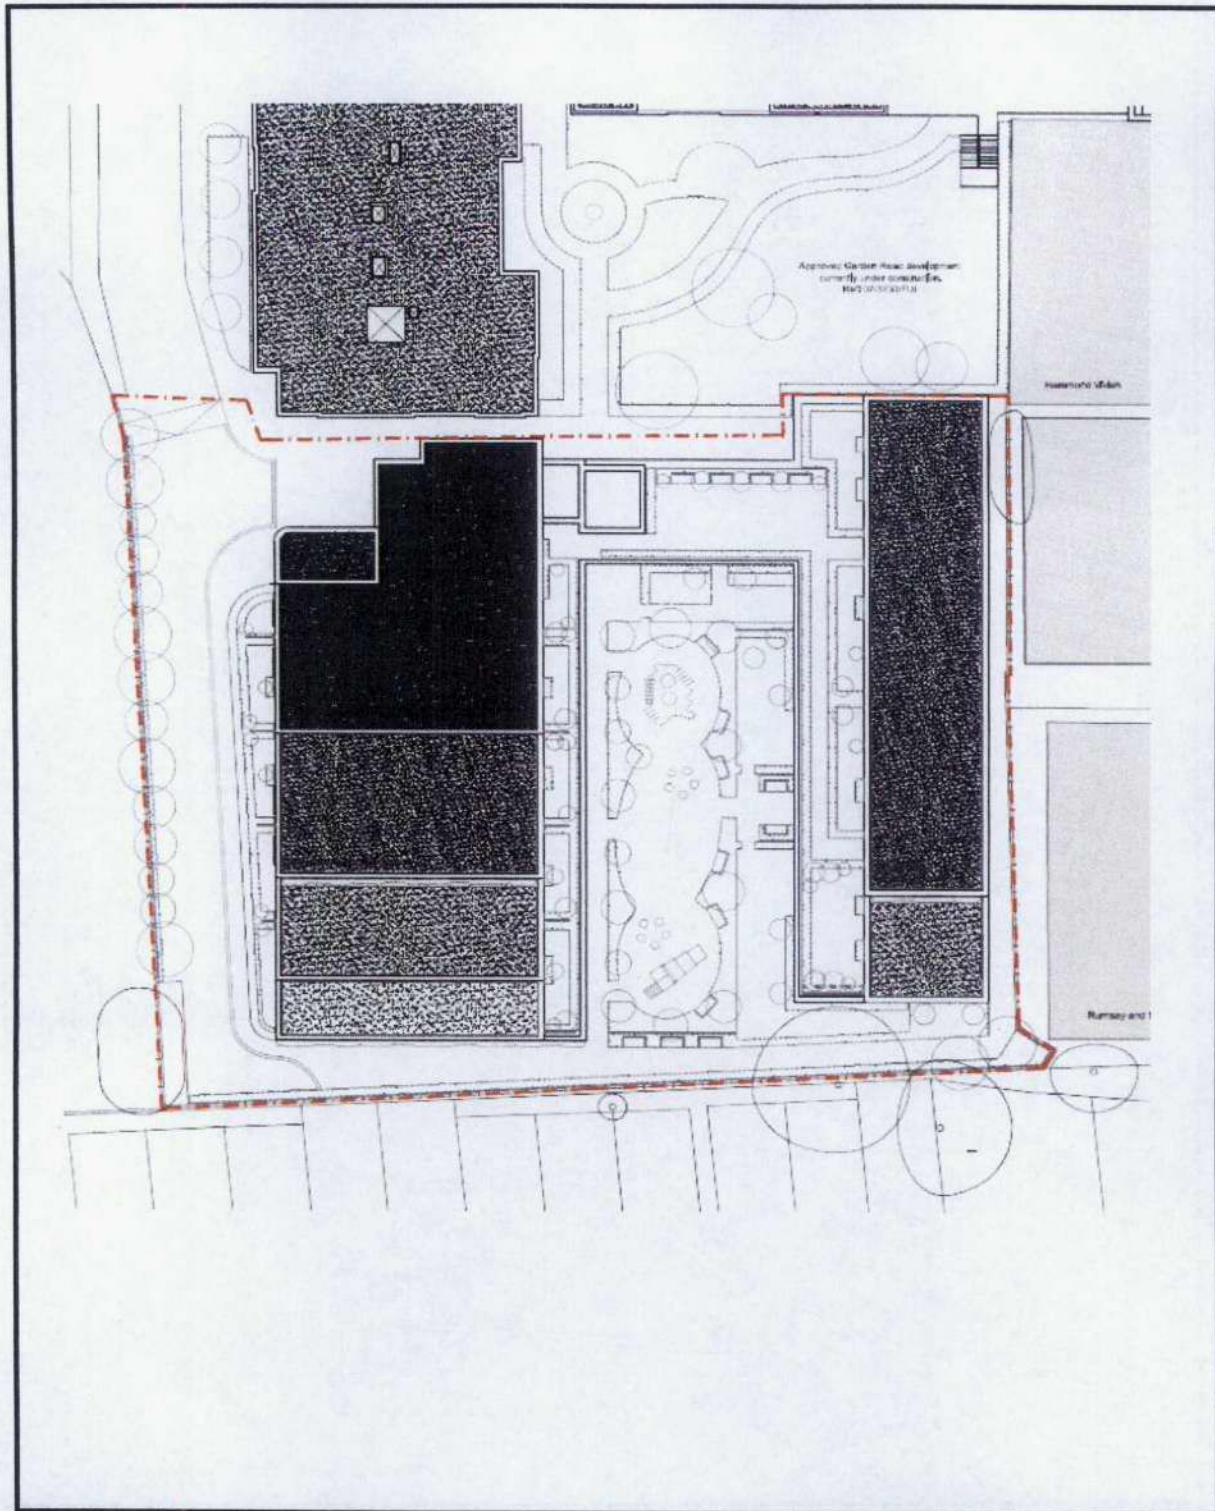
TITLE: Proposed Development		REF: LS0360	
PROJECT: Express Dairy		VERSION v1	
CLIENT: Harepath		FIGURE: 3	
PREPARED: AC	CHECK: ET	DATE: 05/09/2011	SHEET No: page: 1 of 1

It was understood that the proposed development was to comprise the construction of a two low to medium rise structures to comprise flats with communal soft landscaping. Figure 3 illustrates the ground floor layout of the proposed redevelopment.

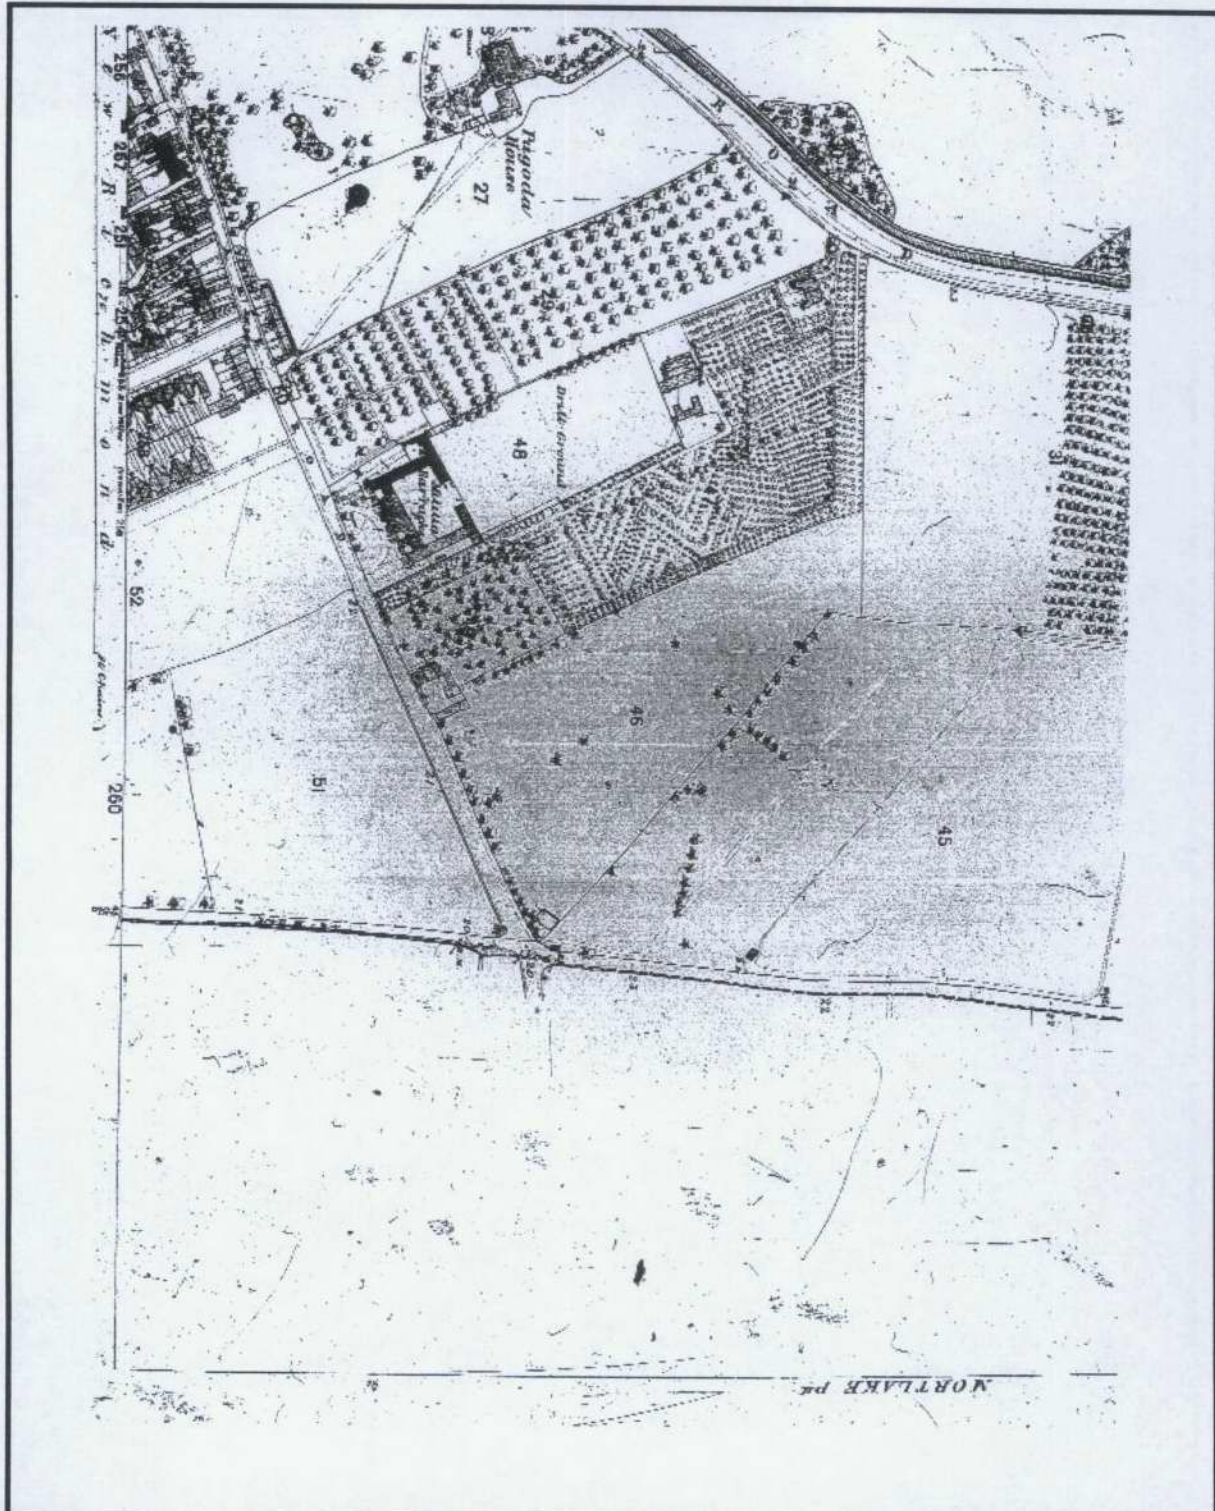
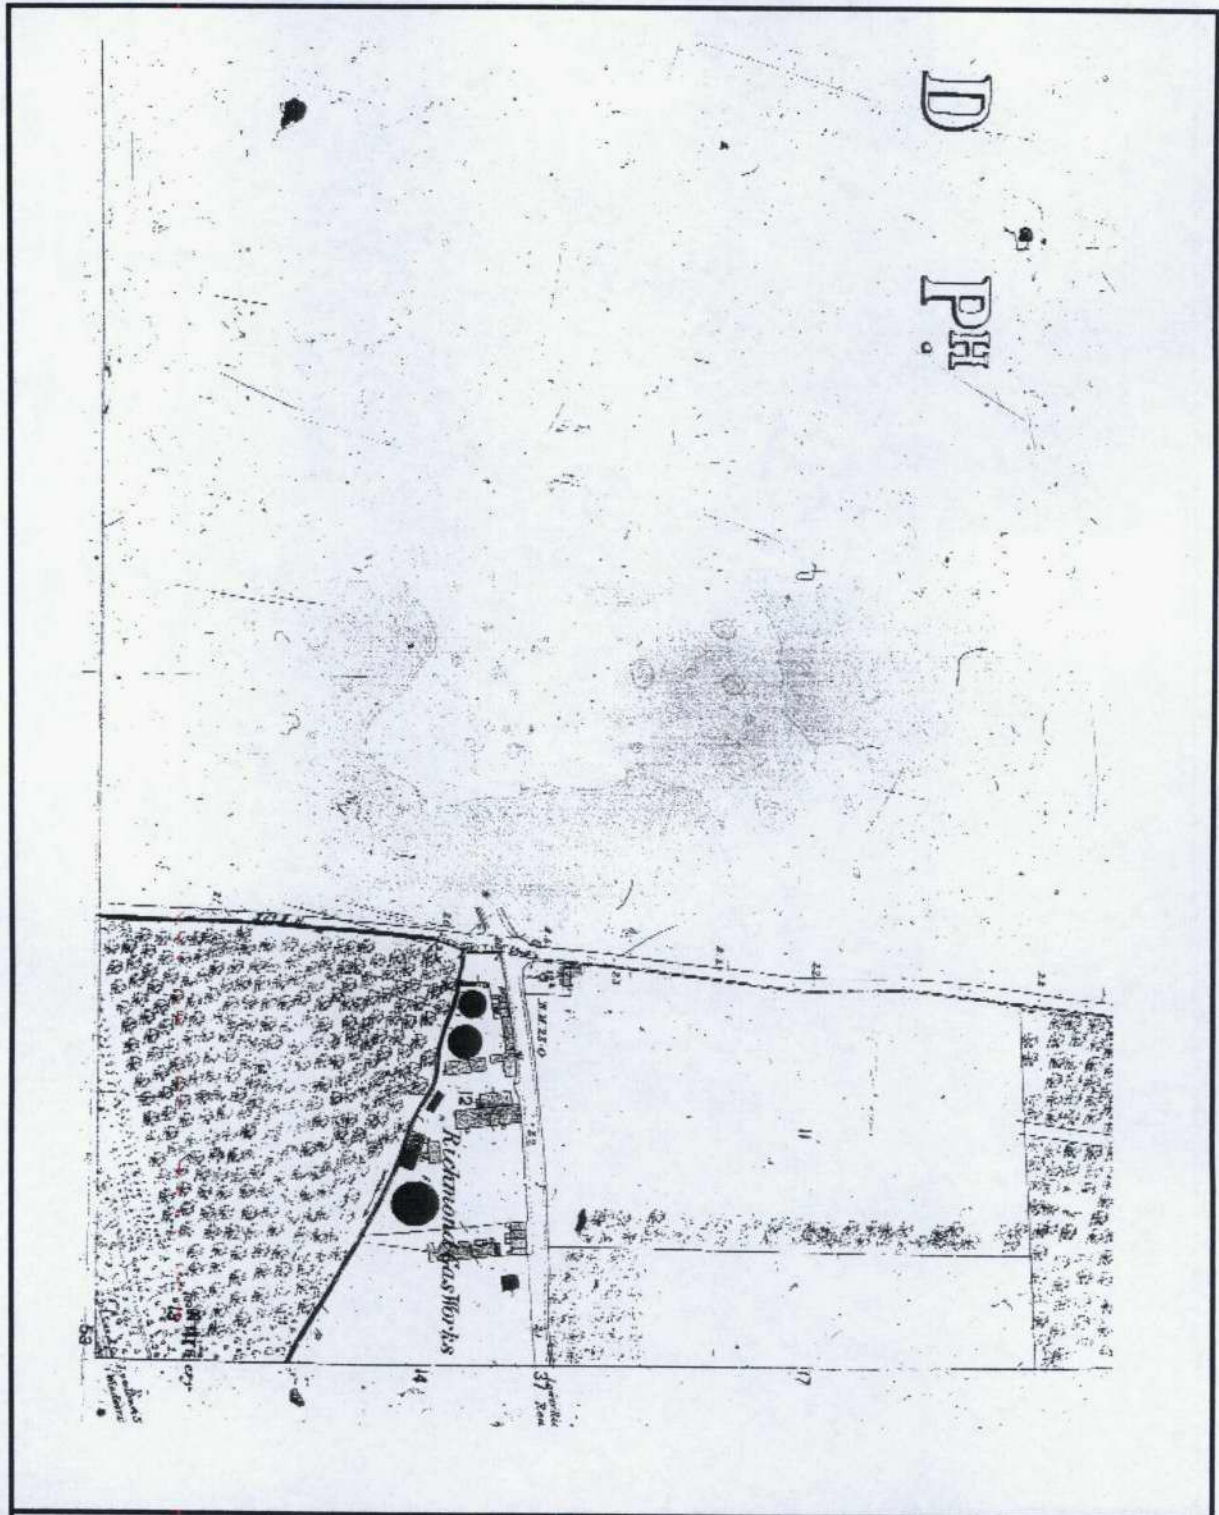
TITLE: Historical Map Extract: 1870		REF: LS0360	
PROJECT: Express Dairy		VERSION: v1	
CLIENT: Harepath		FIGURE:	
PREPARED: AC	CHECK: ET	DATE: 05/09/2011	SHEET No: page: 1 of 1

Date	On Site	Off Site
1870	The site falls partly within an open field (tithe no. 14) and a (plant) Nursery. A stream crosses the site from north-west to south-east.	A number of terraced dwellings are noted to the north. To the north-west is Richmond Gas works, with three gas holders and a number of associated buildings shown.
1894	Part of the eastern site boundary is shown. A triangular shaped arrangement of buildings is noted in the north-west corner, representing possible stores or stables etc.	The gas works has been extended and further terraced residential dwellings are noted to the north.
1913	One of the stores or stables is possibly indicated to be a Smithy (Blacksmiths). The southern site boundary is noted.	Terraced dwellings are noted to the south.
1933	The buildings, the stream, or nursery are not indicated. The site is open to the adjoining gas works. A small building is indicated along the eastern boundary.	The gas works to the west has been extended and a new holder is indicated adjacent to the site (in the location of the holder noted in the present day).

In summary, the site formed part of open fields and a nursery. The north-west corner was developed as a collection of stables/stores buildings around a courtyard, later with a blacksmiths possibly occupying part; a stream or ditch crossed the site. The buildings were no longer shown c.1933, with the site falling within an adjacent gas works, including for a time one small undifferentiated building along the eastern boundary. The site was then developed as a dairy by c1973, with the boundaries and building accommodation commensurate with the present day.
