37 HAMILTON ROAD, TWICKENHAM

Phase III Geoenvironmental Investigation

Report No. 3719-2

5 June 2012

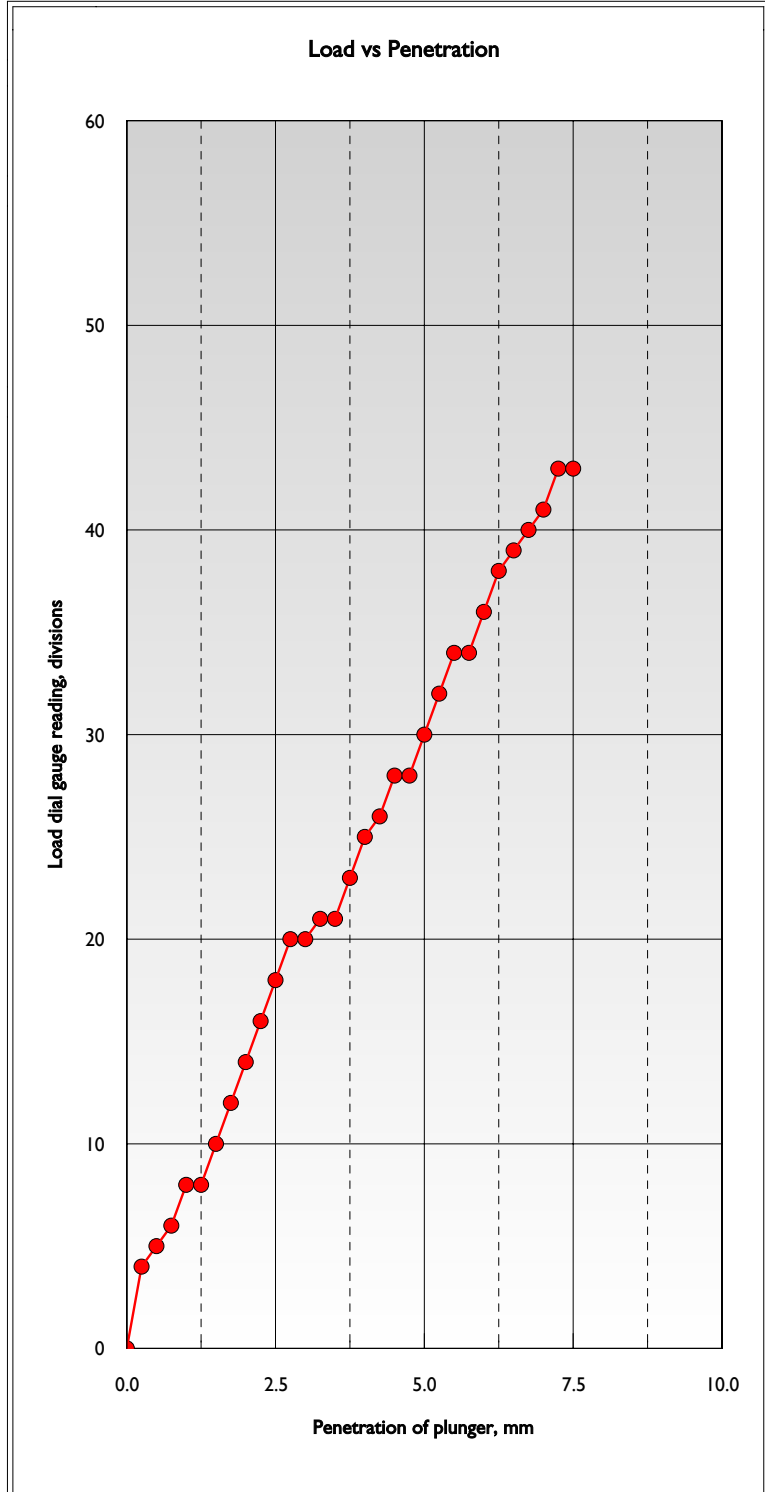
CBR at 2.5mm = (Dial reading x ring factor)/132.4

CBR at 5.0mm = (Dial reading x ring factor)/199.6

C B R	Top	Bottom
	3.6	
	4.0

Five California Bearing Ratio (CBR) tests were undertaken at shallow depth on the Made Ground. The results of these tests are presented in Appendix B and indicate values of 1.0 to 4.0%

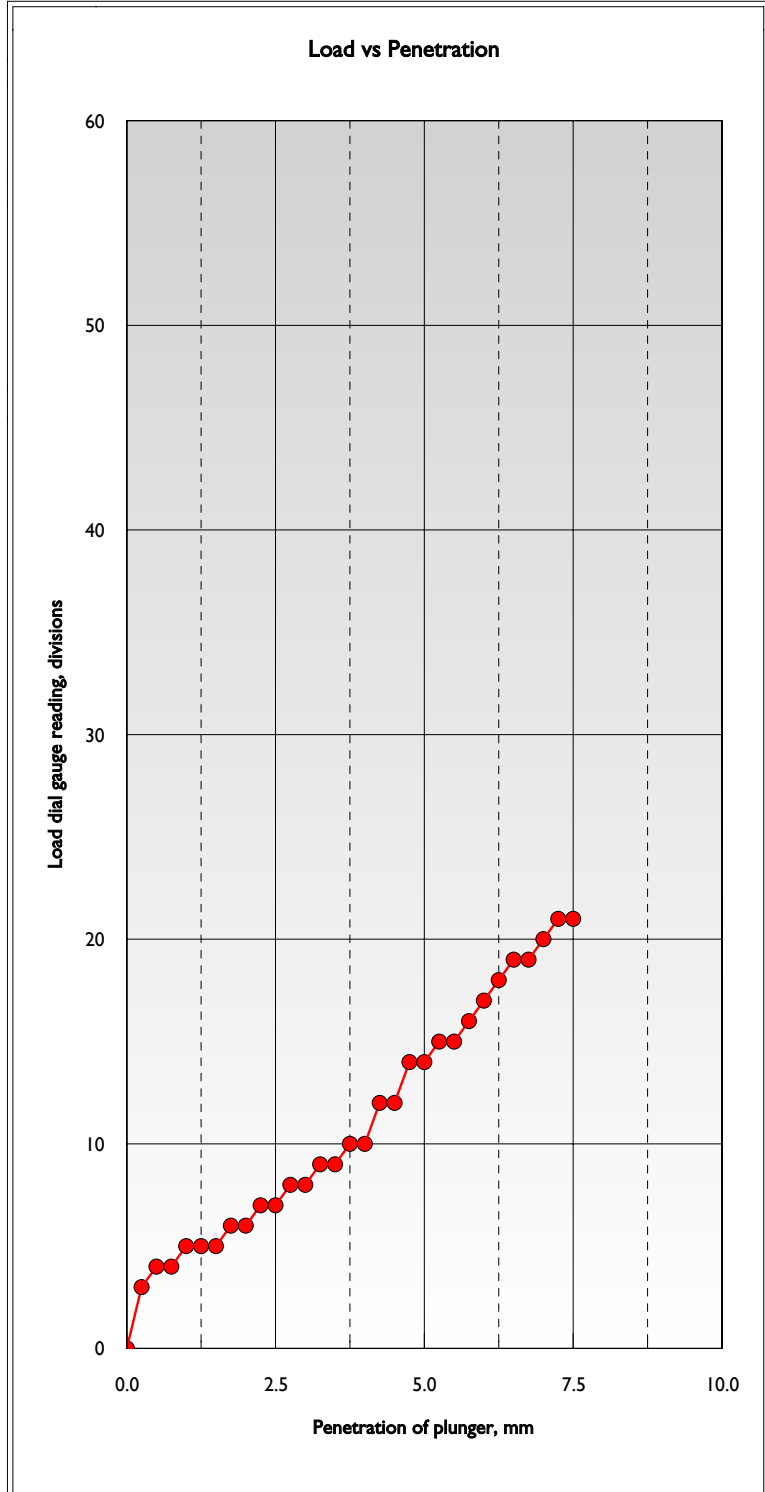
CBR at 2.5mm = (Dial reading x ring factor)/132.4

CBR at 5.0mm = (Dial reading x ring factor)/199.6

C B R	Top	Bottom
	1.4	
	1.8

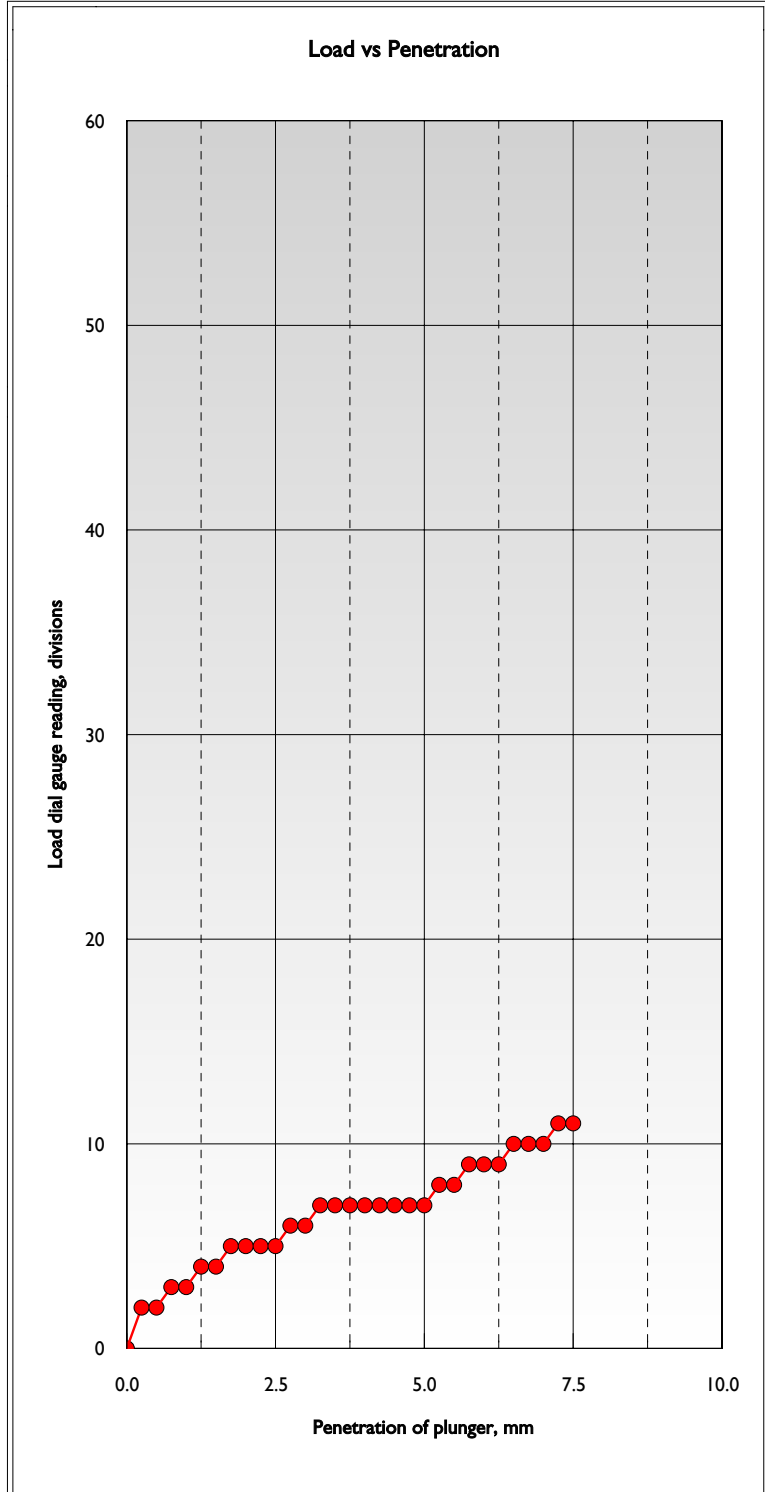
CBR at 2.5mm = (Dial reading x ring factor)/132.4

CBR at 5.0mm = (Dial reading x ring factor)/199.6

C B R	Top	Bottom
	1.0	
	0.9

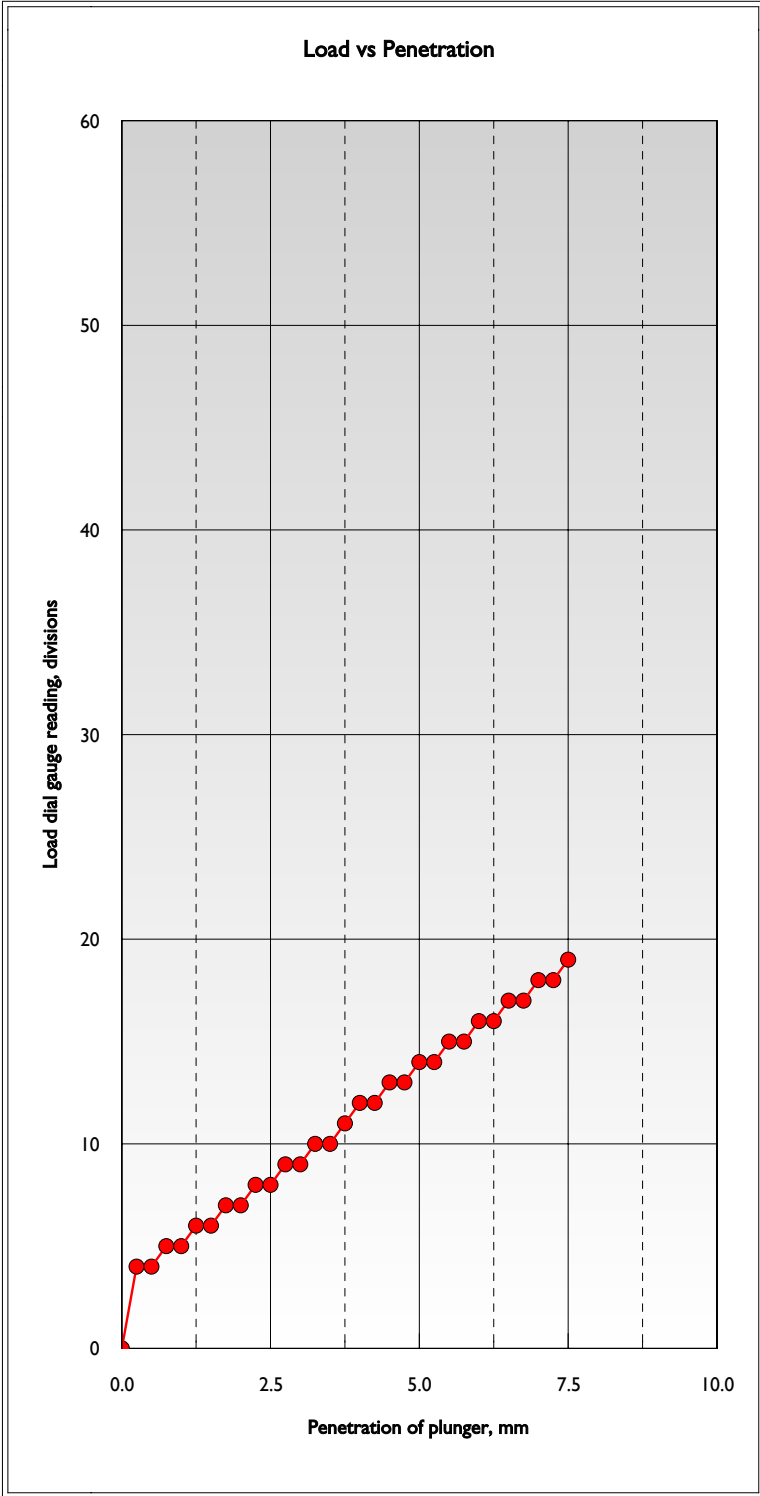
CBR at 2.5mm = (Dial reading x ring factor)/132.4

CBR at 5.0mm = (Dial reading x ring factor)/199.6

C B R	Top	Bottom
	1.6	
	1.8

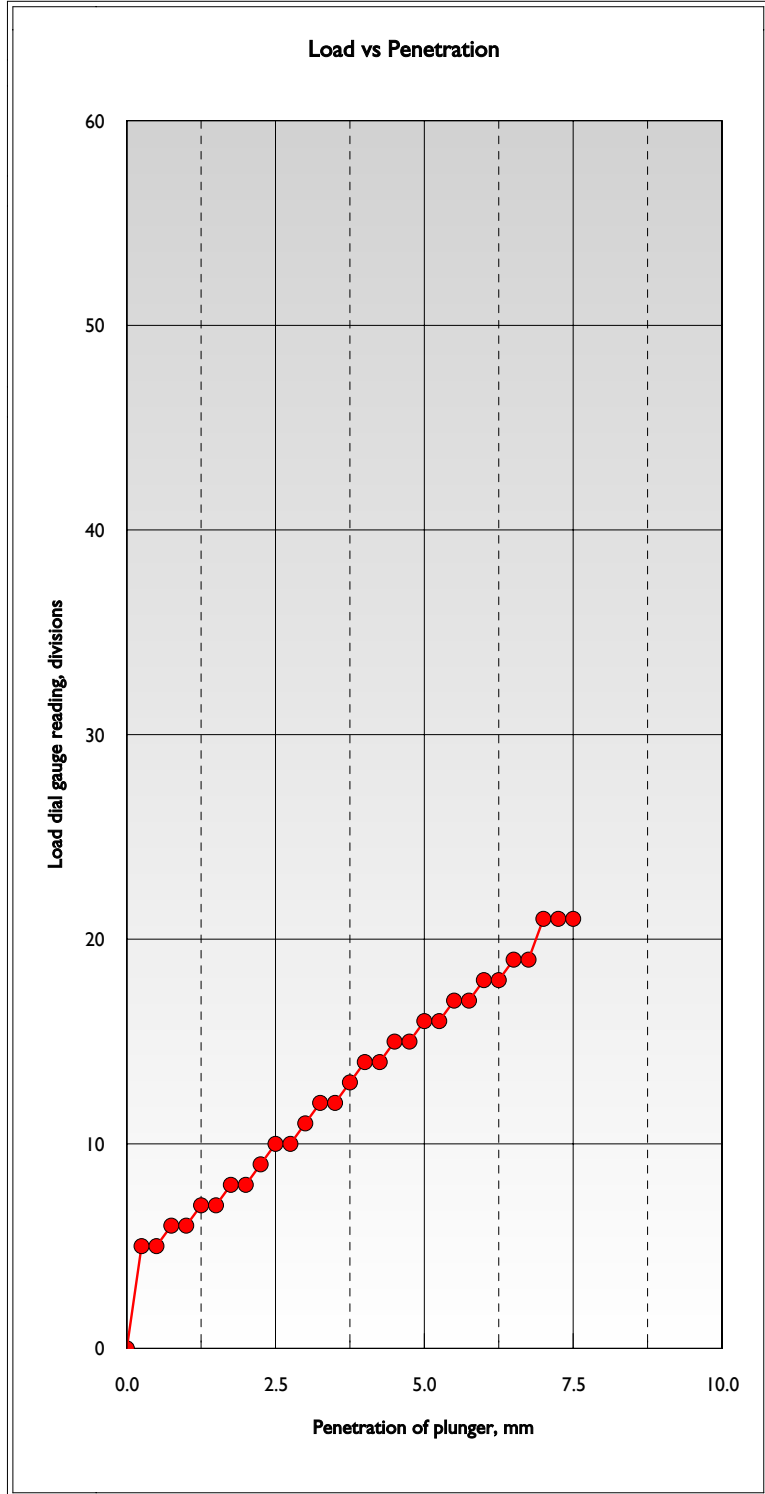
CBR at 2.5mm = (Dial reading x ring factor)/132.4

CBR at 5.0mm = (Dial reading x ring factor)/199.6

C B R	Top	Bottom
	2.0	
	2.1

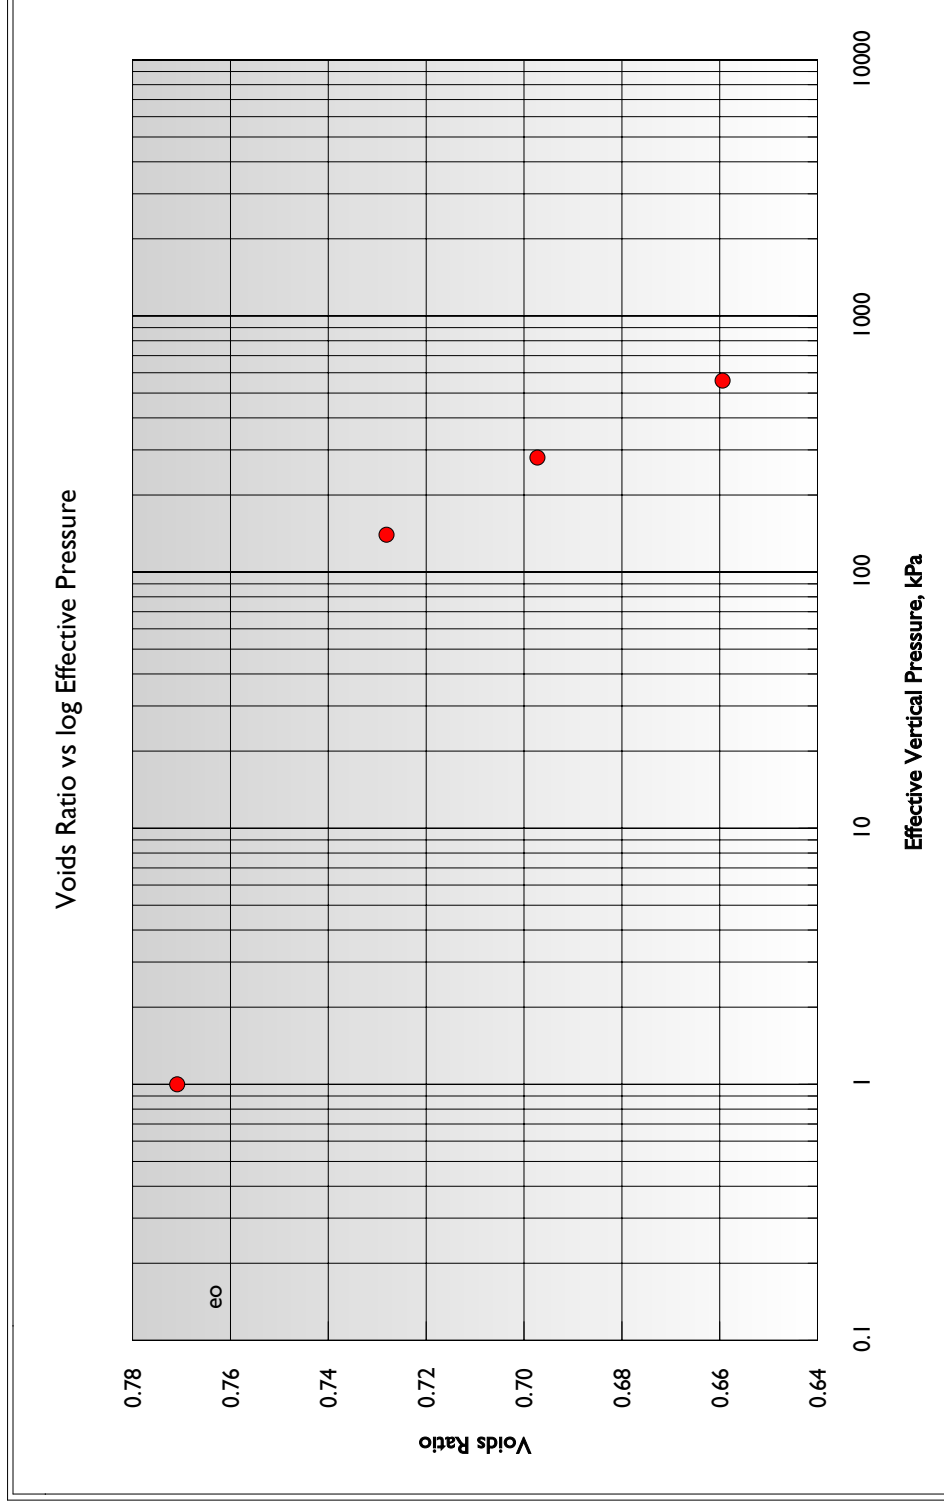
Project No: 3719
 Sheet No. 1/3

Borehole	Sample	Depth, m		
A	U9	6.50		
Description				
Stiff orange brown silty CLAY with occasional fine sand horizons				
Specific Gravity	Moisture Cont. %	Dry Density Mg/m ³		
2.730 measured	start 25 finish 23	1.542		
Pressure kPa	Coefficient of Consolidation m ² /year	Coefficient of Compressibility m ² /MN		
0	0.522	0.173		
140	0.450	0.128		
280	0.310	0.080		
560	0.295	0.086

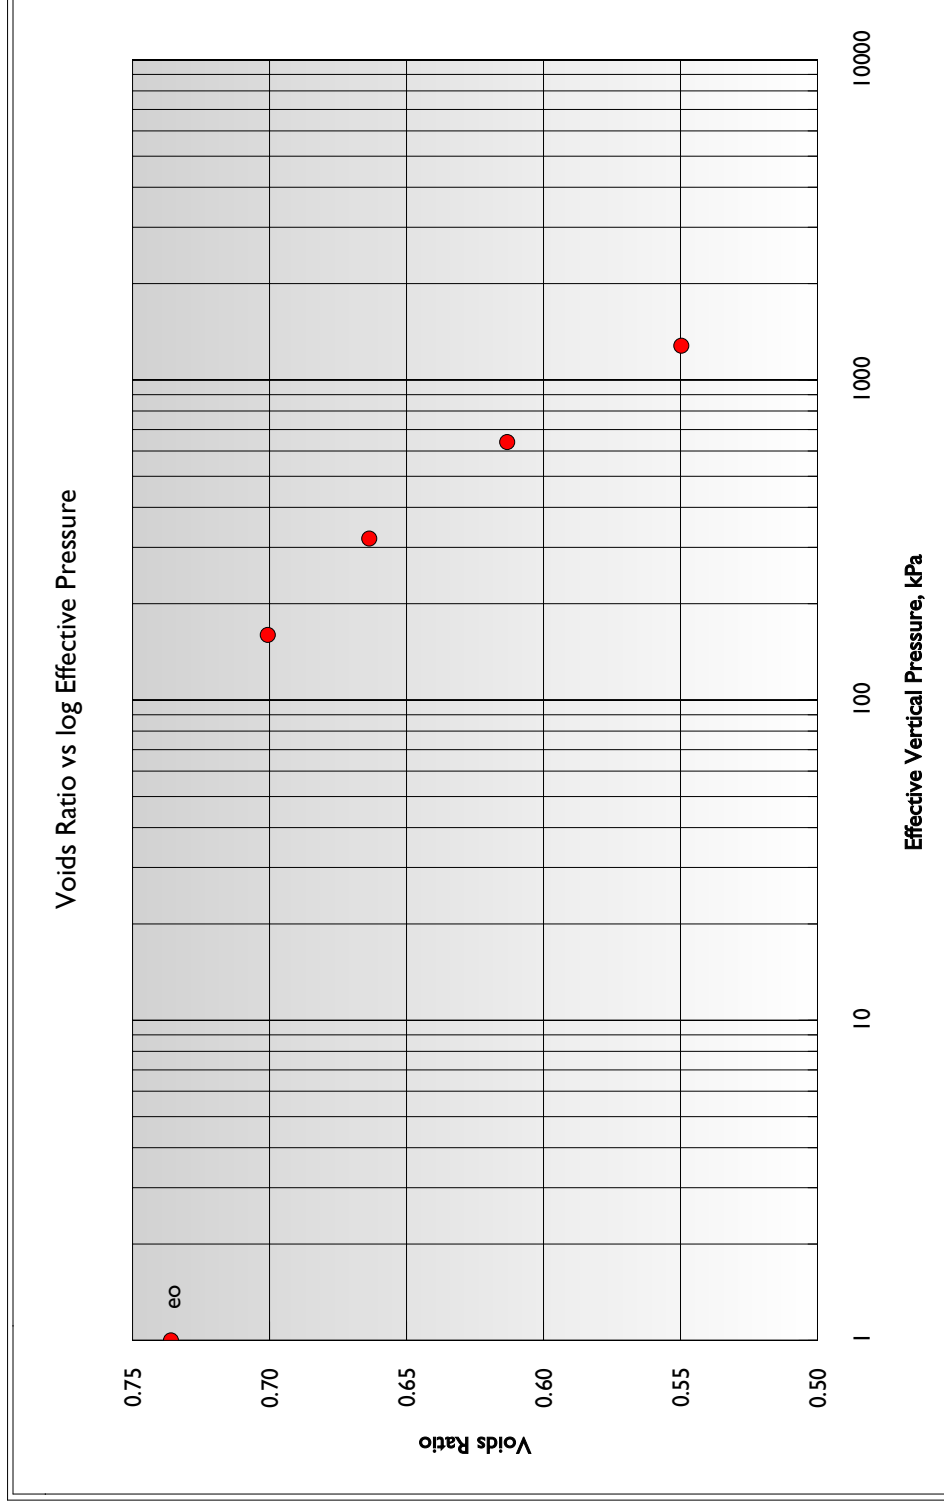
Project No: 3719
 Sheet No. 2/3

ONE - DIMENSIONAL CONSOLIDATION TEST

Borehole	Sample	Depth, m		
B	U8	6.00		
Description				
Stiff orange brown silty CLAY with occasional fine sand horizons				
Specific Gravity	Moisture Cont. %	Dry Density Mg/m ³		
2.730 measured	start 24 finish 22	1.573		
Pressure kPa	Coefficient of Consolidation m ² /year	Coefficient of Compressibility m ² /MN		
0	0.522	0.127		
160	0.450	0.136		
320	0.310	0.095		
640	0.295	0.062		
1280

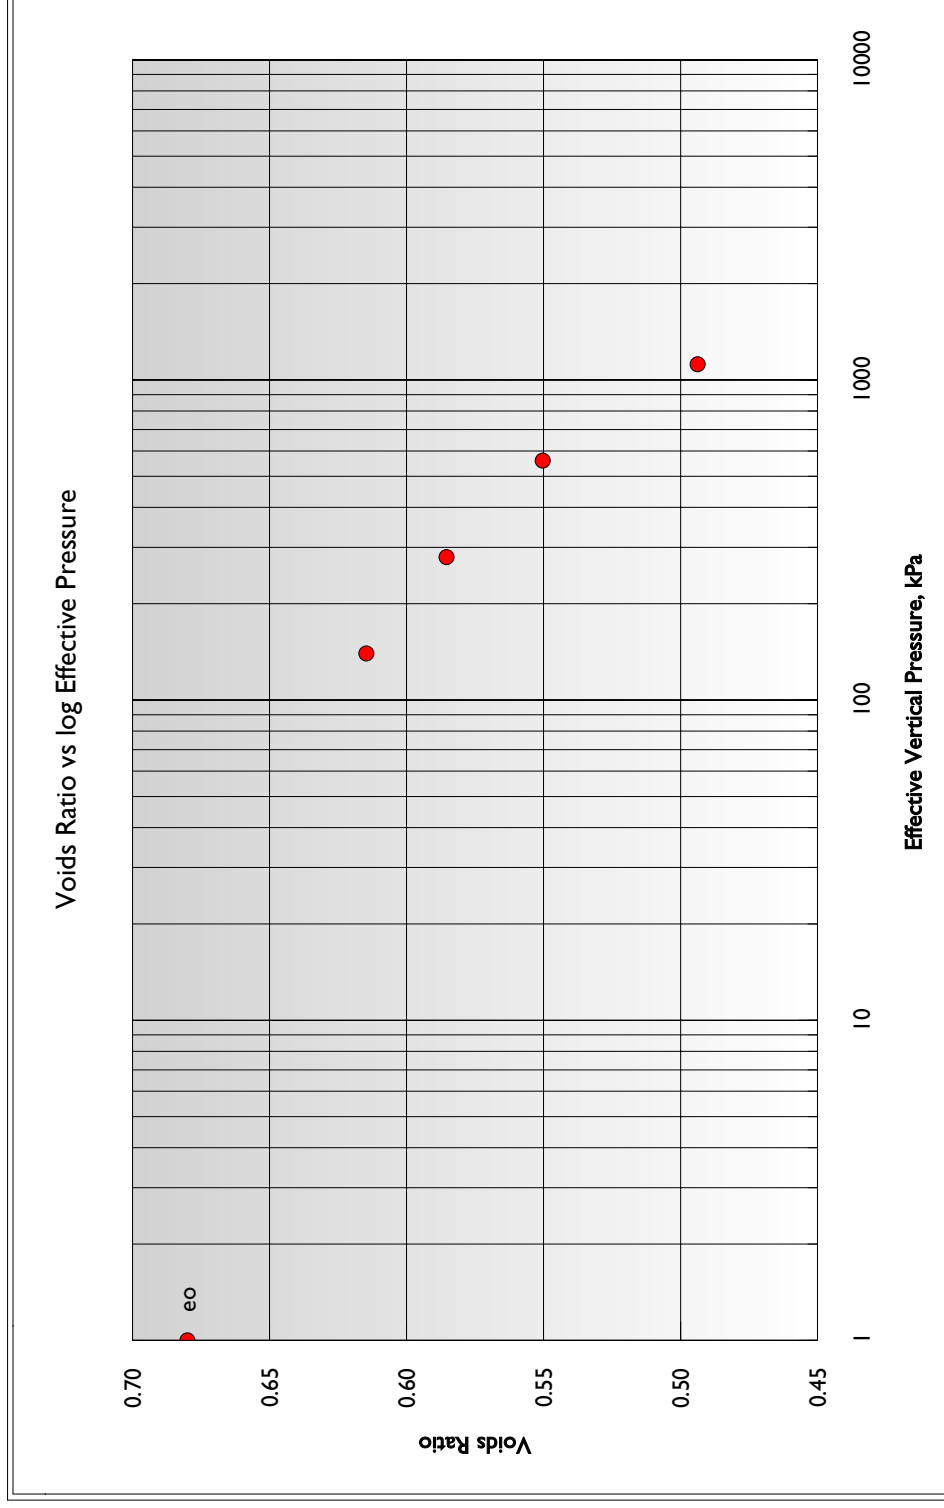
Project No: 3719
 Sheet No. 3/3

ONE - DIMENSIONAL CONSOLIDATION TEST

Borehole	Sample	Depth, m
C	U8	5.00
Description		
Stiff orange brown mottled light grey silty CLAY		
Specific Gravity	Moisture Cont. %	Dry Density Mg/m ³
2.730 measured	start 24 finish 22	1.625
Pressure kPa	Coefficient of Consolidation m ² /year	Coefficient of Compressibility m ² /MN
0	0.522	0.278
140	0.450	0.129
280	0.310	0.079
560	0.295	0.065
1120

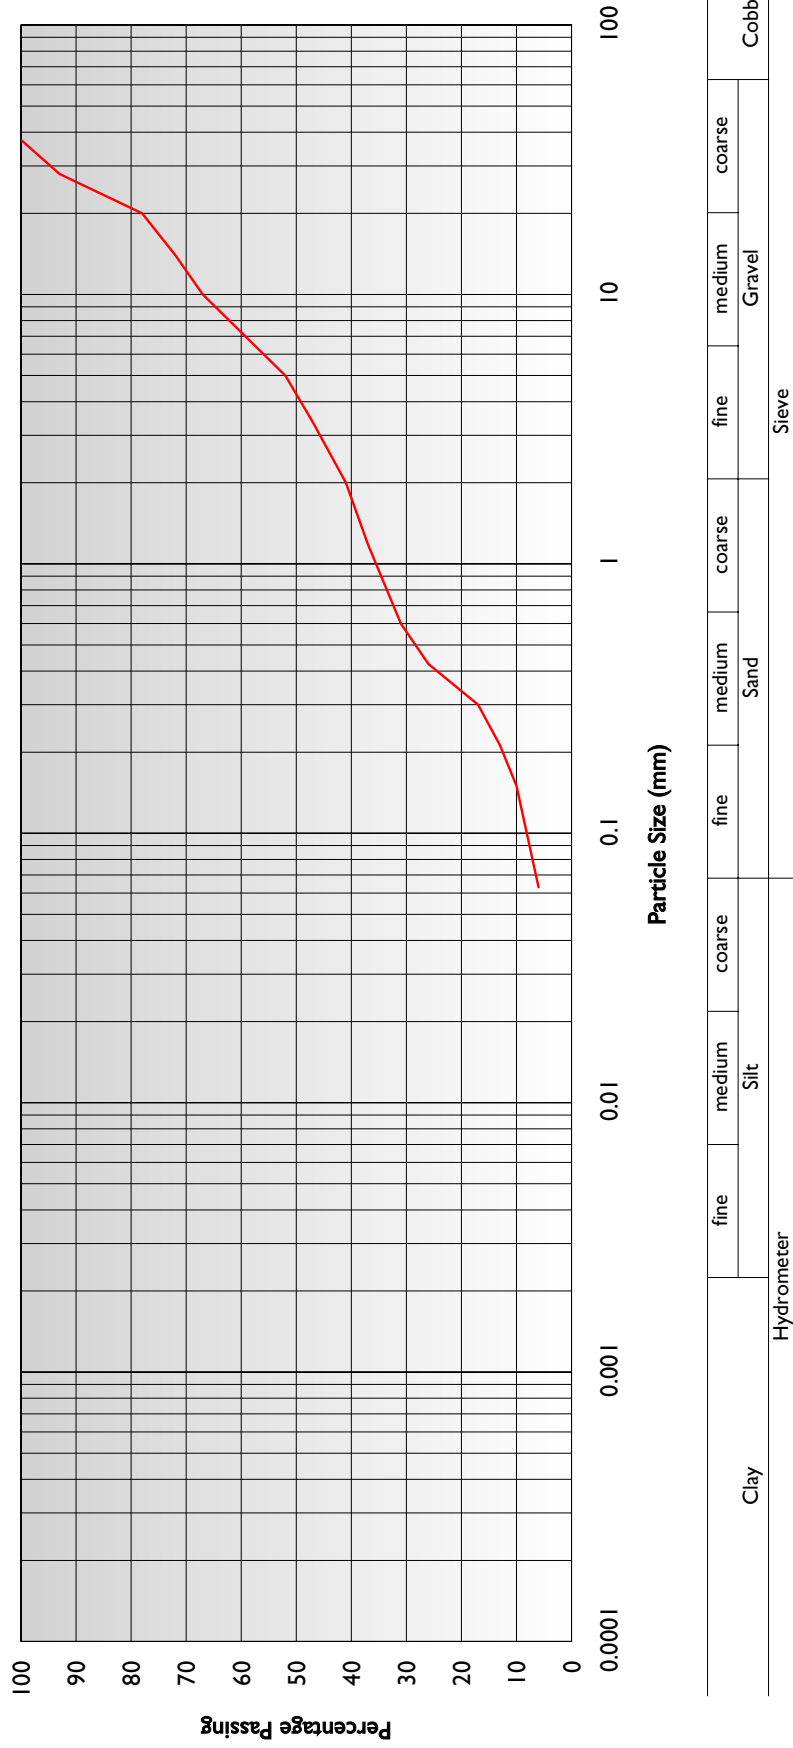
Project No: 3719
 Sheet No: 1/2

PARTICLE SIZE DISTRIBUTION

Location: **BHA**
 Sample: **B5**
 Depth, m: **4.00**

Description:-
 Orange brown medium to coarse SAND and fine to coarse GRAVEL

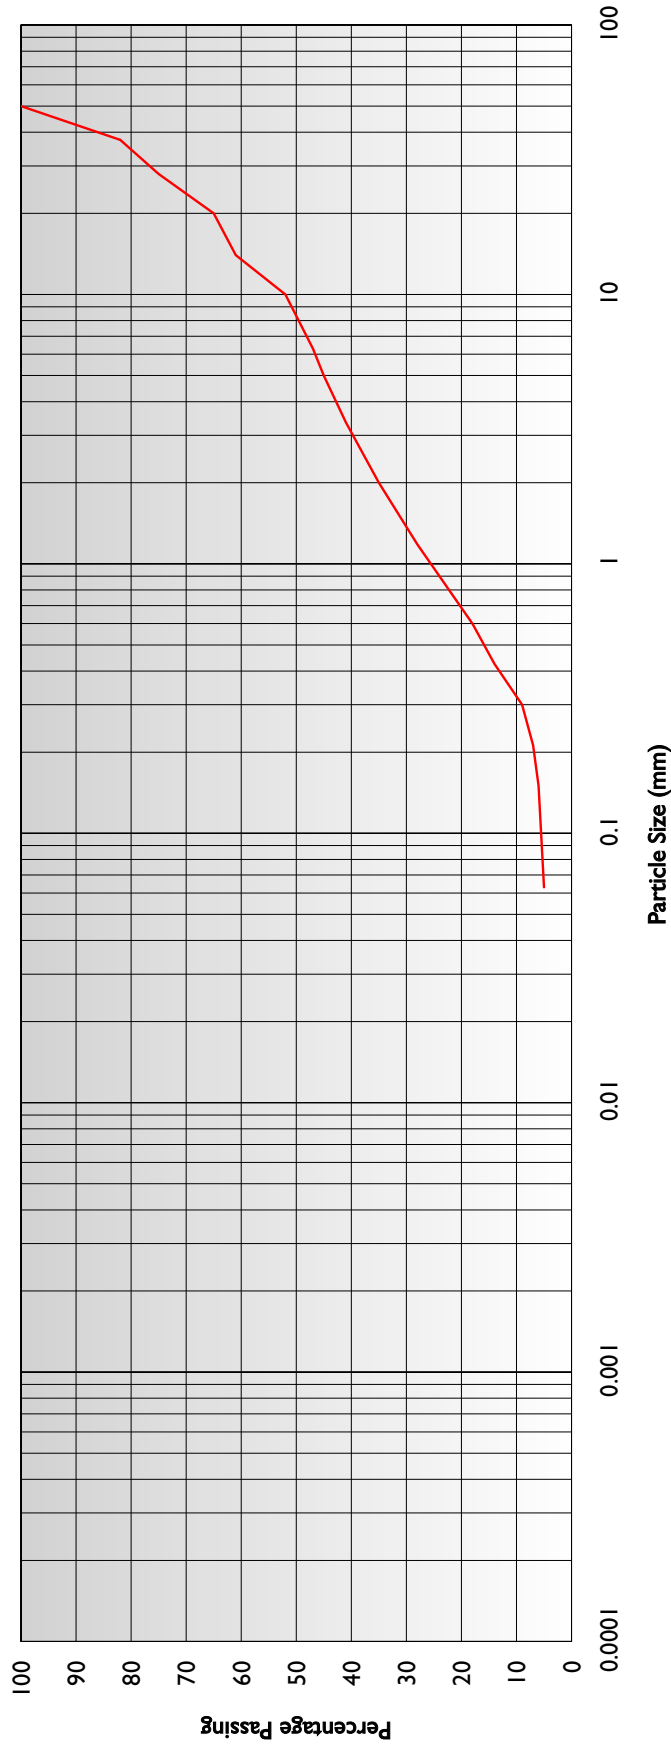
Project No: 3719
 Sheet No: 2/2

Location: **BHC**
 Sample: **B6**
 Depth, m: **3.00**

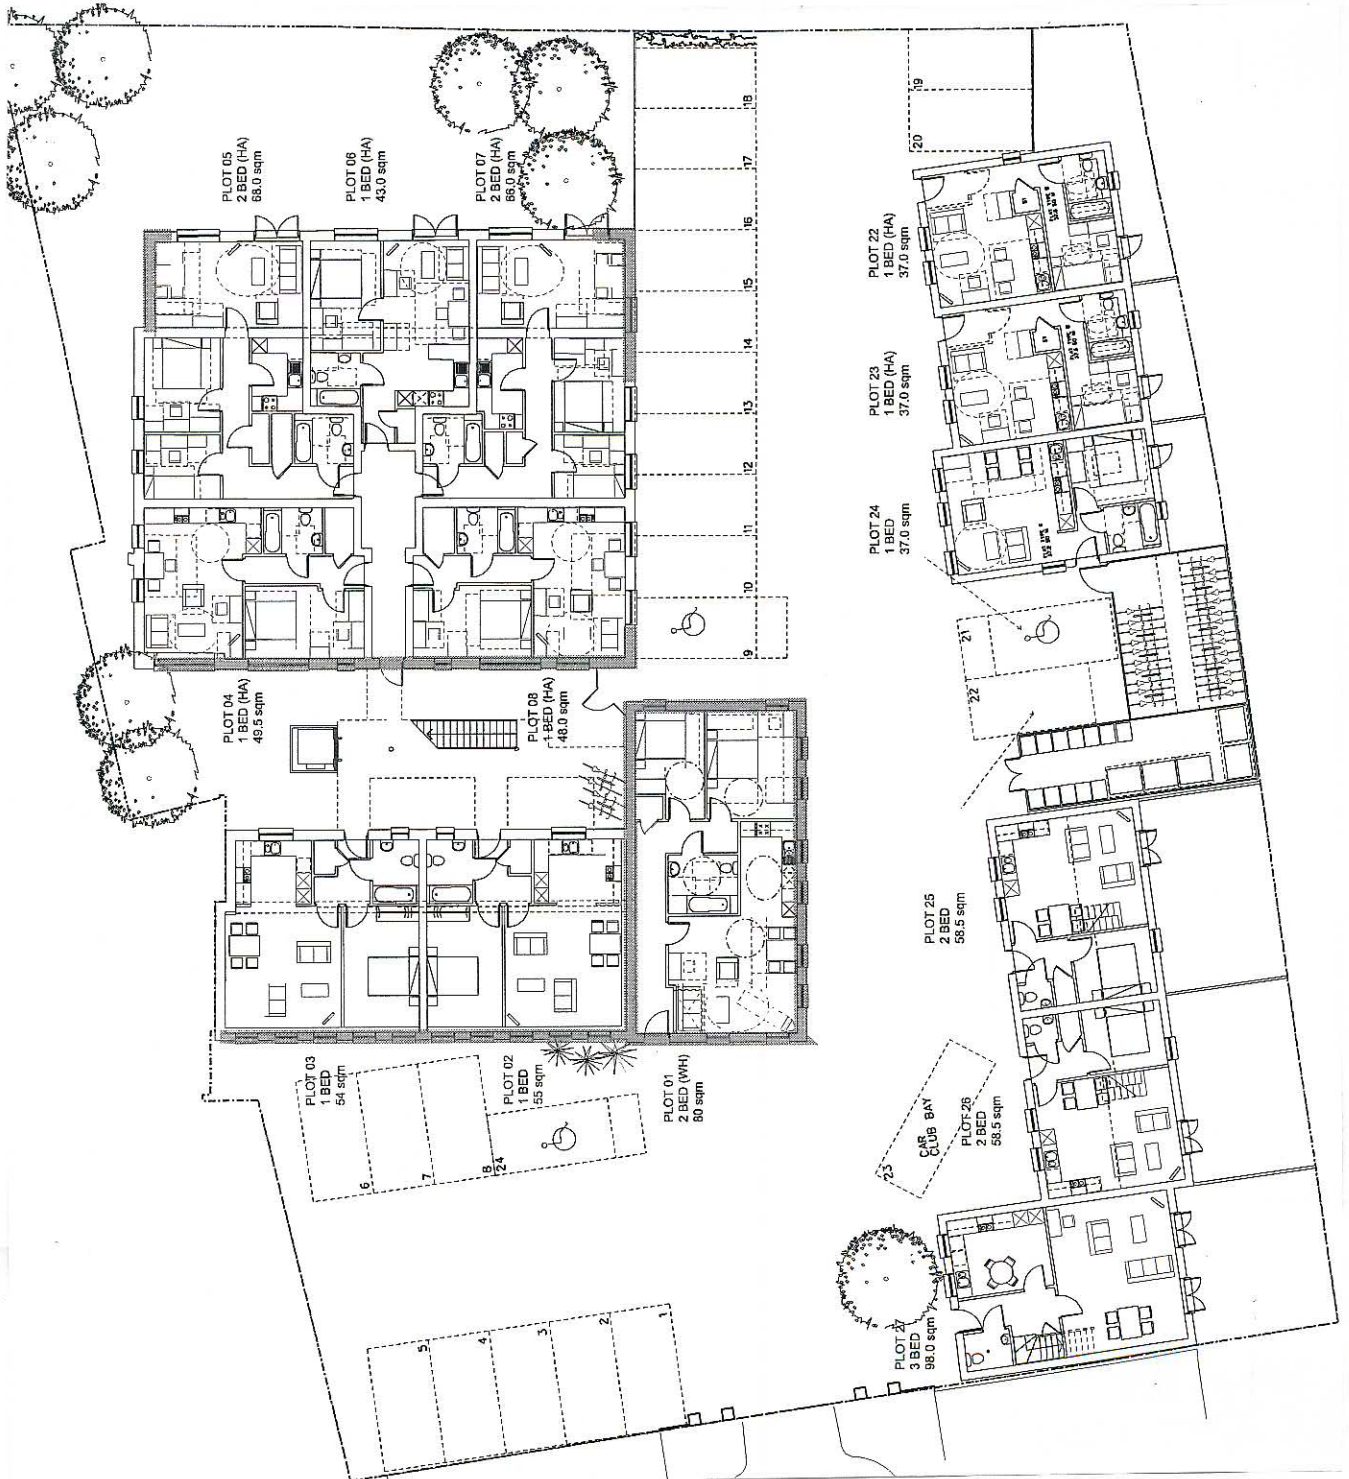
Proposed site plan

The main building will utilize a combination of existing/ retained foundations and new footings as shown at Figure 2 of Appendix E, which also shows the proposed layout.

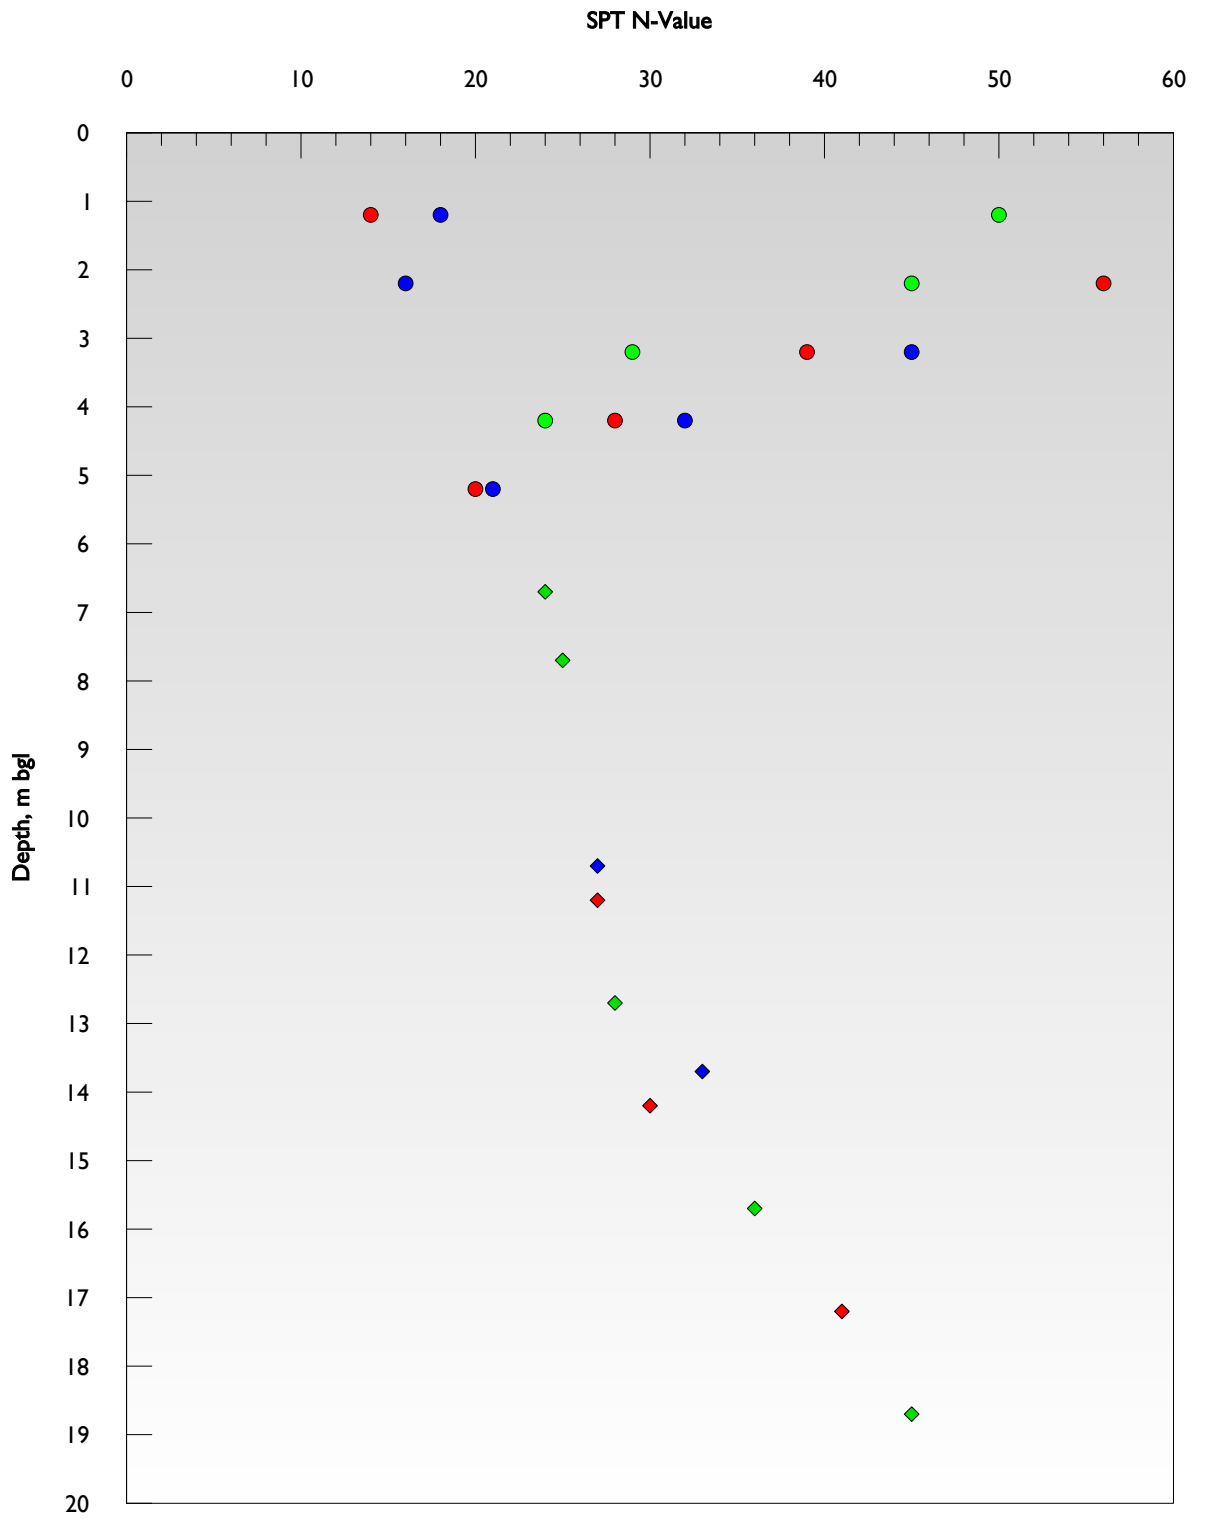
SPT PROFILE
37 Hamilton Road, Twickenham

Cohesive strata shown as diamonds
Granular strata shown as circles
N values >50 extrapolated to 300mm penetration

Representative soil and water samples were recovered from the borehole for subsequent laboratory examination and testing; whilst Standard Penetration Tests (SPT) were carried out as appropriate. Details of the strata encountered are provided on the Borehole Records at Appendix A; together with particulars of the samples recovered, groundwater observations and SPT results. A profile of the SPT data against depth is provided at Figure 3 of Appendix E.
