**Appendix G: Visual Impact Assessment of Floodlighting  
(01/05/13)**

St James Group

VIA of floodlighting at proposed residential development at the Twickenham Sorting Office

**Date** 1 May 2013

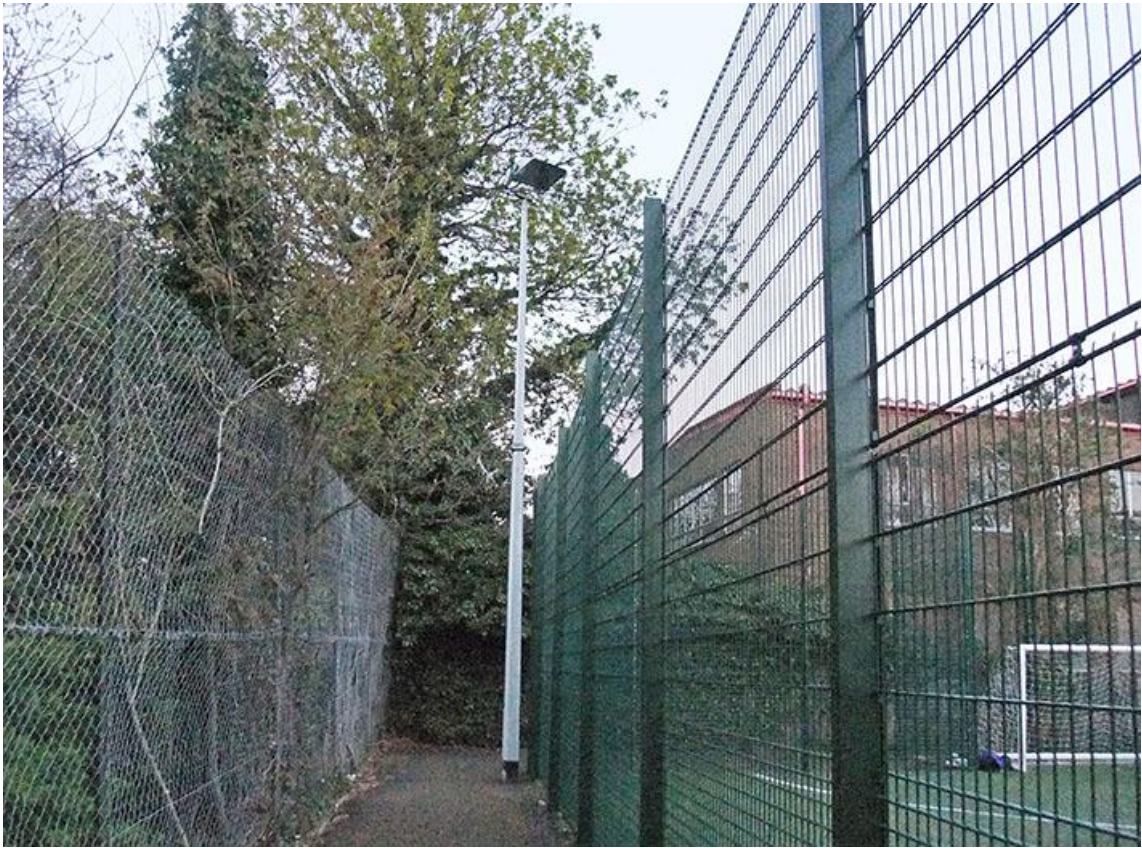
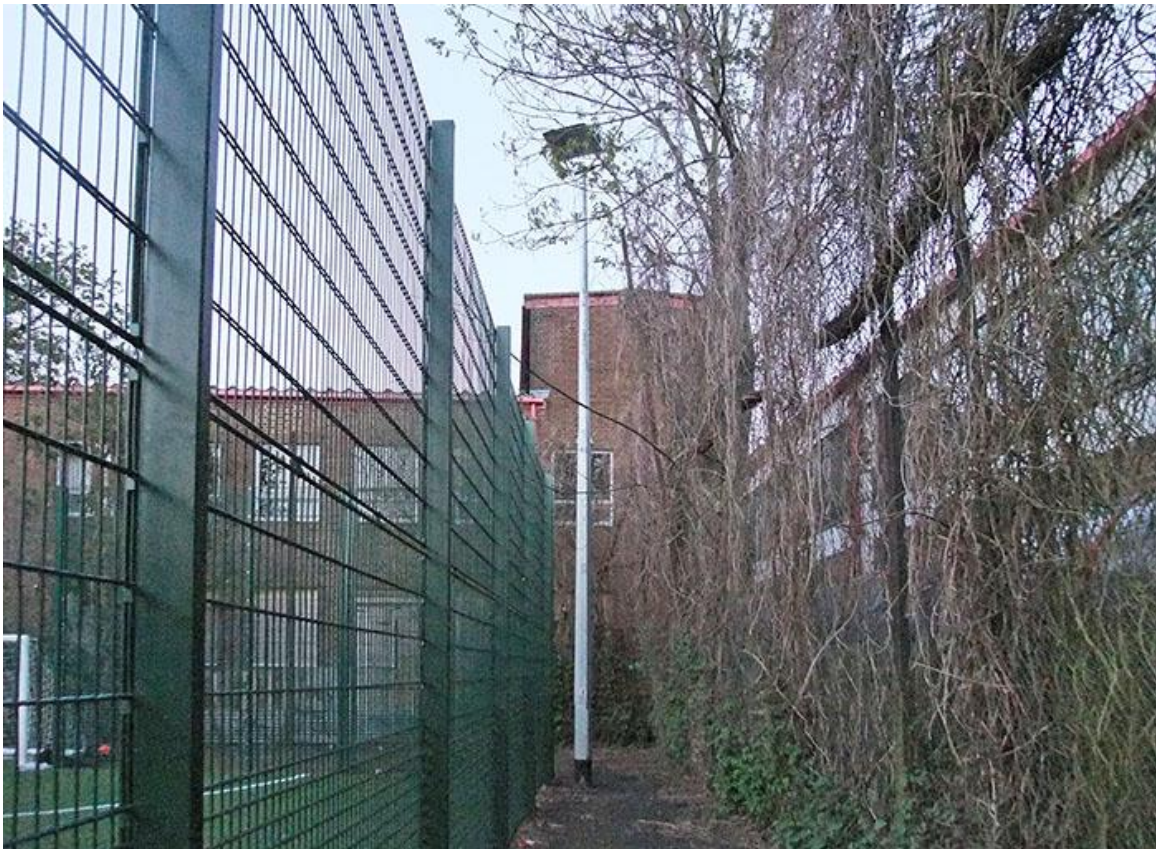
<b>Twickenham Sorting office</b>																				
<b>Measured lux levels on 5 a side pitch</b>			30 April 2013																	
Values below taken 6m from end of pitch i.e. Boundary with basketball court																				
Eh			Eh path			Allotment			Allotment			Allotment			Eh path			Eh path		
15			210			100			257			90			137			96		
12			150			45			90			30			54			26		
25																				
25			Goal mouth			Playing Area			Area			18m x 36m			Goal mouth					
40																				
15

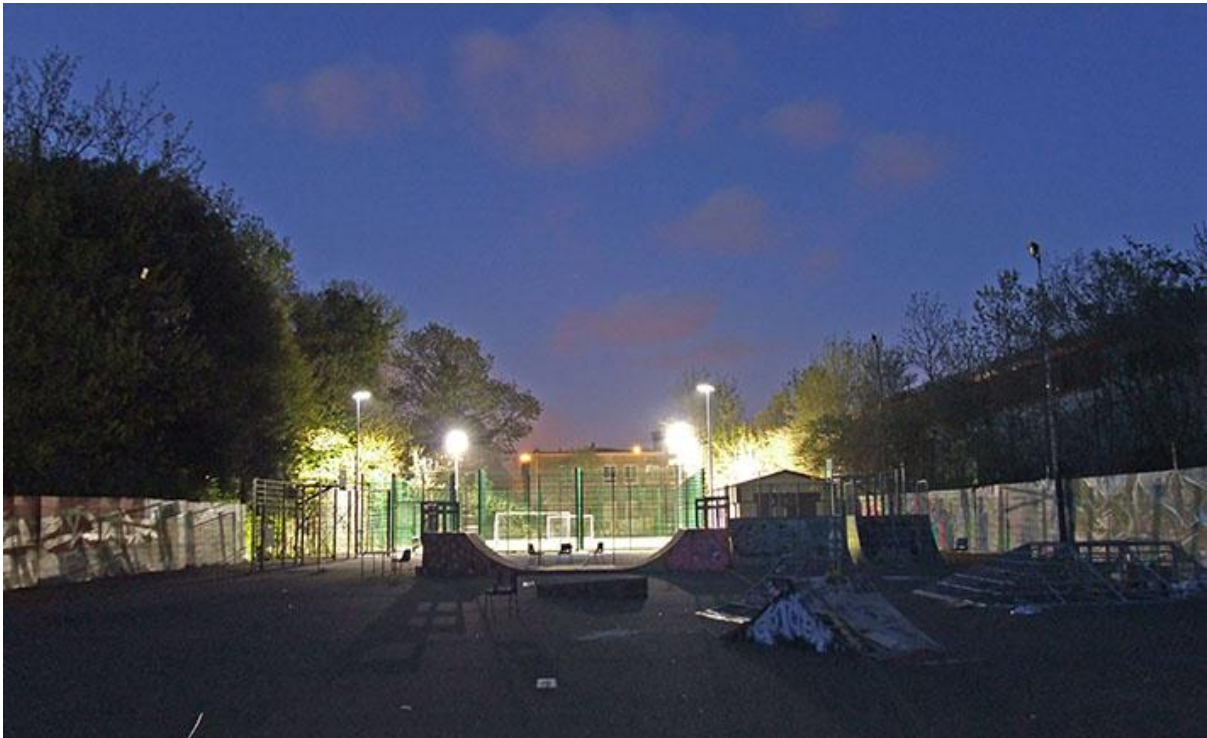
The Eastern boundary path is 2m – 3m from the end of the pitch and the average vertical illumination is in the region of 17 lux although this measured value may be slightly low since there was some shadowing from the foliage overhead.

In order to gain a better indication of the rearward spill, we measured values at the fence-line of the basketball court which is some 6m (remember that the apartment block is 8m) from the edge of the 5-a-side pitch. Here, the average vertical value at 1.5m above ground is 22 lux but, in places, exceeds 40 lux.

**View towards Eastern end of pitch**

In terms of light intrusion into windows, the measured values exceed those recommended by the ILP. However, it is likely that fitting rear baffles to the floodlights will lead to a significant improvement and may cut off the light completely. Note that fitting rear baffles will not adversely affect the lighting on the pitch. We recommend that baffles are fitted.

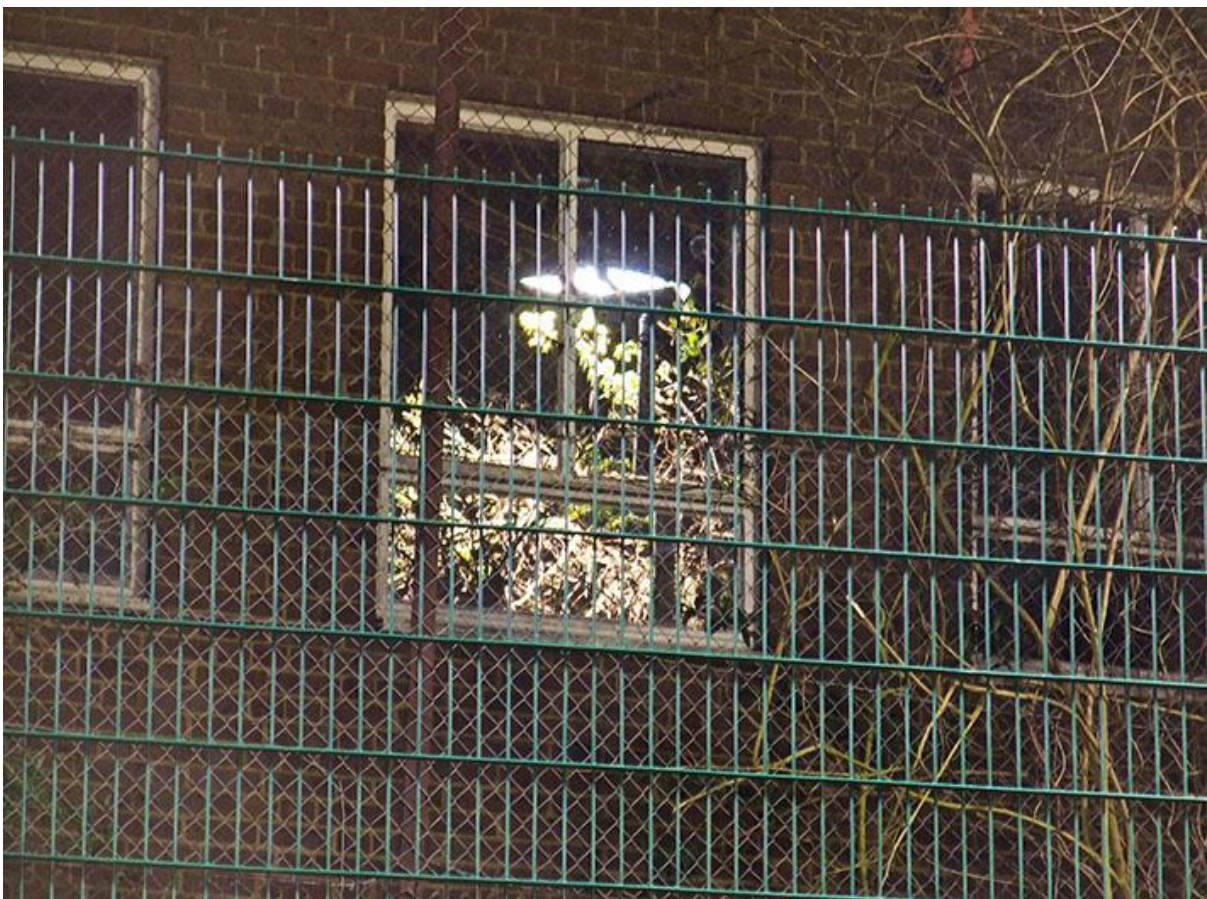
You can see from the photos that there is some spill light across the whole of the building, albeit the level is quite low.

**View showing some spill light on vertical face of Sorting Office (at end).**

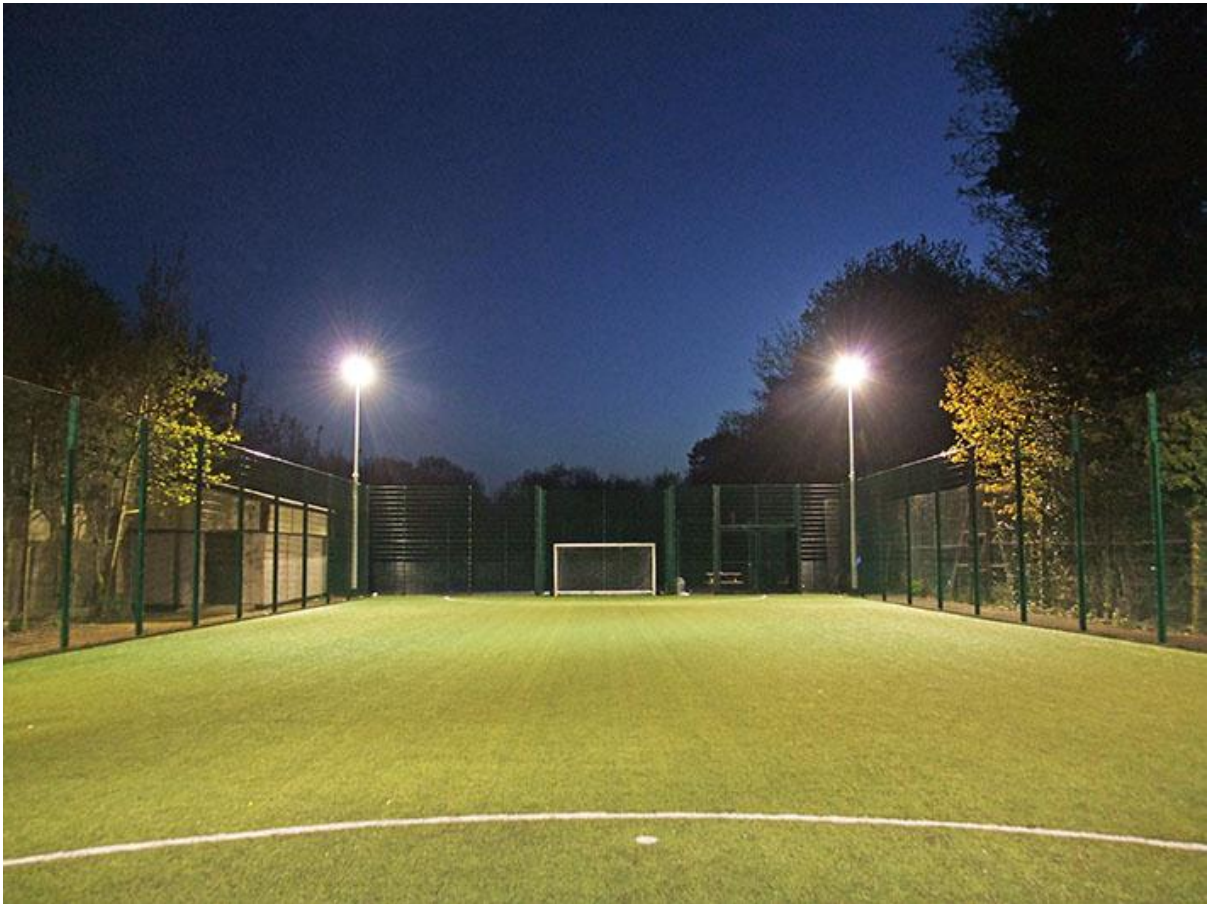
Currently, some windows do receive a direct view. This can be seen in the photograph where there is a reflection of the floodlight in the window. However, it is quite possible that this is below the 10,000 Cd limit.

**Closeup view of reflection in window**

Direct view of the lamp/reflector from the rear can be eliminated by using a visor. It is sometimes possible to view the lamps from the front and some manufacturers offer front visors. Tilting the floodlight downwards can ameliorate the situation but risks adversely affecting the lighting on the pitch.

We recommend fitting rear visors on the two floodlights closest to the apartment block. The deeper the visors, the greater the reduction in rearward light. Similarly, if possible, front visors should be fitted to the floodlights further away.
