Teddington Riverside, Teddington

Geoenvironmental Desk Study

Haymarket Media Group

11477

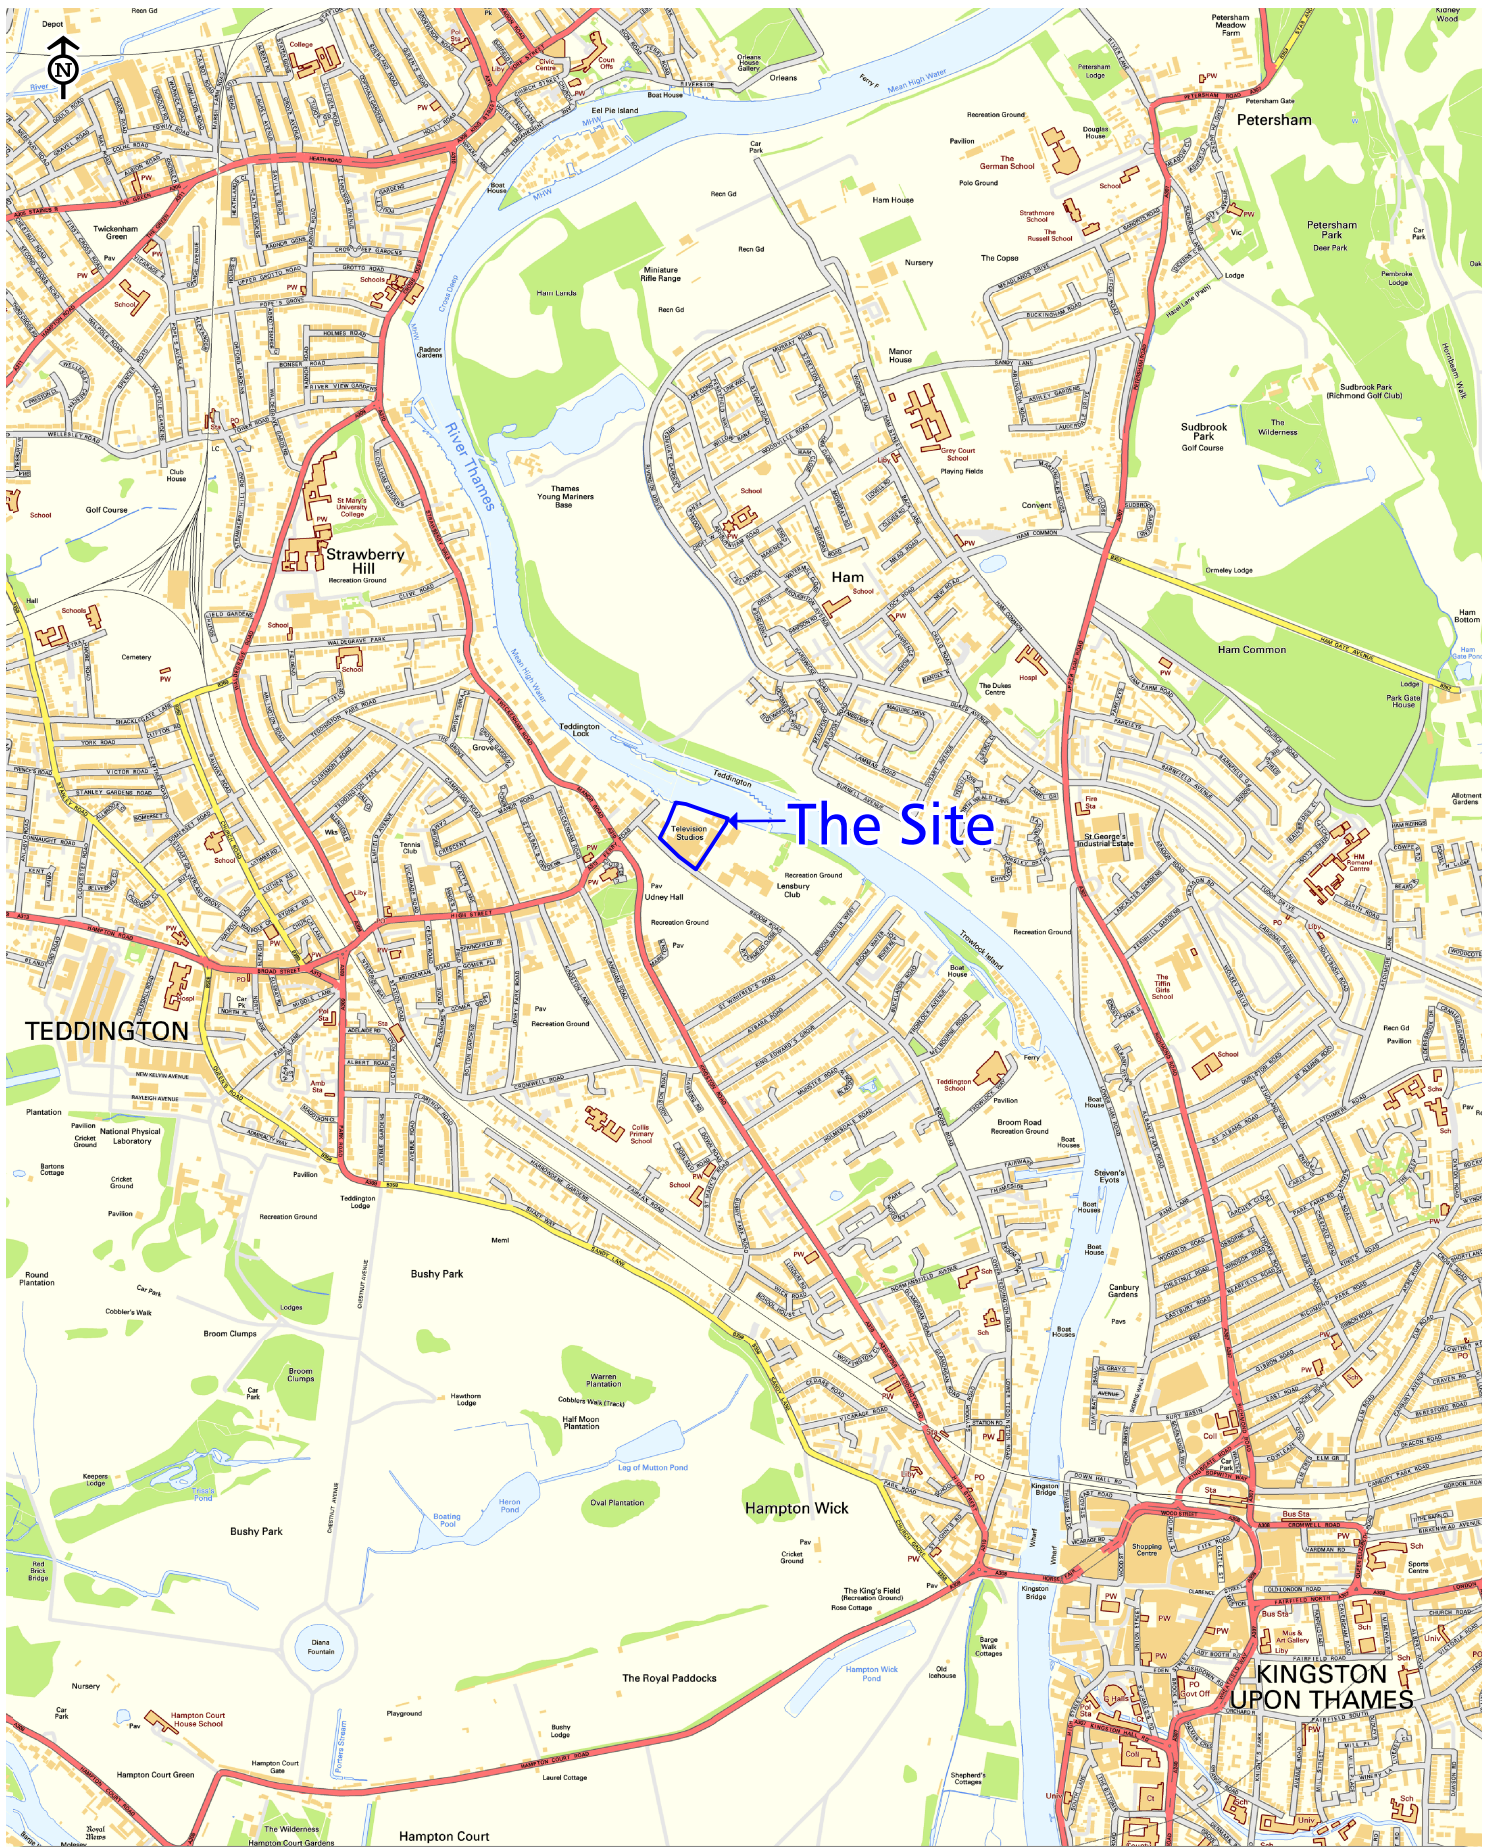
Site Photographs

- 2.3 An annotated site layout plan is presented in Figure 2.2 and site photographs in Appendix A. A site walkover was undertaken by a CampbellReith engineer on 1st October 2013, which forms the basis of the following description.
