38-42 Hampton Road,
Teddington TW11 0JE

Phase One Environmental Assessment (Desk Study)

BYRNE GROUP

March 2015

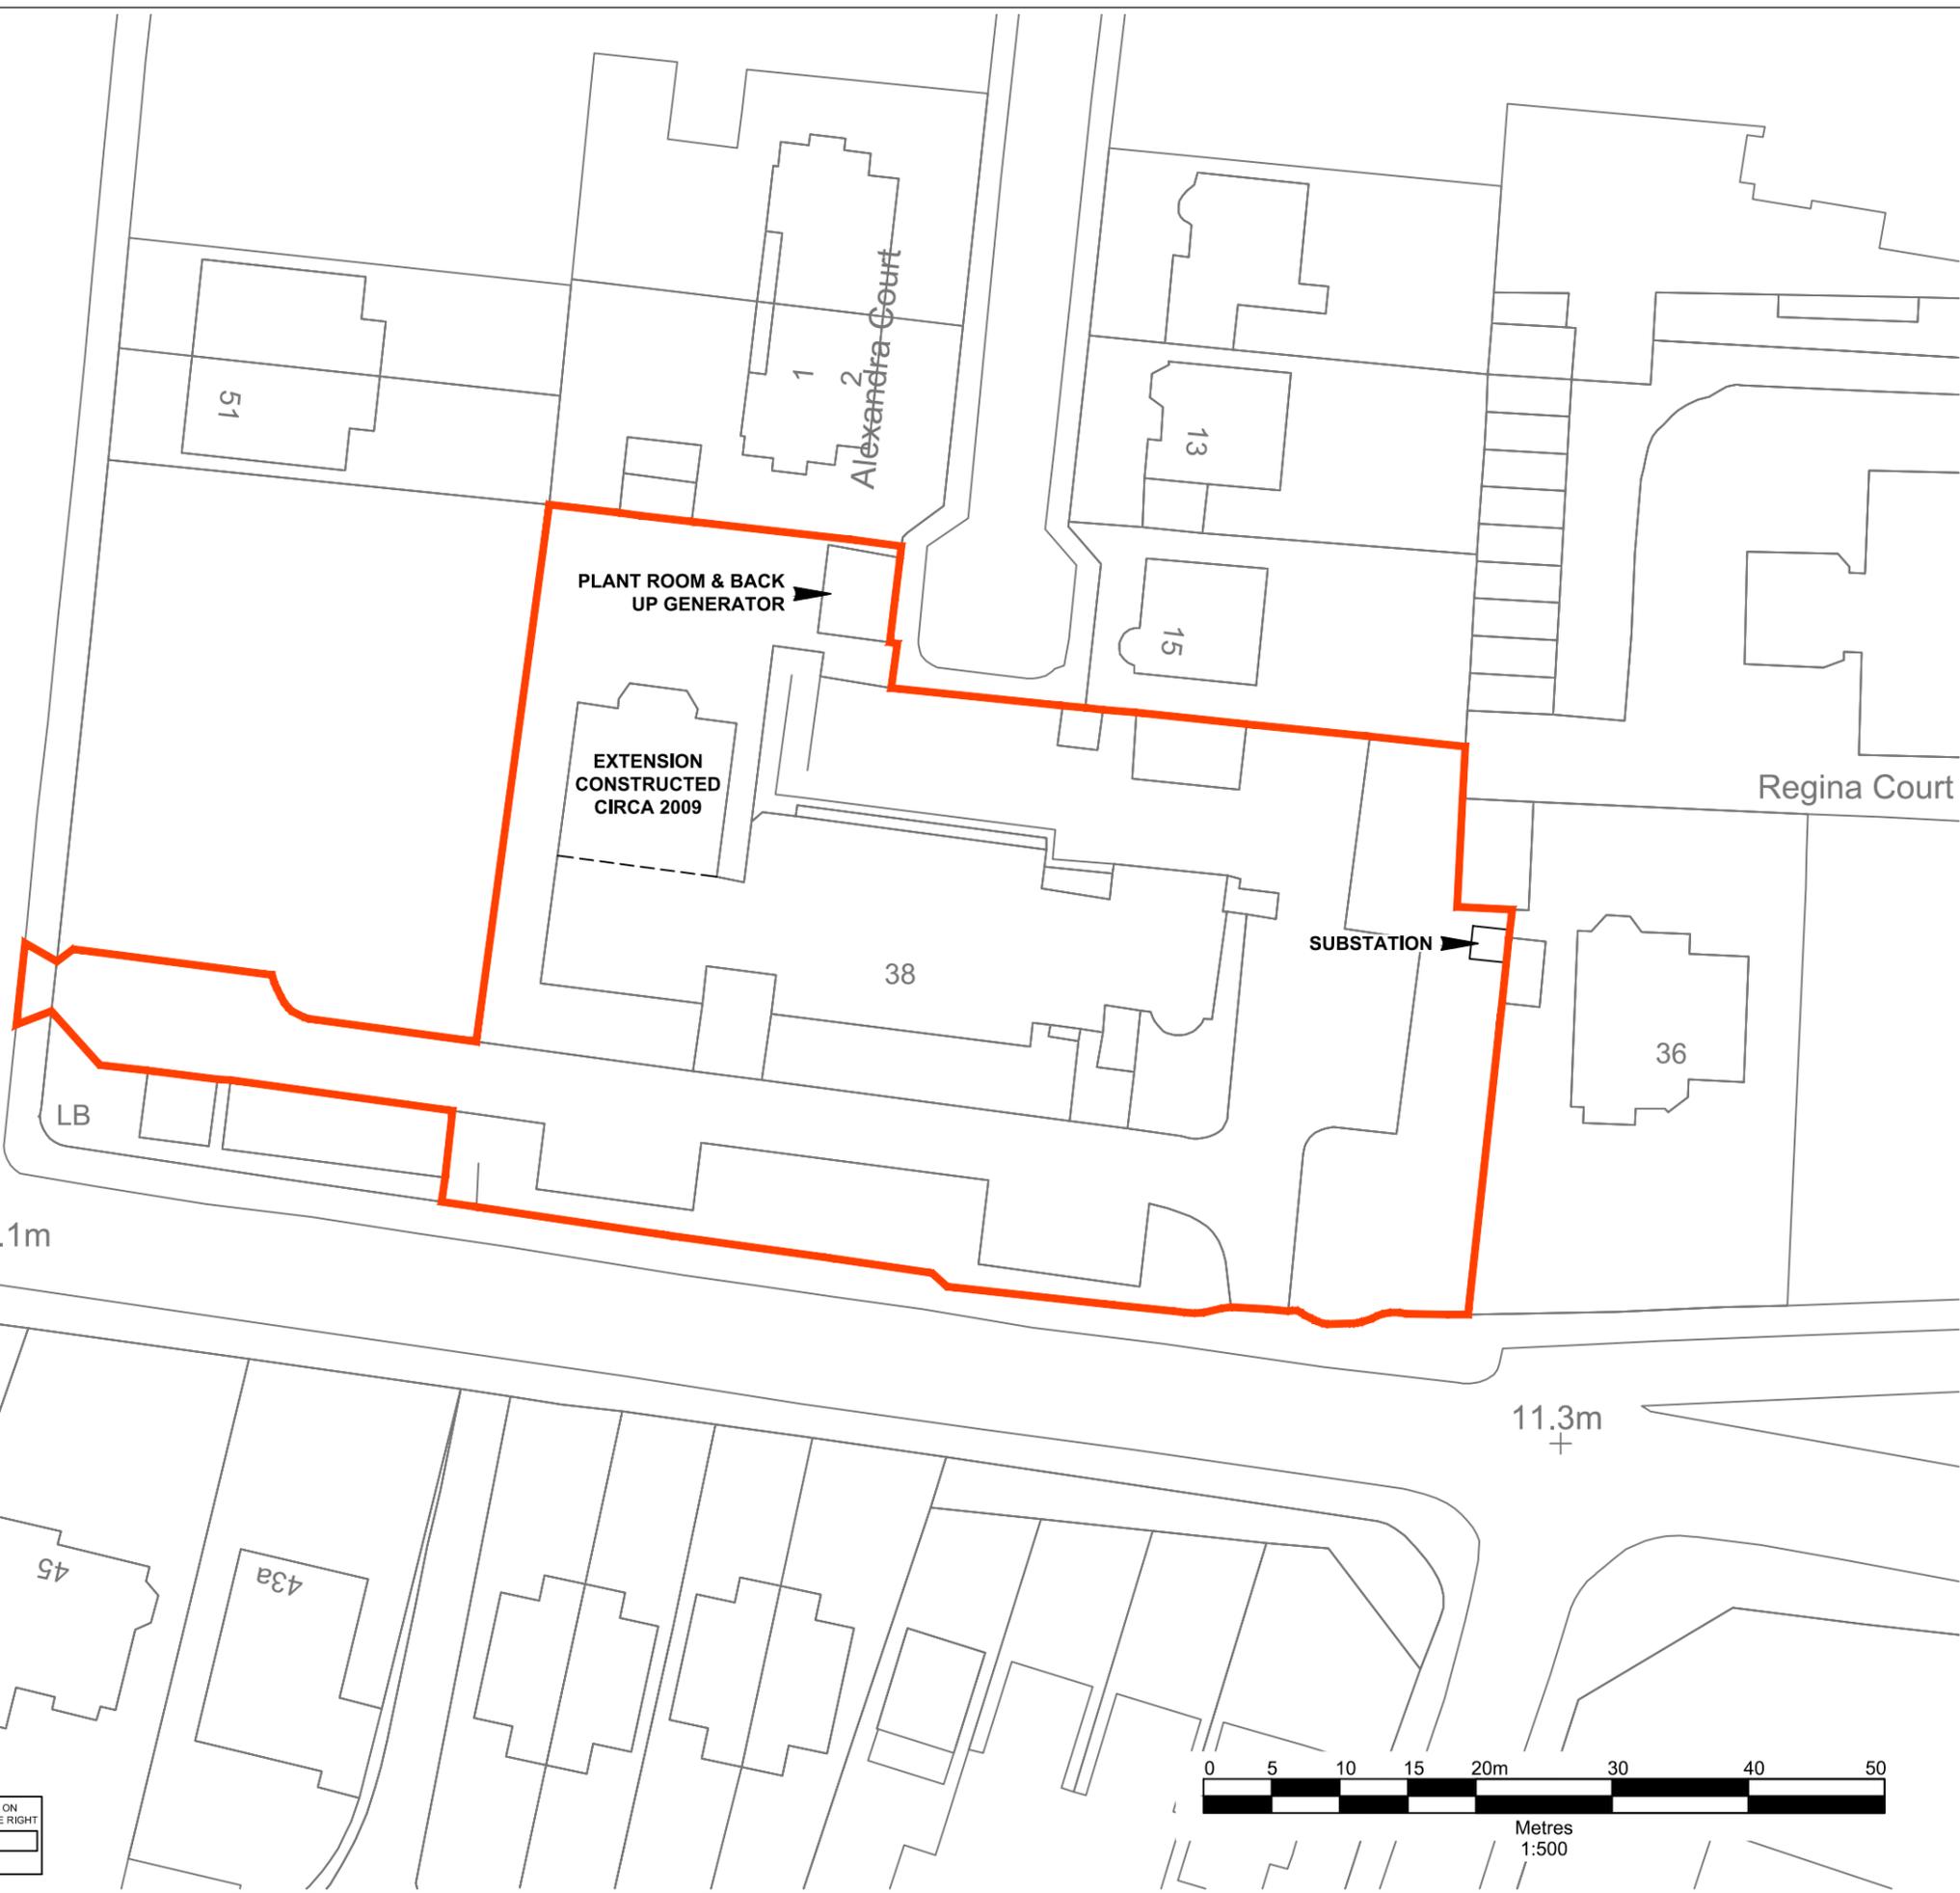
DWG No. 1

This report concerns the site identified as 38-42 Hampton Road, Teddington TW11 0JE (the site). The site comprises a four storey office building on the north side of Hampton Road; the study boundary and current site layout are shown on Drawing 1.

The study boundary is shown on Drawing 1.

38 - 42 HAMPTON ROAD
TEDDINGTON
PHASE ONE ENVIRONMENTAL
ASSESSMENT
SITE LAYOUT PLAN

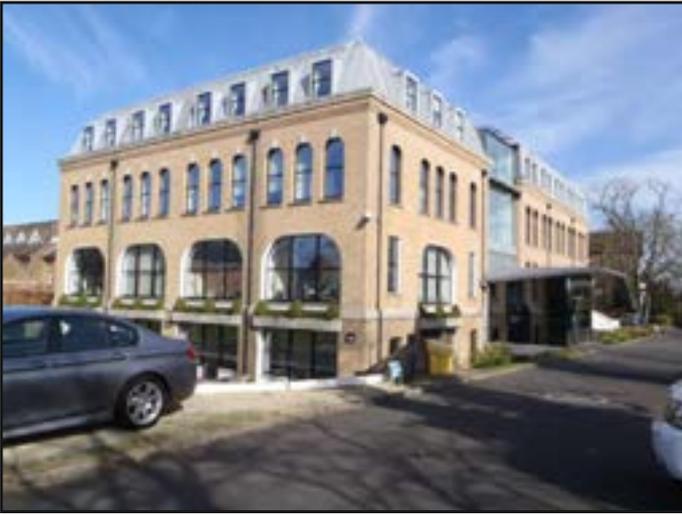
PHOTO 1

The majority of the site is occupied by a four storey office building of apparently conventional construction. The site includes two small subsidiary buildings on the north site boundary (a plant room and a furniture store) and hardstanding to the north, south and east of the main building. There are some small areas of soft landscaping, particularly on the south site boundary, but the landscaped garden located immediately west of the main building is outside the site boundary.

Main building from the south west

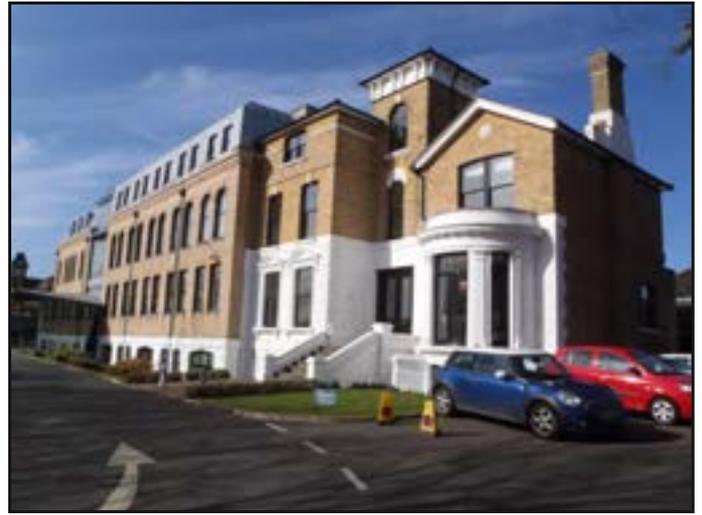
PHOTO 2

Main building from the south east

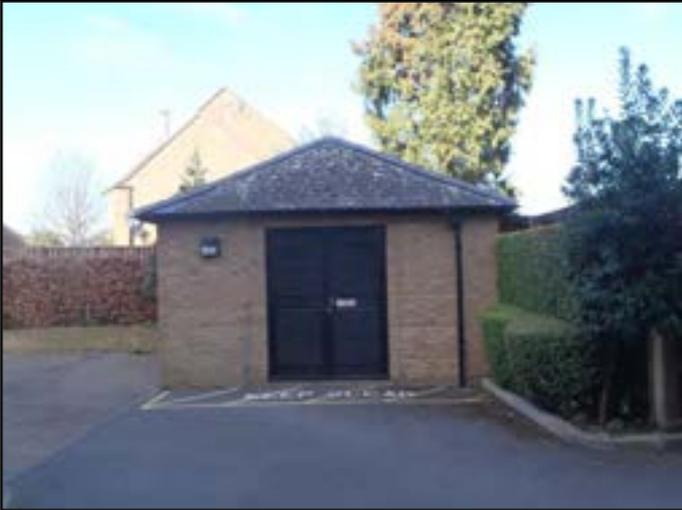
PHOTO 3

One of the subsidiary buildings on the north site boundary is a plant room which houses a back-up generator. The generator is supplied directly from 205litre drums of gas oil of which two were present at the time of SLR's site visit. The drums are unbanded but there was no staining to the floor of the building or any other evidence of spillages.

Plant room

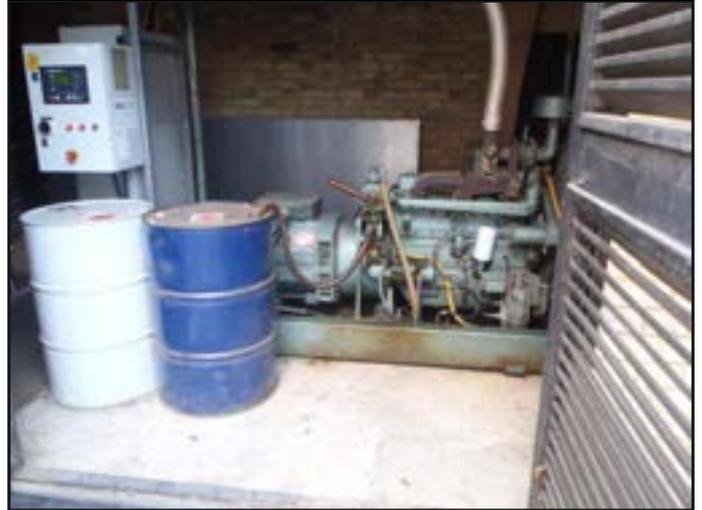
PHOTO 4

The back-up generator (housed in one of the ancillary buildings) is supplied directly from 205litre drums of gas oil, these were observed to be unbanded but no staining or evidence of spillages was observed.

Back up generator
