APPENDIX C

Topographic Survey & Architect's Scheme Drawings

W:\Projects\5228 FRA, M and M, 2 sites on Bucklands Road, Teddington TW11 8SQ\2.3 Specifications & Reports\F. Flood Risk Assessments	Date March 2014	Job No. 5228/2.3F
---	--------------------	----------------------

Project: Garages at Bucklands Road, Richmond, London, TW11

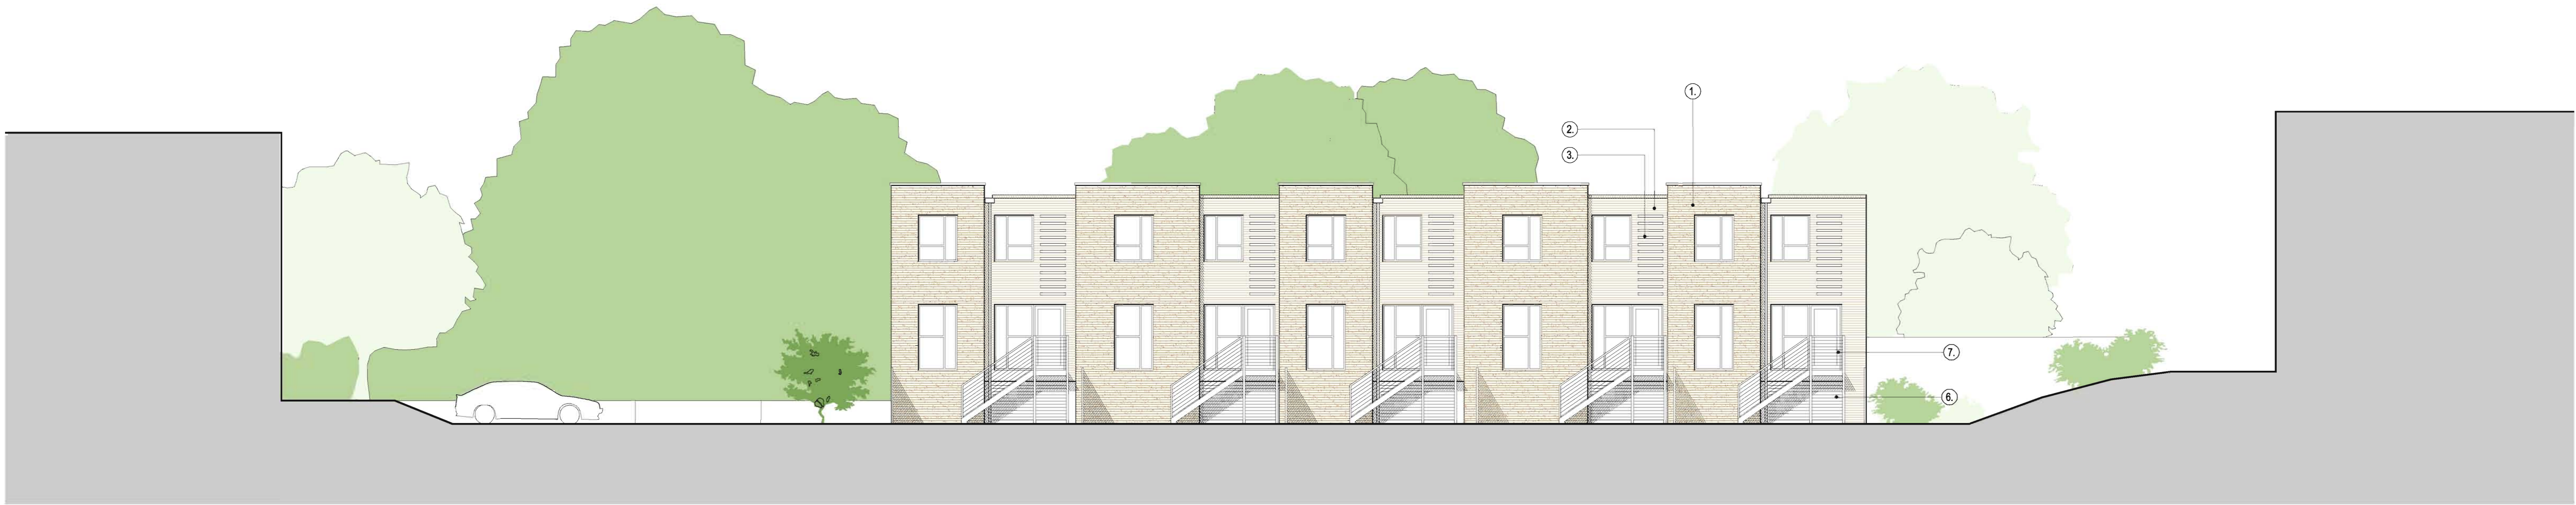
REAR ELEV (A) (1:100)

- 1. London stock brick
- 2. Contrasting Lighter brick
- 3. Protruding brick rows detail
- 4. Metal window frames, colour: dark grey
- 5. Glass and metal canopy
- 6. Metal Grill
- 7. Metal Railing
