# Former Royal Mail Depot, London Road, Twickenham - Metropolitan Open Land (MOL)

Updated Supplementary Geoenvironmental Site Investigation

25024-R06 (01)

FEBRUARY 2016

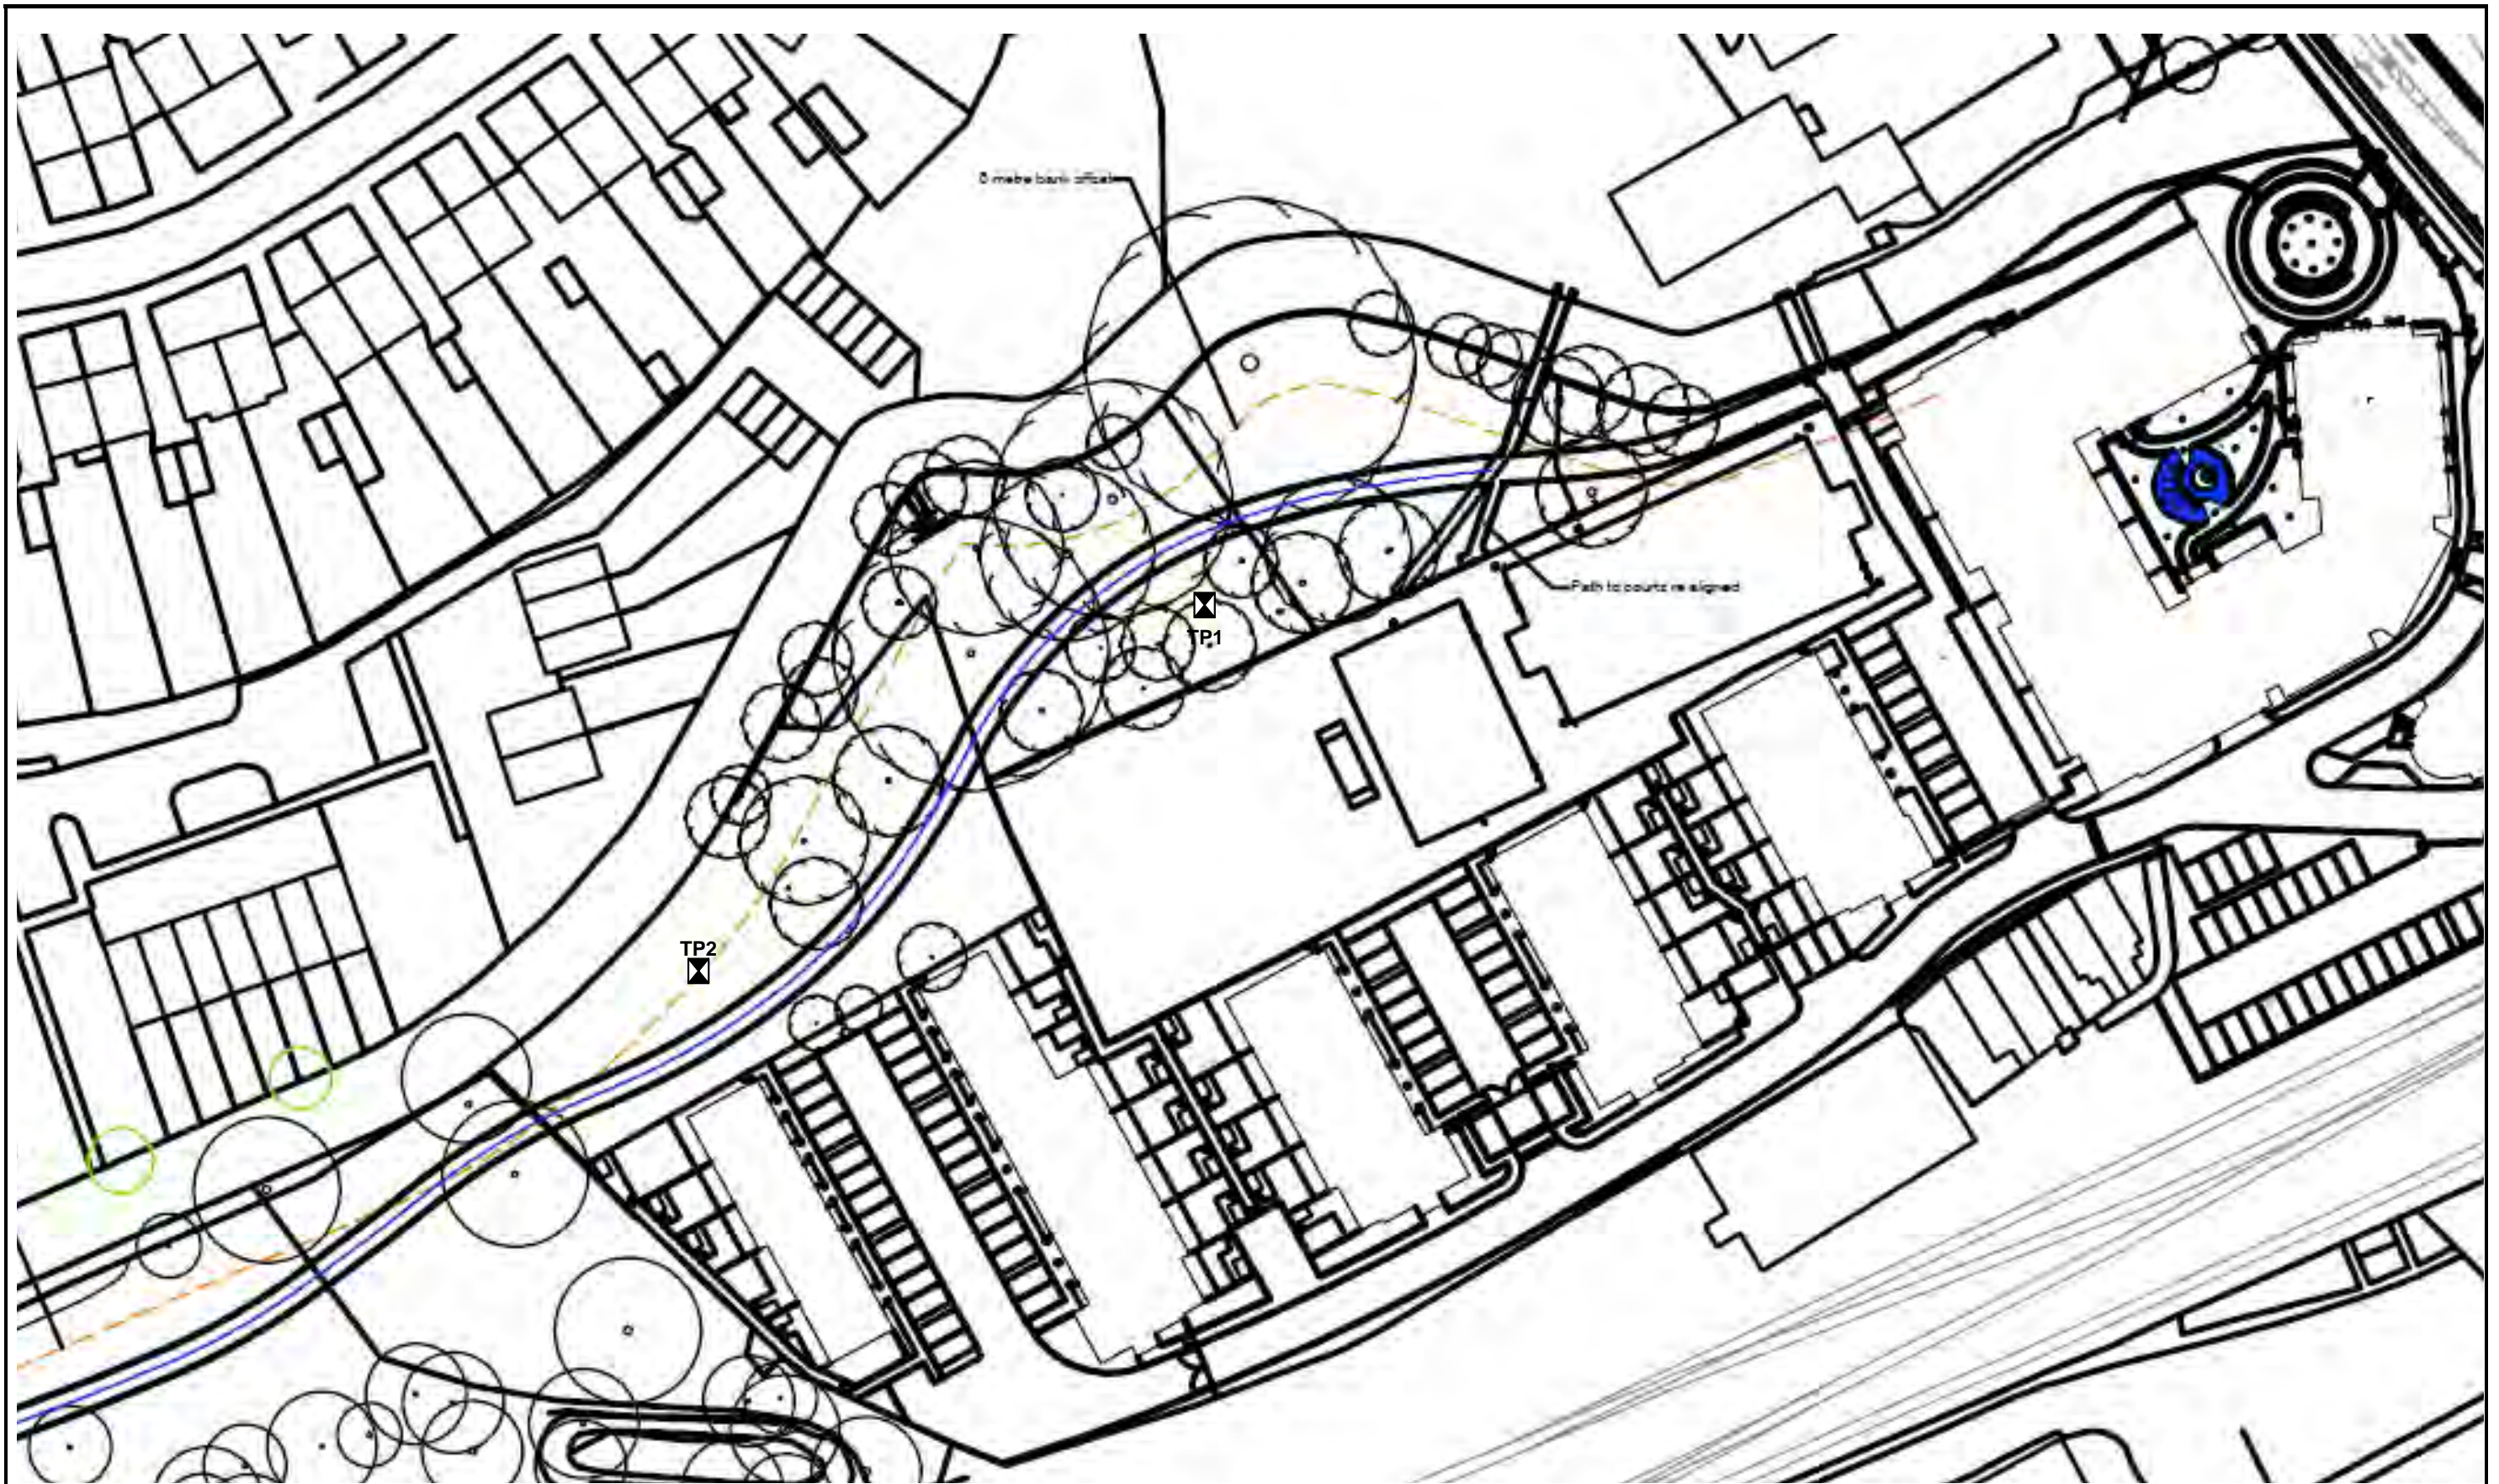
Client:	St James	Figure No:	2b
Site:	Twickenham Sorting Office - MOL	Job No:	25024-06 Rev1
Scale:	-	Source:	-

**Exploratory Hole Location Plan (Northern MOL area)**
