# 275 Sandycombe Road, Kew, London

## Bat Assessment Report

**V1 February 2016**

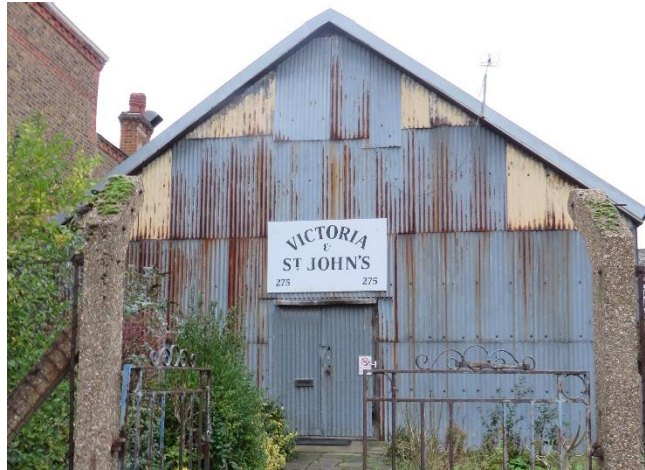
**Photo 1- B1 External**

3.1.3.1 B1 is a single storey corrugated tin building with a double pitched corrugated roof that contains two chimney vents (see Fig.1 on page 6 and Photo 1 below).

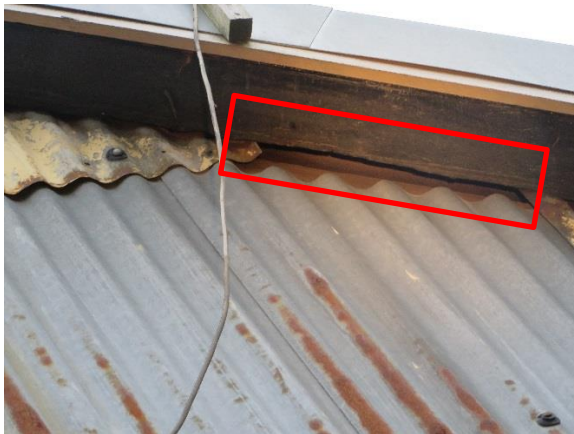
**Photo 2- Gap underneath Soffit**

3.1.3.2 Gaps were noted underneath the soffit and apex of the western gable end, which could allow bats access into the loft space (see Photo 2 and 3 below).

- 4.1.1.4 To mitigate any low/residual risk of harming bats when B1 is demolished, it is recommended that the external corrugated tin panels are removed by hand by the contractor prior to the demolition of the building, to mitigate the low potential risk of encountering a bat. If any bats or evidence of bats are found during the removal of the external corrugated tin panels, work should cease immediately and a licensed bat ecologist should be contacted for advice on how to proceed.

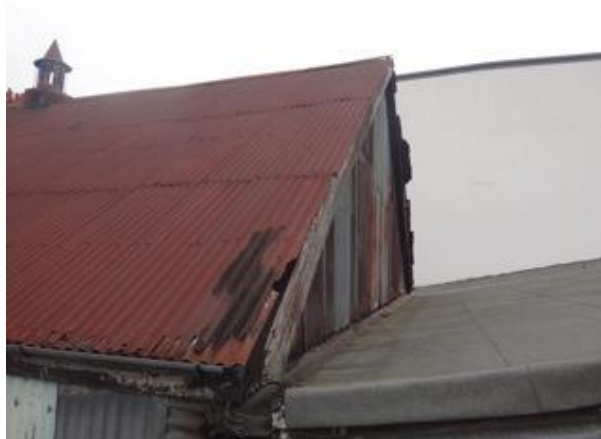
**Photo 5- Eastern Aspect of B1**

3.1.3.4 The eastern aspect of B1 was assessed from the roof of B3 (see Photo 5 below). This revealed no additional external features or evidence of bats.

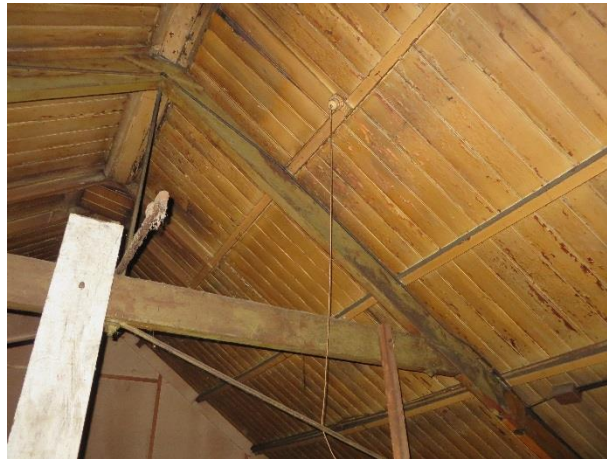
**Photo 6- B1 Section 1 Loft Interior**

- 3.1.3.5 The loft space of B1 was split into two sections that were partitioned by an internal wooden boarding that had a crude door cut in (see Section 1 and 2 on Fig. 1, page 7).
- 3.1.3.6 The loft interior was large and spacious (around 7.5m x 10m), wooden framed structure, clad with corrugate tin externally and lined with pine panelling on both the walls and the roof (see Photo 6 overleaf).

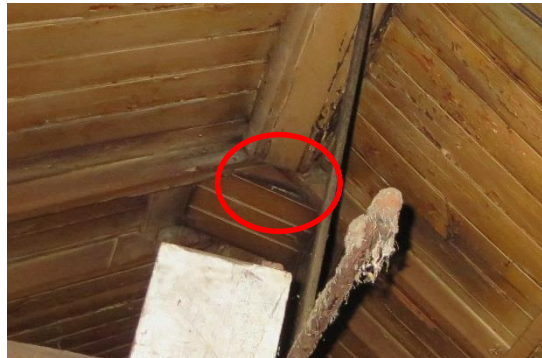
**Photo 7- Small Access Hatch Leading to Open Chimney Vent**

- 3.1.3.7 A large arched church door aperture (around 3.5m) had been cut out of the internal panelling walls on the western gable end which could permit bats to access the loft space from the external access features noted at this end of the building.
- 3.1.3.8 A small access hatch which leads to the westernmost external chimney was also noted which would allow bats to access the loft through the open chimney vent (see Photo 7 below).

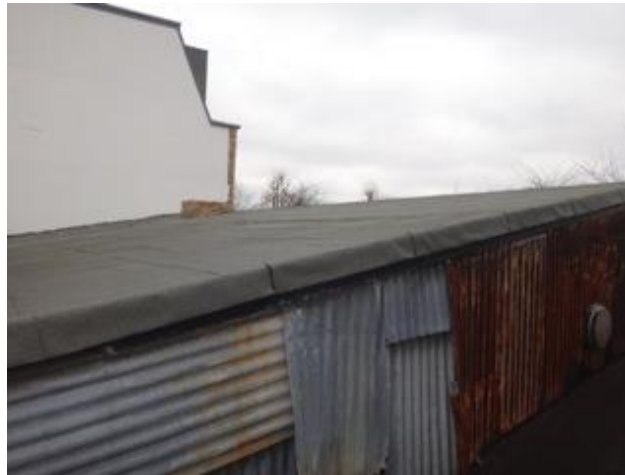
**Photo 8- Roof and Southern Aspect of B2**

- 3.1.3.12 B2 is adjoined onto B1's eastern aspect. It has corrugated tin walls and a single pitched felt roof (see Fig.1 on page 7 and Photo 8 overleaf).
- 3.1.3.13 The roof and southern aspect of B2 were assessed from the roof of B3. No external access features were recorded and the roof appeared to be in good condition (see Photo 7 overleaf). No external features were noted on the eastern aspect of the building, although this assessment was limited to what could be seen through binoculars from the other side of the railway track.

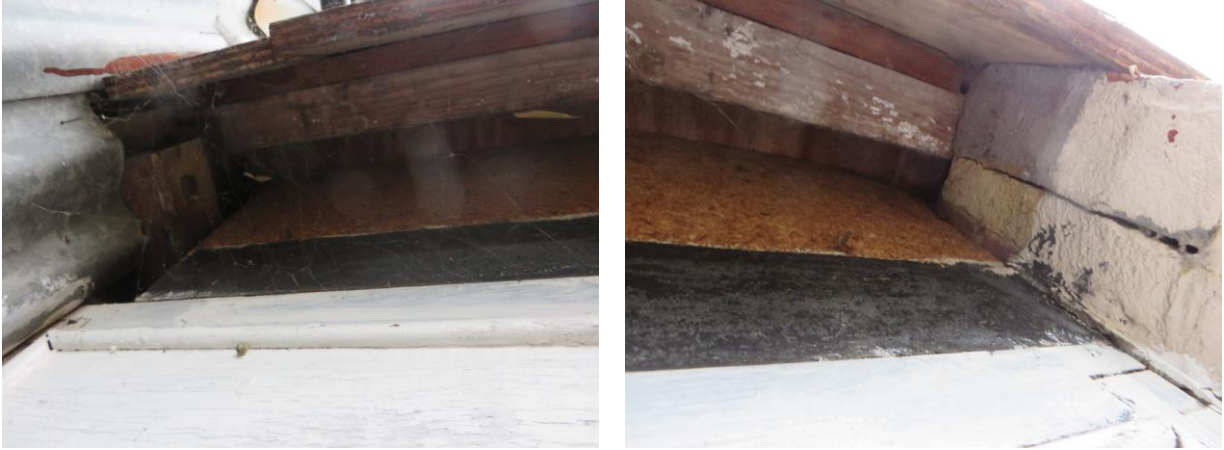
**Photo 9 and 10- Potential Access Points above Door on Western Aspect**

- 3.1.3.15 B1 is a small brick built corrugated flat roofed block that is built out from the southern aspect of Building 1 and 2.
- 3.1.3.16 Two potential access points were noted above the door on the buildings western aspect (see Photo 9 and 10 overleaf). However, the access points appeared cobwebbed during the survey which suggests a lack of recent bat activity.
