APPENDIX C

Topographic Survey & Architect's Scheme Drawings

W:\Projects\5228 FRA, M and M, 2 sites on Bucklands Road, Teddington TW11 8SQ\2.3 Specifications & Reports\F. Flood Risk Assessments	Date March 2014	Job No. 5228/2.3F
---	--------------------	----------------------

Project:
Garages at Bucklands Road, Richmond, London, TW11

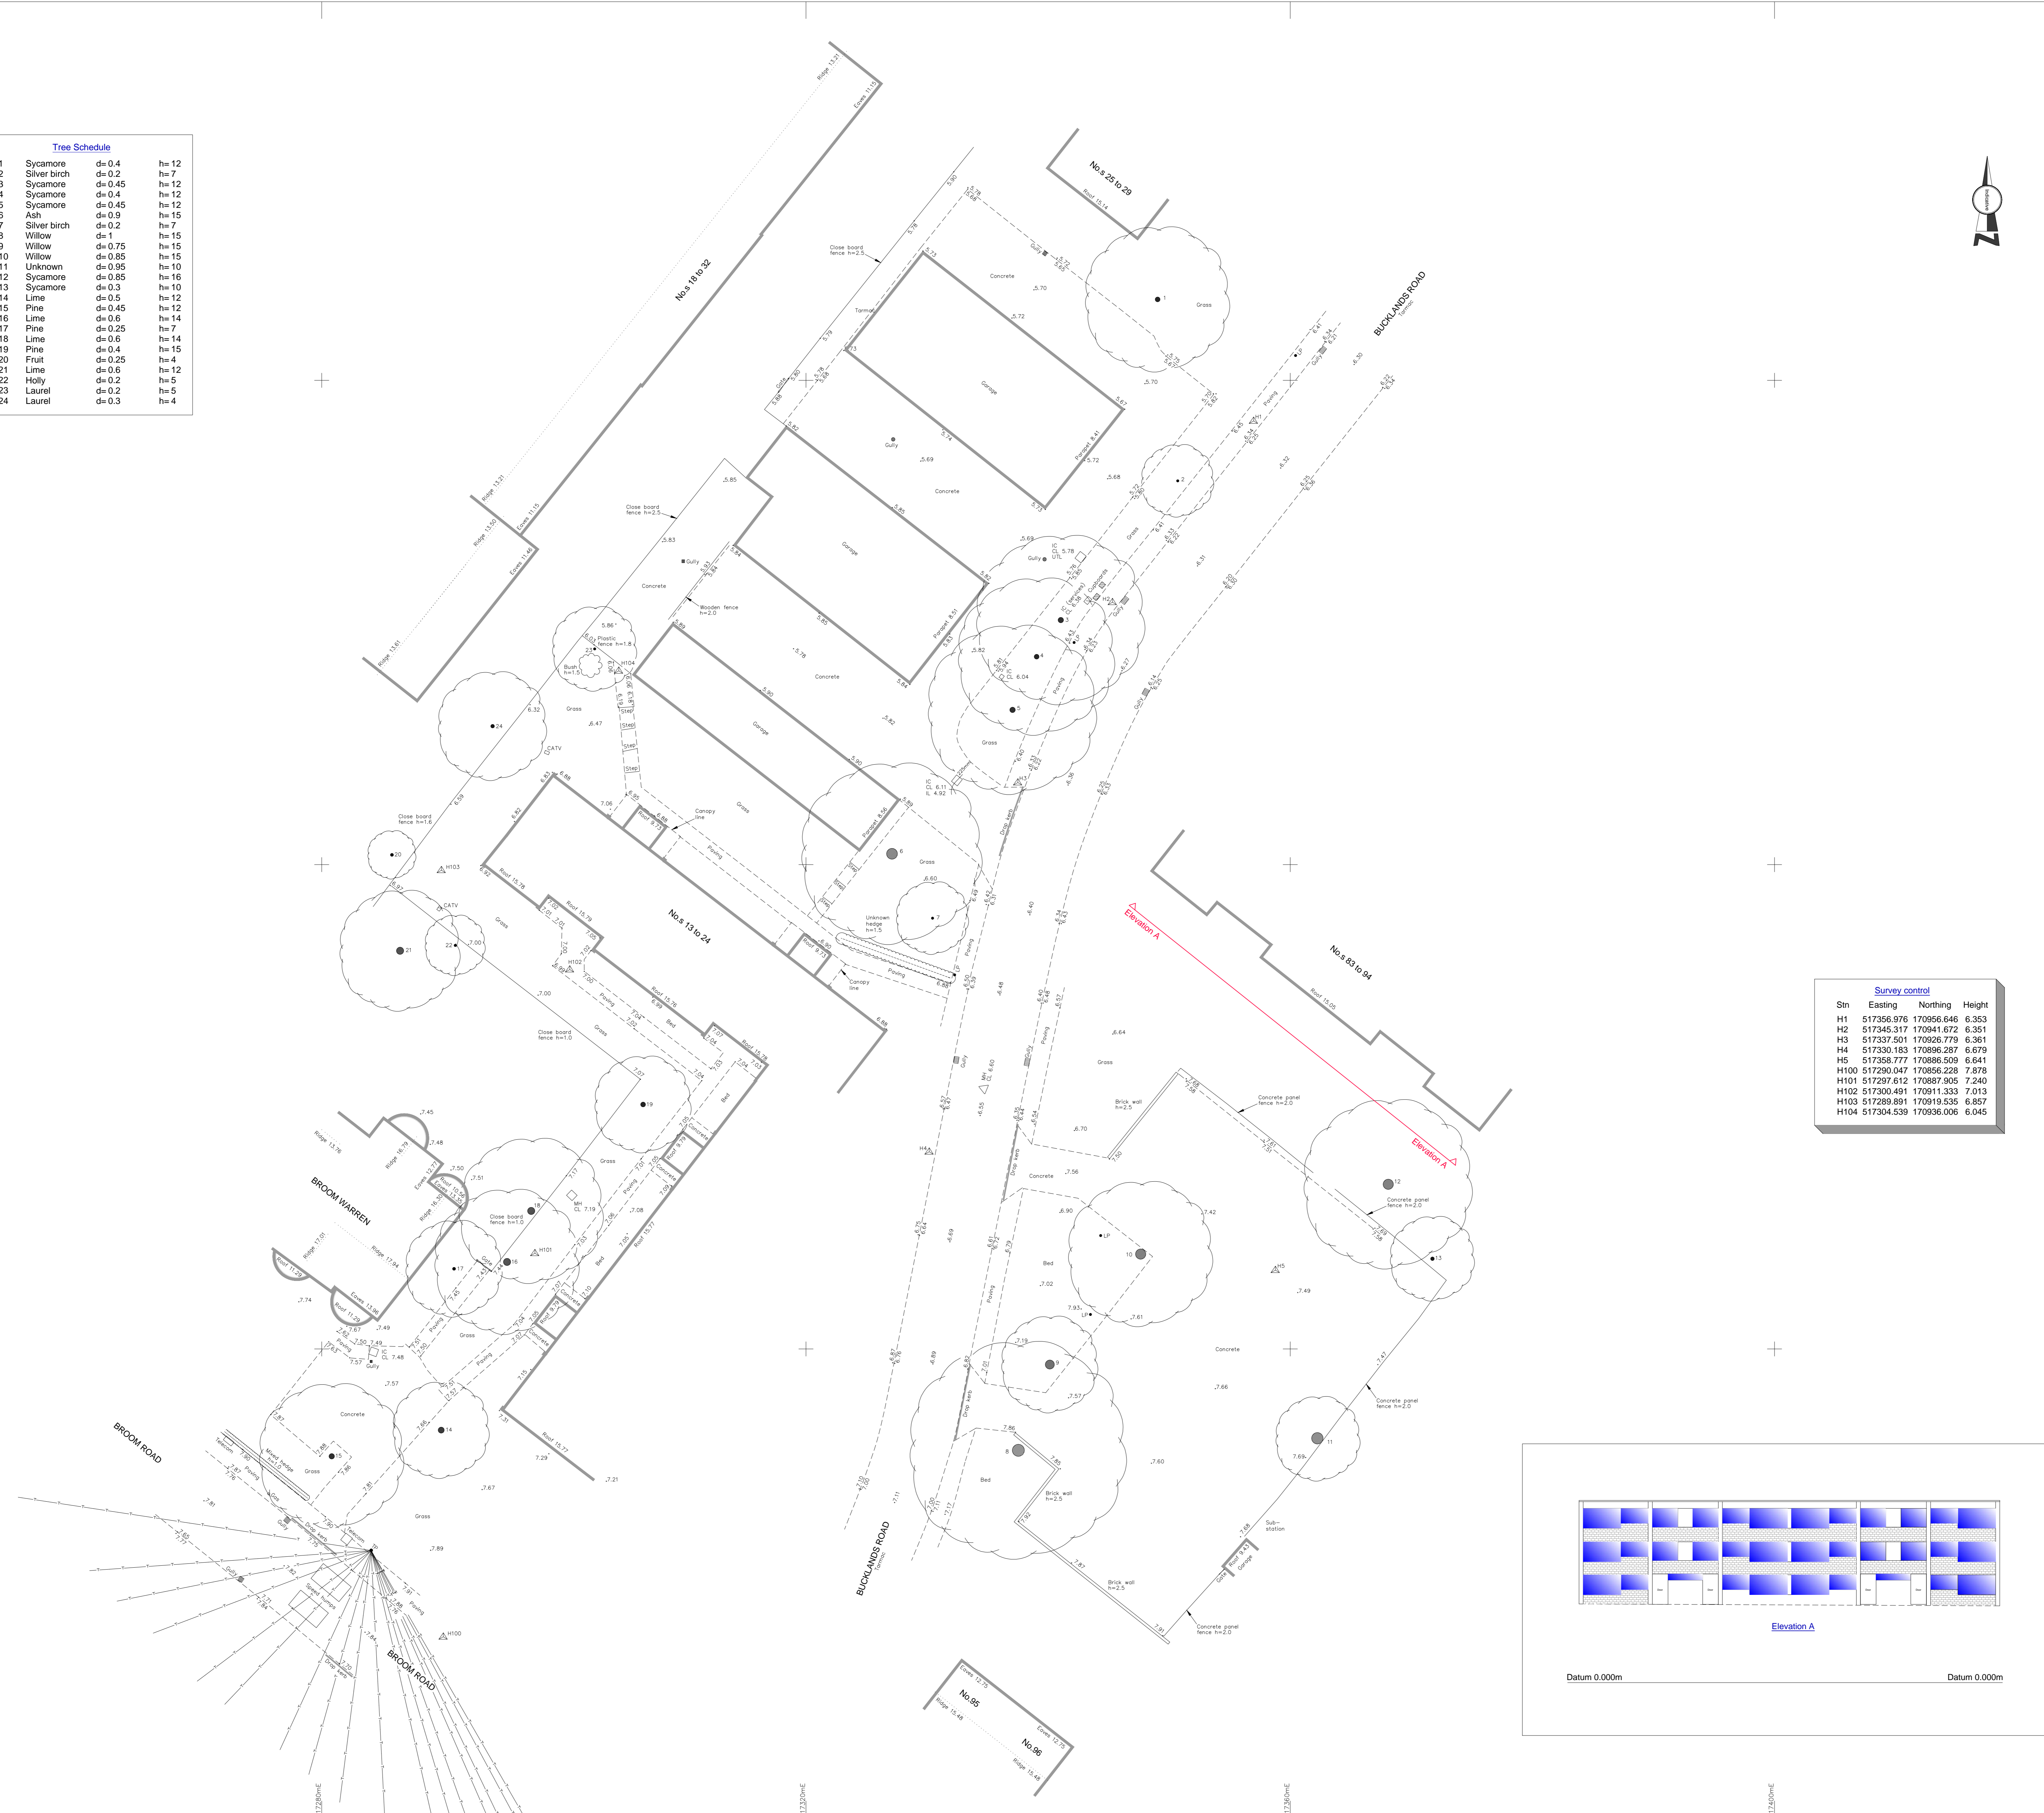
Drawing title:
Topographical Survey

All trees are identified where possible. Species, spread, height and girth are indicative only.

Drainage has been surveyed where found, and traced where possible.

Eaves and ridge heights of surrounding buildings have been surveyed where possible.

Grid & Levels related to:
Pseudo Ordnance Survey Coordinate System at a scale of 1:0000 based around Stations H1 & H2

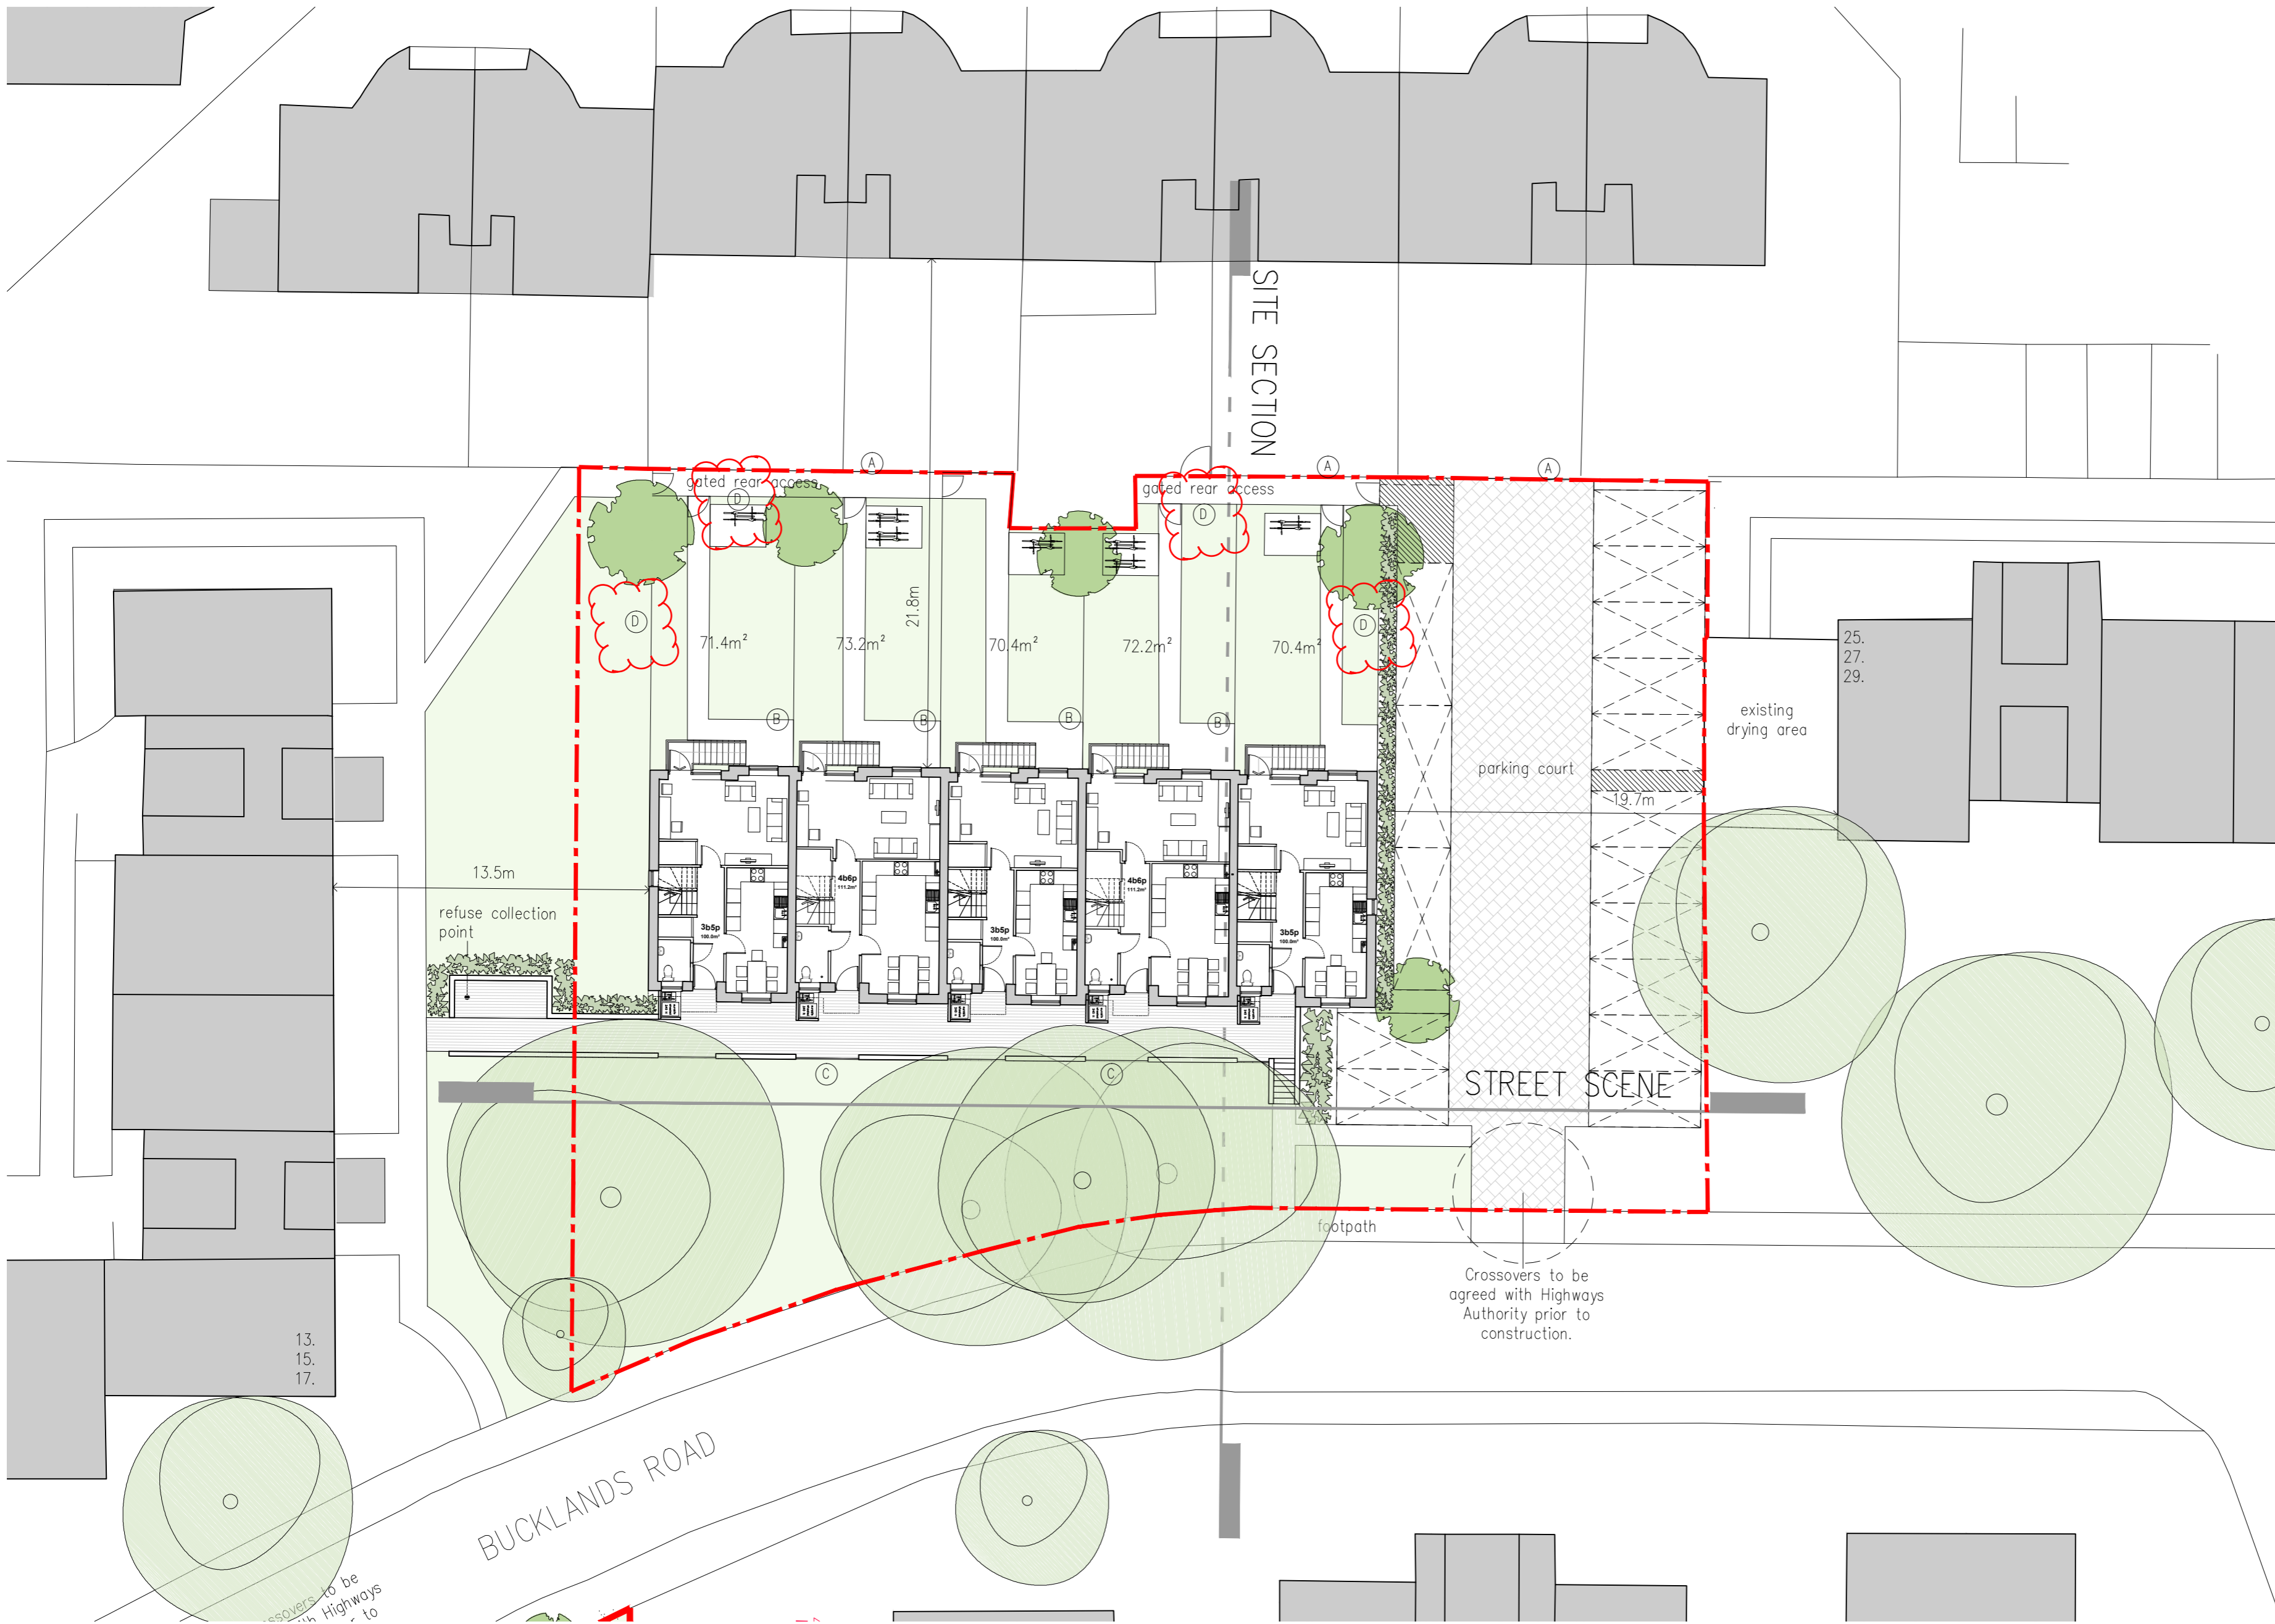
Date: JUN 2014	Client: Richmond Housing Partnership
Drawn: GC	Project: Bucklands Road
Check:	Title: Site Layout - Site A
Scale: 1: 200@A2	Dwgno: 12.143 / D(27)A-11
	Revision: C

- existing tree
- proposed new tree
- tree to be removed
- 1.8m high close boarded timber fence with 450mm trellis
- 1.8m high privacy screen for 2m followed by 1200mm hit and miss timber fencing topped with 450mm trellis
- 1100mm high metal railings
- 1.8m high hit and miss timber fencing topped with 450mm trellis

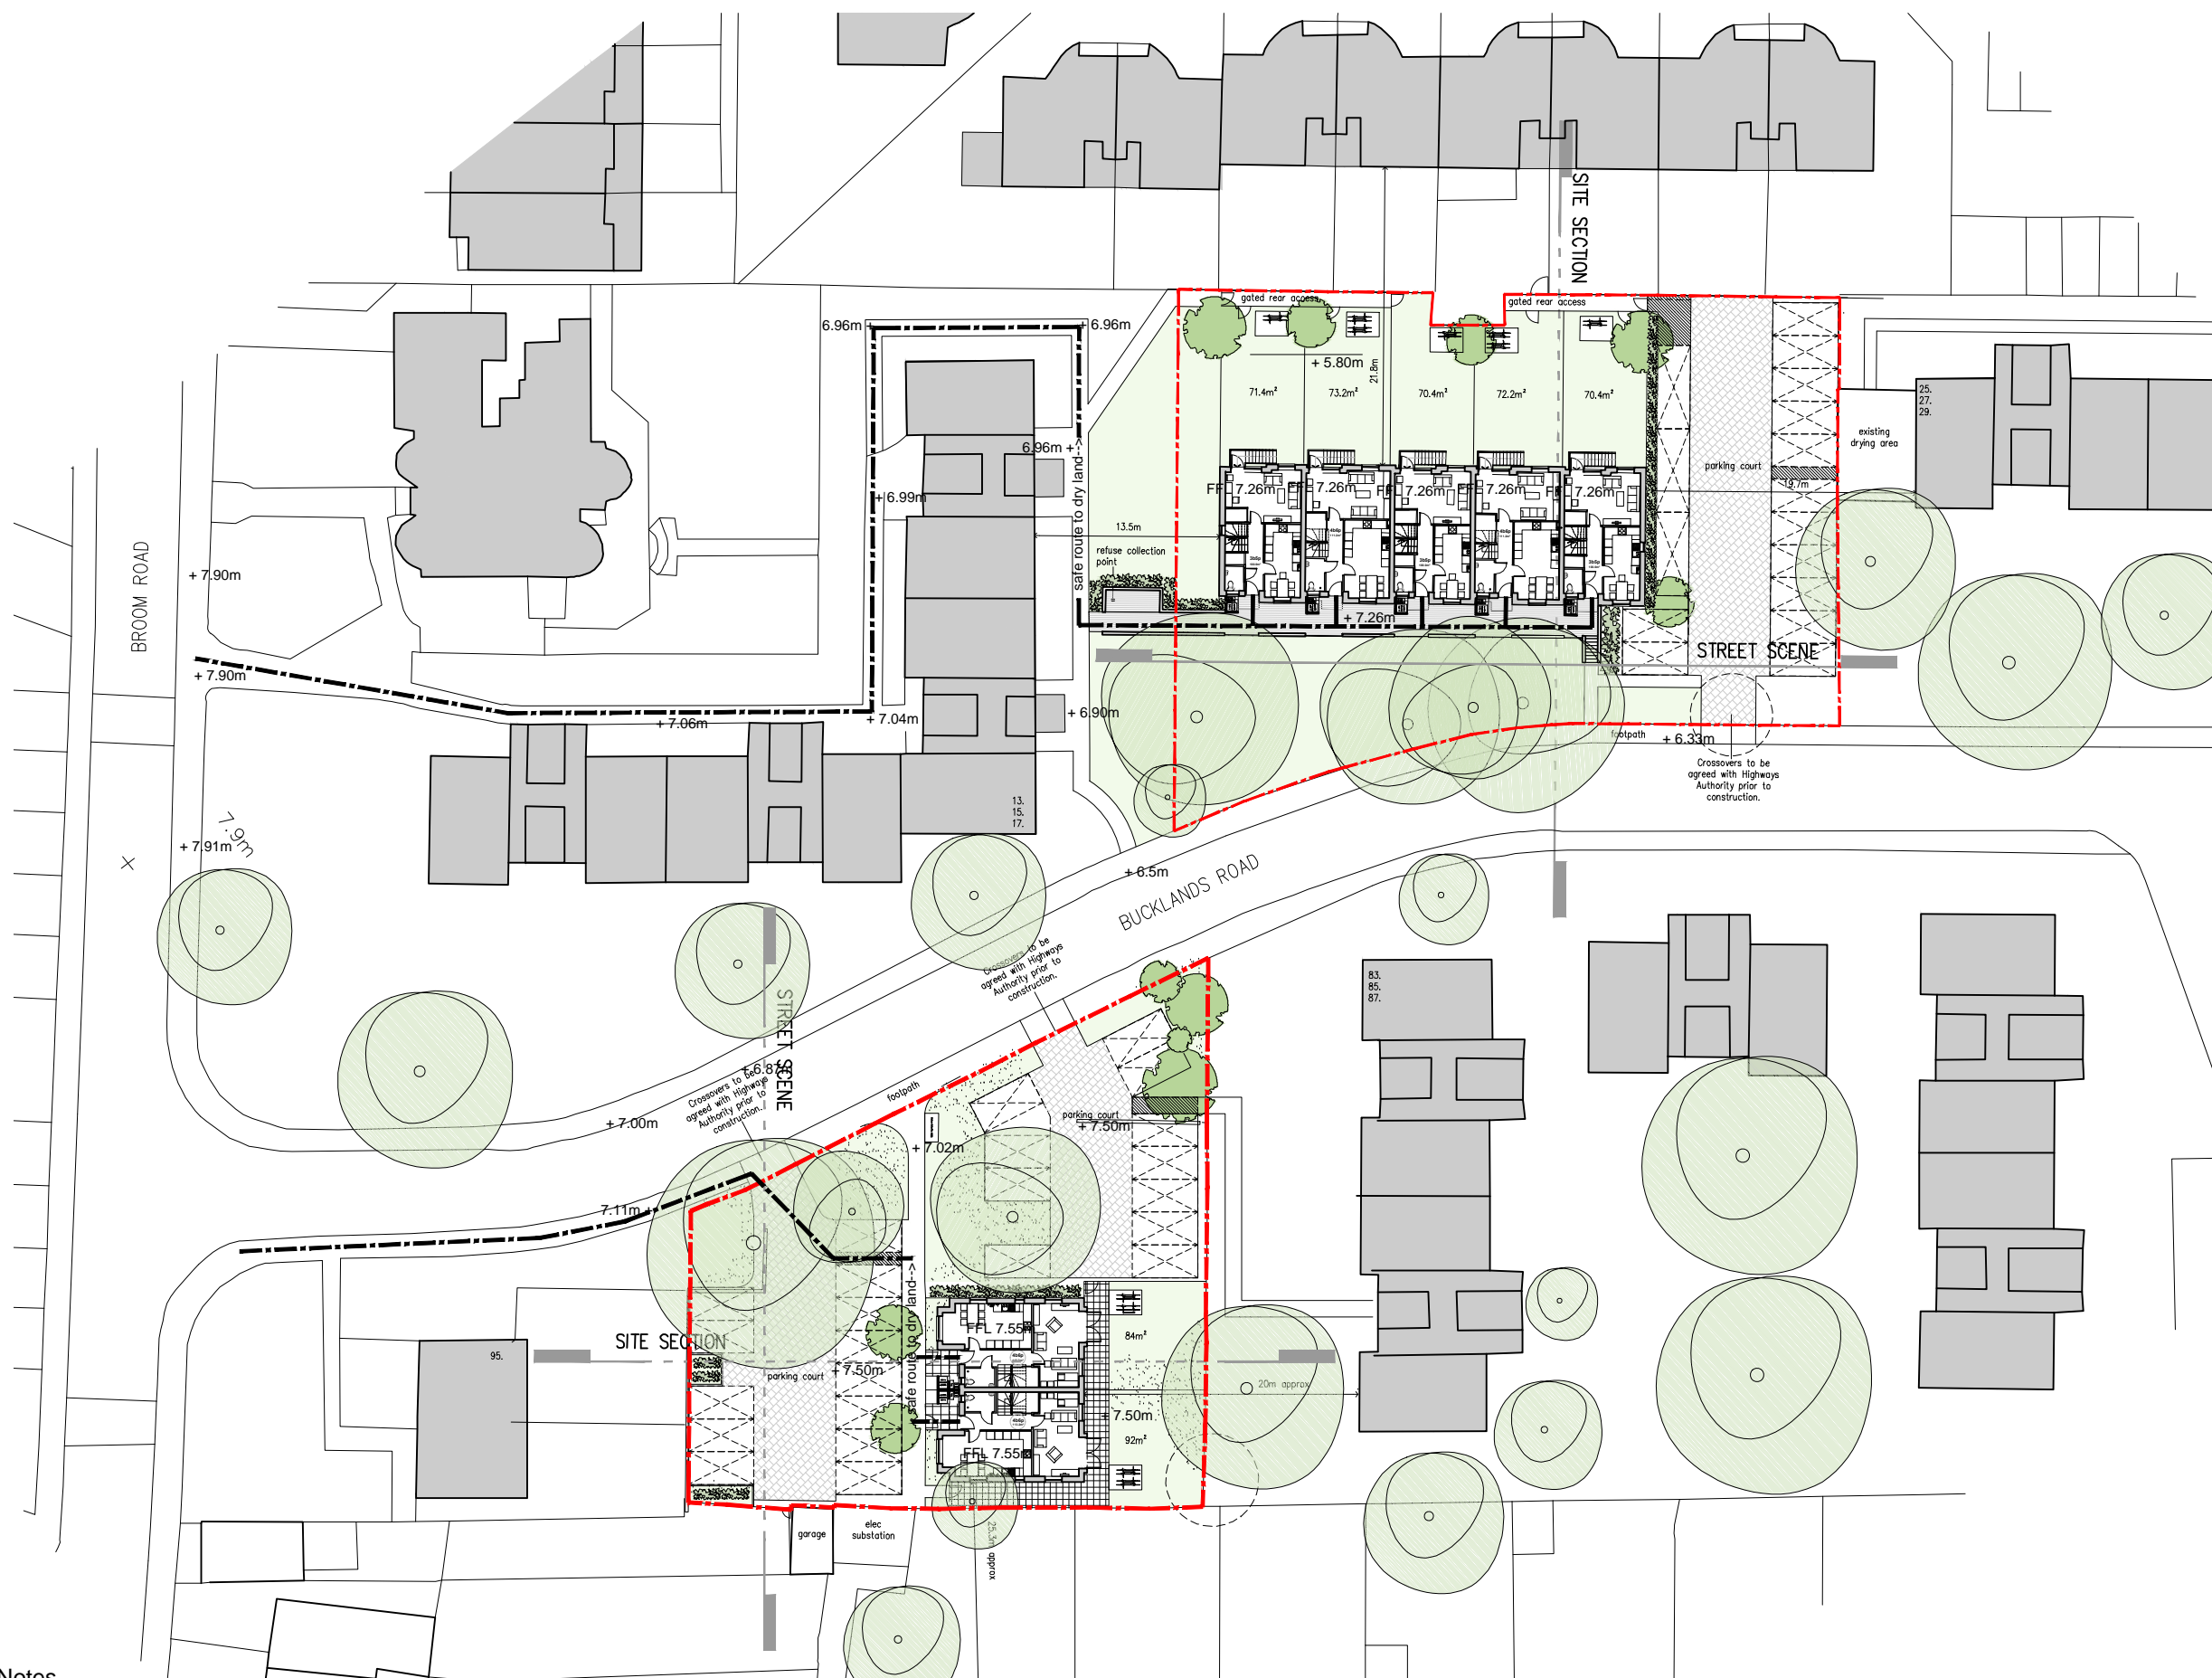
Date: JUN 2014	Client: Richmond Housing Partnership
Drawn: GC	Project: Bucklands Road
Check:	Title: Site Layout - Site A - Flood Risk Safe Route Strategy
Scale: 1: 500 @ A3	Dwgno: 12.143 / D(27)01
	Revision: B

Flood Risk Safe Route Strategy

The design level for a 1 in a 100 year flood event is 6.96m.

site A
The lowest finished floor level is set at 7.26m which allows for a climate change adjustment.

The safe route to dry land is form the front doors onto the raised walkway also at the 7.26m level which joins the footpath around the existing flat block and on to Broom Road which is outside of the flood zone 3.

Site B

The lowest finished floor level is set at 7.55m well above the required level of 7.26m.

The safe route to dry land is form the front doors, across the parking court to the higher level of Bucklands Road and on to Broom Road.

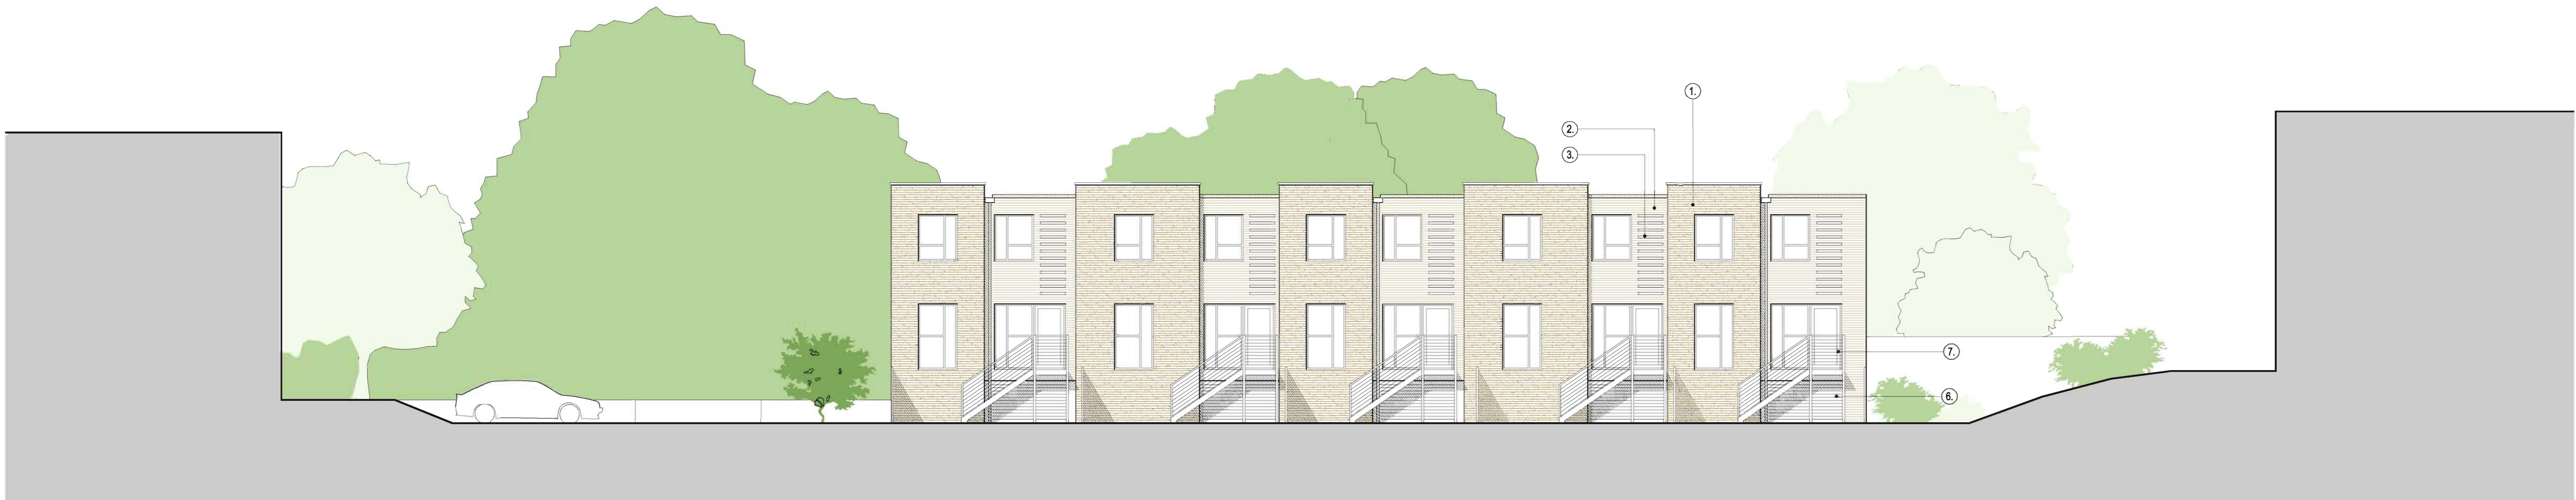
REAR ELEV (A) (1:100)

- 1. London stock brick
- 2. Contrasting Lighter brick
- 3. Protruding brick rows detail
- 4. Metal window frames, colour: dark grey
- 5. Glass and metal canopy
- 6. Metal Grill
- 7. Metal Railing

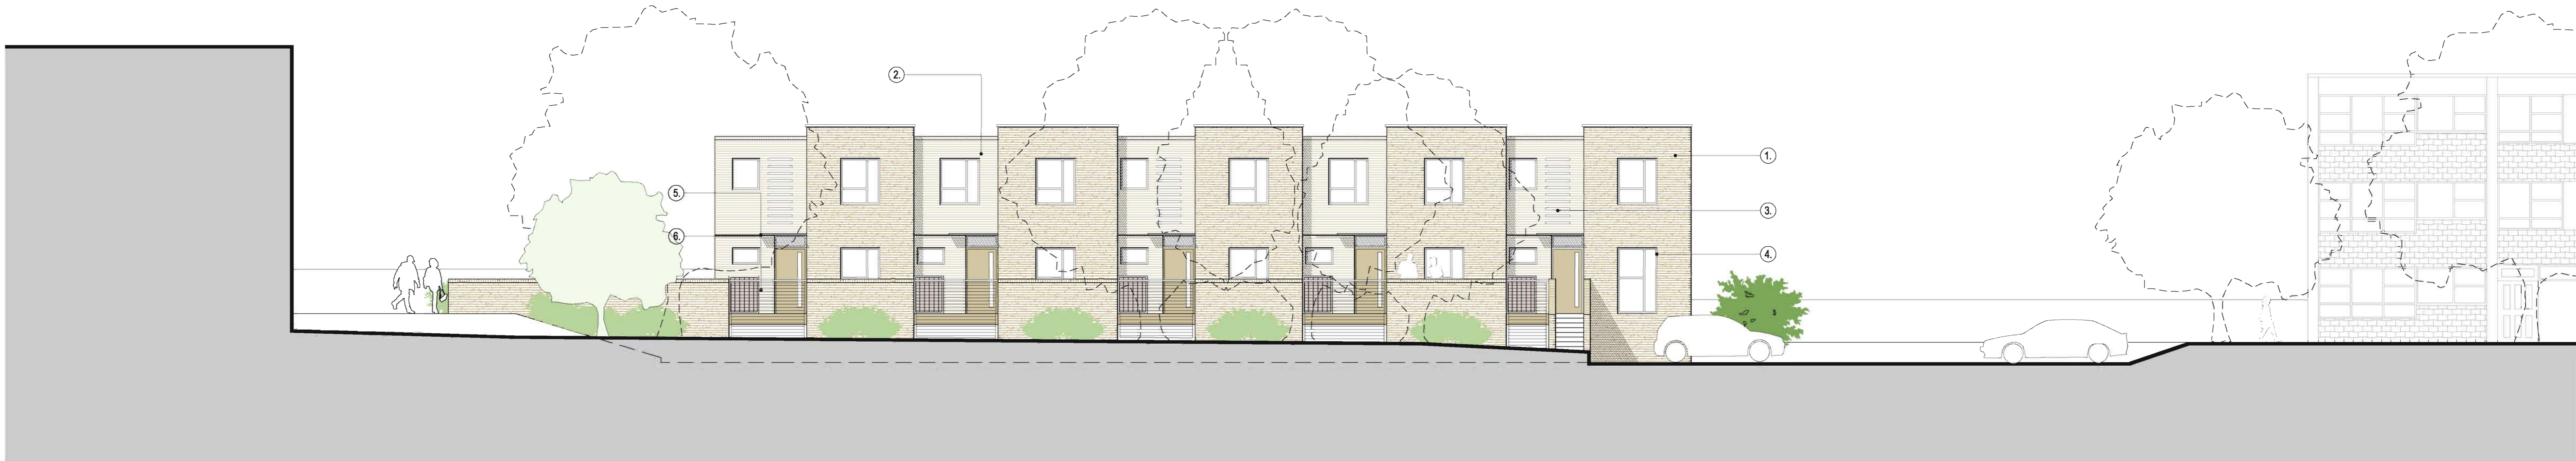
STREET SCENE (A) (1:100)

- 1. London stock brick
- 2. Contrasting Lighter brick
- 3. Protruding brick rows detail
- 4. Metal window frames, colour: dark grey
- 5. Glass and metal canopy
- 6. Metal Grill
- 7. Metal Railing

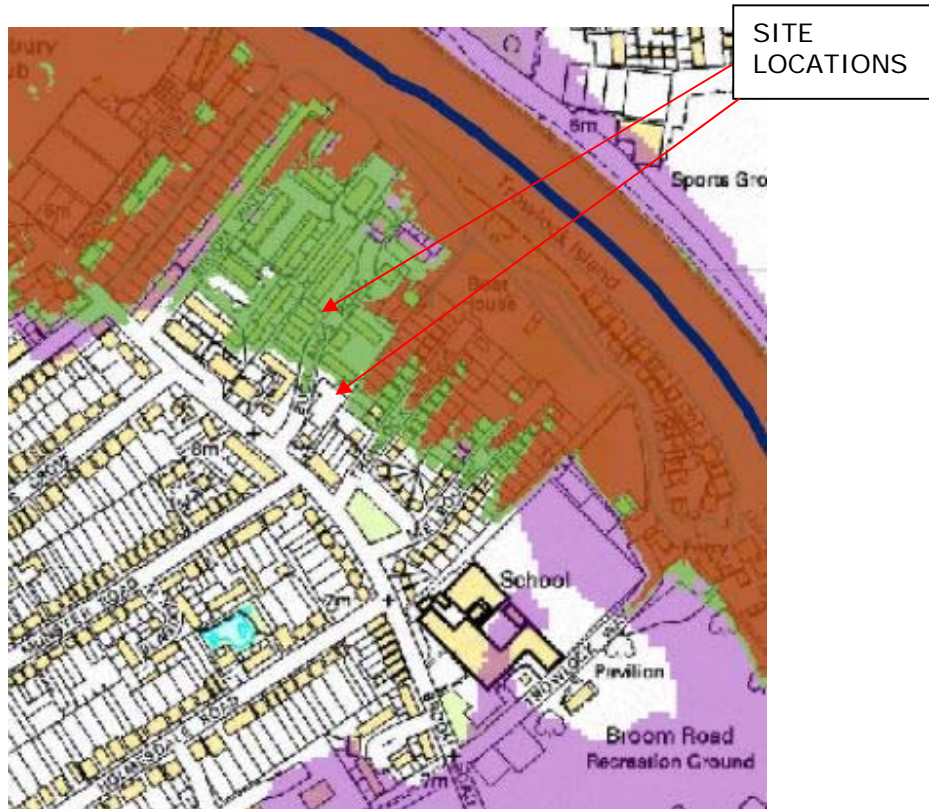
Flood zone map – Site A is within FZ3A, and Site B is which FZ1. These differ to the EA flood map zones.
