**INFORMER HOUSE
2 HIGH STREET, TEDDINGTON, TW11 8EW**

**PHASE 1:
ENVIRONMENTAL RISK ASSESSMENT**

RHP

Our Ref: HLEL40231/001R

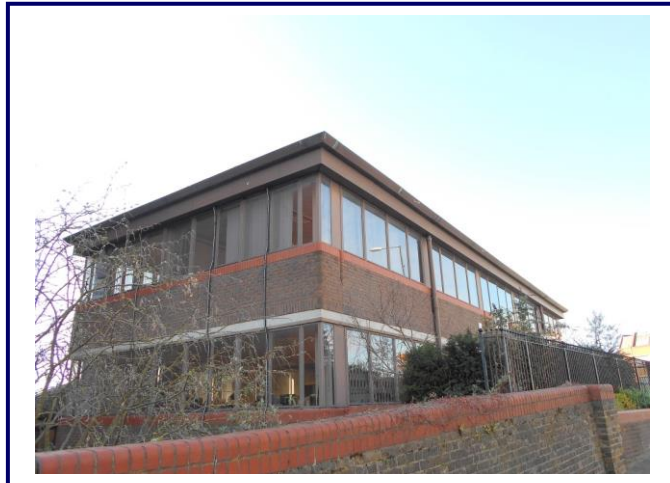
General view of the site. For further photos see Appendix B.

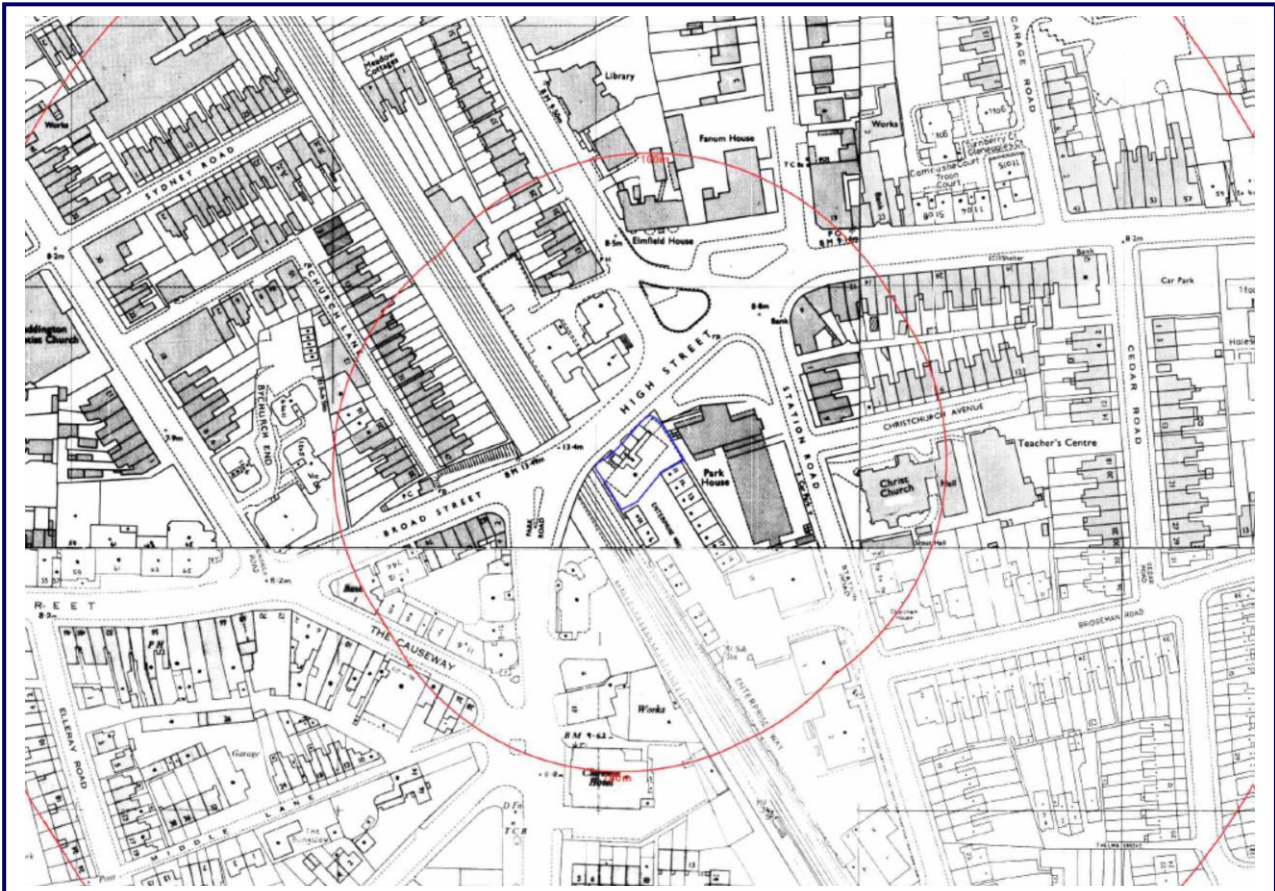
Figure 8: Historical Map Extract

Map Date: 1991

On-site Land Use and Features	Dates
Site comprised predominantly undeveloped land with gradients present in the north and west.	1864 – c.1896
<i>Then</i> Railway tracks/sidings were present in the far south and west of the site. The majority of the remainder of the site appeared to comprise land associated with the railway.	1896 – c.1915
<i>Then</i> small unlabelled building present in the north of the site. Gradients no longer shown.	1915 – c.1959
<i>Then</i> site appeared to comprise part of a yard associated with the railways to the west.	1959 – c.1978
<i>Then</i> railway tracks no longer situated in the south and west of the site.	1978 – c.1989
<i>Then</i> the current building formation had been constructed on site.	1989 – c.2014

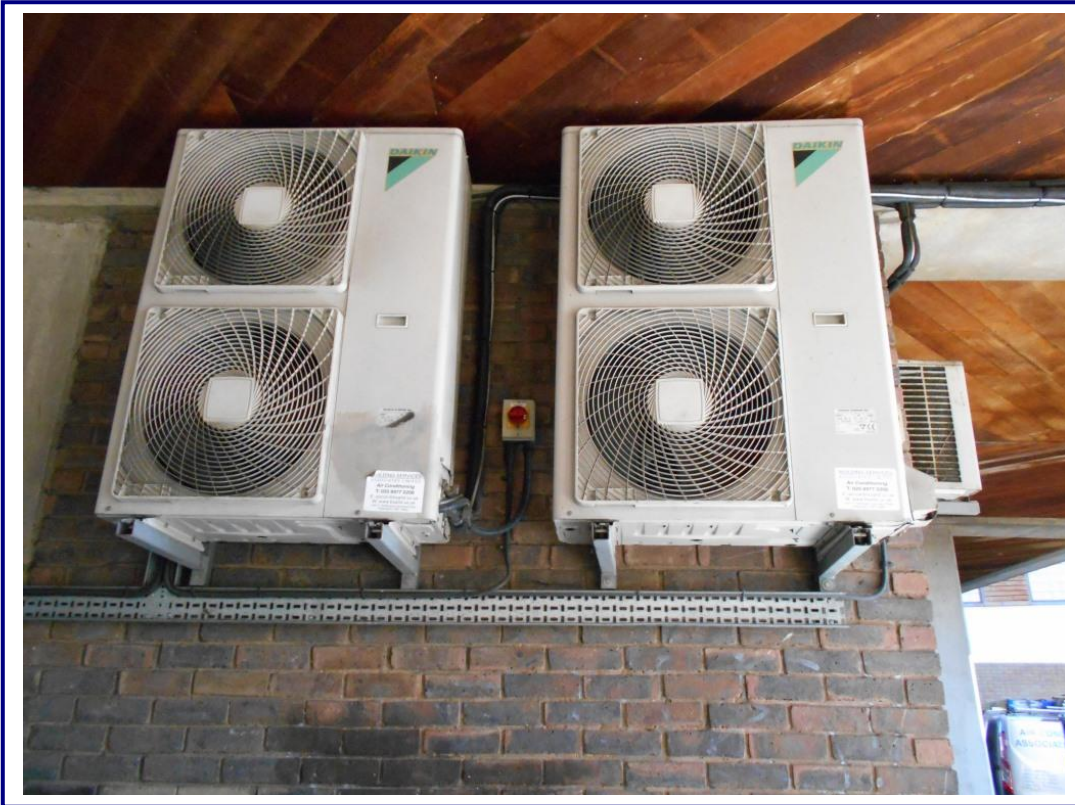
<i>Drainage:</i>	<p>A Thames Water sewer plan reviewed by RPS indicates that water from the site likely discharges into separate surface and foul water sewers. RPS noted drainage grates were located within the undercroft car parking area.</p> <p>No covers considered likely to relate to an oil interceptor were observed on site.</p>
<i>Storage / Tanks:</i>	No bulk storage tanks were present on site at the time of the walkover survey.
<i>Waste:</i>	Waste produced by the office was collected within one wheelie bin in the undercroft car park area. Site representatives advised this was collected weekly but were not aware which company carried this out. RPS also noted numerous wooden pallets left adjacent to the building at lower ground floor level (see Photo 4, Appendix B).
<i>Air Emissions:</i>	Various air conditioning units were noted within the undercroft car park area (see Photo 1, Appendix B). RPS was unable to ascertain the refrigerants within all of the units, however noted that some of these contained R22, which is an ozone-depleting substance (ODS).

Photo 1: Air conditioning units within the undercroft car park.

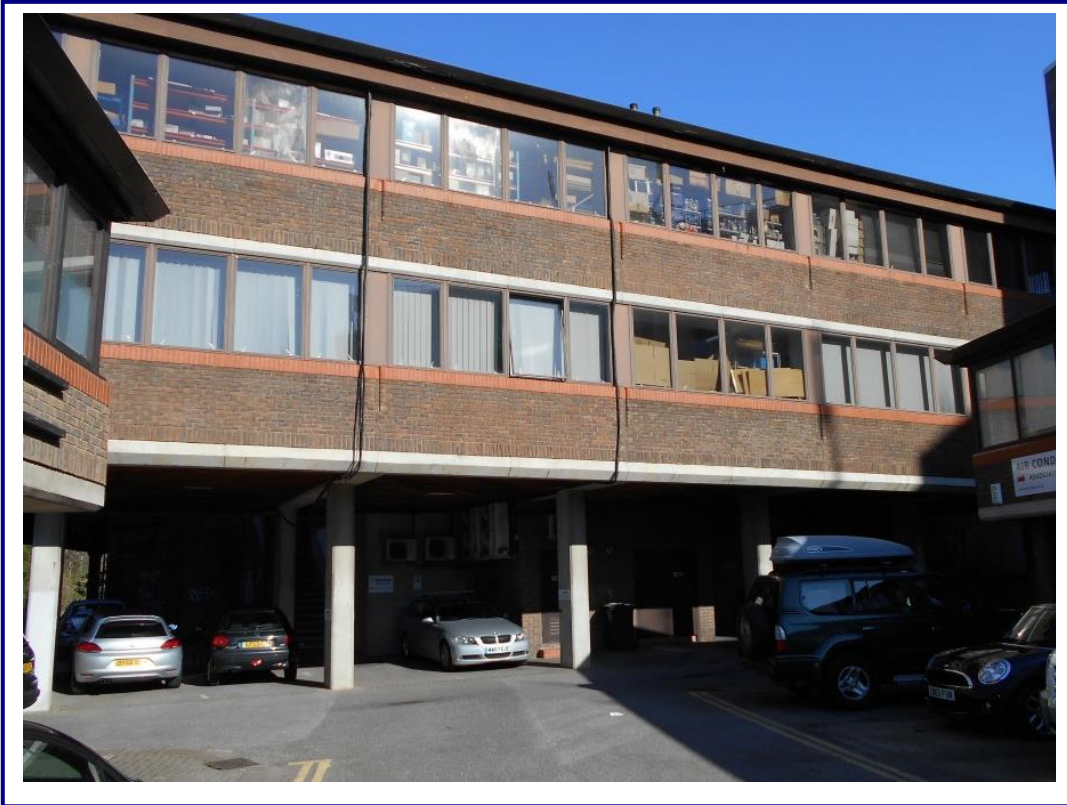
<i>Electricity Transformers:</i>	No electricity sub-stations were observed on site at the time of the inspection.
<i>Visual Evidence of Contamination:</i>	Minor hydrocarbon staining was observed within the undercroft car parking beneath the site. No significant visual or olfactory evidence of contamination was noted during the site walkover.
<i>Statutory Nuisance:</i>	RPS is not aware of any complaints relating to the site.
<i>Other Issues:</i>	<p>An asbestos survey carried out at the property in March 2007 by <i>Alfred McAlpine</i> found no asbestos containing materials (ACMs) within the building fabric.</p> <p>The site representative advised RPS that no incidences of flooding had occurred at the site.</p> <p>No <i>Japanese Knotweed</i> or <i>Giant Hogweed</i> (invasive plant species) were readily</p>

Photo 3: View from the rear of the site showing the undercroft car parking.

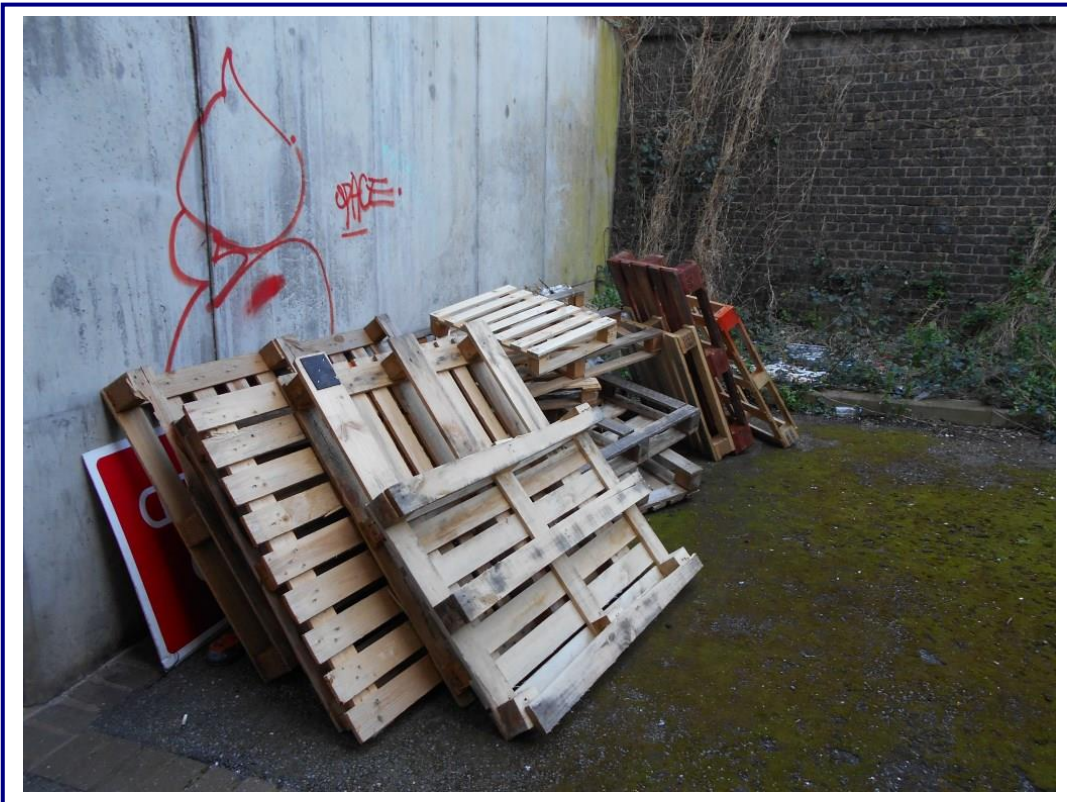
Photo 4: Pallets stored adjacent to the building at lower ground level.
