Appendix 8 – Tree and Ground Protection Specification

Appendix 10 – Photographs

Arboricultural Impact Assessment
Twickenham Stadium RFU (Rugby Football Union)

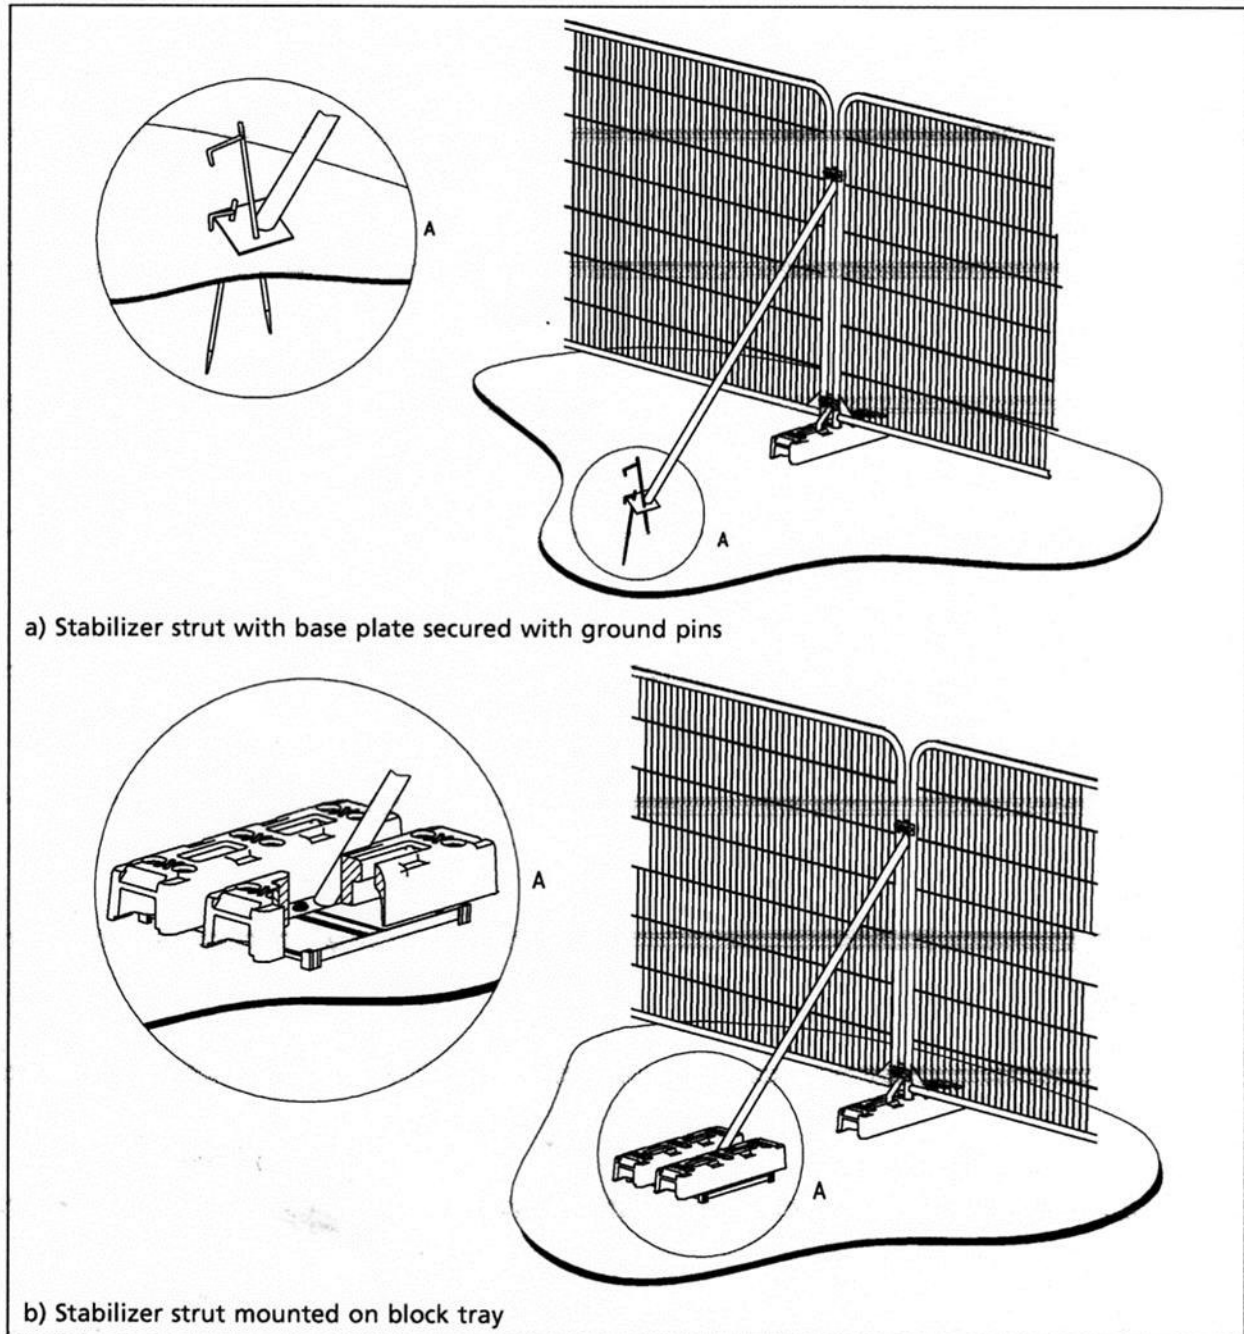
Figure 3 Examples of above-ground stabilizing systems

on retained hard surfacing or it is otherwise unfeasible to use ground pins, e.g. due to the presence of underground services, the stabilizer struts should be mounted on a block tray (Figure 3b).

a) Stabilizer strut with base plate secured with ground pins

b) Stabilizer strut mounted on block tray

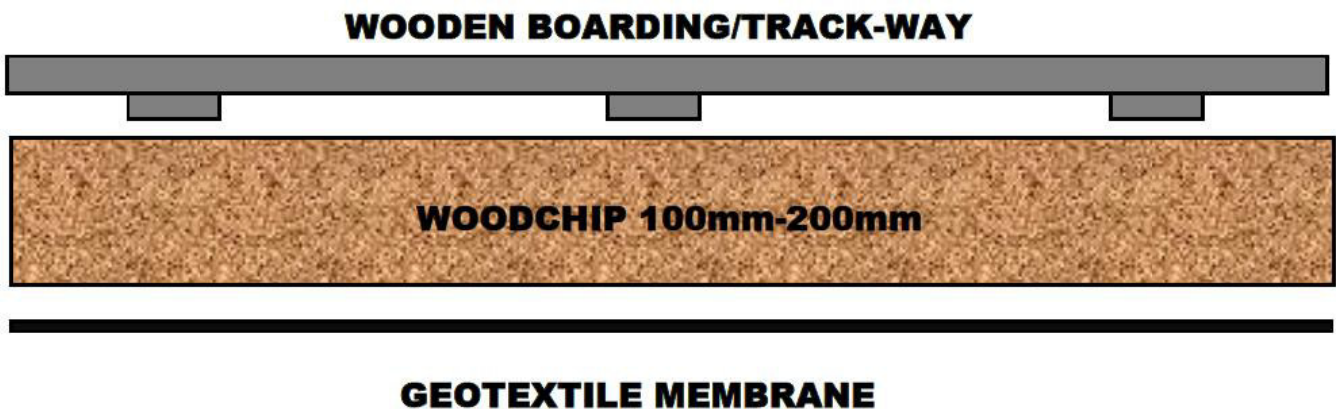
Example 1 - *for pedestrian movements only, a single thickness of scaffold boards places either on top of a driven scaffold frame, so as to form a suspended walkway, or on top of a compression-resistant layer (e.g.) 100mm depth of woodchip), laid on to a geotextile membrane.*

Example 2 - *For pedestrian-operated plant up to a gross weight of 2 t, proprietary inter-linked ground protection boards placed on top of a compression-resistant layer (e.g. 150mm depth of woodchip), laid onto a geotextile membrane;*

Example 3 - *For wheeled or tracked construction traffic exceeding 2 t gross weight, an alternative system (e.g. proprietary systems or pre-cast reinforced concrete slabs) to an engineering specification designed conjunction with arboricultural advice, to accommodate the likely loading to which it will be subjected.*

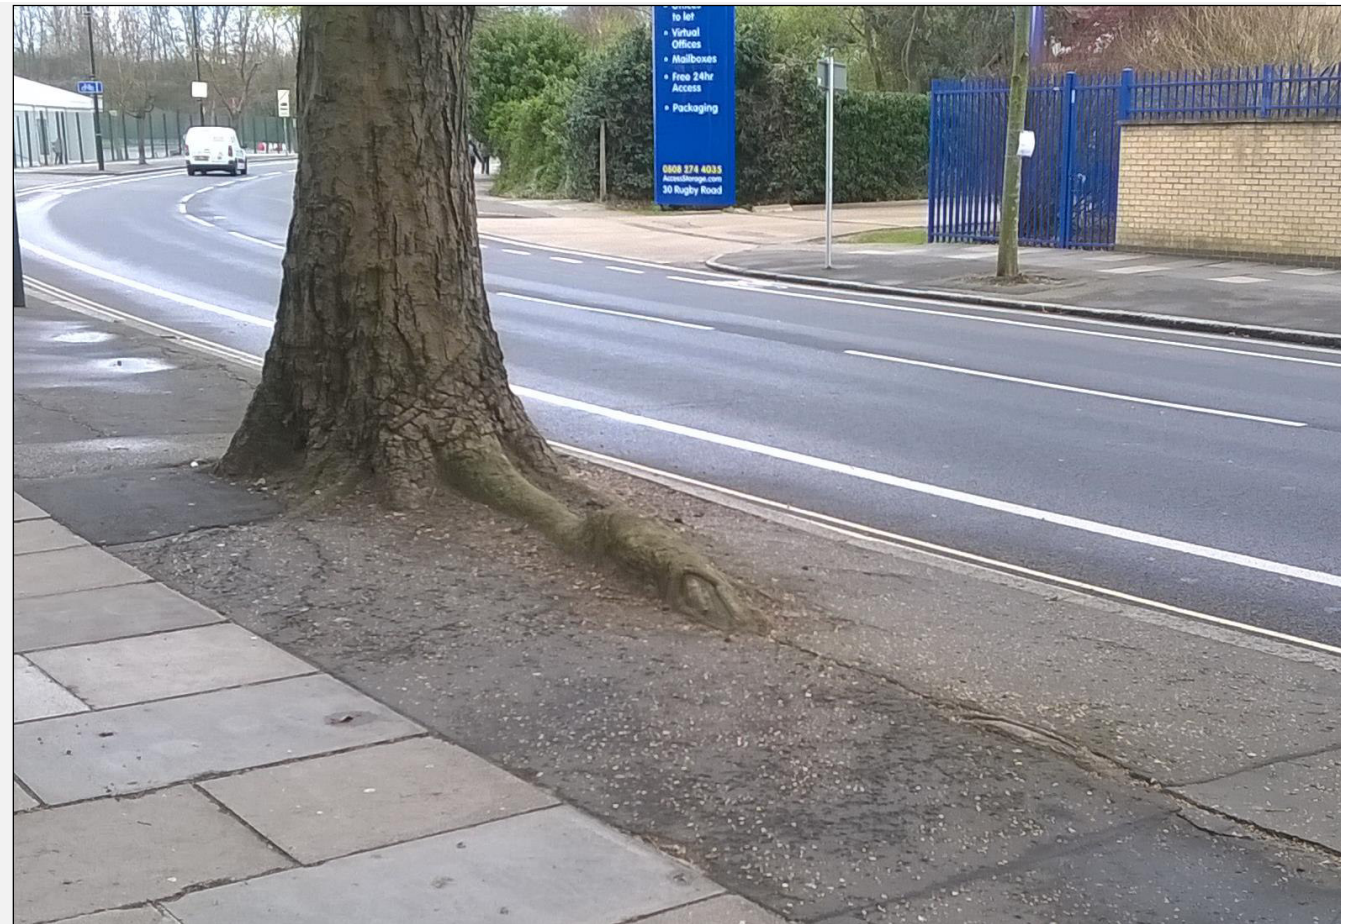
Large buttress roots and associated pavement damage observed near T2 – Plane (London)

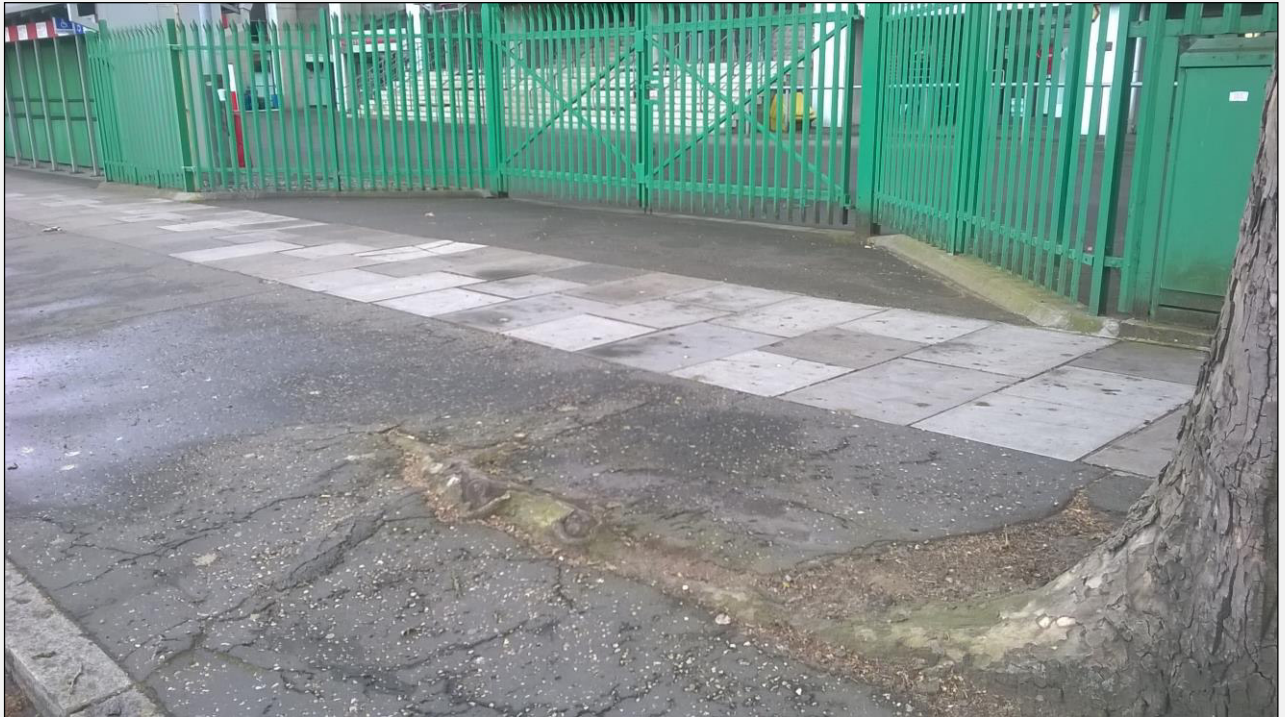
Location of T3 – Plane (London) opposite entrance gate; note visible surface roots, pavement damage and potential trip hazard.
