Former Royal Mail Sorting Office, Twickenham

Final Report and Warranty of Works for the Treatment of Japanese Knotweed

Ref: DTR12051

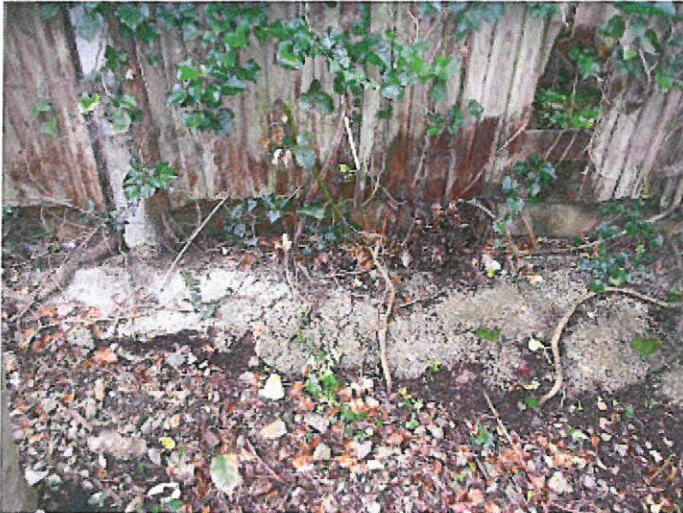
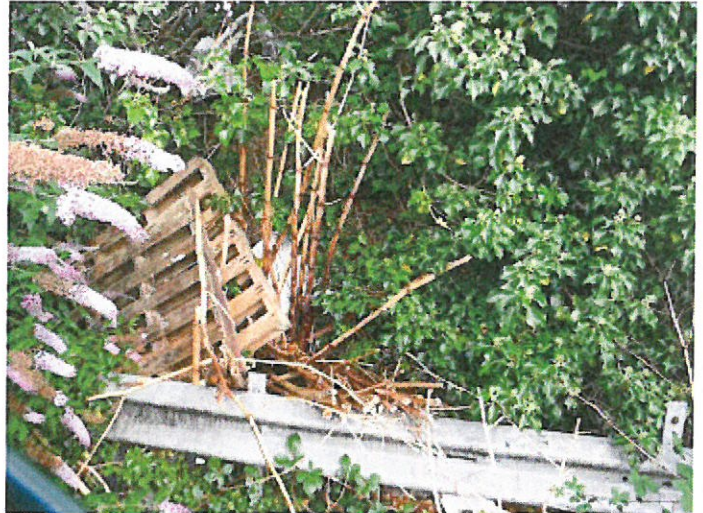
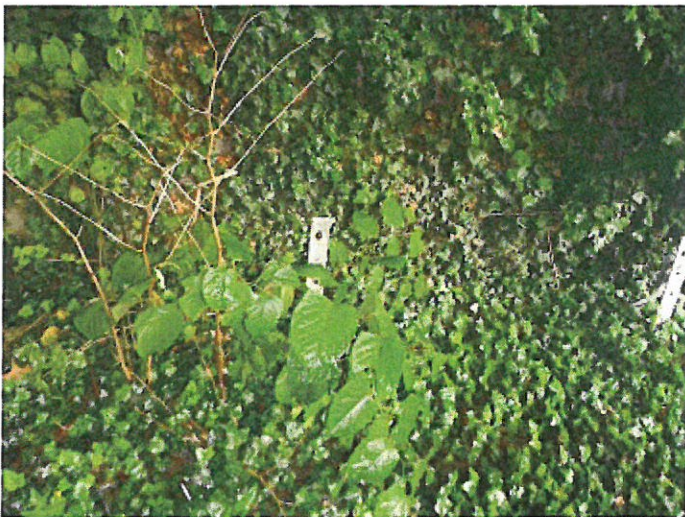
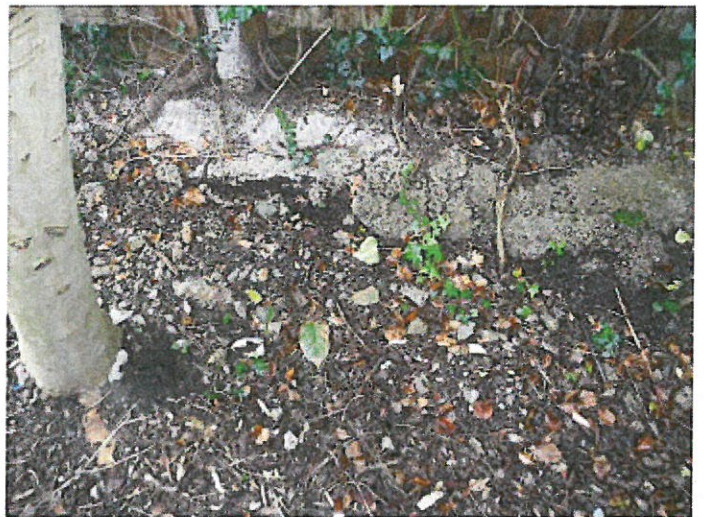
DATE	22 nd August 2012
NAME	St James Group Limited
JOB NUMBER	DTR12051
SITE ADDRESS	The Former Royal Mail Sorting Office London Road Twickenham
SITE VISIT NUMBER	SPR1
SITE PROGRESS	First herbicide treatment of Japanese knotweed
COMMENTS	Our Operative treated all visible Japanese knotweed on site. No new shoots appeared around the main stand. The knotweed contaminated area remained undisturbed.
NEXT VISIT SCHEDULED	September 2012
NEXT ACTION	Spray treatment 2
SITE SPRAY TECHNICIAN	Malcolm Stubbs
SPRAY PROGRAMME MANAGER	Katherine Anderson
SIGNED BY	
	Lara Roe Director

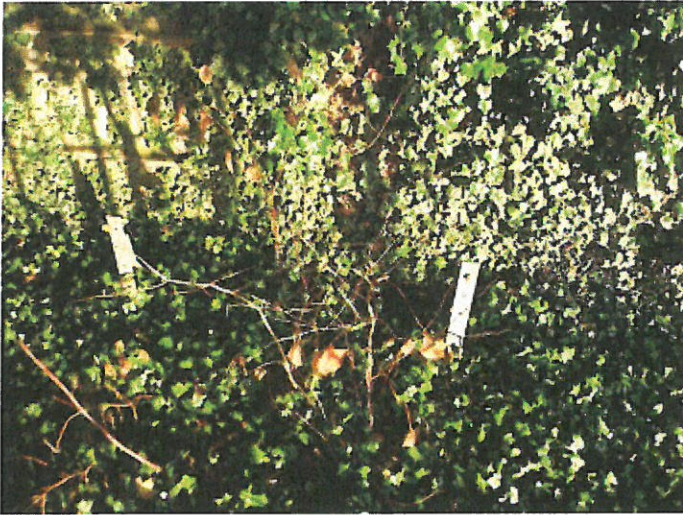
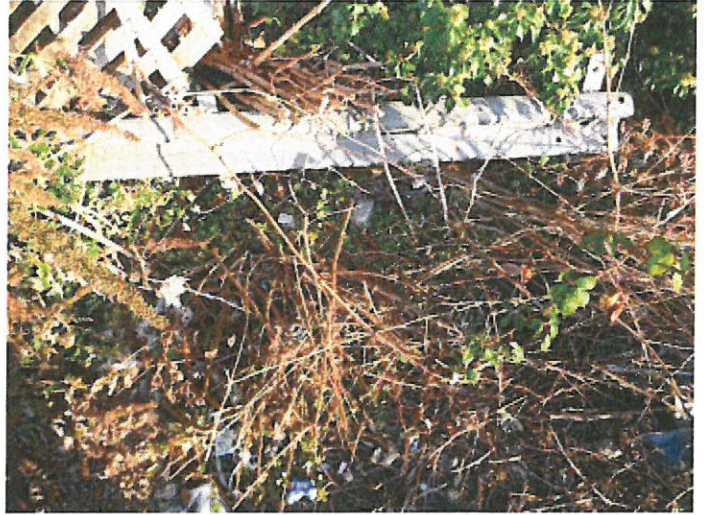
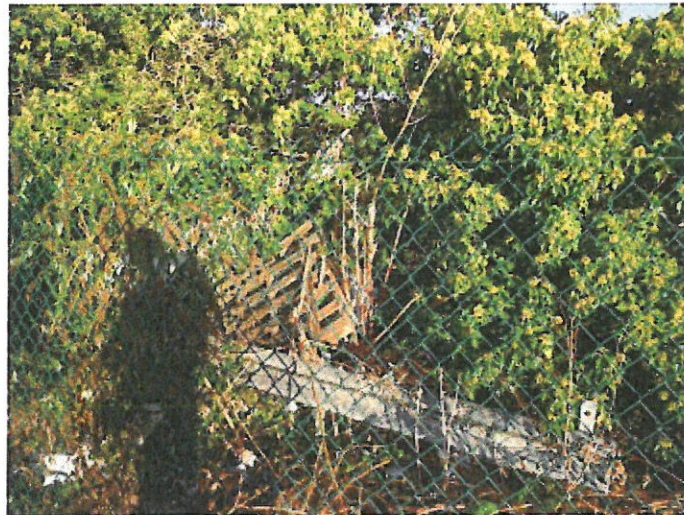
DATE	4 th October 2012
NAME	St James Group Limited
JOB NUMBER	DTR12051
SITE ADDRESS	The Former Royal Mail Sorting Office London Road Twickenham
SITE VISIT NUMBER	SPR2
SITE PROGRESS	Second herbicide treatment of Japanese knotweed
COMMENTS	Our Operative treated all visible Japanese knotweed on the client's site. No new shoots appeared around the main stand. The knotweed contaminated area remained undisturbed. Please be advised that we still haven't received an instruction to treat the Japanese Knotweed on the council land, so we are unable to spray this area. Without treatment of this stand or the installation of a root barrier we will be unable to guarantee your site due to probable re growth from this area.
NEXT VISIT SCHEDULED	November 2012
NEXT ACTION	Spray treatment 3
SITE SPRAY TECHNICIAN	Malcolm Stubbs
SPRAY PROGRAMME MANAGER	Katherine Anderson
SIGNED BY	
	Lara Roe Director

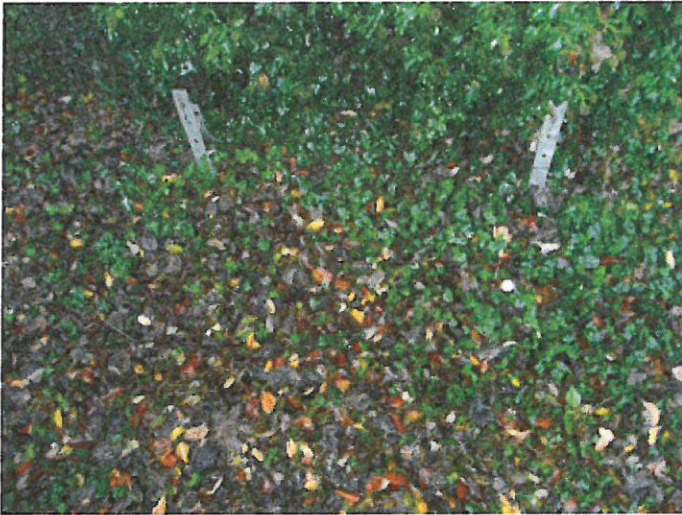
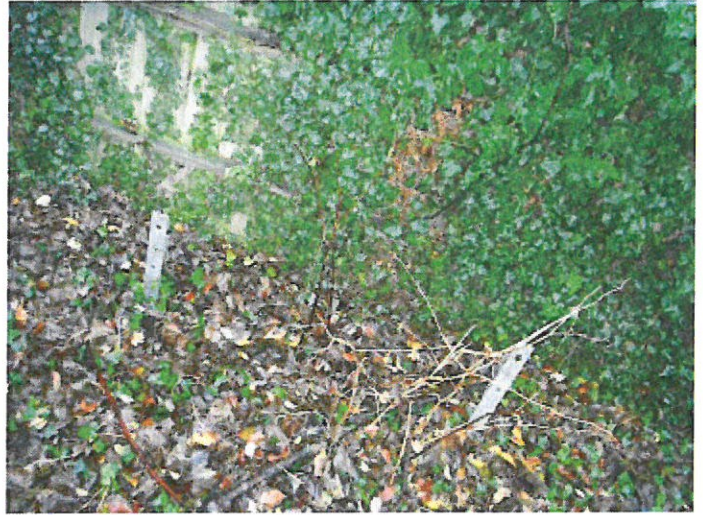
DATE	27 th November 2012
NAME	St James Group Limited
JOB NUMBER	DTR12051
SITE ADDRESS	The Former Royal Mail Sorting Office London Road Twickenham
SITE VISIT NUMBER	SPR3
SITE PROGRESS	Third herbicide treatment of Japanese Knotweed
COMMENTS	Our operative treated all visible Japanese Knotweed on the client's site. The knotweed has responded well to the series of treatments and we will return in February 2013 to perform the final clearance.
NEXT VISIT SCHEDULED	February 2013
NEXT ACTION	Final Clearance of Japanese Knotweed
SITE SPRAY TECHNICIAN	Malcolm Stubbs
SPRAY PROGRAMME MANAGER	Katherine Anderson
SIGNED BY	
	Lara Roe Director

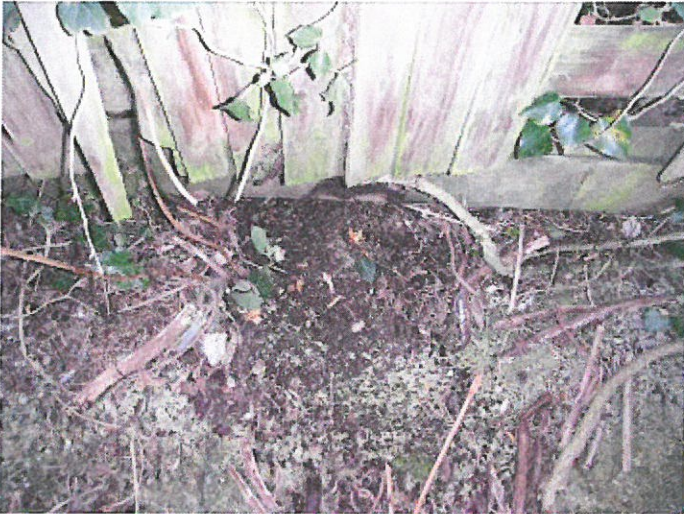
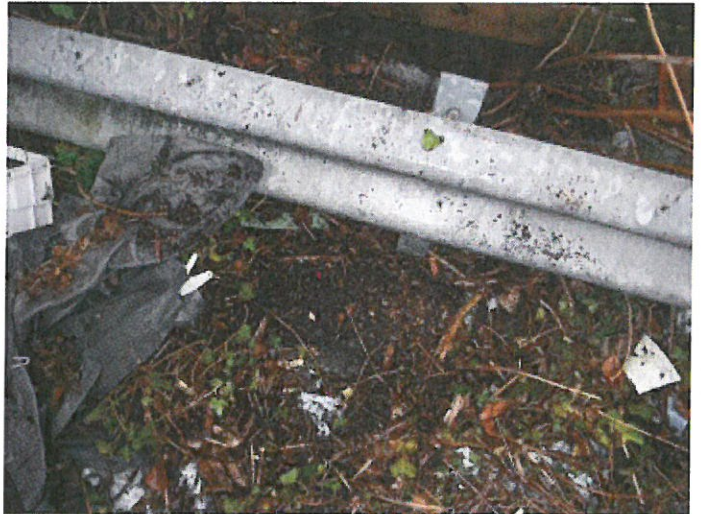
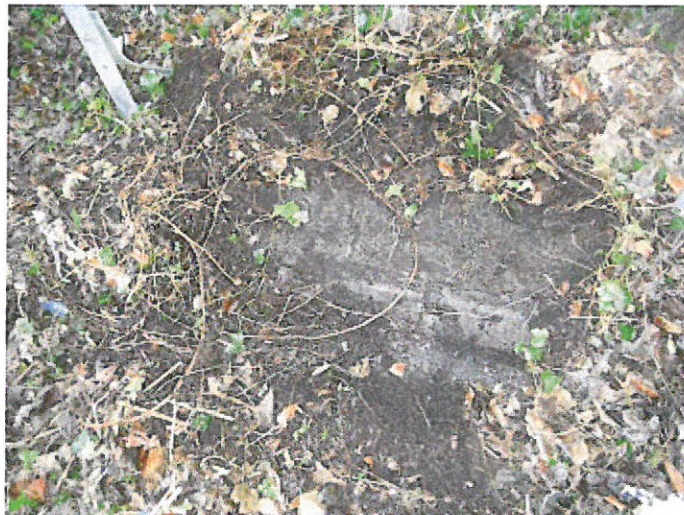
DATE	26 th February 2013
NAME	St James Group Limited
JOB NUMBER	DTR12051
SITE ADDRESS	The Former Royal Mail Sorting Office London Road Twickenham
SITE VISIT NUMBER	SPR4
SITE PROGRESS	Final clearance of Japanese Knotweed on the clients site
COMMENTS	<p>During this visit the treated Japanese Knotweed vegetation was removed along with the surface root crowns, these were excavated by hand and were removed from site to a licensed land fill.</p> <p>As the additional stands that were discovered on the neighboring site are less than 8m away from the clients site Dunton will be unable to provide a guarantee for the treated stands unless a root barrier is installed as per the quotation issued on 21st November 2013. Please feel free to contact me should you wish to proceed with the root barrier installation.</p>
NEXT VISIT SCHEDULED	May 2013
NEXT ACTION	Monitoring Visit
SITE SPRAY TECHNICIAN	Malcolm Stubbs
SPRAY PROGRAMME MANAGER	Katherine Anderson
