Desk Study & Preliminary Site Assessment Report

Site: St Michael's Convent, Richmond

Client: Beechcroft Developments Ltd

Project Reference: A2392(A)

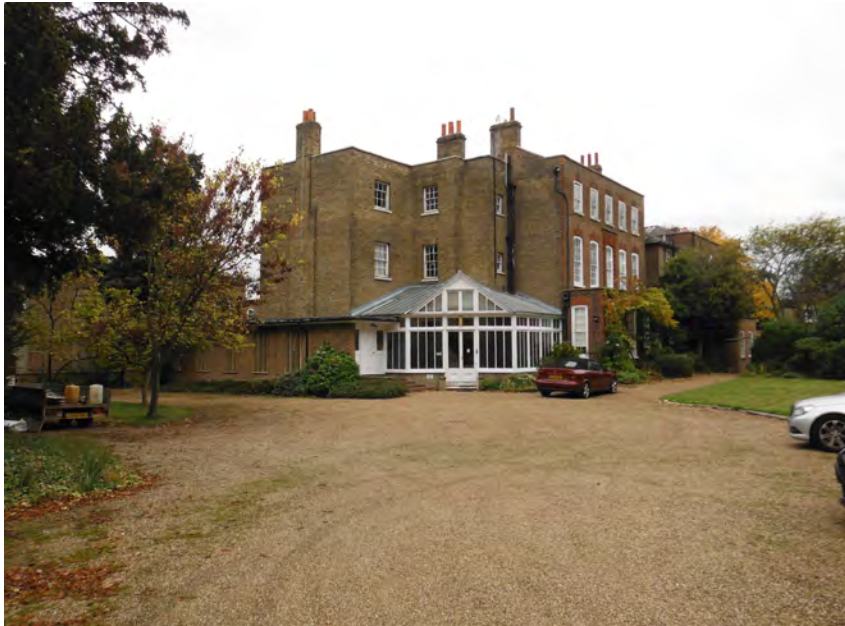
Based on a brief external inspection of the existing main building, there were no signs of significant structural movement, which can sometimes be an indication of poor ground conditions.

Photo 1 – View of existing building from the SW site corner (looking NE)

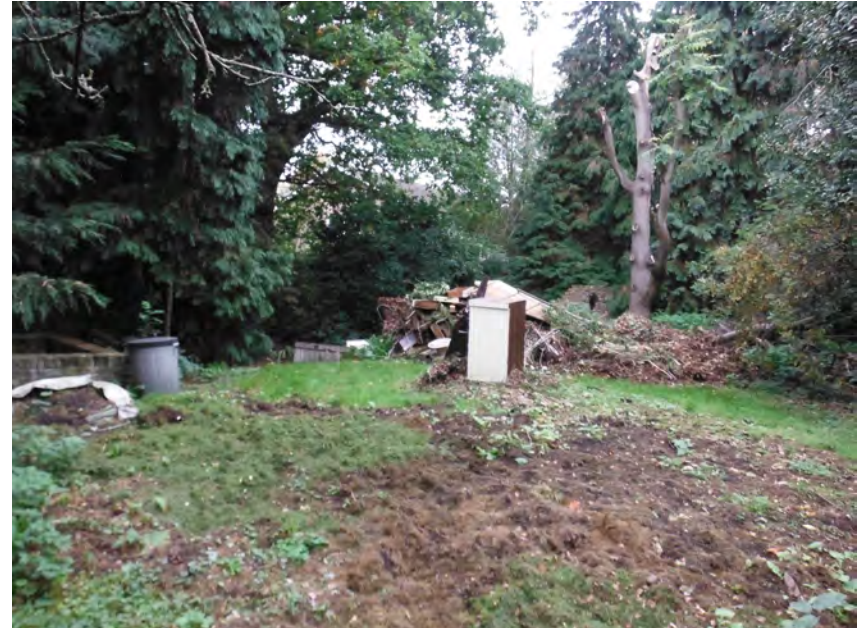
In the northwest of the site there is a small area of deposited garden waste, occasional discarded timber furniture and a very small area which has possibly been used for bonfires.

Photo 12 – Garden waste and rubbish in the NW (looking NW)
