SECOND FLOOR North West block & central block

Project AA6250 St Michael's Convent, Ham

Schedule No. 1

Section 04.
EXTERNAL - Schedule of works

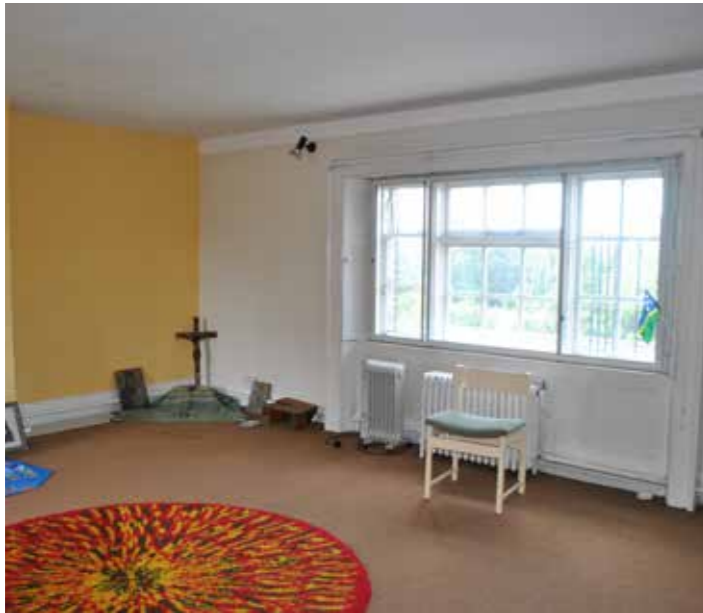
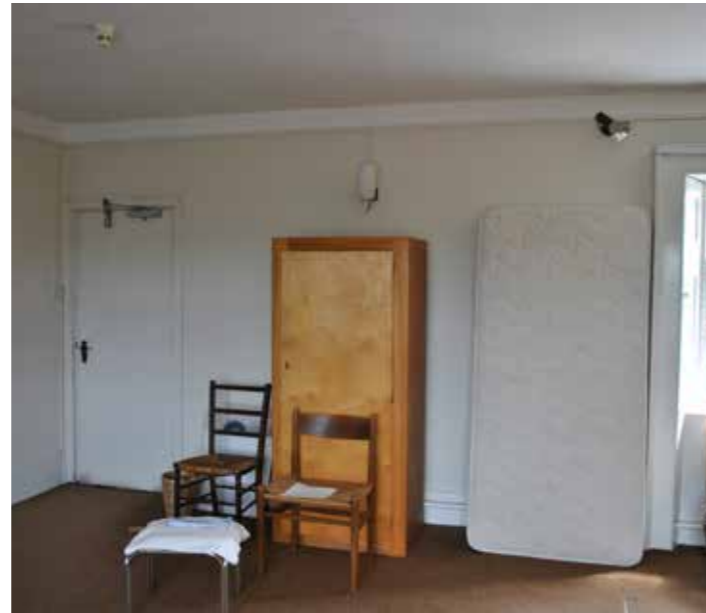
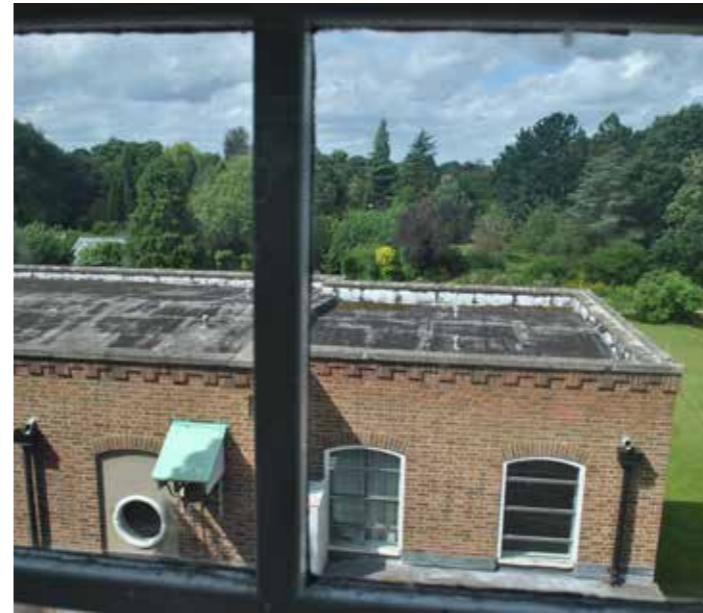
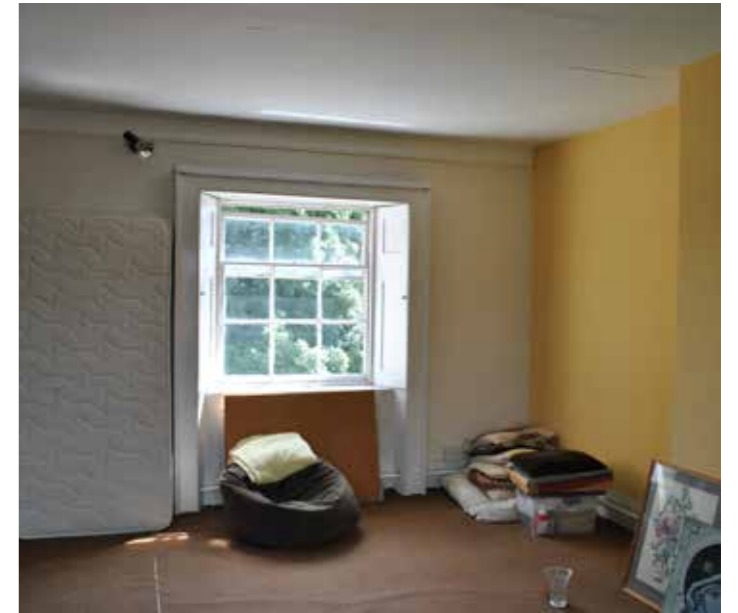
Room S2.0

- Cupboard carefully removed, panelling installed to match surrounding walls
- Door and window architraves and shutters retained
- Existing door to wc rehung to open into corridor

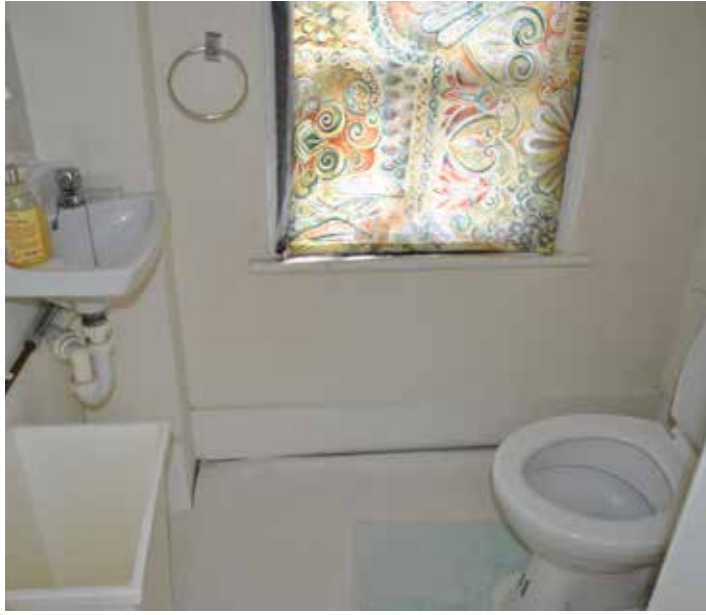
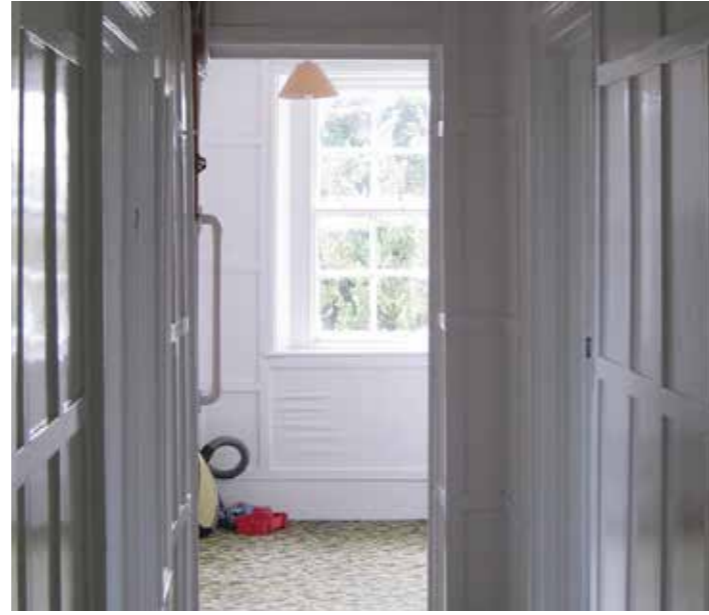
Room S3.0

- Kitchen equipment carefully stripped out
- No other alterations.
- Existing modern door to be replaced with panelled door to match

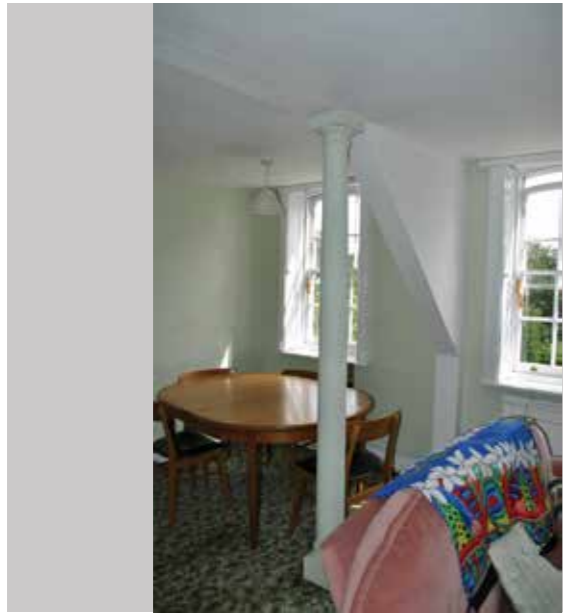
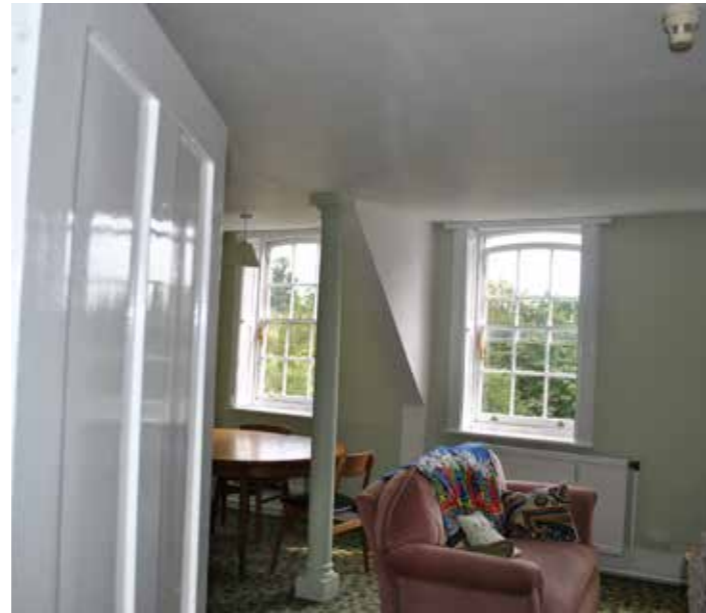
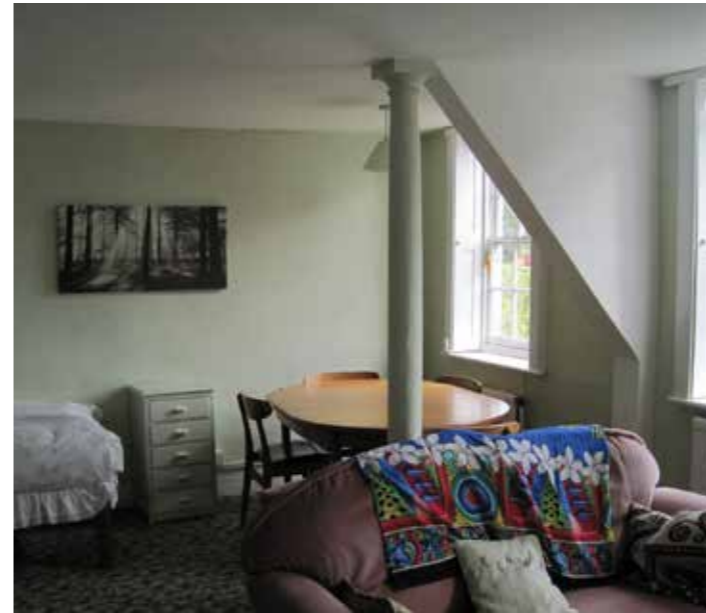
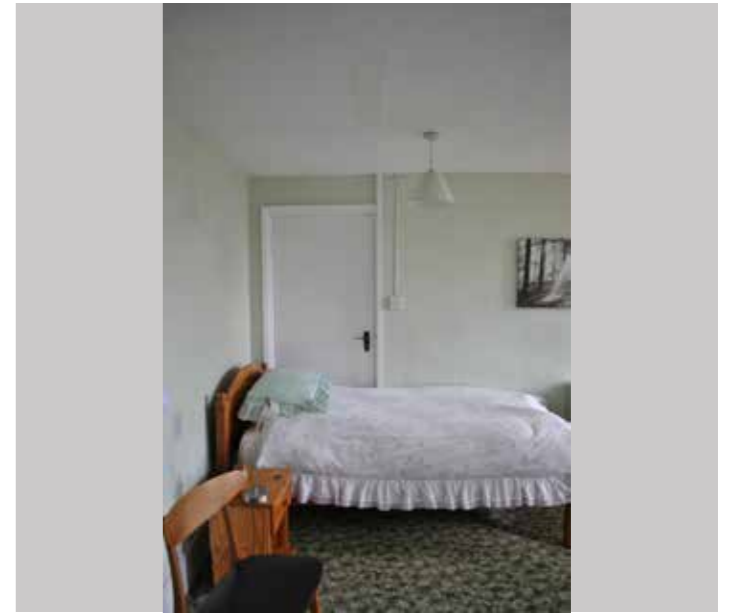
Room S5.0

- Staircase retained with all architectural features

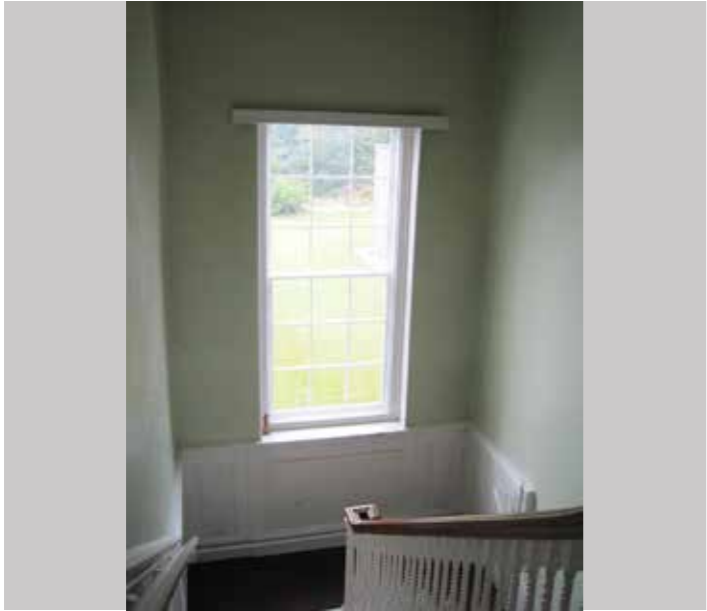
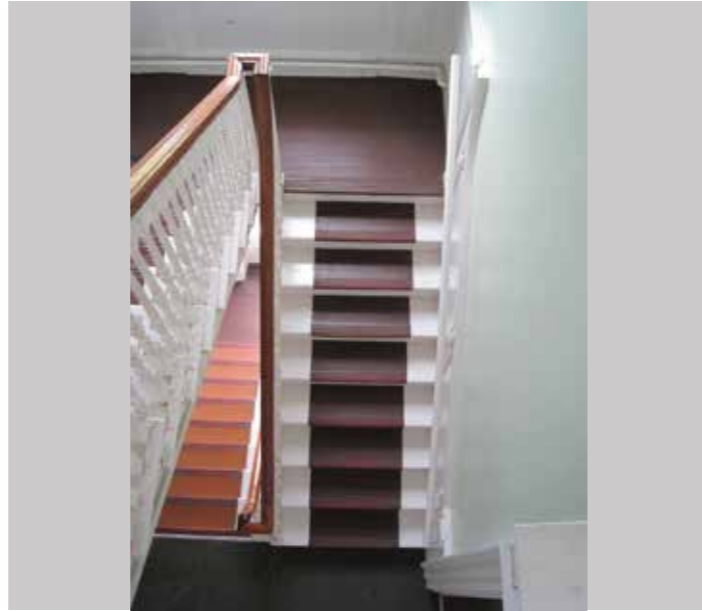
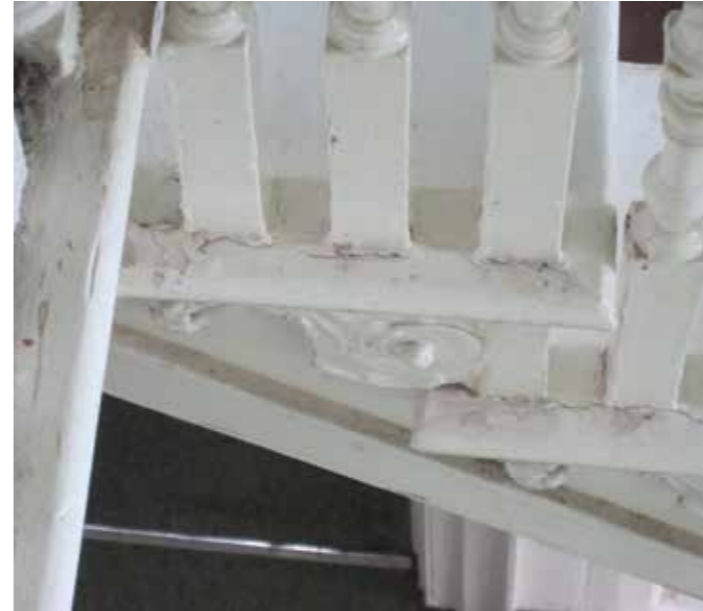
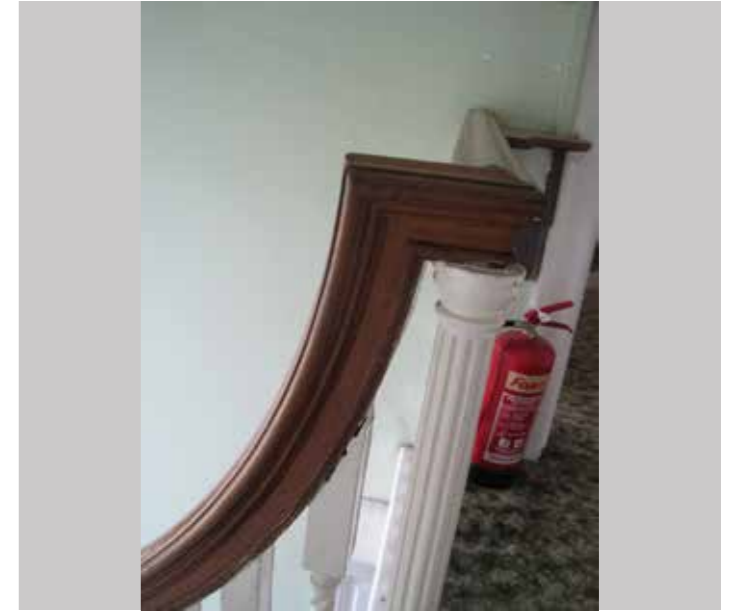
Room S6.0

- New partition walls added to create en-suite and corridor. Existing part wall to corridor removed. Panel in new wall to corridor to match existing.
- Fireplace restored
- Fire resistant lining to be added to back of wall with existing store room off corridor

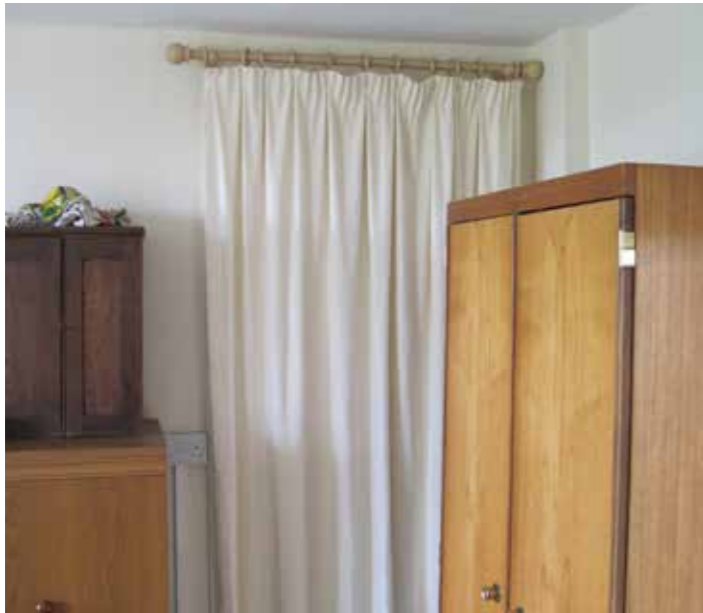
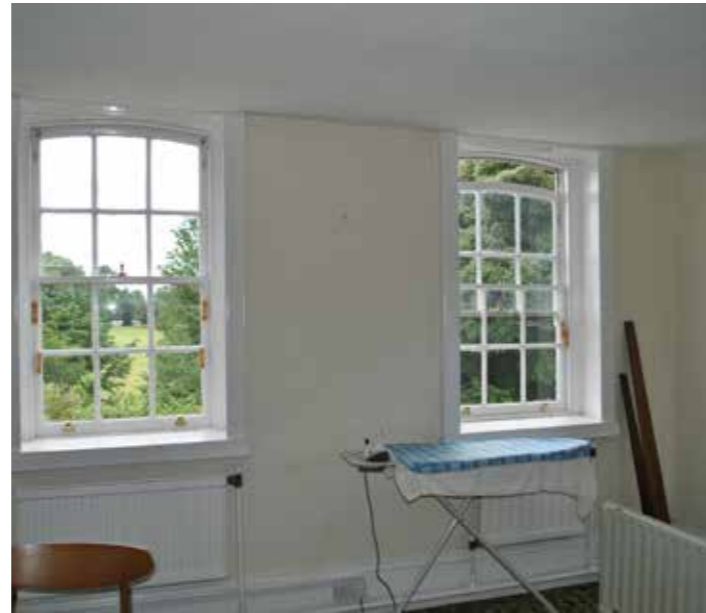
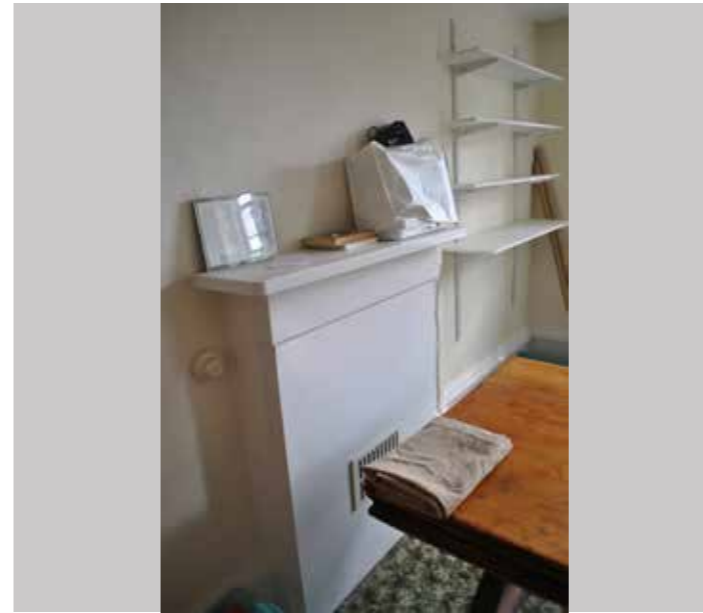
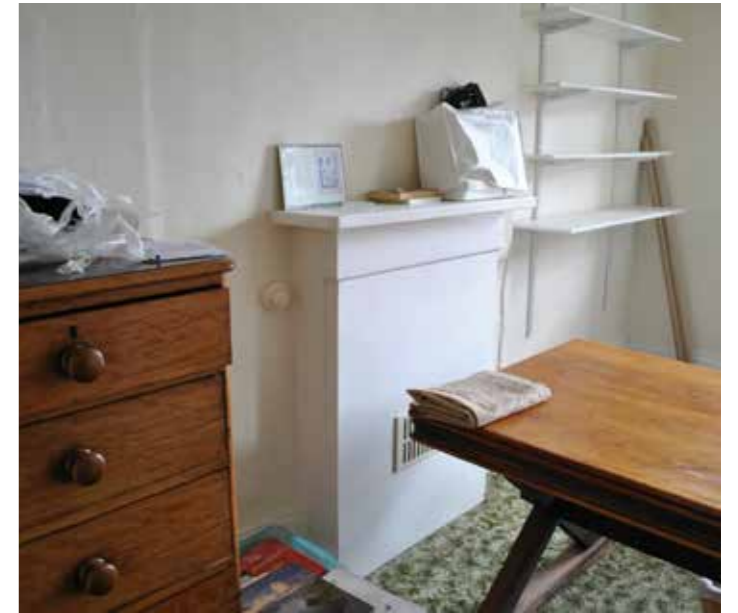
Room S7.0

- Fireplace retained

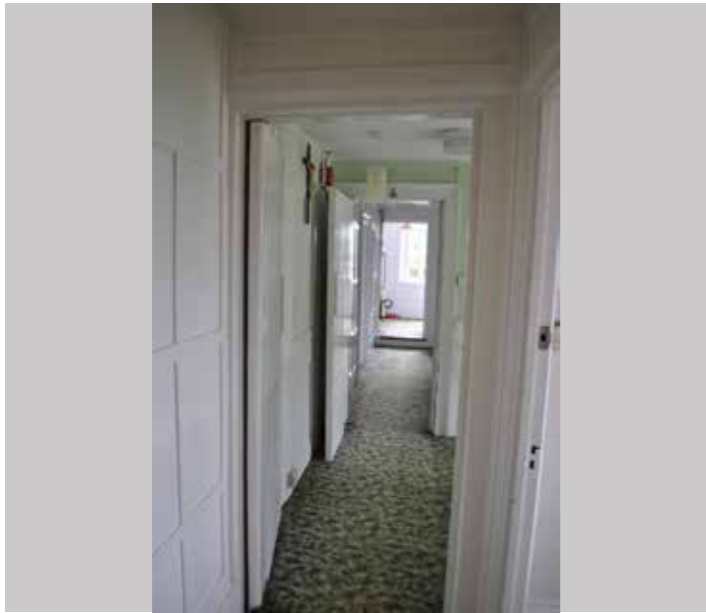
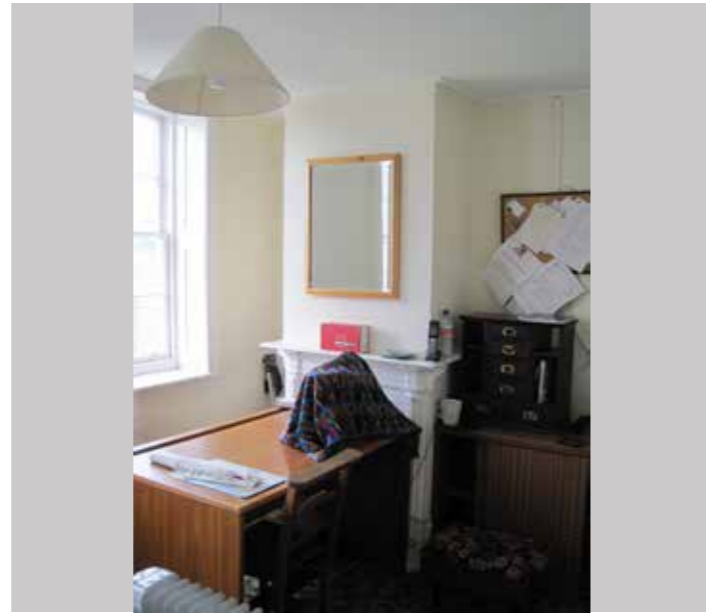
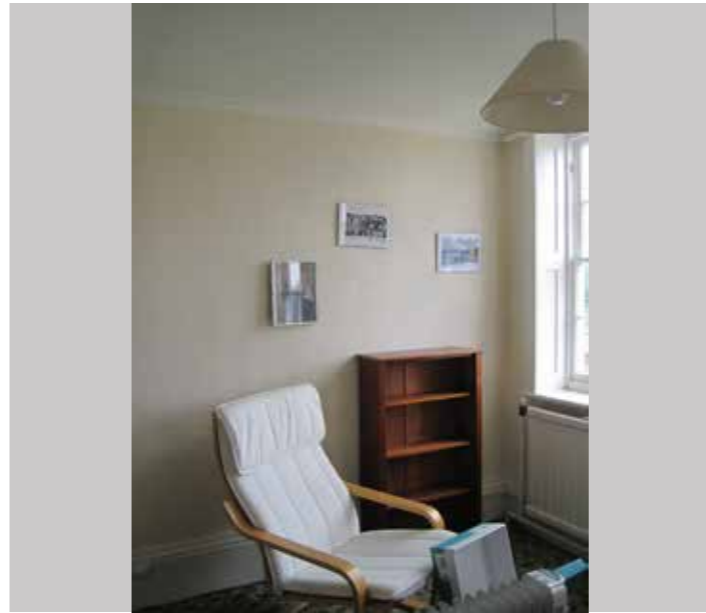
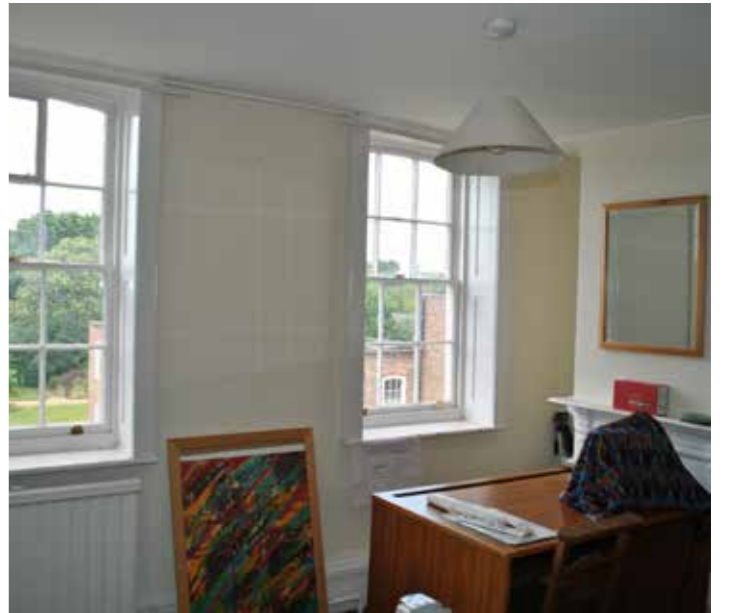
Room S8.0

- Existing stair to be part removed
- New Fire resistant wall to be added and matching balustrade to landing

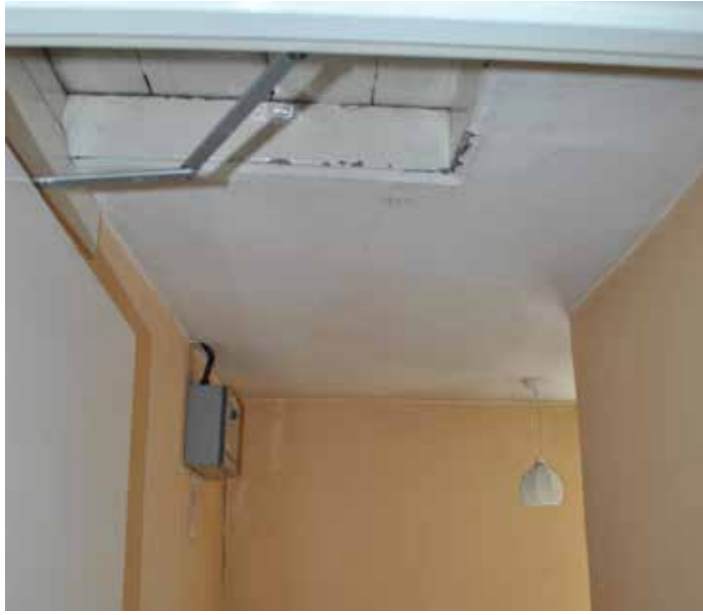
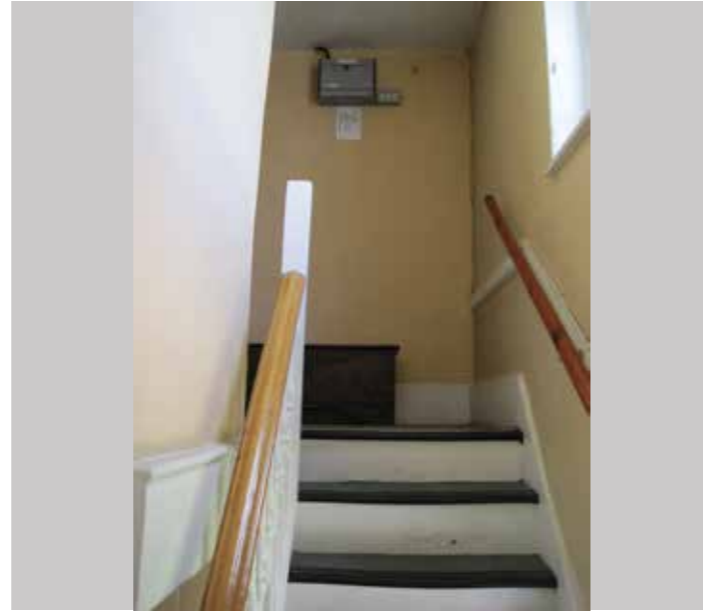
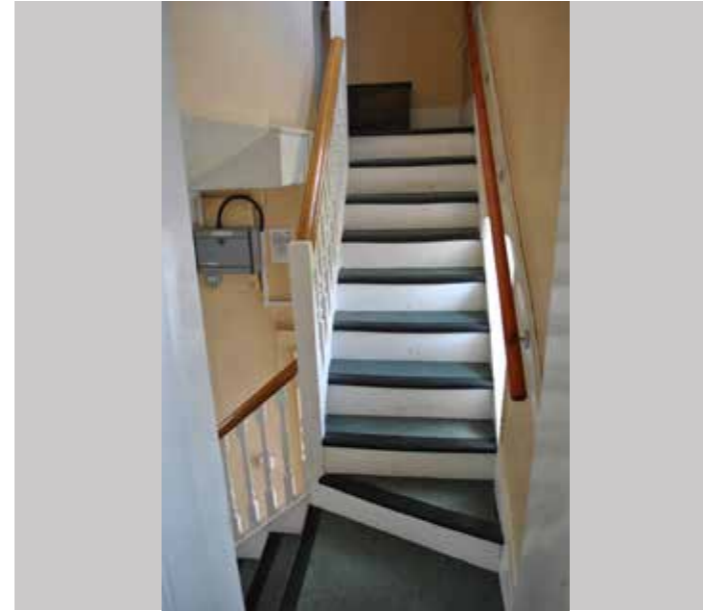
Room S9.0

- Bathroom stripped out
- Water tank removed
- Door and wall to be removed
- New wall and door inserted
- Existing wall and door to corridor removed and new opening formed to lift enclosure

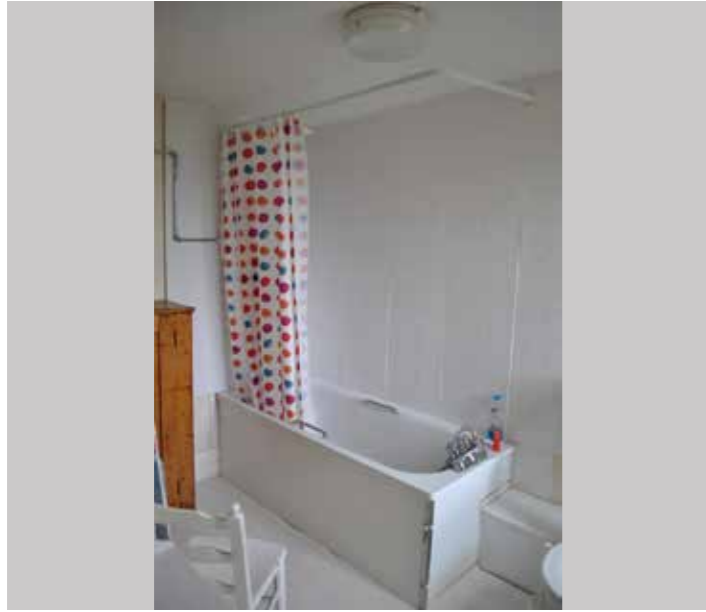
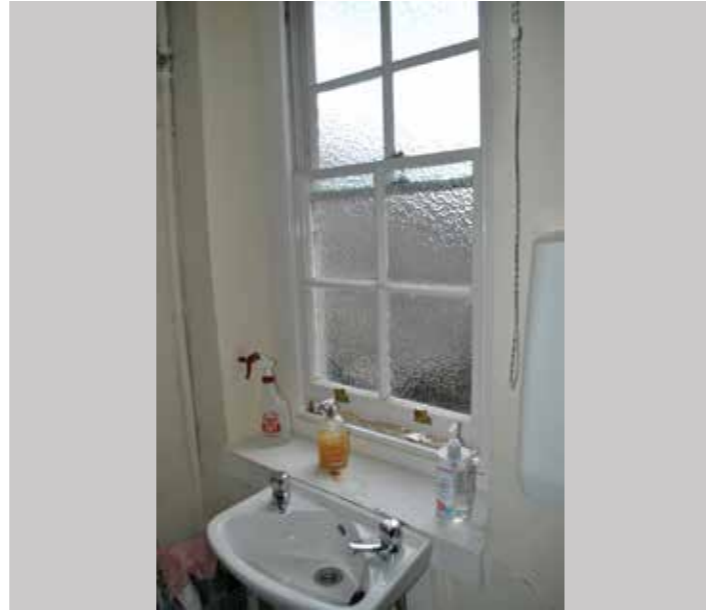
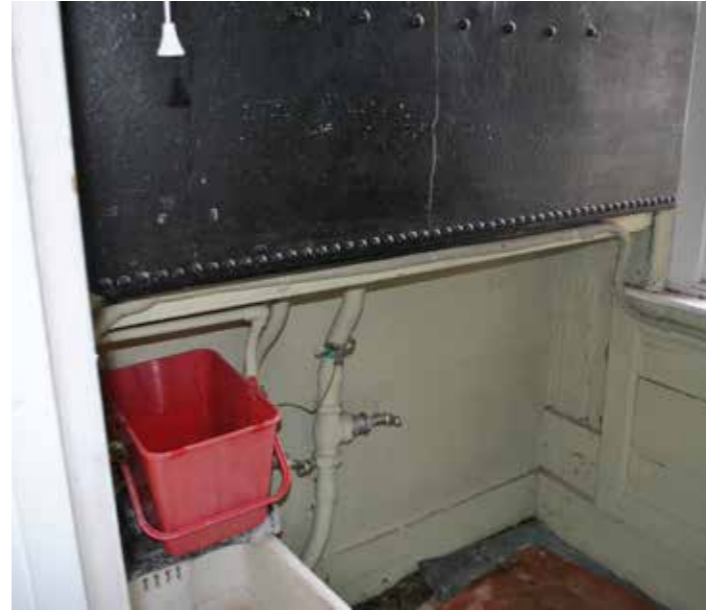
Rooms S10

- Bathroom stripped out
- Modern partition removed -
- New wall added to create en-suite and existing wall and door to corridor removed.
- Opening created in corridor wall and new door added
- Doorway onto corridor blocked off with new wall.

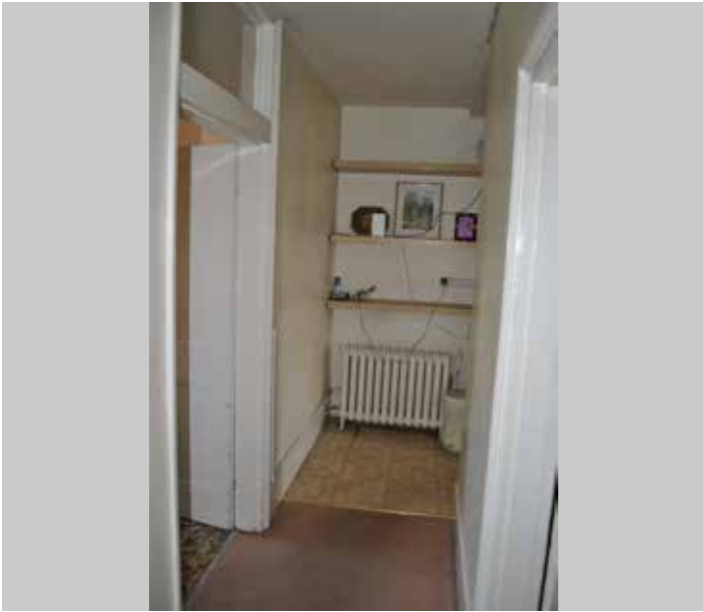
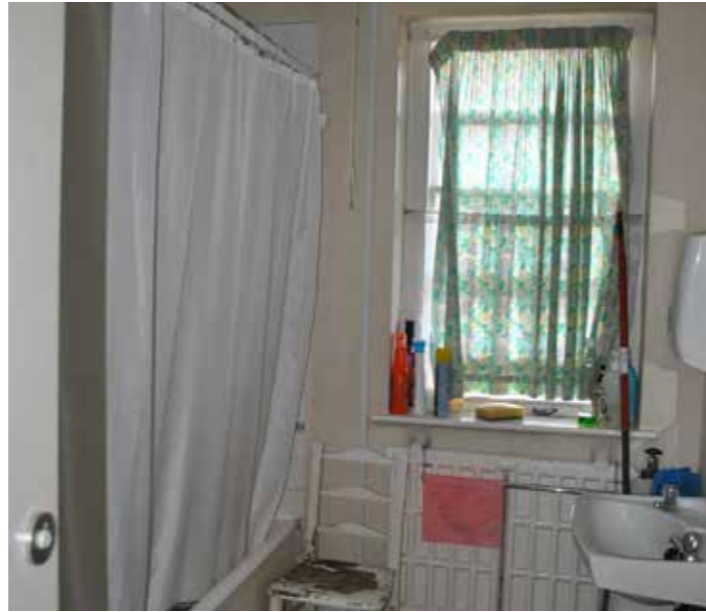
Room S11

- Modern partitions removed
- New wall added to create en-suite and existing wall and door to corridor removed.

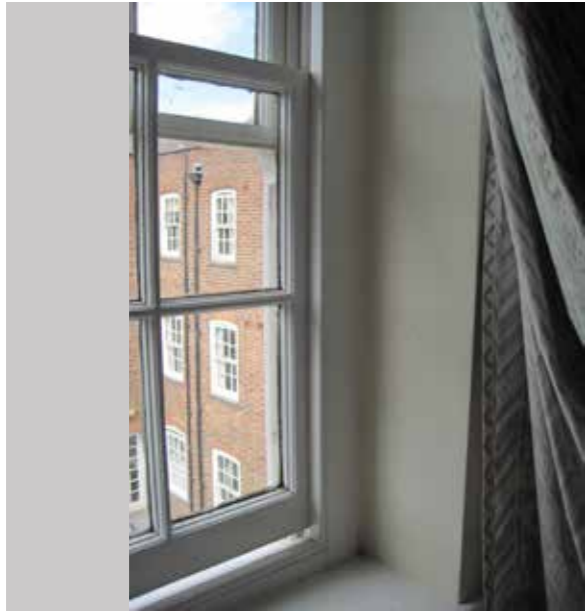
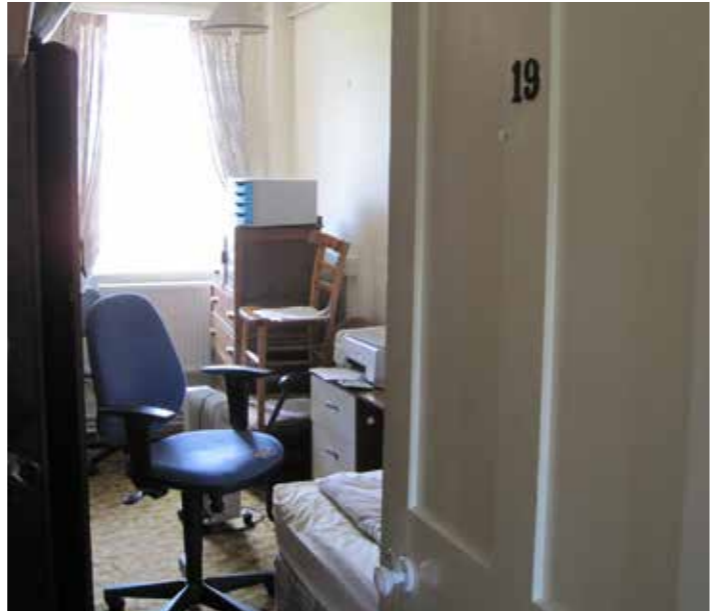
Room S12

- Modern partitions removed

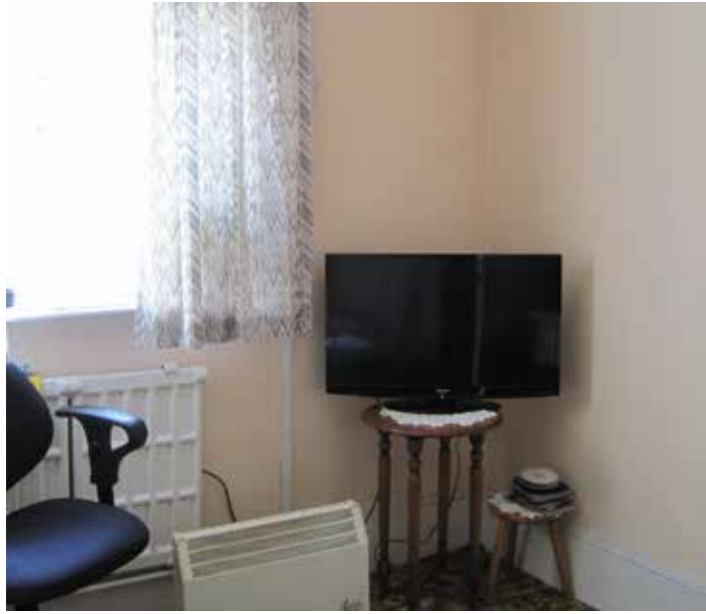
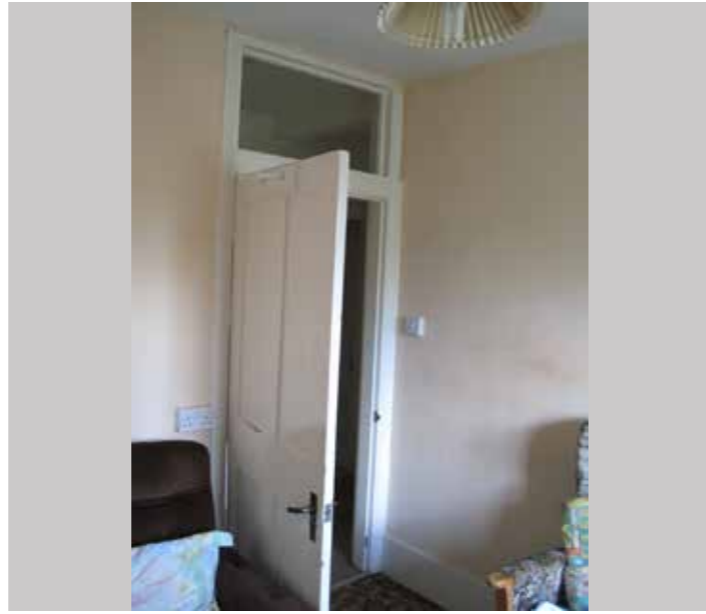
Room S13

- Modern partitions removed
- Fireplace retained and refurbished
- New Fire resisting wall added in party wall

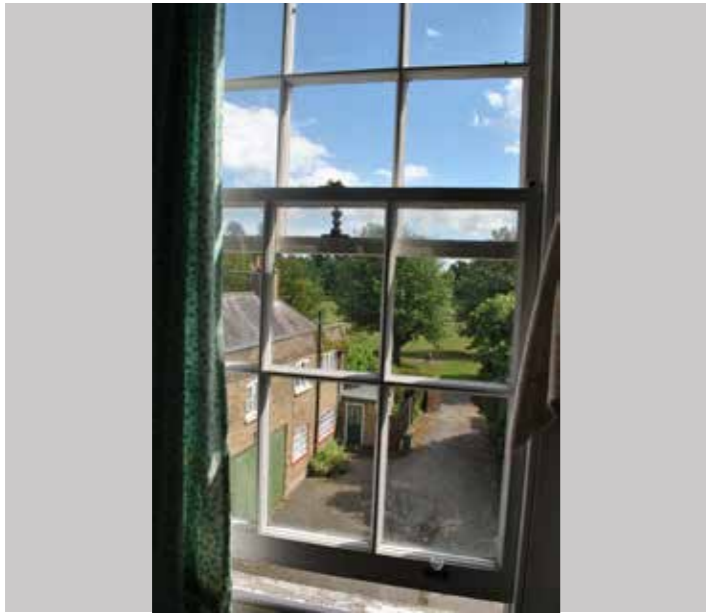
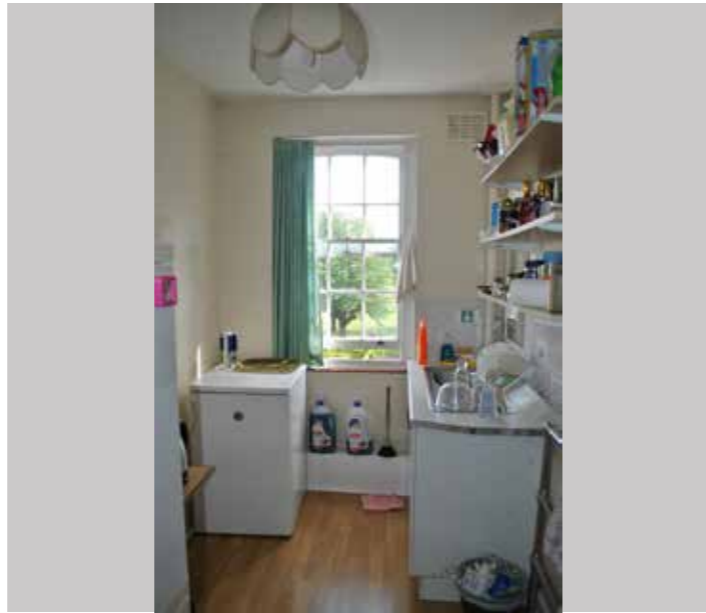
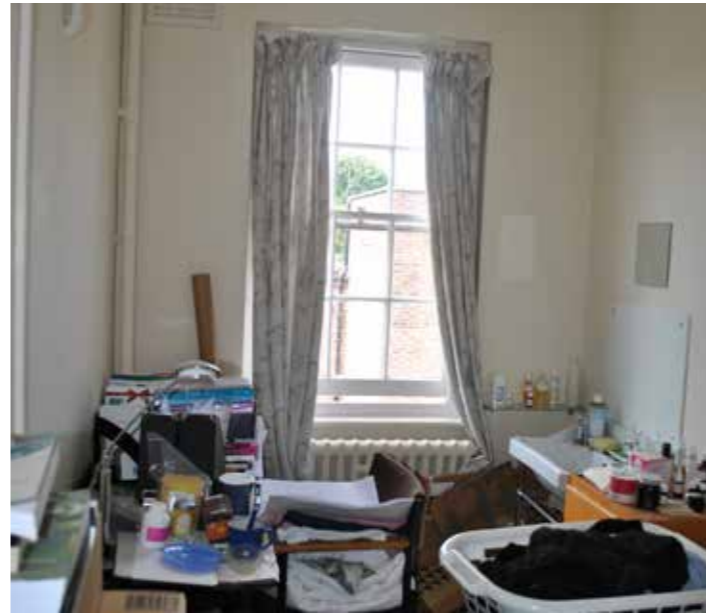
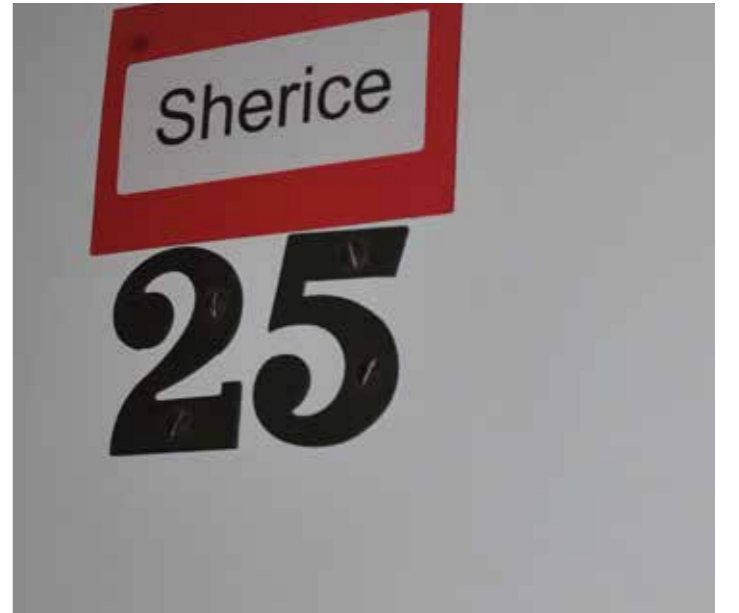
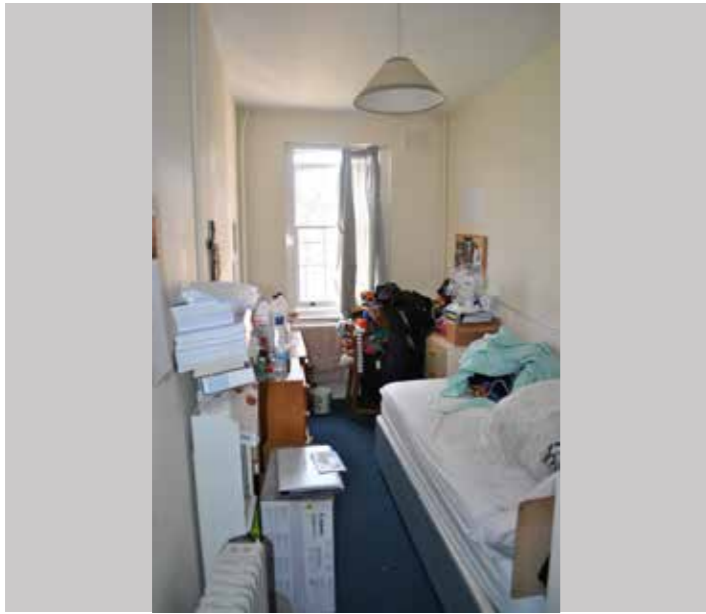
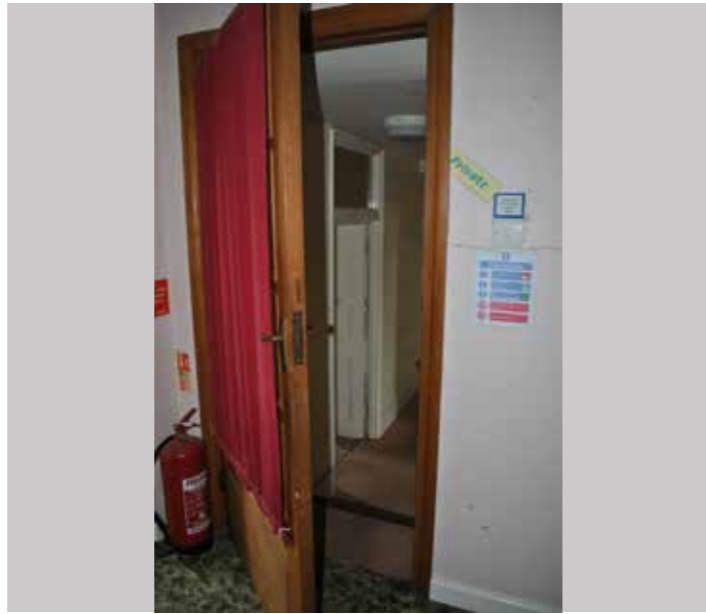
SECOND FLOOR Mid c20 East block		
Project AA6250 St Michael's Convent, Ham		
Schedule No. 1	Revision: 1	Date: August 2016
Location S14.0 - S23.0 + roofspace		
Description <ul style="list-style-type: none">• Alterations to create new apartment. Refer to application drawings• This block was built in the mid 20th century and has no interest and make no contribution to the significance of the original buildings.

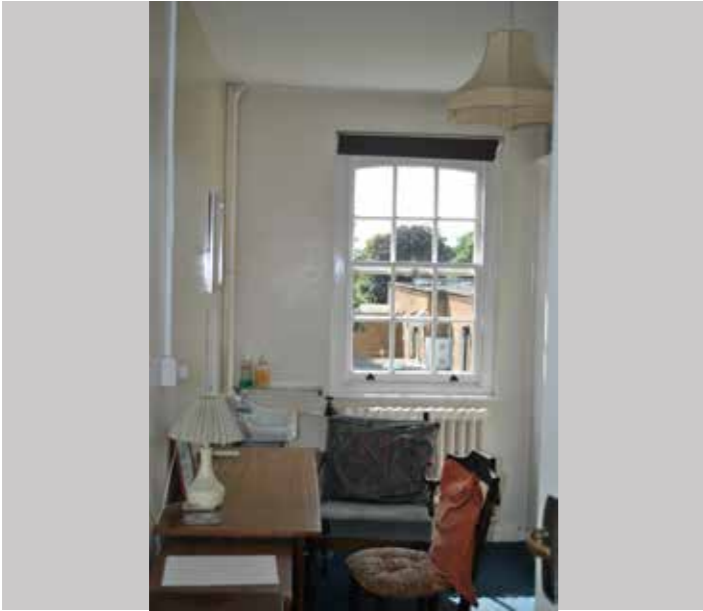
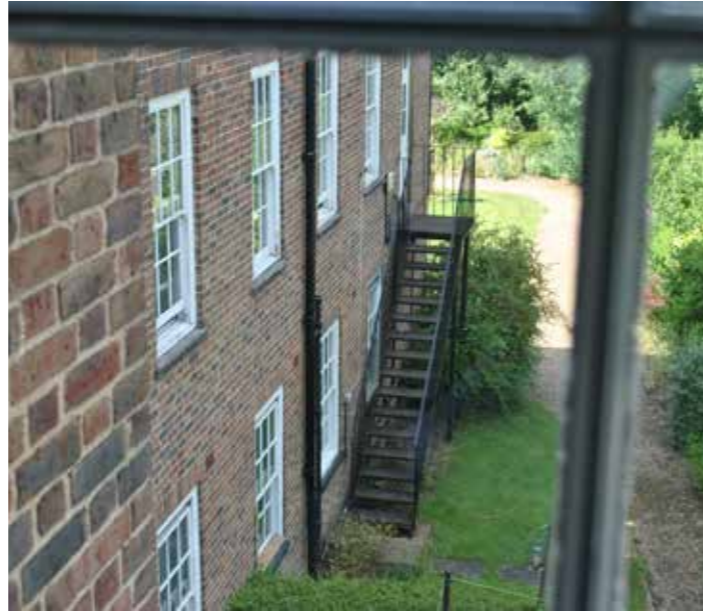
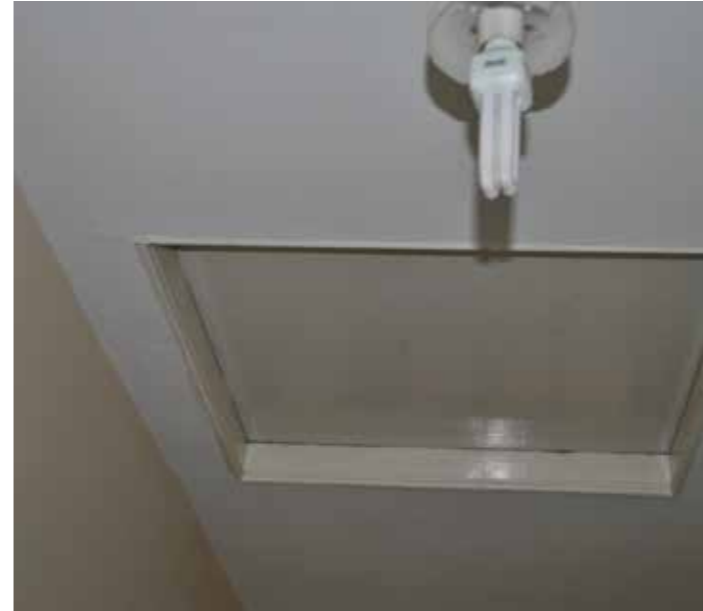
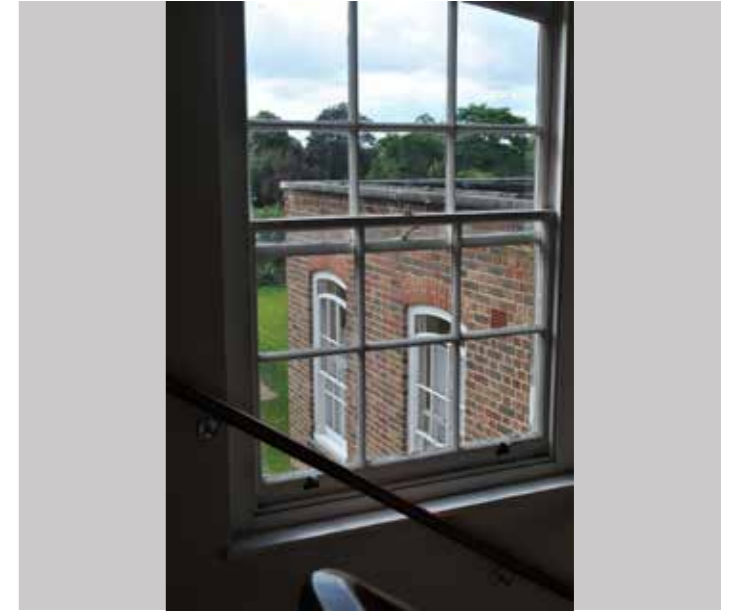
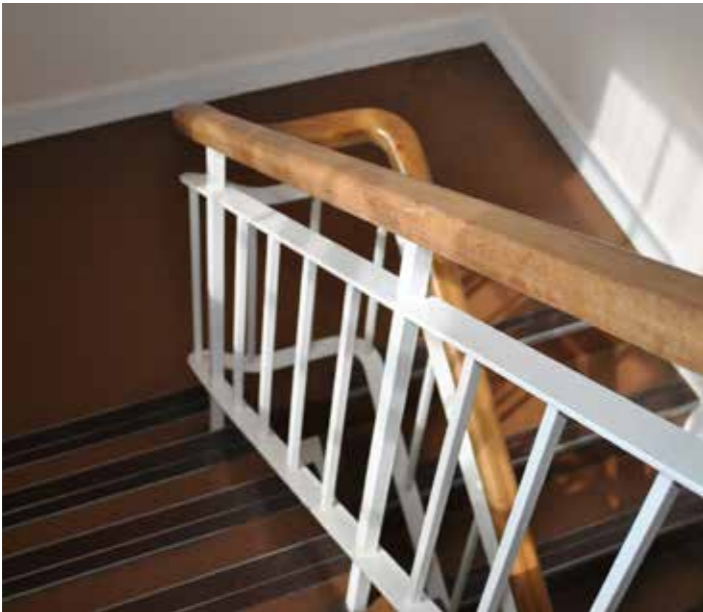
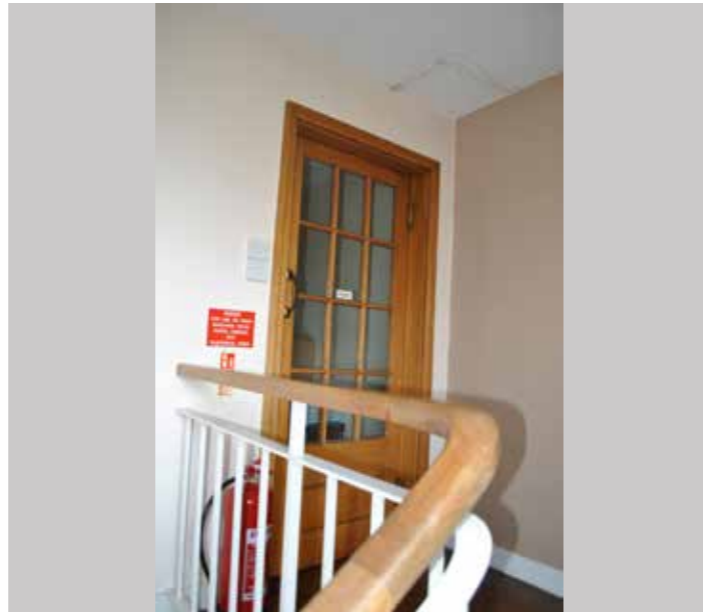
SECOND FLOOR Mid c20 East wing		
Project AA6250 St Michael's Convent, Ham		
Schedule No. 1	Revision: 1	Date: August 2016
Location S24.0 - S31.0		
Description <ul style="list-style-type: none">• Careful removal of S24.0 - 31.0• This wing was built in the mid 20th century and has no historical or architectural interest and makes no contribution to the significance of the original buildings.• Careful making good of revealed external walls to S19.0 (refer to external sheets)
