SECOND FLOOR North West block & central block

Project AA6250 St Michael's Convent, Ham

Schedule No. 1

Section 04.
EXTERNAL - Schedule of works

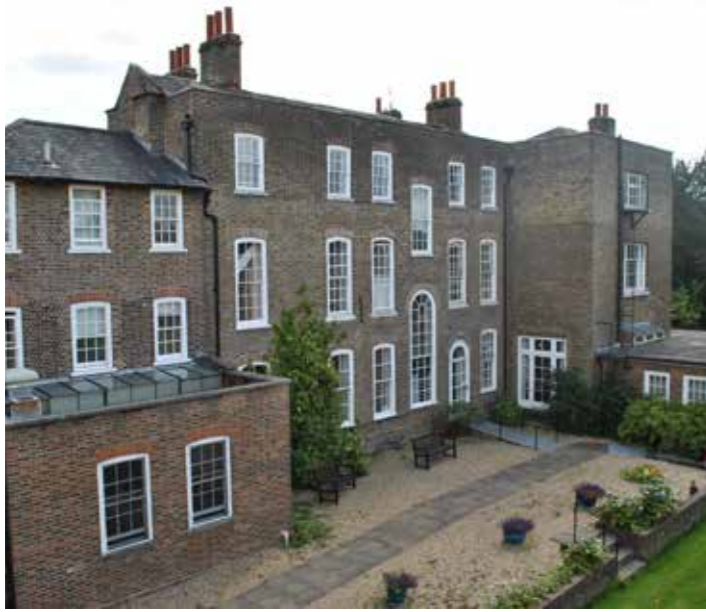
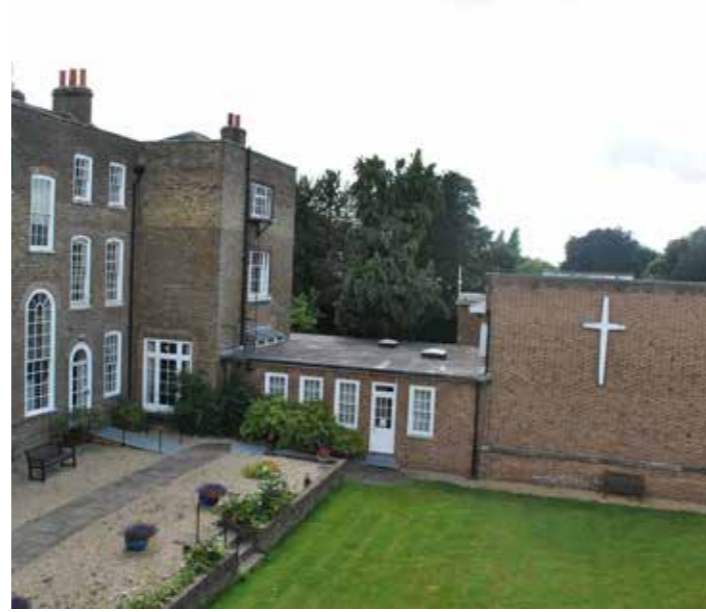
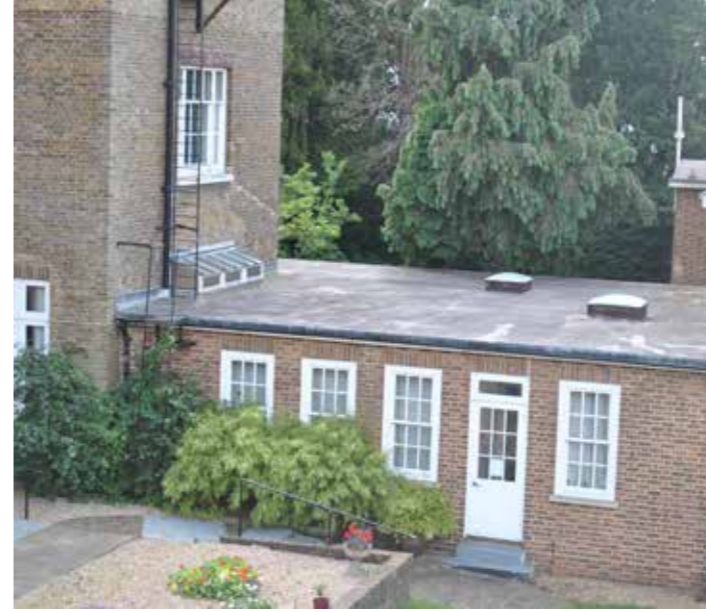
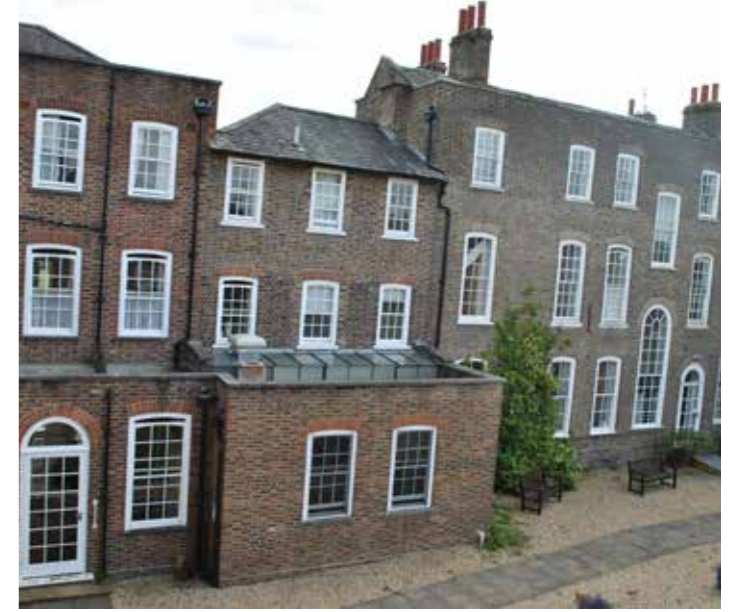
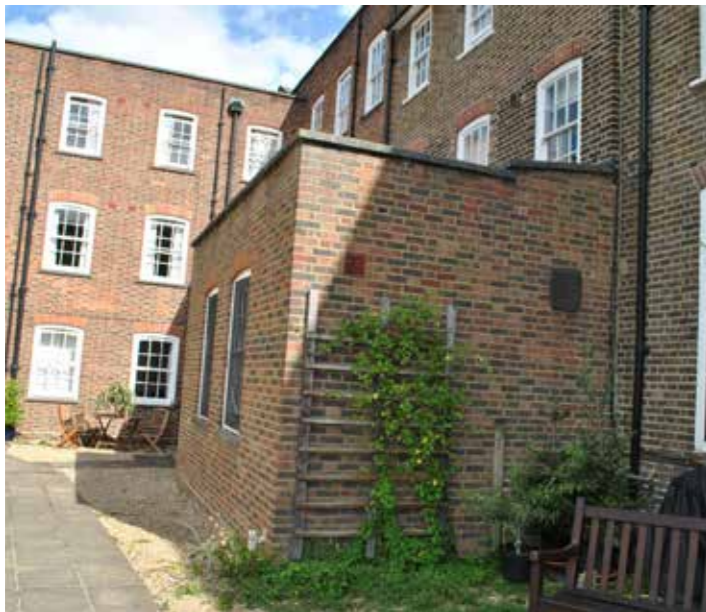
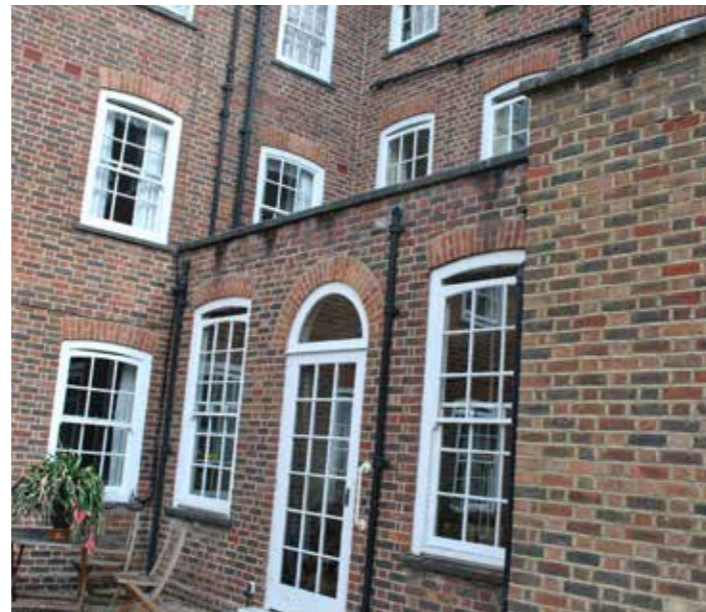
<p>NORTH WEST BLOCK, CONSERVATORY, CENTRAL BLOCK, & EXTENSION, INFILL, EAST BLOCK & EXTENSIONS, MID C20 EAST BLOCK, MID C20 EAST WING</p>		
<p>Project AA6250 St Michael's Convent, Ham</p>		
Schedule No.	Revision:	Date:
Location		
<p>Description</p> <ul style="list-style-type: none"> • Following demolition of the West Chapel Wing the exposed external flank wall of the North West Block, including the projecting chimney stack, would be restored back to original brick. This would be dependent on the condition of the brick work and may need to be rendered. A new opening would be made within the north wall of this block and a new window inserted to match the window overhead on the First Floor. • At the front of the Central Block the existing central window would be carefully removed and the opening extended to accommodate a new main entrance into the building, matching existing surrounding brickwork construction and detailing. • Single storey addition to the front of the East Block demolished, the exposed façade cleaned up and restored as brickwork to match existing at upper levels. A new entrance and windows inserted reflecting the design of existing door and windows in the façade • Following demolition of the Mid-20th Century East Wing and construction of the replacement wing, exposed sections of the north elevation would be made good. • All windows and doors repaired where necessary and painted. • Brickwork pointing repaired where necessary. • Roofing repaired where necessary.

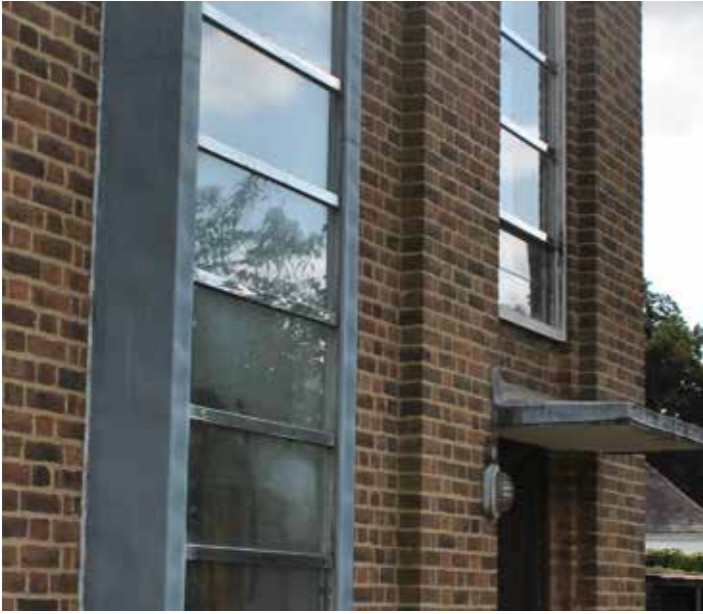
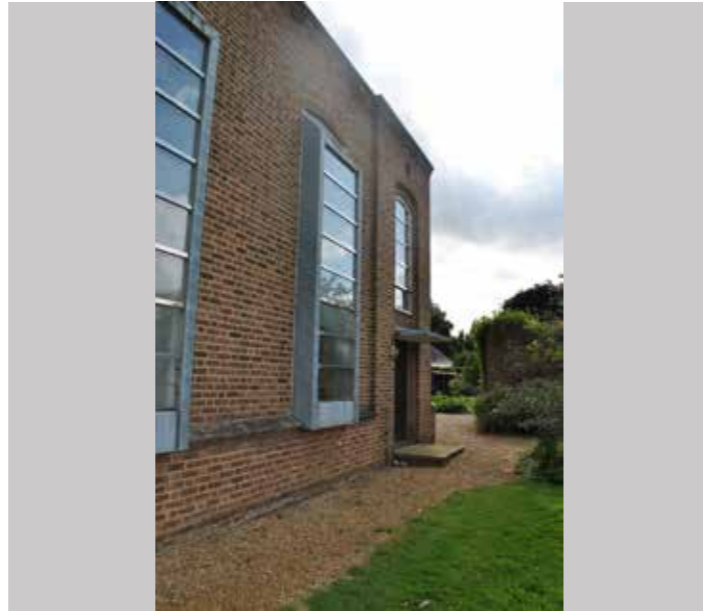
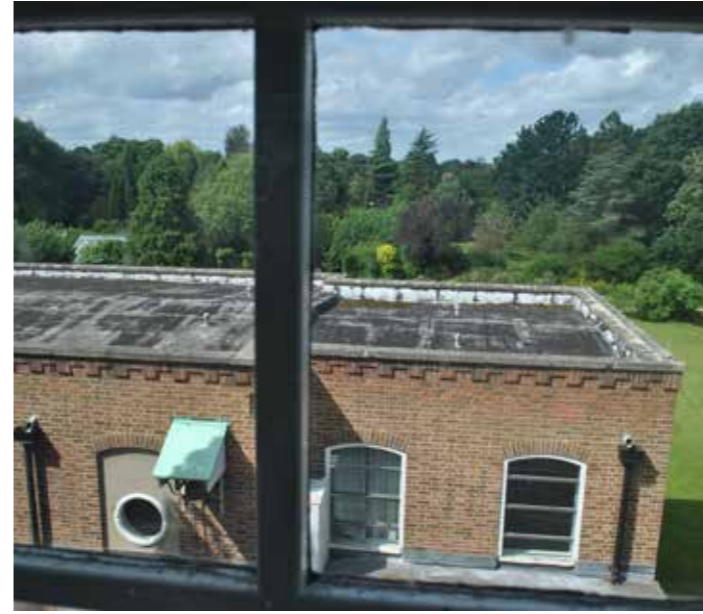
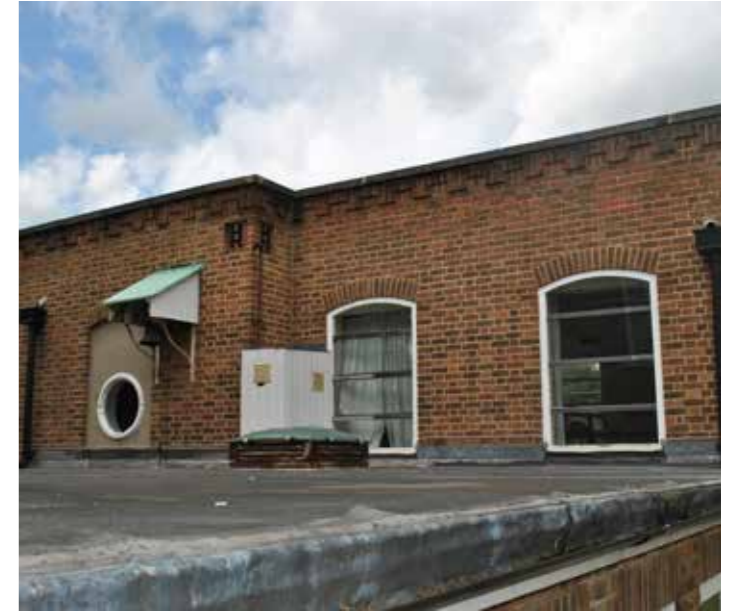
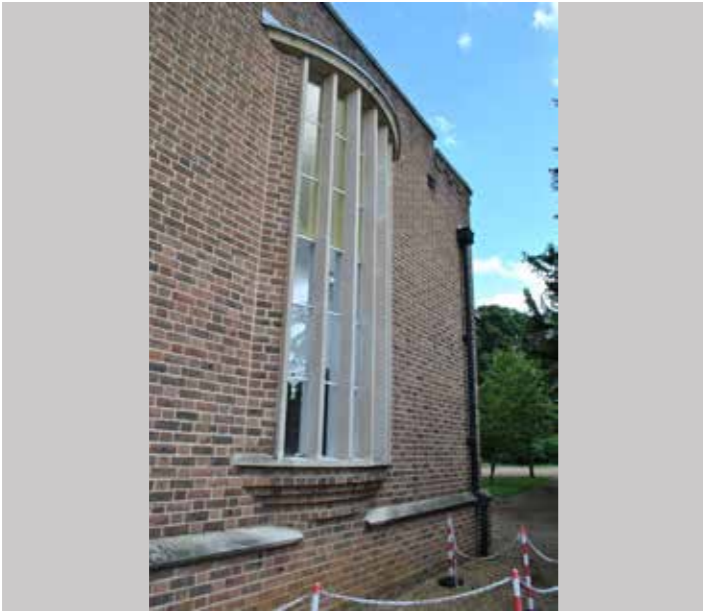
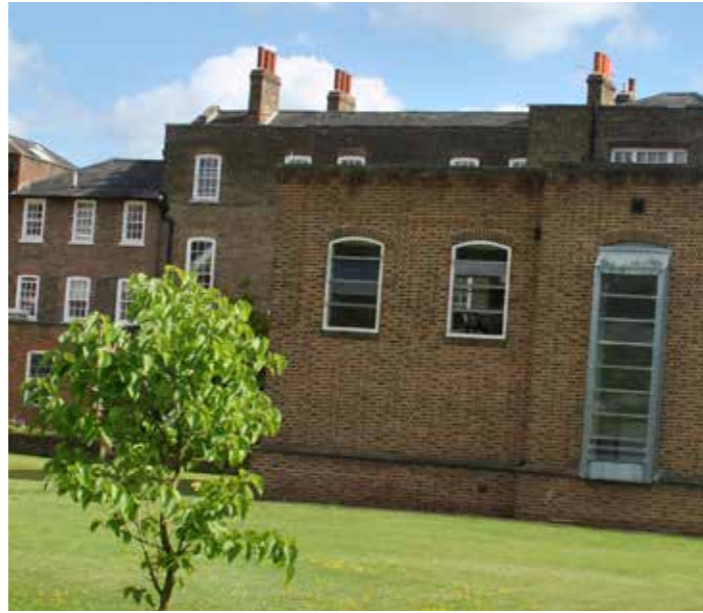
WEST CHAPEL WING

- Careful removal of chapel and linking corridor
- This wing was built in the mid 20th century and has no historical or architectural interest and makes no contribution to the significance of the original building
- Exposed brickwork restored (this may require a render finish dependant on the condition of the exposed brick)
