Phase I Environmental Assessment 149 - 151 Heath Road Twickenham, TW1 4BN UK

On behalf of:
Price and Myers LLP

Project Reference:
016-1481

Date:
September 2016

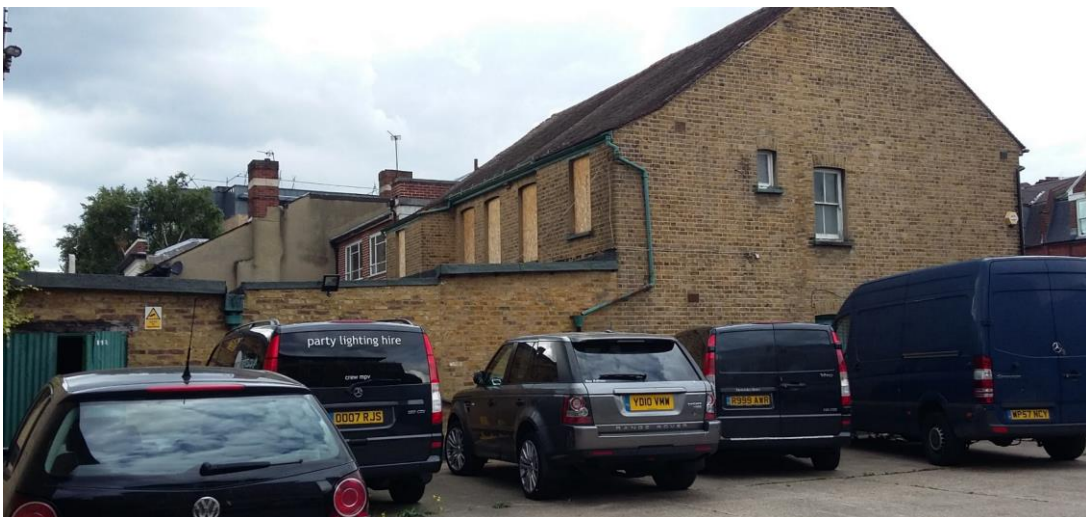
Photograph 2.1: *Yard and side of building and single storey store*

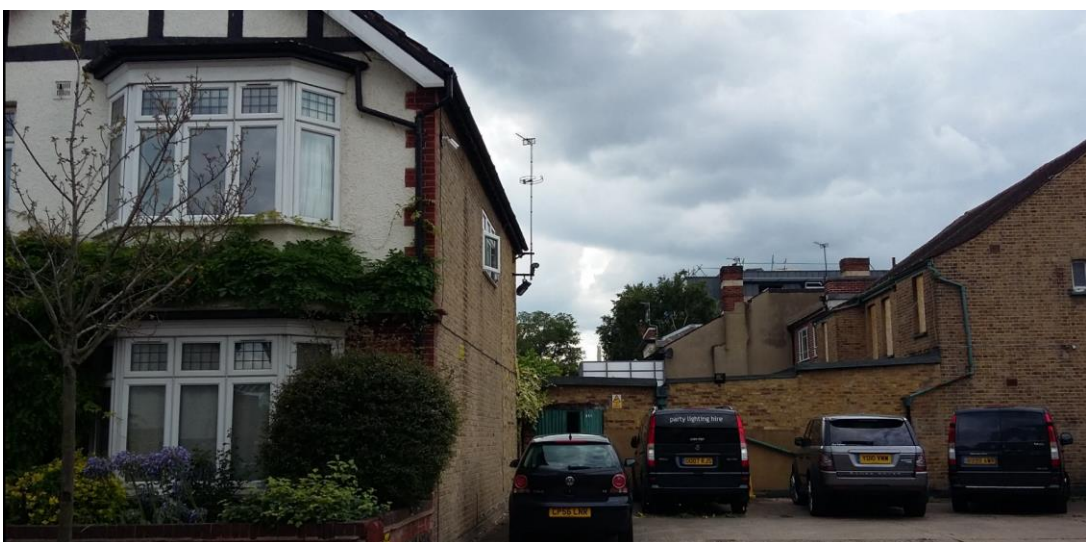
Photograph 2.2: *Adjacent residential property (Saville Road) and yard*

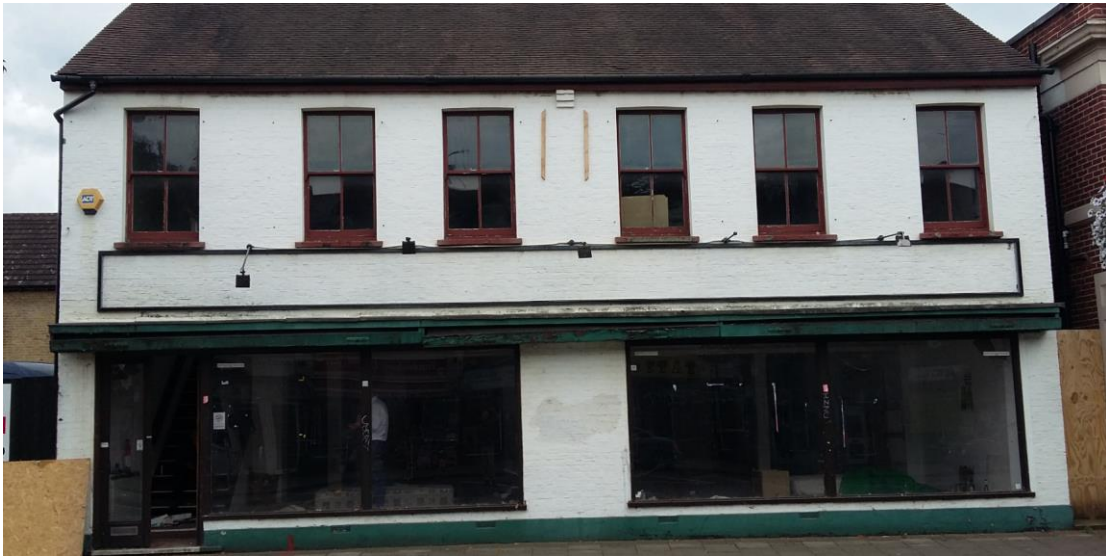
Photograph 2.3: *Main building (149-151 Heath Road)*

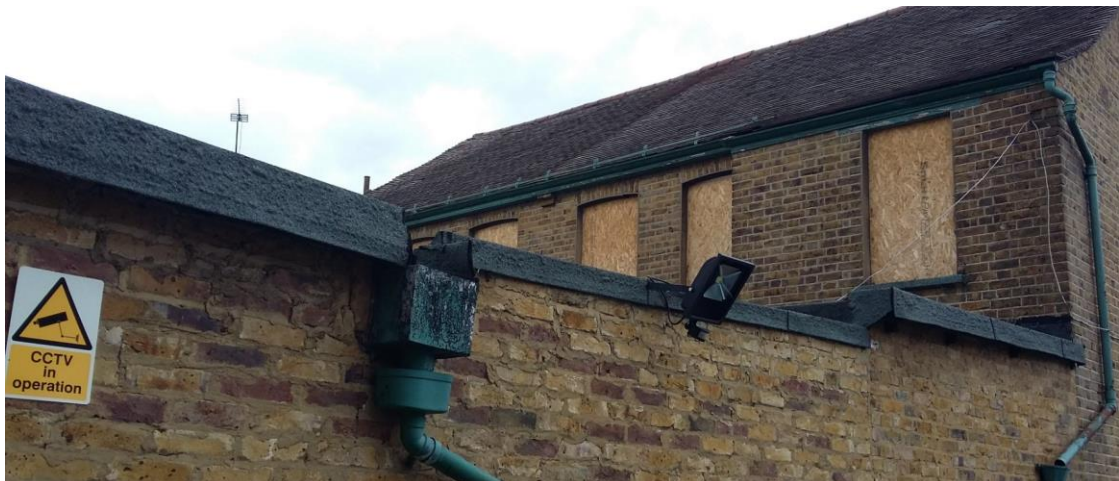
Photograph 2.6: *Roof of single-storey store and two-storey main building*

No (visible) Potential Asbestos Containing Materials (PACMs) were observed during the Site inspection. However, no asbestos survey has been undertaken on the building or the store. Given that ACMs can be hidden from sight within the structure of a building a refurbishment/demolition ACM survey should be undertaken.

Due to the age of the structure a refurbishment/demolition asbestos survey should be undertaken prior to demolition/site clearance
