**1-9 SANDYCOMBE ROAD  
NORTH SHEEN, RICHMOND TW9 2EP**

**PHASE 1 PRELIMINARY RISK ASSESSMENT**

***GOLDCREST LAND***

November 2016

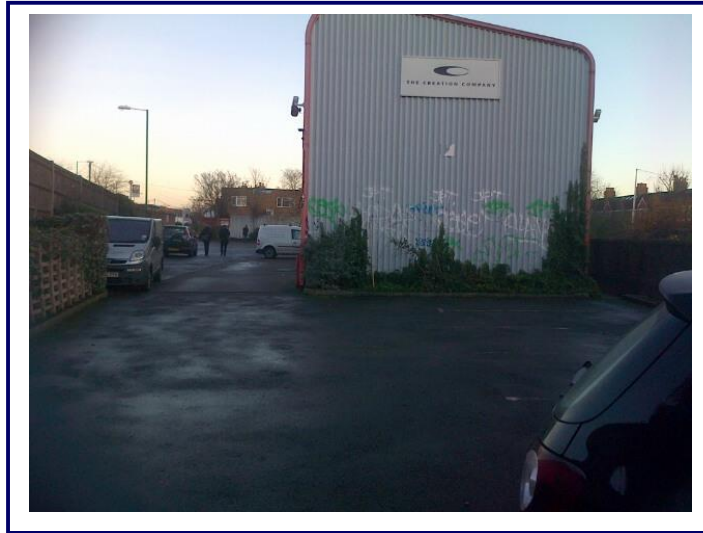
*General view of the site. For further photos see Appendix B.*

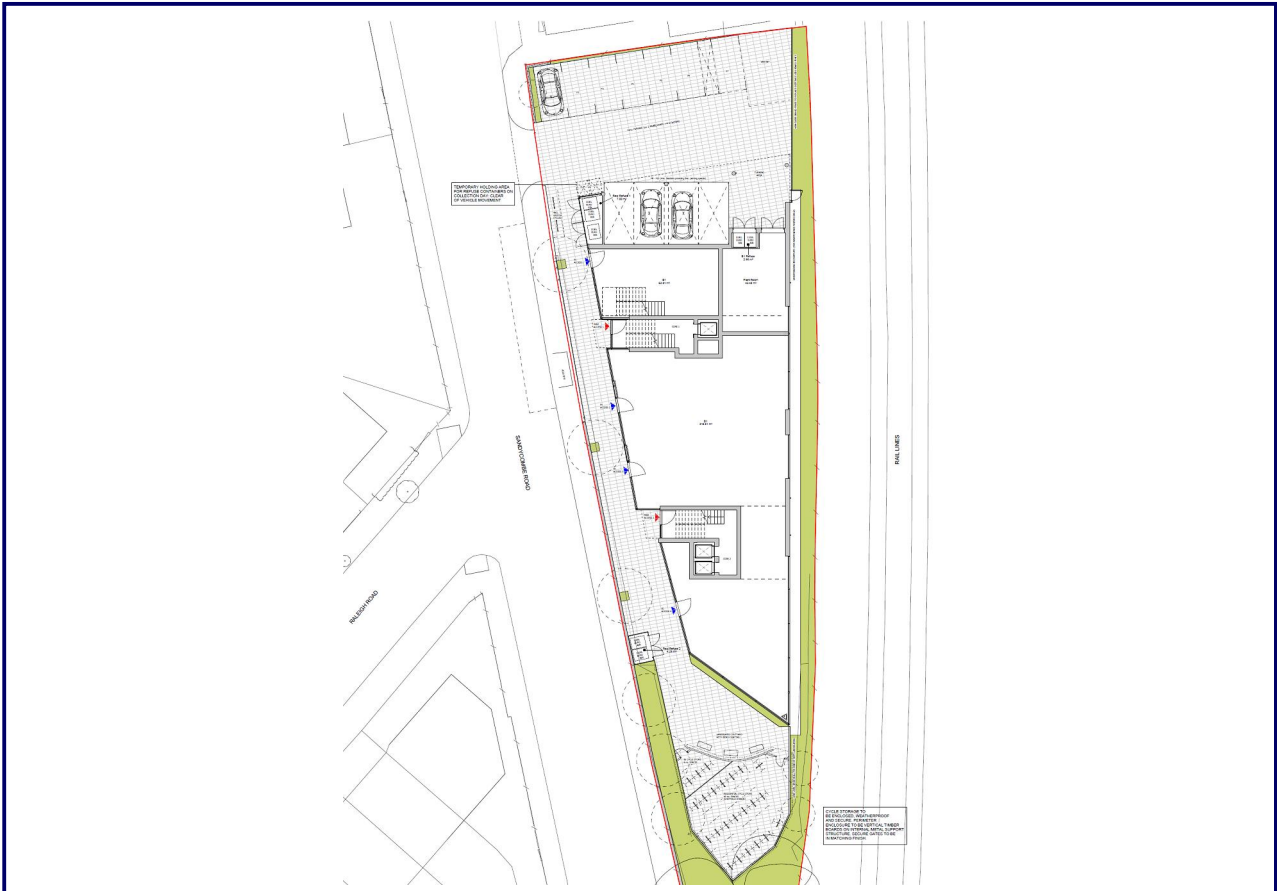
**Figure 3:** Proposed Development Plan (Ground Floor)

The proposed development will comprise a part four / part five-storey property (without basement), with associated areas of car parking and some areas of soft landscaping. It is understood that the ground floor of the property is proposed to be occupied by office accommodation, with the upper floors in use as residential apartments. It is understood that trees in the south of the site will be retained as part of the proposed development and planting in this area will be enhanced. New trees will be planted along the western boundary of the site and a planted buffer will be located along the eastern boundary. A proposed development plan is included as Figure 3.

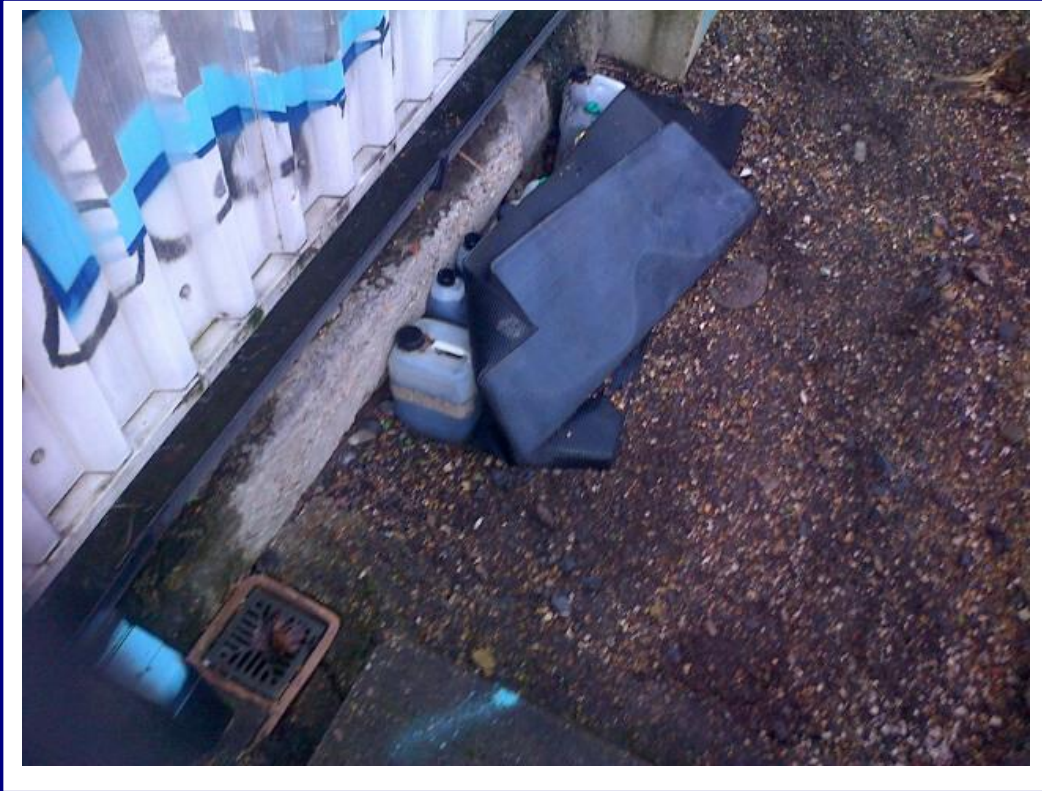
Photo 1: Several small containers of unconfirmed contents were observed to be stored directly onto gravel surfacing to the rear (east) of the building.
