**1 TO 9 SANDYCOMBE ROAD
NORTH SHEEN, RICHMOND TW9 2EP**

**PHASE 2 ENVIRONMENTAL AND GEOTECHNICAL SITE INVESTIGATION
REPORT**

Our Ref: HLEI34438/002R

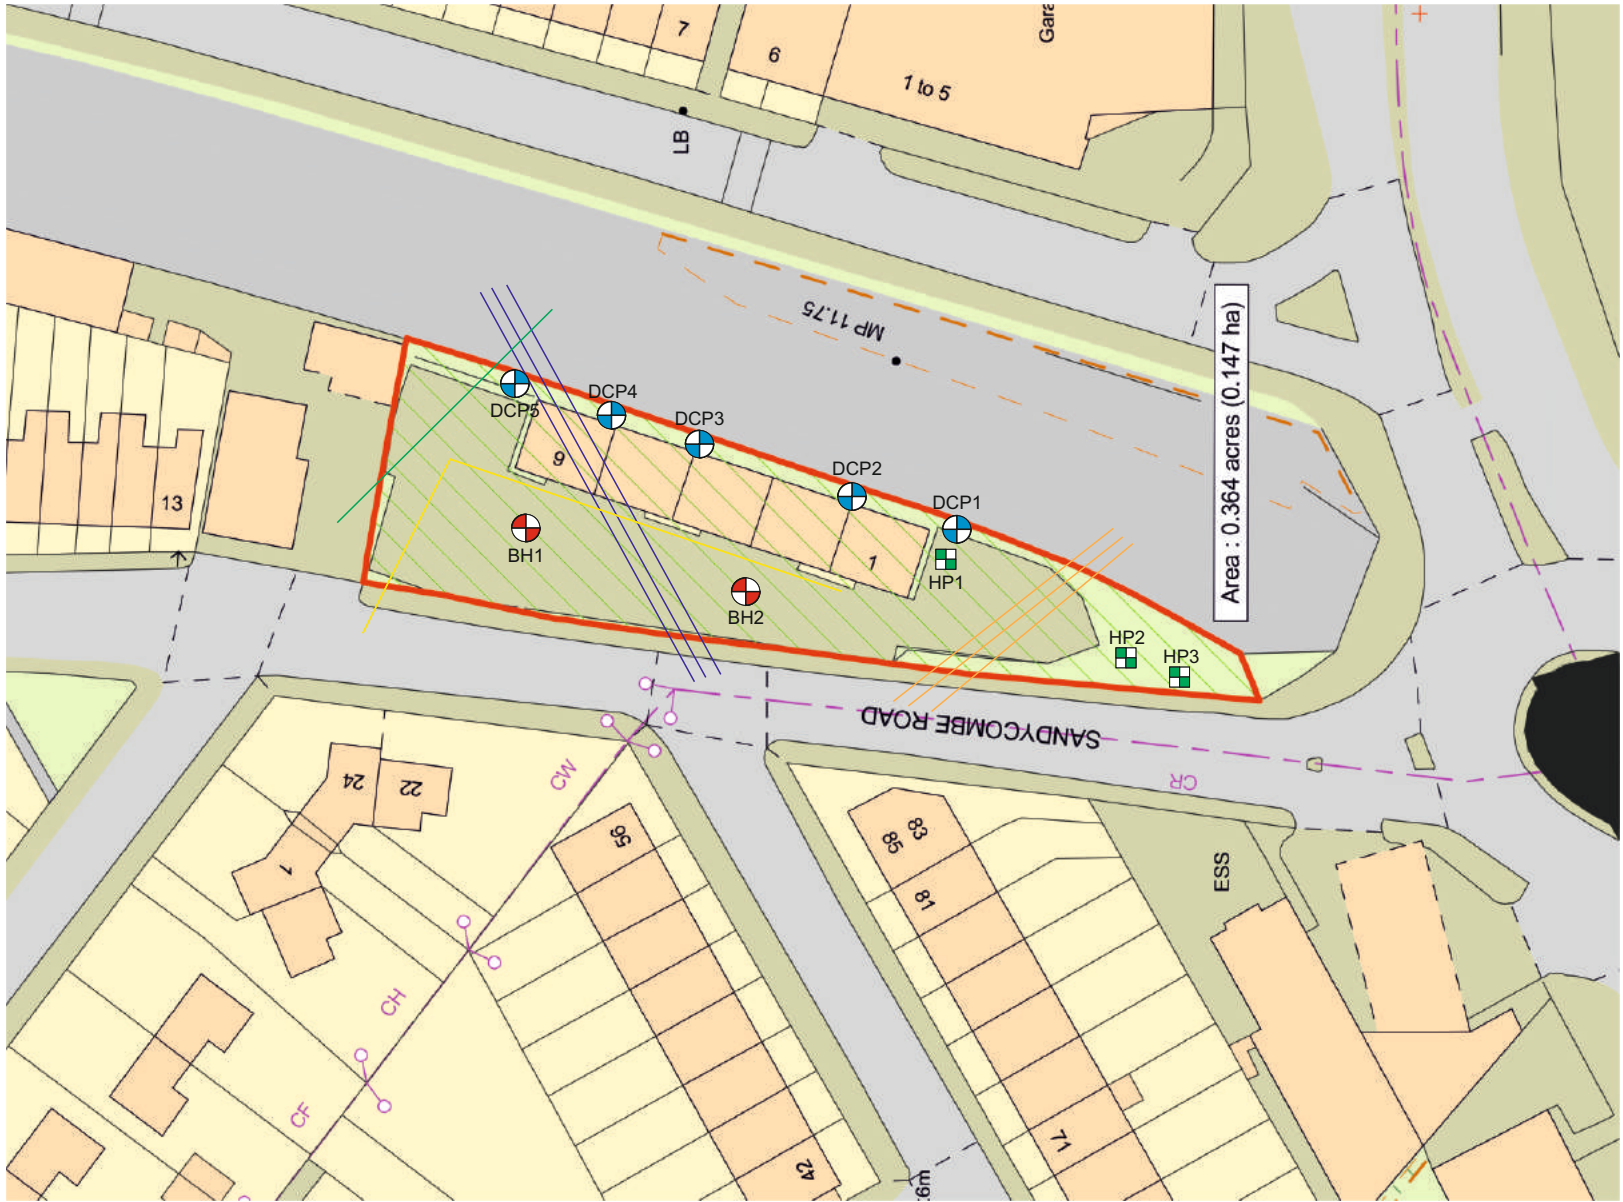
- Site boundary
- ⊕ 20m Borehole Locations
- ⊕ Hand Pit Location
- High Pressure Gas Main Crossing Site
- BT Duct Crossing Site
- Foul Water Sewer Crossing Site
- Low Pressure Gas Main Entering Site

An active high pressure gas main and fibre optic cables are known to cross the proposed development area. Foundations and associated excavations for the proposed development will need to be designed in order to avoid these and any easement zone specified by the service providers.

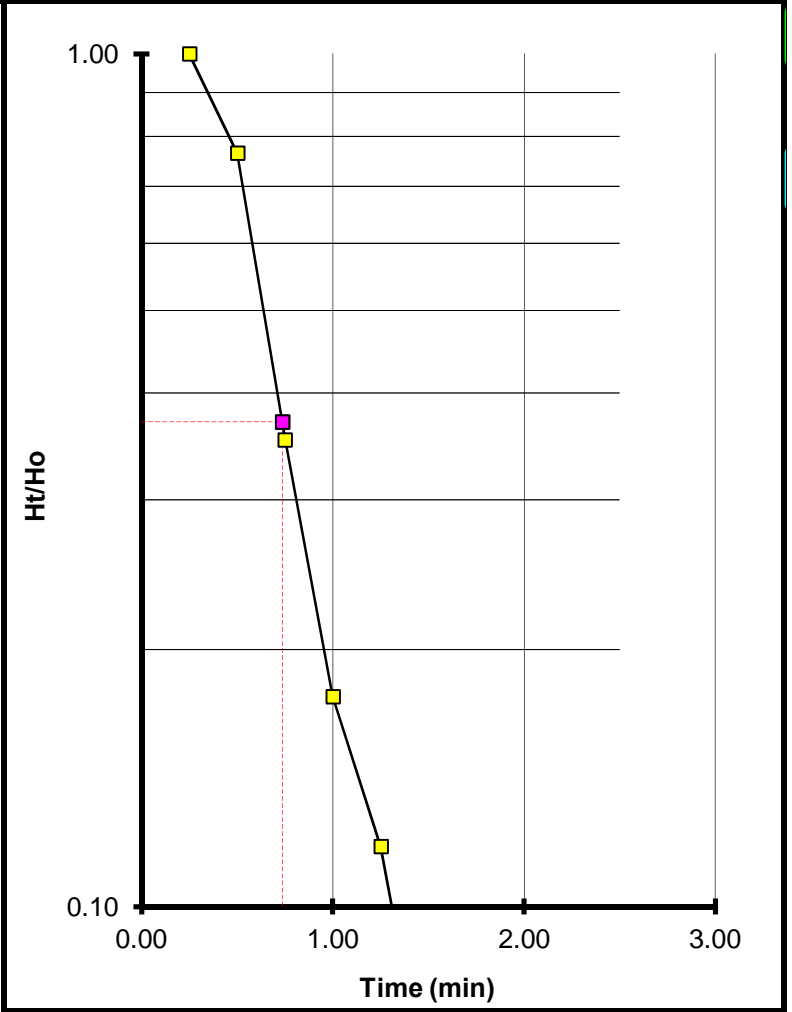
Project No.:	HLEI 34438	TEST RESPONSE ZONE DETAILS:	
Project Name:	1 to 9 Sandycombe Road	Top (mbgl):	1.80
Client:	Goldcrest Land Plc	Bottom (mbgl):	7.20
Borehole No.:	BH1 - Test 1	Length (m):	5.40
Compiled By:	LF	Diameter (m):	0.050
Date:	15/04/2016	Initial Standing Water Level (m below top of casing):	6.248
Checked By:	RA	Height of casing or standpipe : above ground level (m)	0.00
Date:	15/04/2016	Falling or Rising Head Test?	Falling

Elapsed Time (mins)	Depth to Water* (m)	Ht/Ho
0.25	6.231	1.00
0.5	6.235	0.76
0.75	6.242	0.35
1	6.245	0.18
1.25	6.246	0.12
1.5	6.247	0.06
1.75	6.248	
2	6.248	
2.25	6.248	
2.5	6.248

Cross Sectional Area of Test Zone	A=	0.00196
Shape Factor (Case C)	F=	6.30666
Time to reach Ht/Ho = 0.37 (sec)	T=	44
Permeability (m/s)	K=	7.06E-06

The falling head tests were proposed to comply fully with the methodology detailed within BS5930:2015. The methodology recommends that the test is repeated three times, with the most conservative result selected as the design infiltration value. An equipment malfunction meant that the second test in borehole BH1 could not be completed.

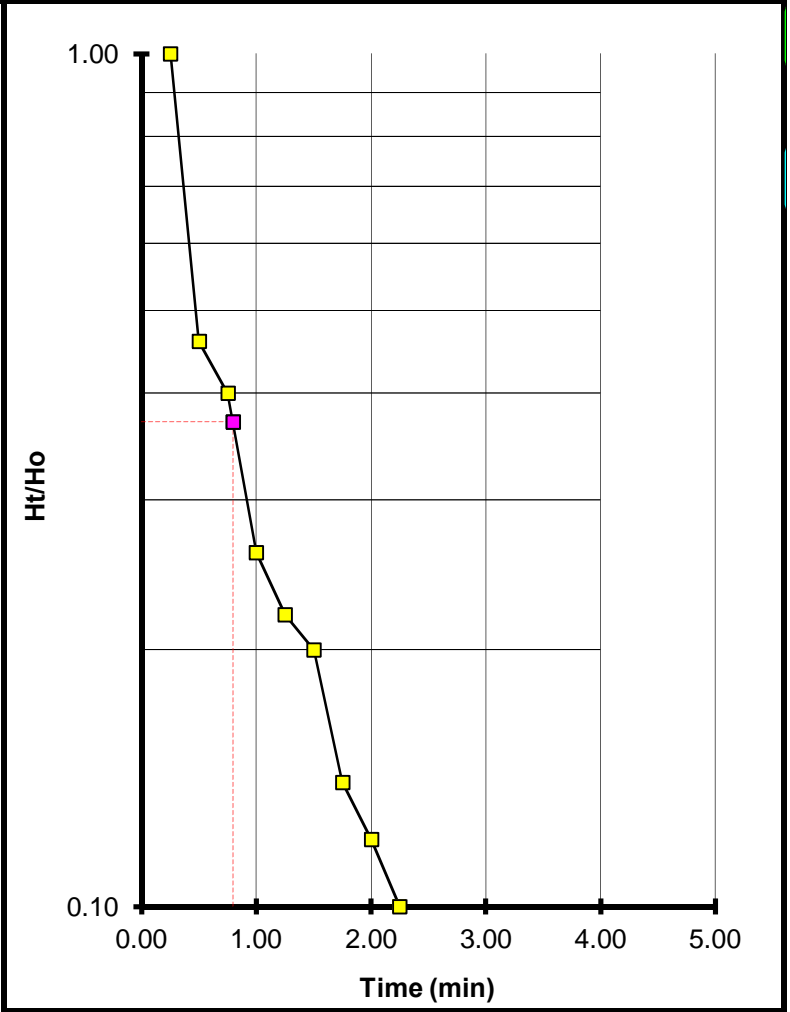
Project No.:	HLEI 34438	TEST RESPONSE ZONE DETAILS:	
Project Name:	1 to 9 Sandycombe Road	Top (mbgl):	1.80
Client:	Goldcrest Land Plc	Bottom (mbgl):	7.20
Borehole No.:	BH1 - Test 3	Length (m):	5.40
Compiled By:	LF	Diameter (m):	0.050
Date:	15/04/2016	Initial Standing Water Level (m below top of casing):	6.24
Checked By:	RA	Height of casing or standpipe : above ground level (m)	0.00
Date:	15/04/2016	Falling or Rising Head Test?	Falling

Elapsed Time (mins)	Depth to Water* (m)	Ht/Ho
0.25	6.19	1.00
0.5	6.217	0.46
0.75	6.22	0.40
1	6.227	0.26
1.25	6.229	0.22
1.5	6.23	0.20
1.75	6.233	0.14
2	6.234	0.12
2.25	6.235	0.10
2.5	6.236	0.08
2.75	6.237	0.06
3	6.237	0.06
3.25	6.237	0.06
3.5	6.238	0.04
3.75	6.239	0.02
4	6.24

Cross Sectional Area of Test Zone	A=	0.00196
Shape Factor (Case C)	F=	6.30666
Time to reach Ht/Ho = 0.37 (sec)	T=	48
Permeability (m/s)	K=	6.52E-06
