Project AA6250 St Michael's Convent, Ham

Schedule No. 1	Revision: 2	Date: February 2017
Location S10.0

Section 04. EXTERNAL - Schedule of works

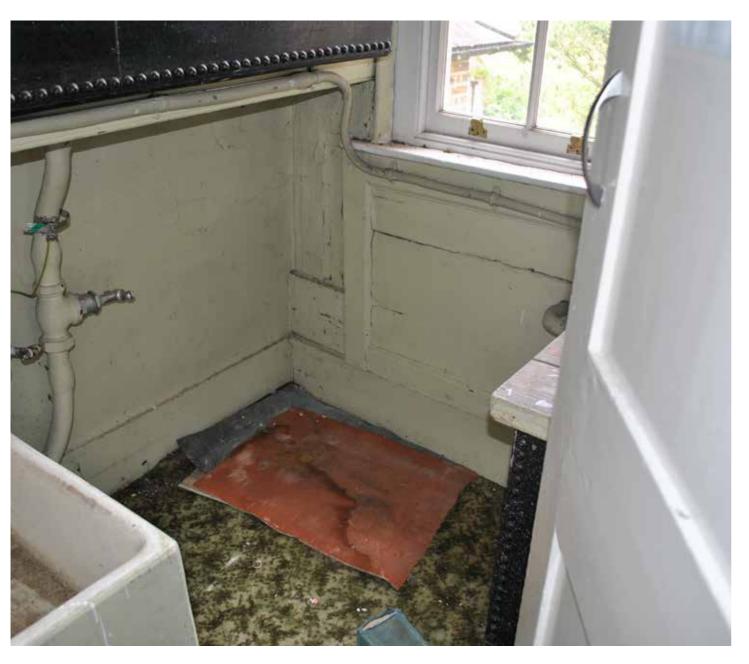
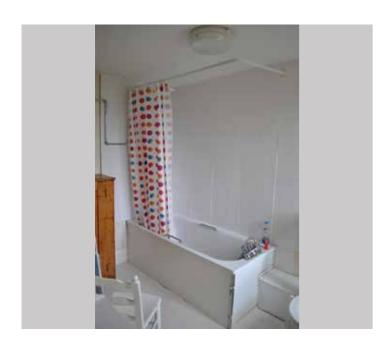
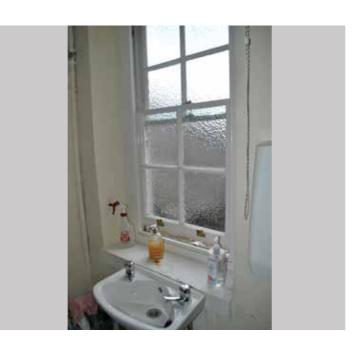
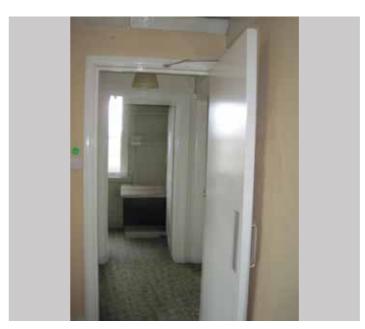
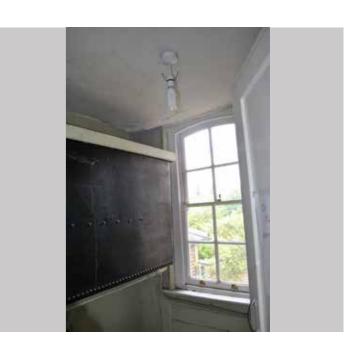
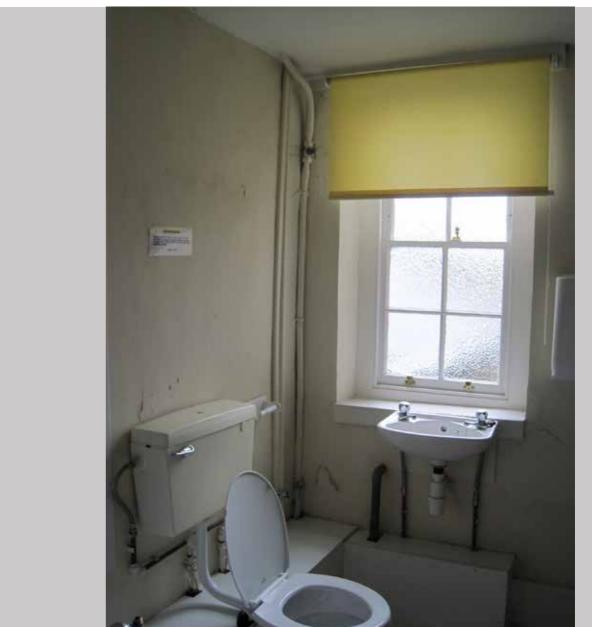
S10.0

- Bathroom stripped out
- New opening in partition wall
- Modern partition door removed
- New fire resistant infill constructed to opening in wall to secondary stairs (S10.0), steps to stairs removed
- Original doors refurbished and reused

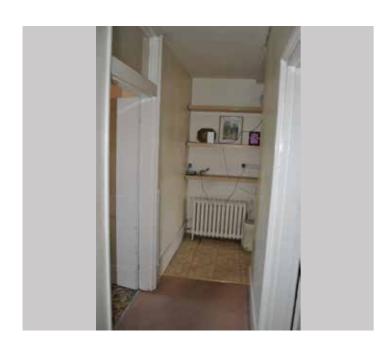
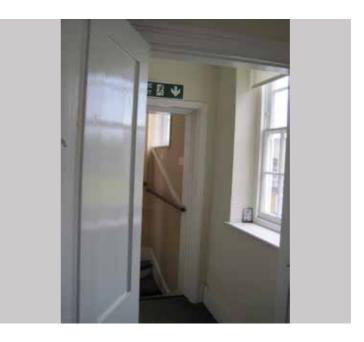
S11.0

- Modern partitions removed
- New wall added to create bathroom
- Steps up to eastern property removed and doorway blocked up with new fire resisting wall
- New door to create store off corridor

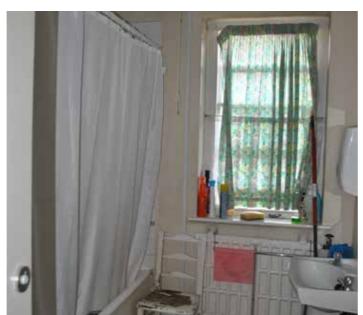
Room S11

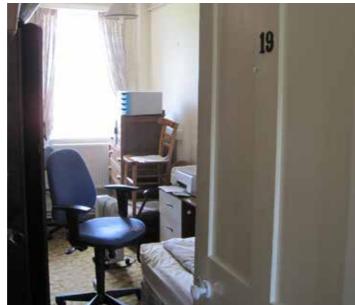
S12.0

Room S12

- Existing door removed and reused elsewhere
- New stair constructed
- Existing window and shutters retained

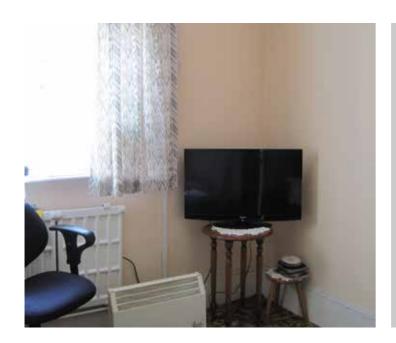
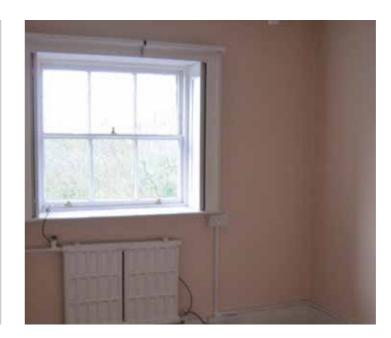
S13.0

- Fireplace retained and refurbished
- Door in partition wall moved
- Existing window and shutters retained

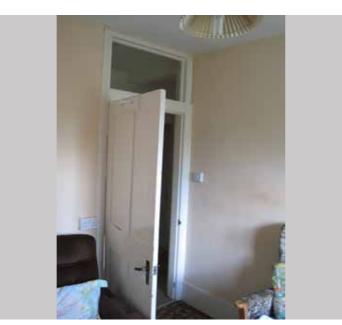
Room S13

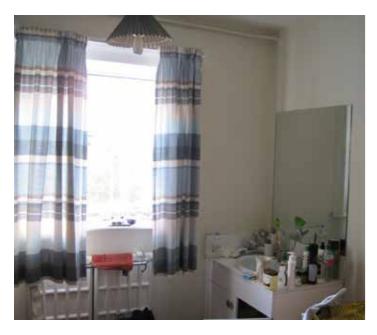
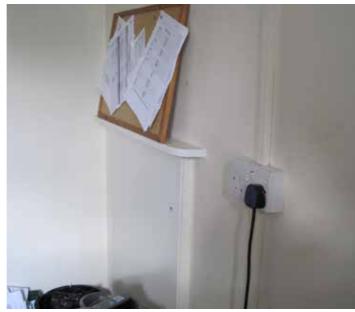
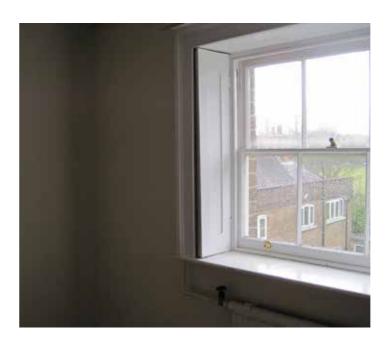
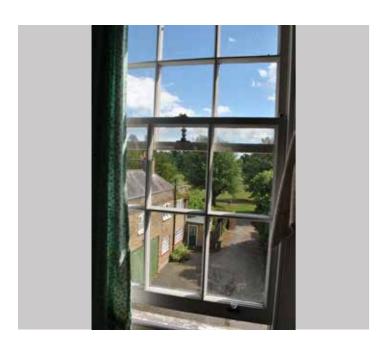
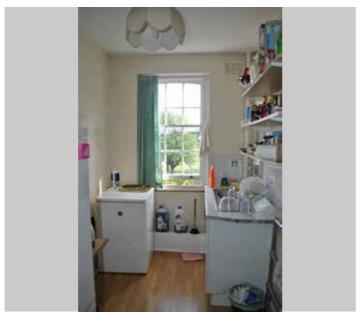
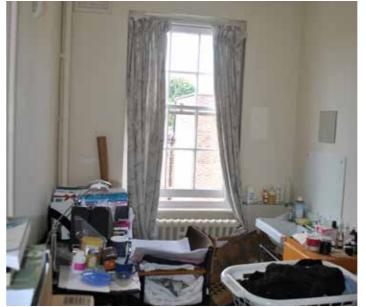
SECOND FLOOR Mid c20 East block Project AA6250 St Michael's Convent, Ham Schedule No. 1 Revision: 2 Date: February 2017 Location S14.0 - S23.0 + roofspace Description • Alterations to create new apartment. Refer to application drawings • This block was built in the mid 20th century and has no interest and make no contribution to the significance of the original buildings.

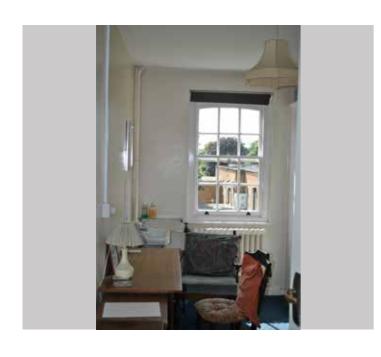
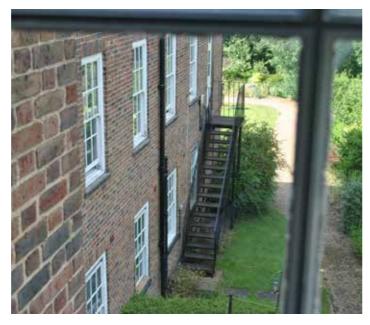
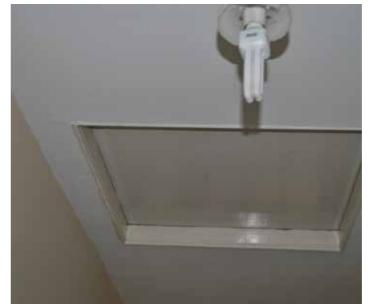
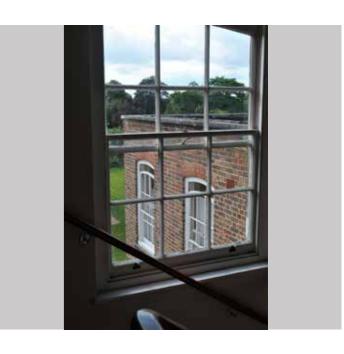
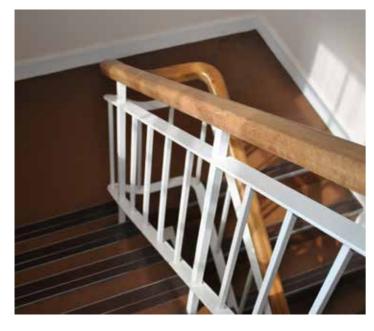
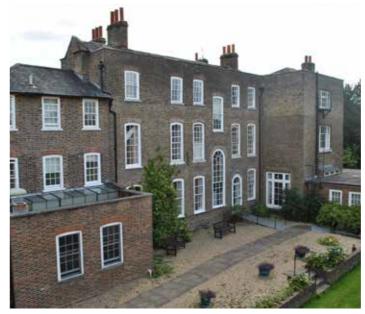
- Careful removal of \$24.0 31.0
- This wing was built in the mid 20th century and has no historical or architectural interest and makes no contribution to the significance of the original buildings.
- Careful making good of revealed external walls to S19.0 (refer to external sheets)

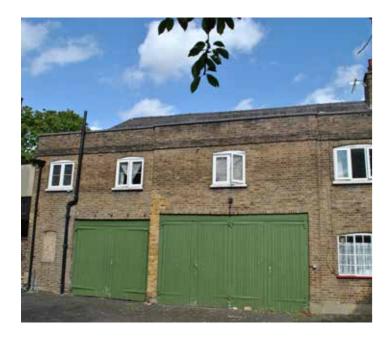
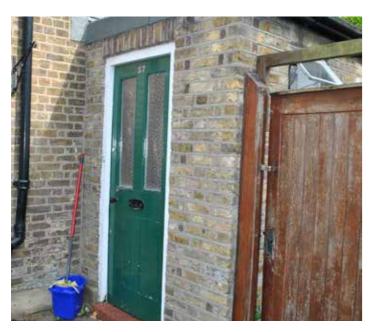
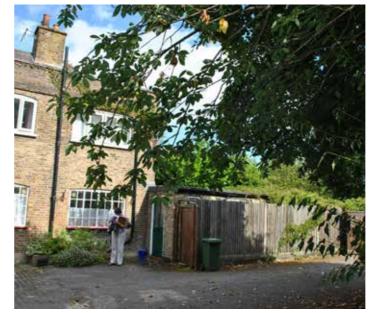
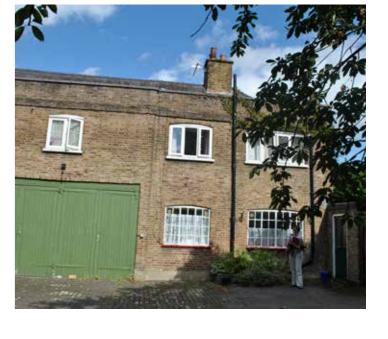
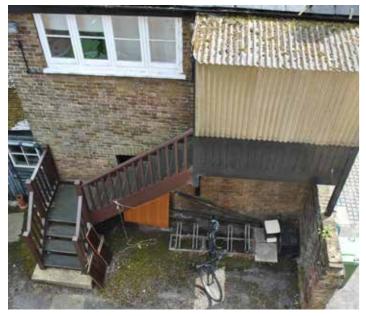
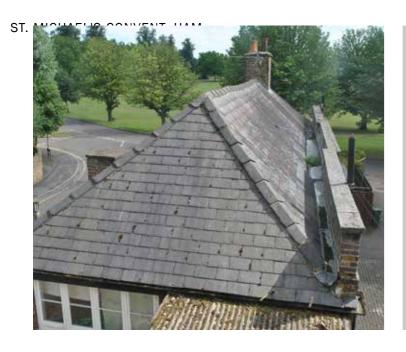
THE COACH HOUSE

- Careful making good of revealed walls.
- External stairs removed (and rebuilt as planning drawings) and brickwork made good
- Existing uPVC windows replaced with timber windows
- Existing external staircase to coach house rebuilt with glazed enclosure at first floor. New window in existing brickedup opening to ground floor coach house
- New velux rooflights inserted into existing roof of coach house. New pitched and slate roof with new velux inserted to single storey flat roofed area (Gst 6.0).
- Following demolition of existing single storey porch Gst 7.0 to coach house, existing door opening bricked up to match existing brickwork
- Ground floor large timber doors to coach house to be replaced with folding timber doors and sliding glass doors on inside
