SPORTS PITCHES

AGRONOMIC ASSESSMENT REPORT

MARBLE HILL PARK

TWICKENHAM, LONDON

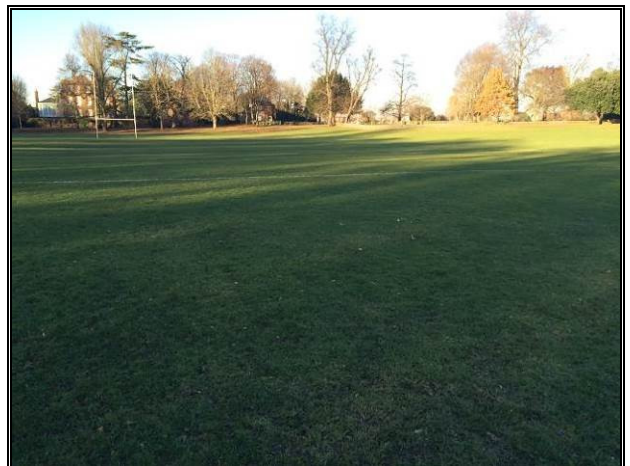
Plate 4: Rugby Pitch 1 – high shade levels

It is understood that the southwestern part of the site is susceptible to flooding from the River Thames, which can disrupt use of the rugby pitches whilst the area is flooded. To reduce the amount of lost usage, it is suggested that allowance is made for appropriate repair and reinstatement works once the water has dissipated. This will require sufficient capital to be set aside within the maintenance budget.

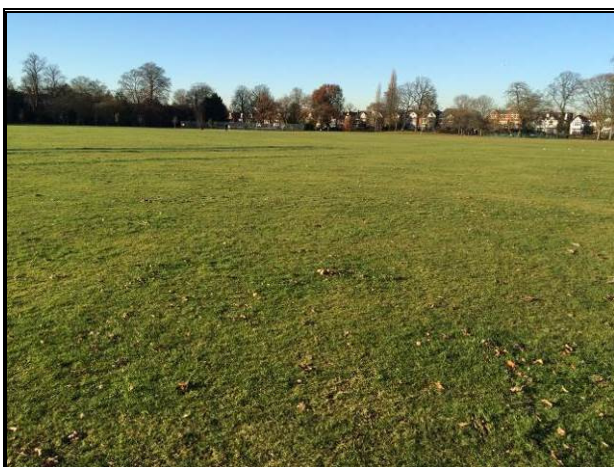
Plate 5: Cricket Outfield

The physical characteristics of the existing soils within this area, including infiltration and drainage, appear to be sufficient to support grass for summer sport. However, the sward does appear to be a little 'hungry' in places and moss is occasionally present. As such, it may be beneficial to address the strong acidity and low fertility status of the topsoil in this area to support an improved sward.

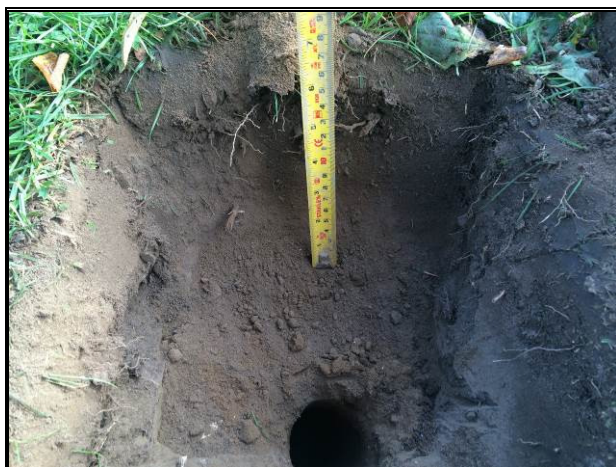
Plate 7: Profile 1 Topsoil at TH26

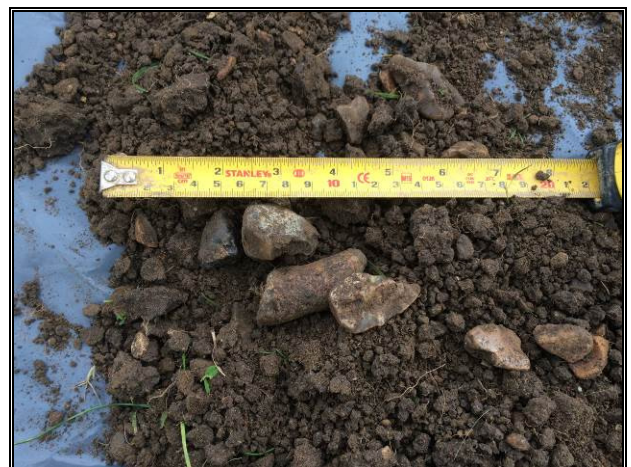
Plate 8: Subangular and subrounded, small to medium sized stones within Profile 1 Topsoil

These works will disturb stones present in the topsoil and as such, stone removal is recommended prior to final levelling and seeding to remove stones from the surface.

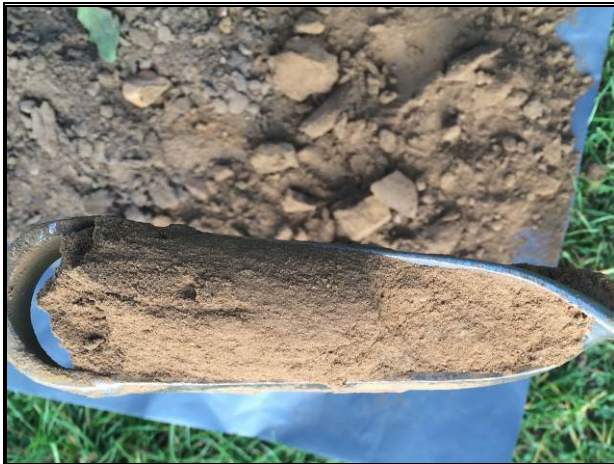
Plate 9: Yellowish brown *Profile 1 Subsoil*

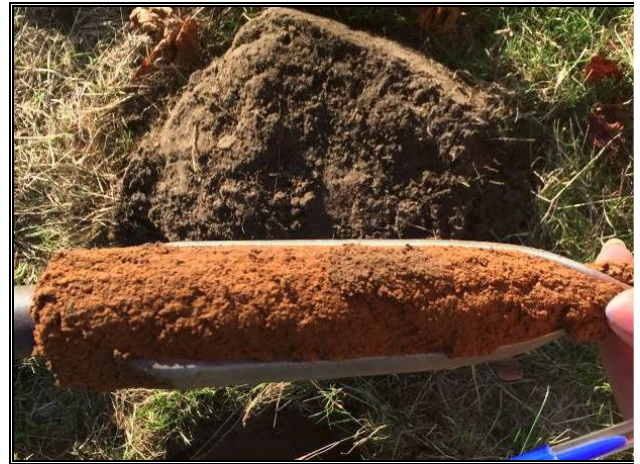
Plate 10: Strong brown *Profile 1 Subsoil*

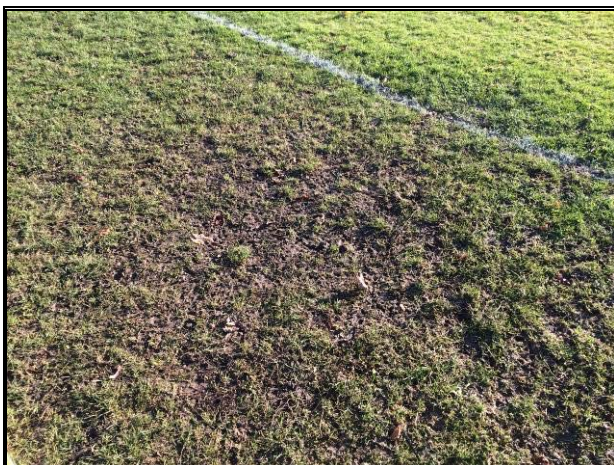
Plate 11: Worn centre circle in football pitch

The overall quality of the turf is moderately high in relation to use for the sports catered for. Evidence of wear was observed in play 'hotspots', such as football goal mouths and centre circles. Significant surface undulations were recorded within these hotspots and as such, localised infilling and regrading may be necessary here.

Budget permitting, sand top dressing over the whole of each pitch could be considered rather than just within goal mouths. Sand top dressing, especially when used in conjunction with aeration treatment, improves and maintains water infiltration and surface wear. Application with a drop spreader with drag mat immediately after spiking/verti-draining allows some of the sand to enter the voids created, and encourages grass roots to grow deeper. If it is carried out year on year, it partially replaces the surface soil layer and thereby improves the wear and tear properties of the pitch. Usually an application rate of between 60-80 tonnes per hectare is recommended.

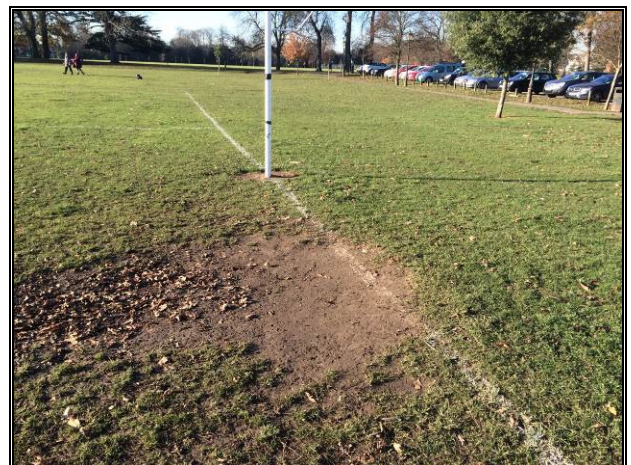
Plate 12: Worn football goal mouth

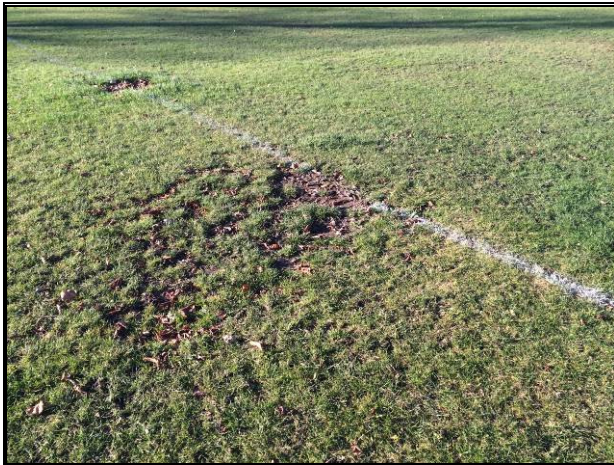
Plate 13: Slight wear in goal mouth – Pitch 4

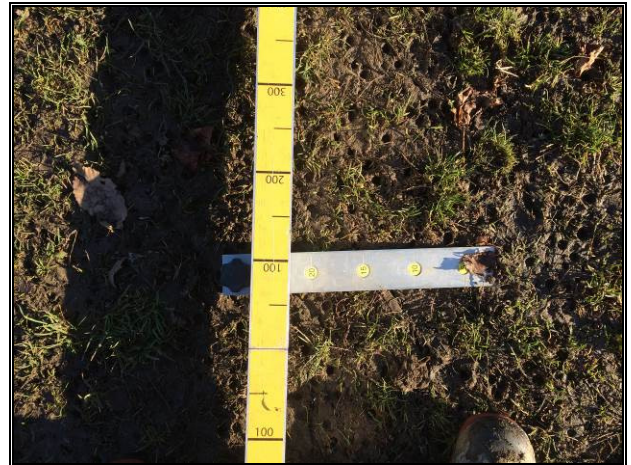
An even playing surface is necessary for the safety of the players and for the consistent roll of the ball for certain sports, including football. In the football pitches there were a number of undulations greater than 25mm along a 2m straight edge recorded in wear hotspots, including the goal mouths and centre circles. These areas may need to be infilled and re-graded to improve evenness.

Plate 14: Undulation > 25mm depth – centre circle

Major modifications to the overall levels of the pitches should not be required, although selective re-grading is recommended, particularly across the football pitches, to remove surface undulations and to create a suitably flat playing surface.

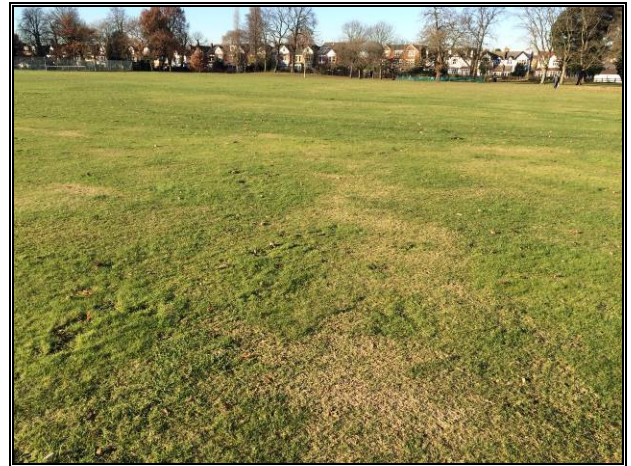
Plate 16: Patchy grass colour – cricket outfield

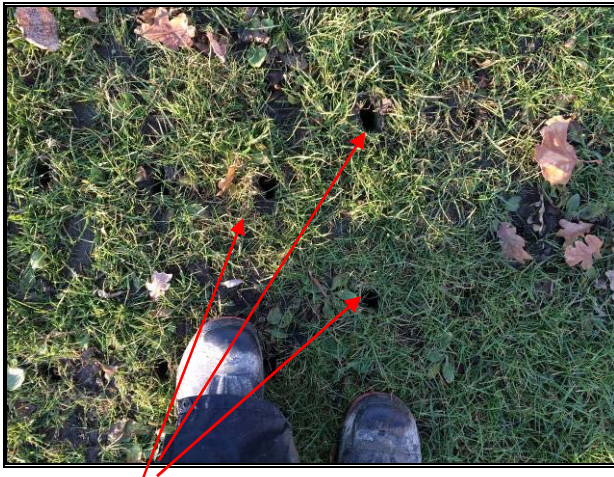
- Mowing – grass height is reasonably consistent in each area inspected
- Verti-draining/spiking – tine voids seen in rugby pitches and football pitches
- Marking-out – Measurements were being taken by groundsmen on the rugby pitches at the time of the visit

Plate 18: Verti-drain holes

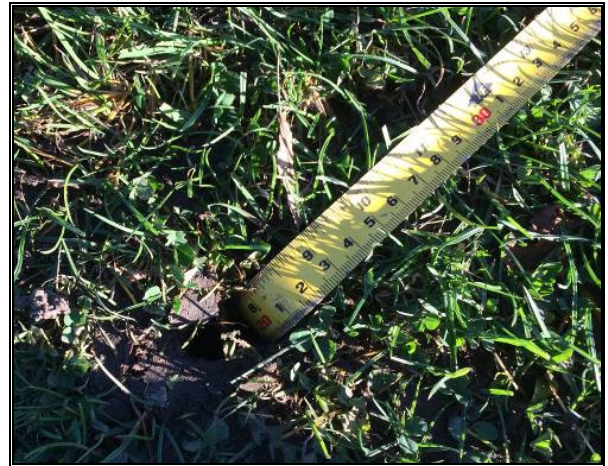
Plate 19: Measured depth of vert-drain hole 210mm

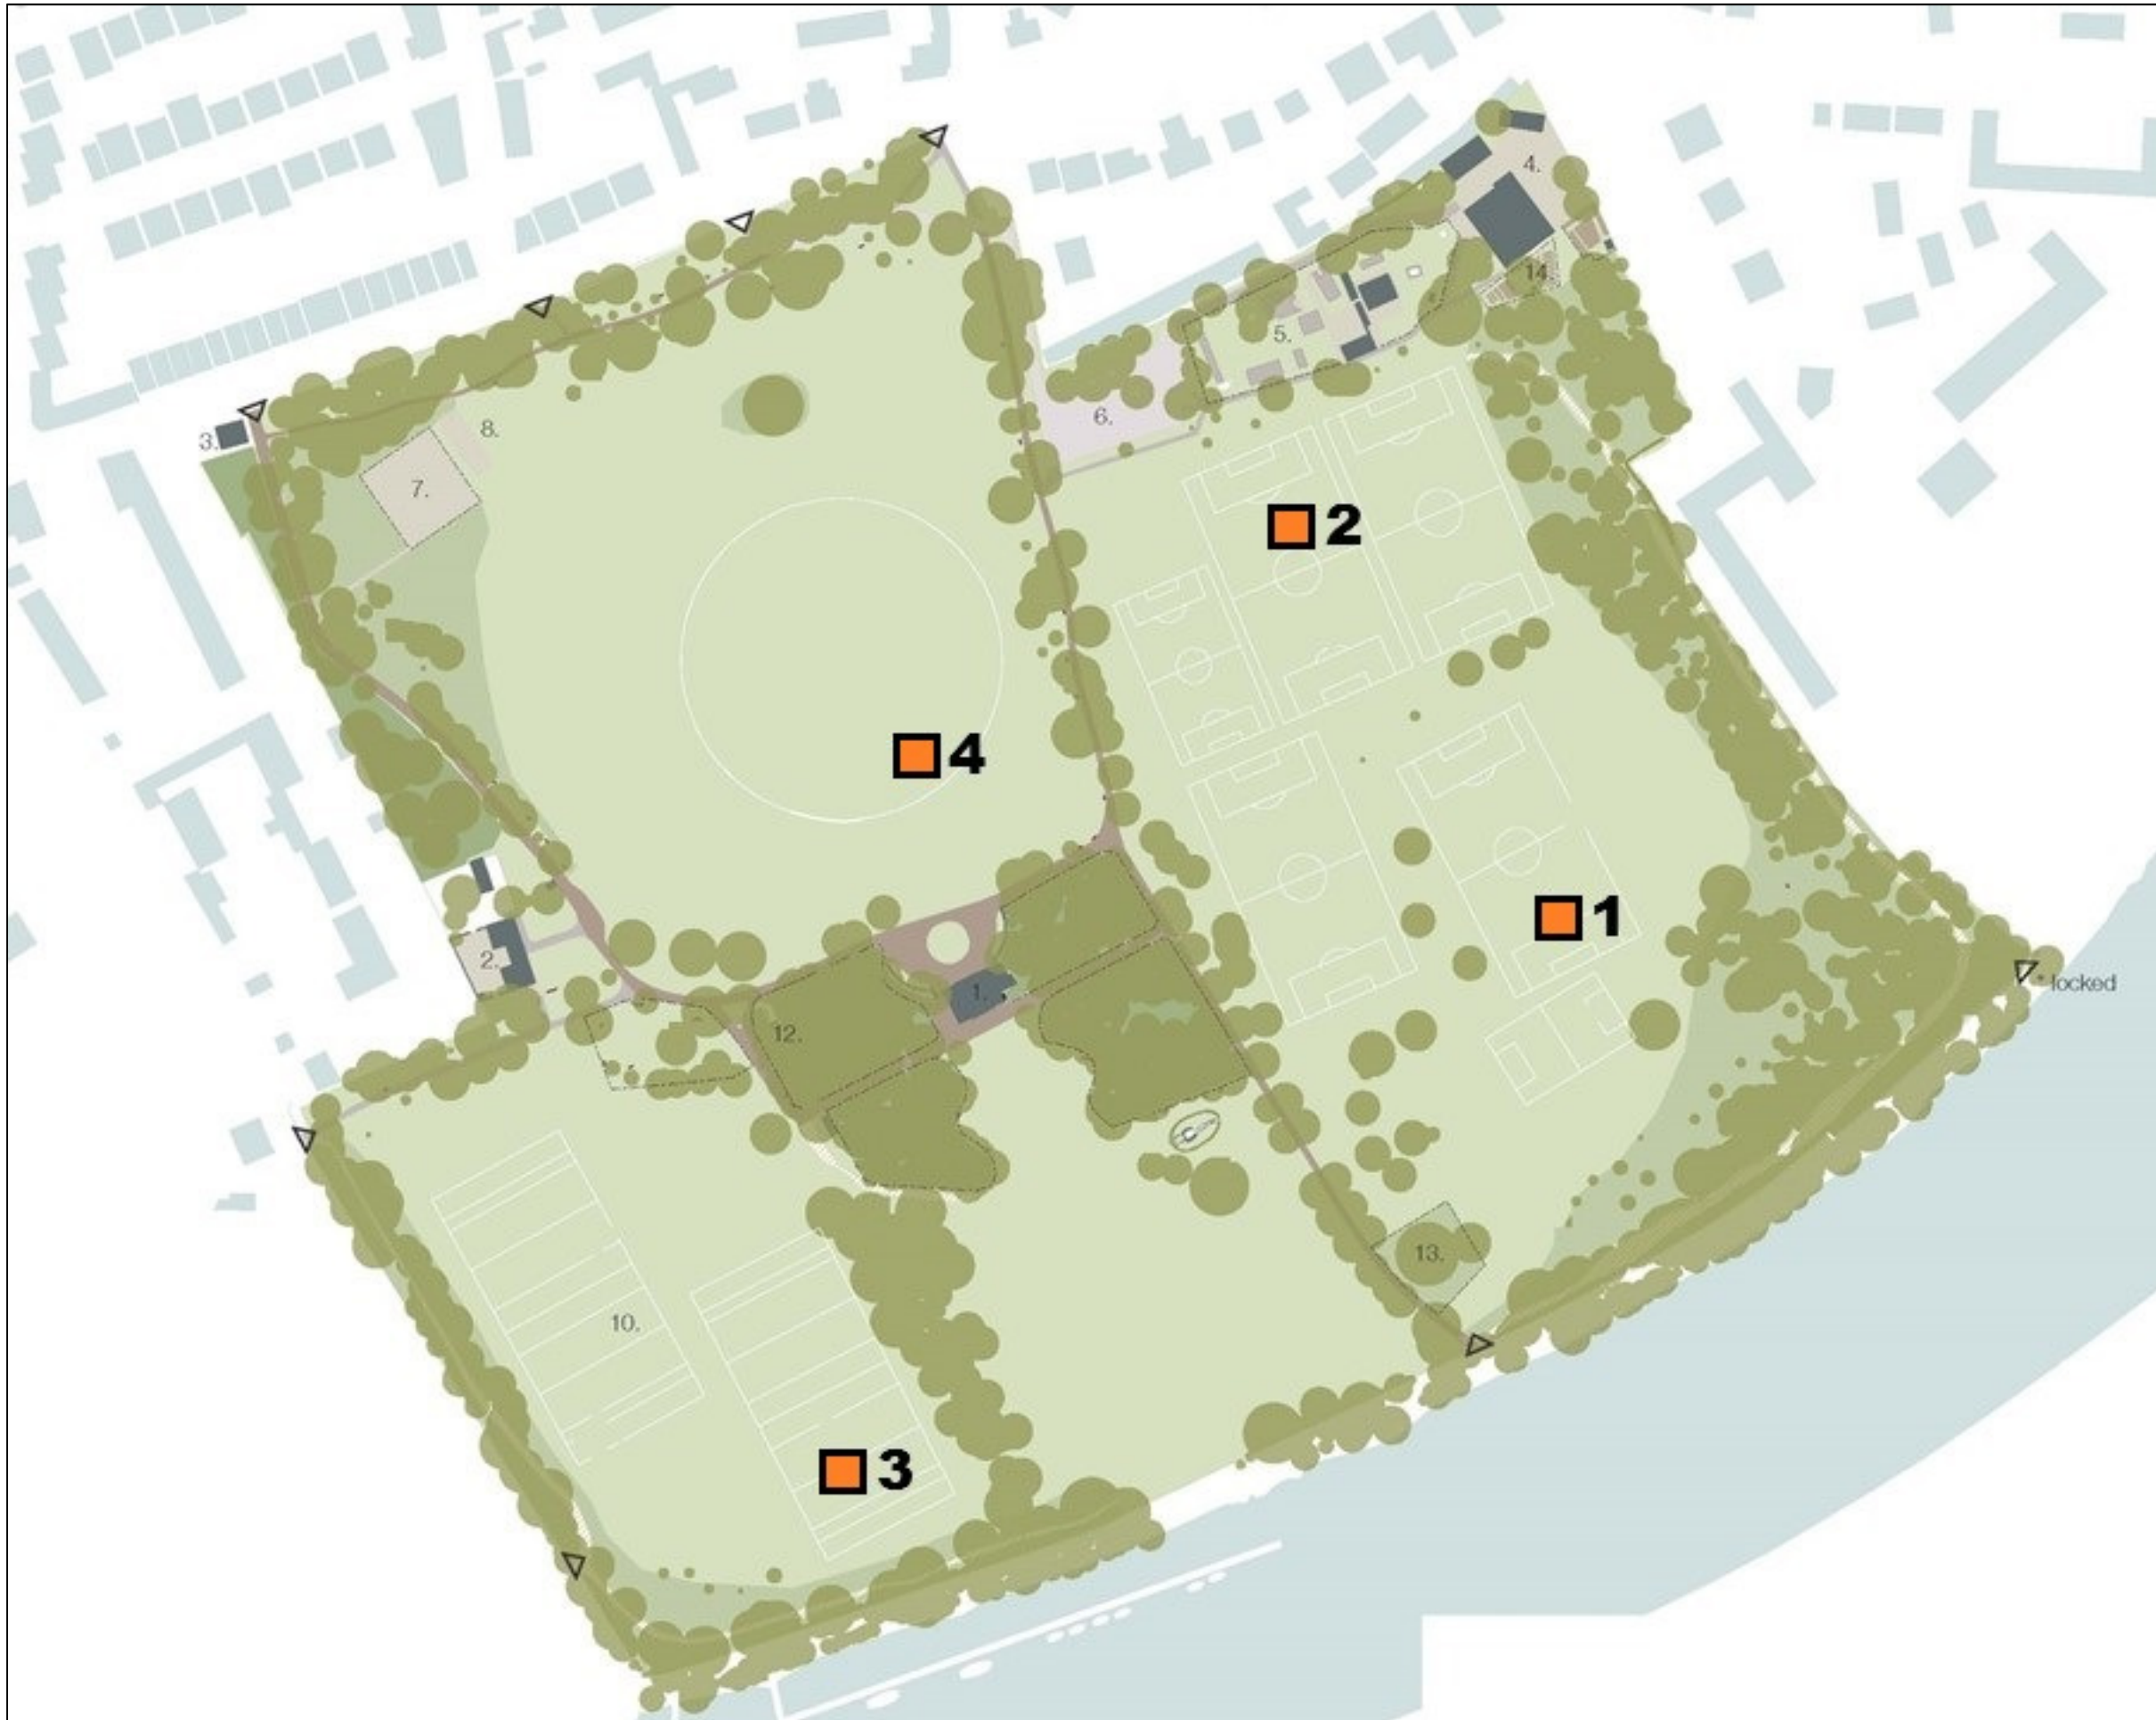
Site Plan – Infiltration Test Locations

A total of 4 No. surface infiltration tests were carried out using double-ring infiltrometer apparatus. The test locations are indicated on the supplied plan in Appendix 2.

At location IF1 the infiltration rate is lower, which is likely to be indicative of this pitch having heavy use, resulting in increased surface smearing and loss of infiltration performance.
