8.34 MARBLE HILL HOUSE - SAC REPORT

Evaluation of the grounds at Marble Hill House, Twickenham, London Borough of Richmond

Site Archive Completion Report

Compiled by Kevin Wooldridge and Alice Forward

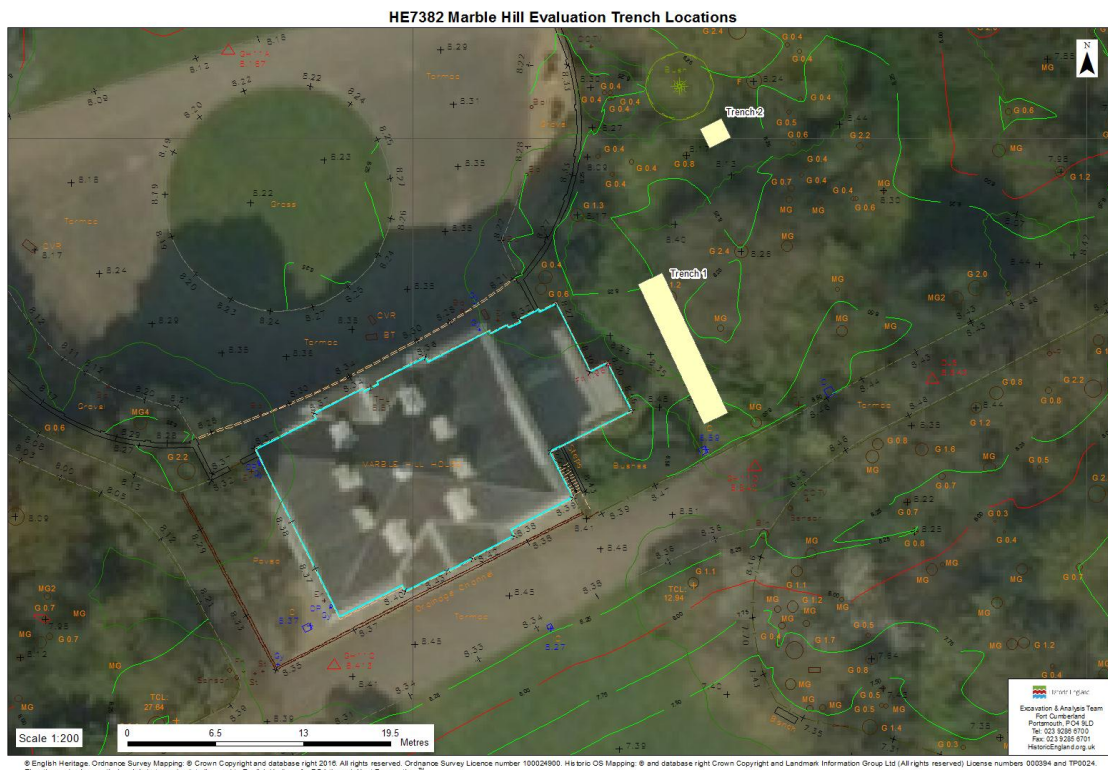
Figure 1 showing the trench locations

1.2 Trench locations (fig 1)

Trench 1 was designed to be located over the site of the Service Wing of Marble Hill House. The Service Wing was constructed in the first half of the 18th century and was demolished in 1909. The trench was planned to measure 11m long and 2m wide. The area where the trench was placed (fig 3) was one of the less densely covered areas of shrub and therefore no mature trees were at risk from the work. Access was from the tarmac path running in front of Marble Hill House after the removal of a fencing panel. A mini digger was used, under archaeological supervision, to remove topsoil and expose the highest surviving archaeological levels.

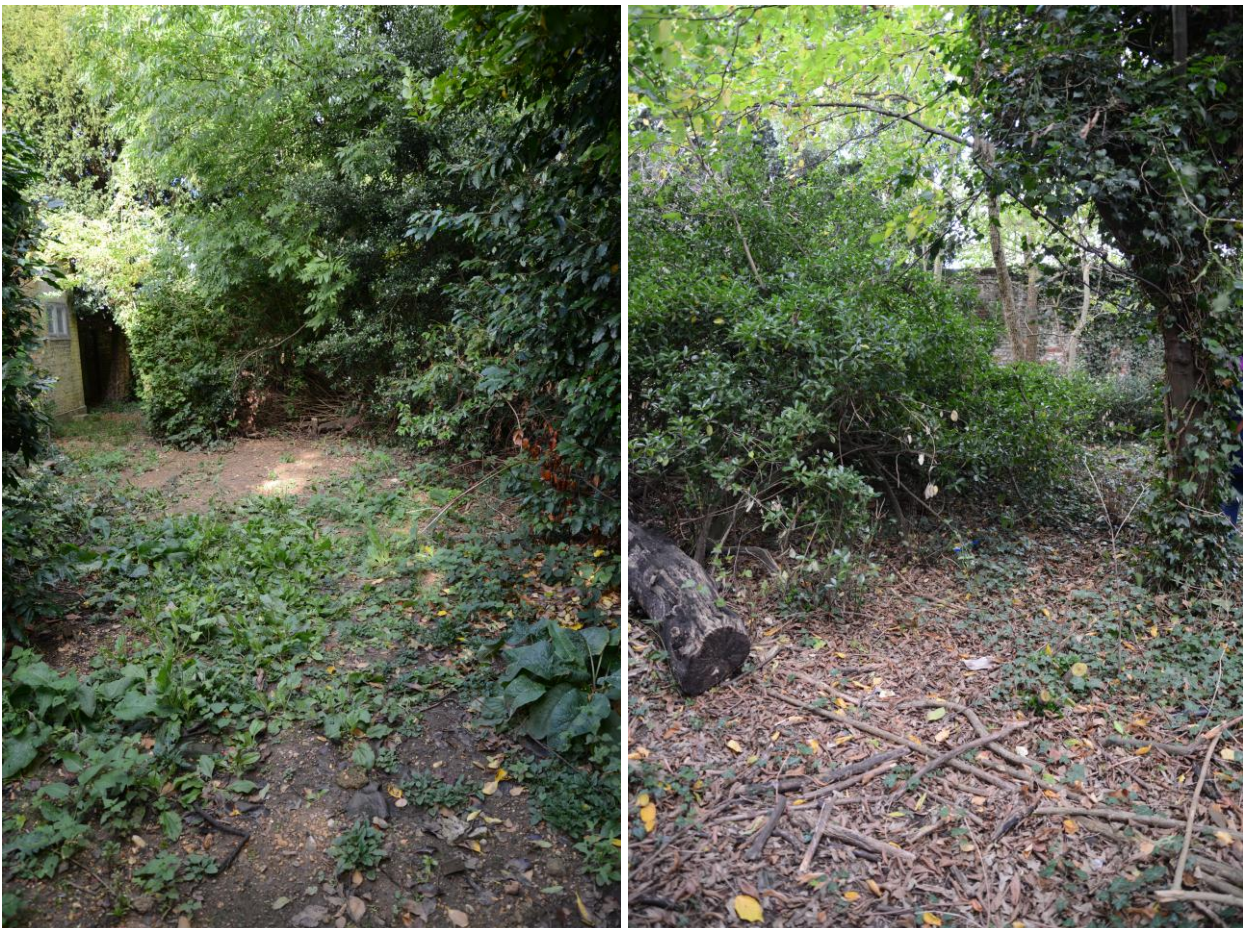
Figure 3 showing the pre-excitation trench locations (Trench 1 left and Trench 2 right)

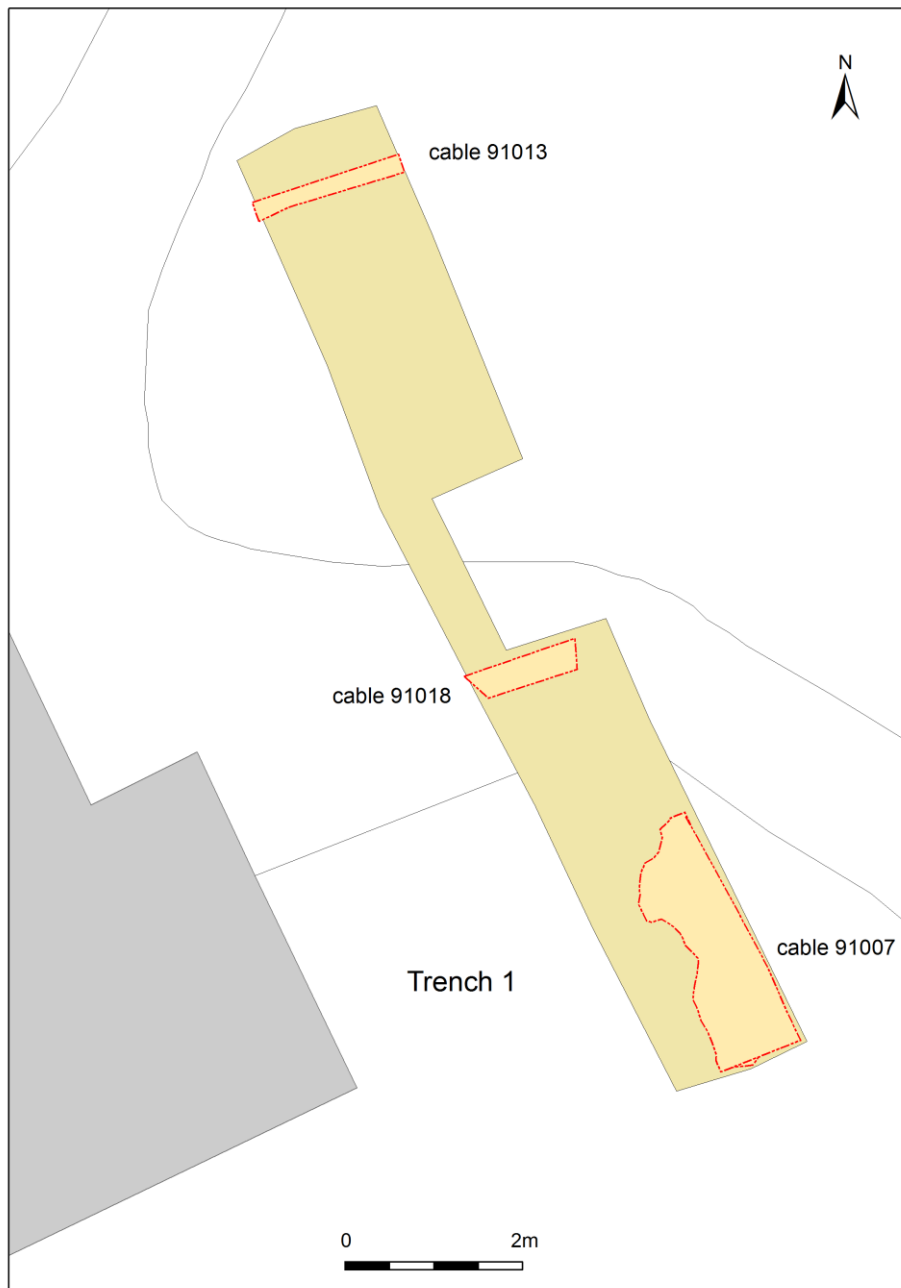
Three unmapped electrical cable trenches (Figure 10) were encountered during the course of the machining of the trench. These are numbered 91007, 91013, 91018, but only one (91007) was recorded in detail (cut 91007 and fills 91005 and 91006). Although these services were unknown, the nature of the exposed cables (and the covering including modern hazard tape) suggested they were of relatively recent date and probably serviced the security cameras and monitors surrounding the house. In all instances the services were reburied by hand and with replacement hazard warning tape. Needless to say the location of the buried cables restricted any deeper excavation in these areas.

Figure 10 Cable trenches 91007, 91013, 91018

The locations of previous unknown services and drains in the area of trench 1 have been noted and mapped.

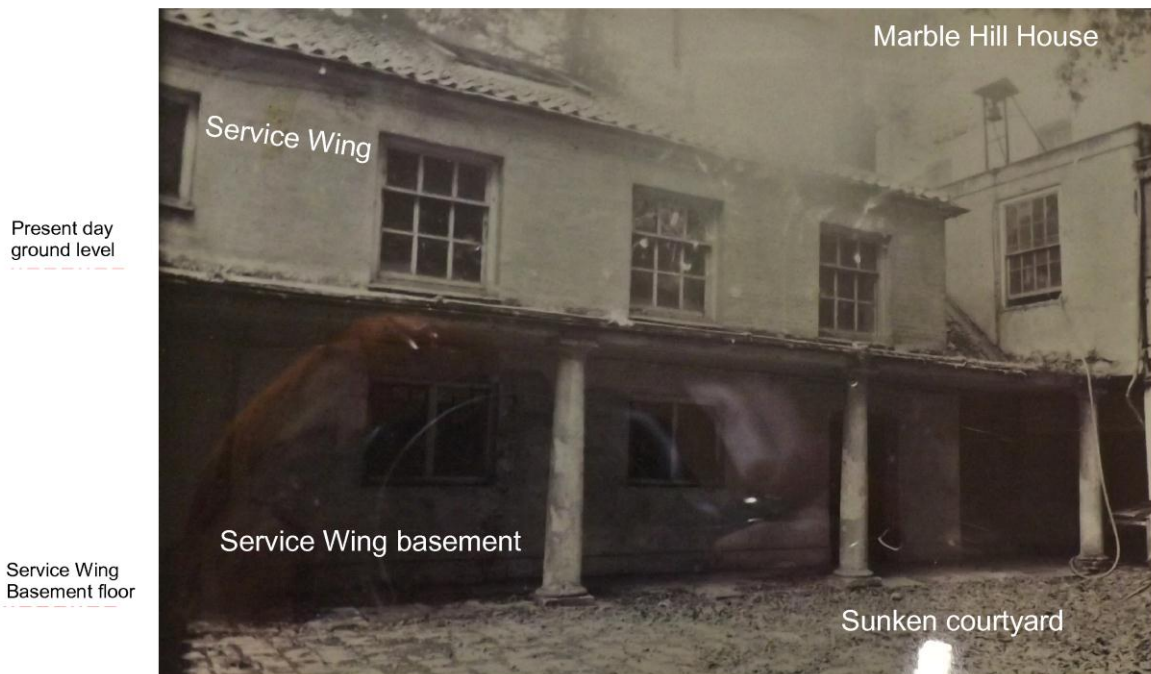
No in-situ remains of the buildings comprising the Service Wing of Marble Hill House were found during the excavation of trench 1. The location of the demolition backfill 91012 however seems likely to confirm the location of the basement of that building and the sandy fill 91002 the location of the sunken courtyard area to the north of the Service Wing. The excavations concentrated on the northern end of the Service Wing where it met the sunken area and no walls or foundations were seen in this area. The southern edge of the basement would appear to have been located in the area taken up by the later concrete drain 91003 and no excavation below the level of the drain was possible in this area. A photograph (fig 11) dating from before the 1909 demolition, shows the depth of the sunken courtyard and the equally deep basements of the Service Wing.

Figure 12 Pre-1909 photograph showing depth of sunken courtyard area and Service Wing basement

The complete lack of any basement walls showing during the excavation suggests that the 1909 demolition was comprehensive in this area. The archaeological excavation in this area stopped at a depth of 1.10m below modern ground level due to the soft nature of the backfill and clearly the floor levels of both the courtyard and the Service Wing basements in this area are deeper than that. Figure 12 shows the location of the evaluation trenches with regard to the 1904 (and seemingly accurate) architects plan of the Service Wing and house, and it seems unlikely that the excavation missed any surviving structures due to an inaccurately located trench.
