8.36 MARBLE HILL HOUSE - PAINT REPORT (2016)

**INVESTIGATION OF DECORATIVE SURFACES
AND INTERIOR DECORATION
THE BREAKFAST PARLOUR AND PAPER ROOM
MARBLE HILL HOUSE, TWICKENHAM**

CLIENT: ENGLISH HERITAGE

RESEARCH UNDERTAKEN 2016

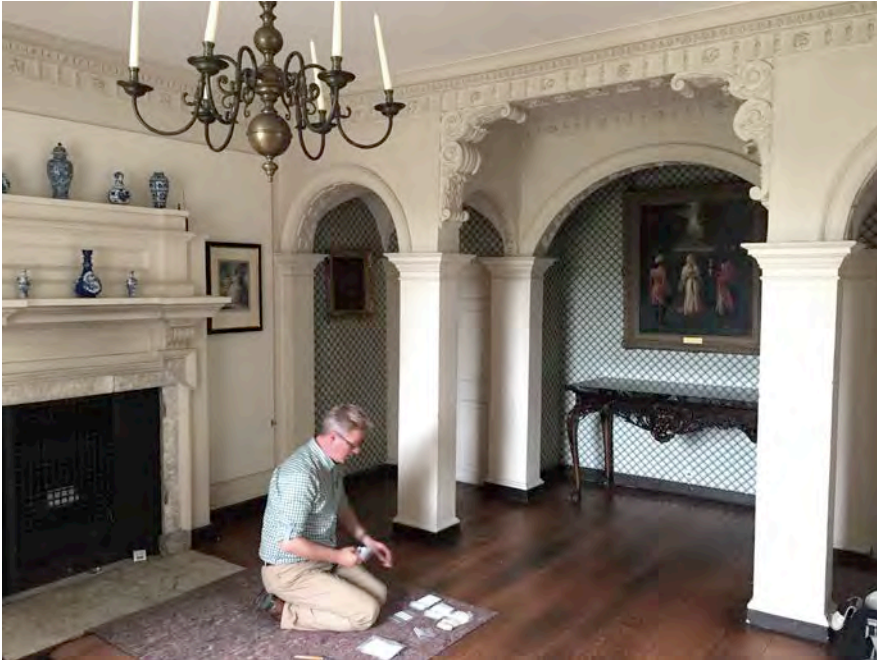
Figure 1: Breakfast Room at the time of sampling

Figure 1 above shows the interior at the time of this investigation. The scheme appears to imitate a plain lead white finish using a modern alkyd paint system. The photo also shows trellis wallpaper within the alcove and side bays, surviving from the 1965 restoration. Figure 2 adjacent shows the same interior fully papered in the trellis scheme based upon a fragment found during the 1965 works and recreated.

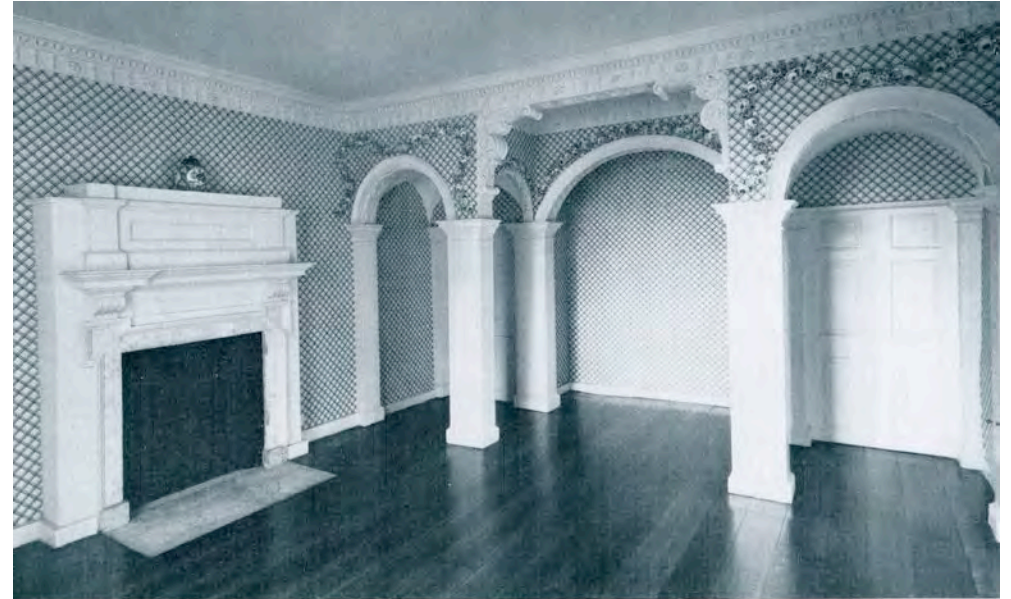
Figure 2: Photograph taken in 1970 showing the 1965-66 restoration

At that time it was known that the paper was not appropriate for a 1720s recreation, justifications were made for its recreation. The following extract taken from *Marble Hill House & Its owners, Marie P. G. Draper, 1970* records that:

Very little in the way of positive restoration was needed in the ground-floor rooms. ...In the Breakfast Parlour the wallpaper and the painted garlands reproduce a decorative scheme of which considerable remains were found on the walls. Although not belonging to the period of Lady Suffolk's residence it seemed so appropriate to the playfully miniature character of the room that an exception was made in its favour, for the sake of variety.

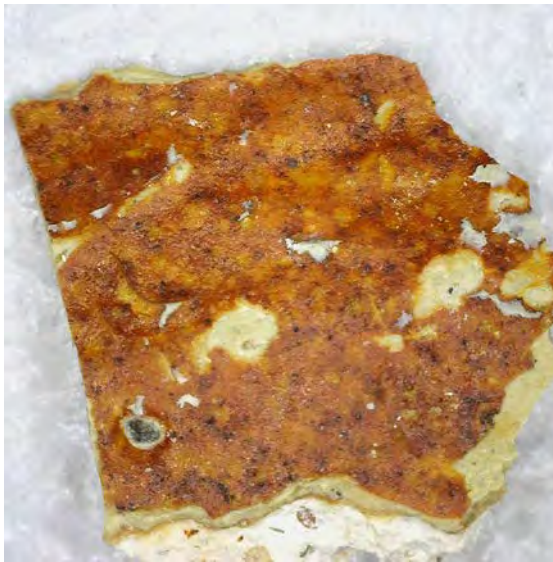
Small area of the uncovered decoration taken from the cornice

The third scheme is of significance as it recreates the initial distemper treatment, but this time in traditional oilpaint finishes. Referred to again as 'mahogany colour' in this report, a small area of exposed surface colour can be seen in the image below (copied from Figure 14 in this document)

The finish is definitely not a grained effect, it does appear to be a 'broken' finish, but this may be an effect of the uncovering exercise.

What is definite is that it is an intentional colour treatment, recreating the trial 'Builder's Finish' of scheme one. It was also retained for a significant period of time, suggesting that it was enjoyed by the owner and perhaps related to a distinctive treatment within this small space.

It is recommended that a larger area of finish is revealed on site and that this is related to any further evidence that can be gained from the wall faces.

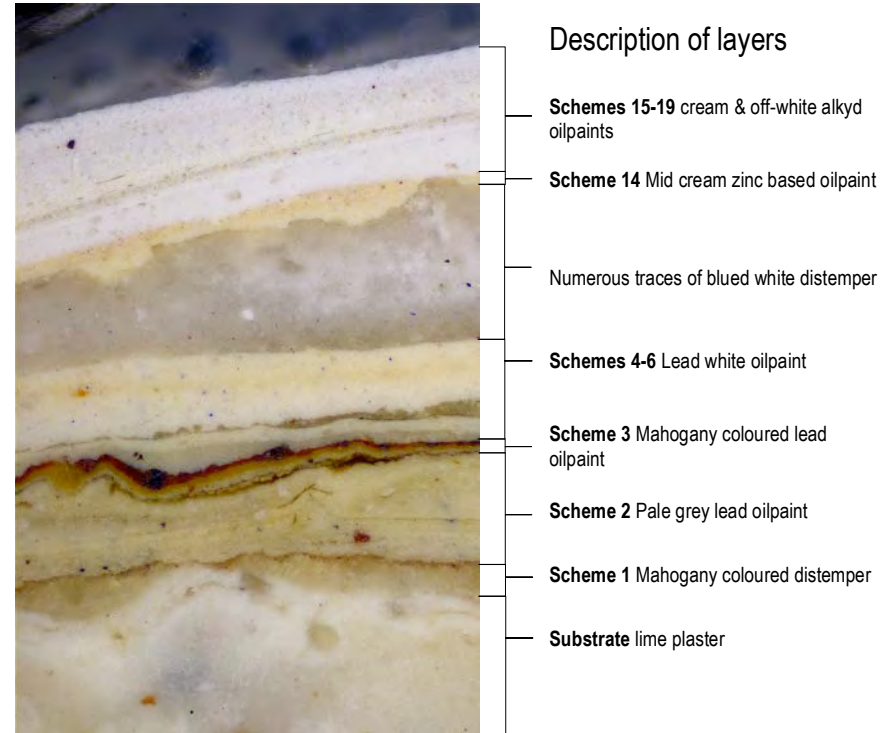
Figure 6: Sample no Marb.H.H/ int 4.4

The adjacent image of the paint cross-section clearly shows the initial mahogany coloured distemper scheme and its repetition in oilpaint at scheme three. This sequencing of schemes is clearly visible in figure 8 on the following page.

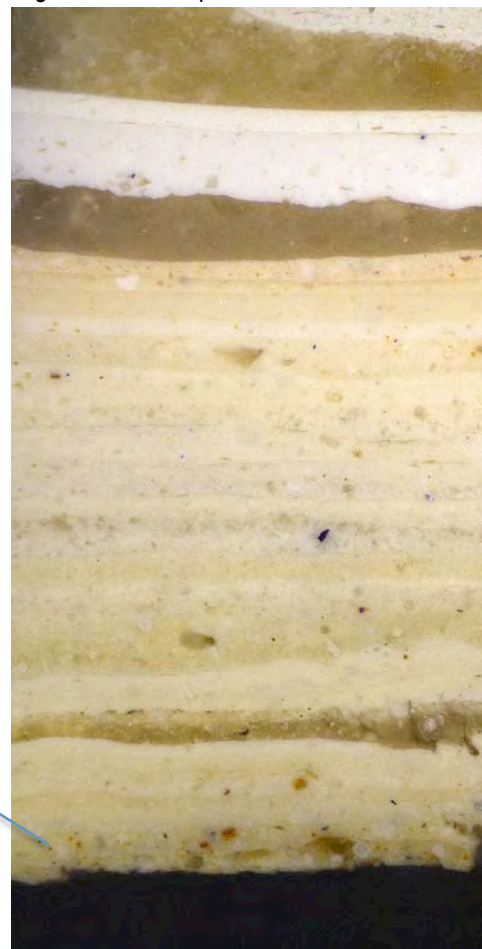
Figure 10: Sample no Marb.H.H/7.28

Description of layers

Schemes 15-19 cream & off-white alkyd oilpaints

With filler between schemes 14-15 & 17-18

Scheme 14 Mid cream zinc/lead based oilpaint

Schemes 12-13 Cream zinc oilpaint

Schemes 3-11 Lead white oilpaint

Schemes 1-2 Pale grey lead oilpaint

Substrate Timber (not shown)

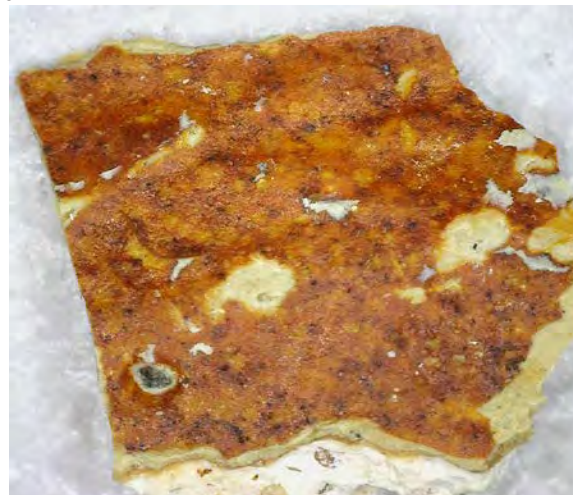
Figure 14: Small area of the uncovered decoration

The exact nature of this unusual finish would require further on site uncovering to better understand what this decorative effect is. In cross-section, the colouration of the paint layers would suggest a mahogany type decoration however the small sample uncovered may perhaps suggest something different.
