Marble Hill House and Park,
London
Conservation Management
Plan
Volume 2: Gazetteer

January 2017

Conservation Management Plan Volume 2: Gazetteer

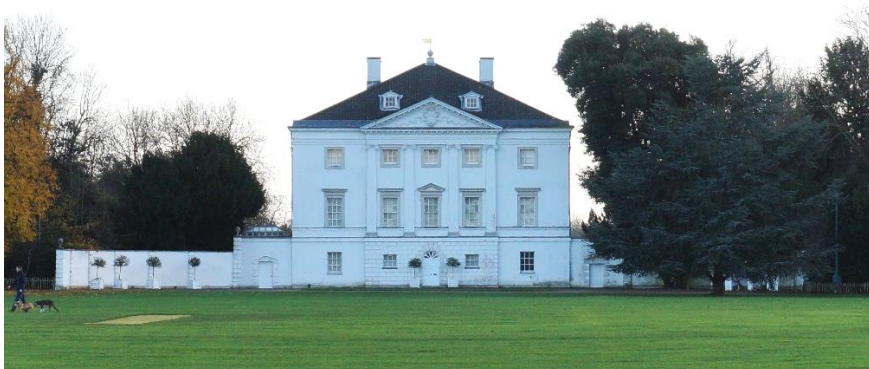
Location: North front

Brief description: This is the entrance front of the mansion and the most ornately treated of any of its elevations. It is five bays wide and three storeys high. The ground floor is treated as a basement in architectural terms – the windows have no architraves - with the *piano nobile* occupying the first floor above. A thick platband marks the division between the ground and first floors, and a thinner one runs above it at the level of the first-floor window sills. The windows have moulded architraves; those of the central bay have lugs (the central window at first-floor level has a pediment as well) to give them greater emphasis. The wall surface is, in fact, almost uniform: the rusticated base of the attached, tetrastyle giant order ionic portico is created by thickening the middle three bays of the wall. The portico has an entablature with a pulvinated frieze and a cartouche in the middle of the pediment. There is a lead-clad blocking course. To either side of the front are screen walls, whose cornices are extensions of the lower plat band, with returns terminating in rusticated piers carrying stone spheres. Both screen walls have doorways with rusticated surrounds. The north door now opens into the shop and serves as the visitors' entrance, while that to the west opens into the terrace by the west elevation. Lower, curved extensions run out from the end piers of both screen walls to create a cour d'honneur. These have rusticated intermediate piers and rusticated end piers crowned by stone spheres. A low, unmoulded stone plinth runs continuously the whole length of the screen walls and the whole width of the north front.

Notes: The modillions are made of fibreglass and were introduced during the 1965-6 restoration, replacing concrete predecessors which had been introduced in a restoration of 1951 and were incorrectly spaced. At the same time the pediment cartouche was renewed in fibreglass. The design of the fanlight is crude, lacking any mouldings, and it looks as though it may be a C20 replacement.

Element	Description (including history)
Walls	Brick, finished in painted stucco, with stone dressings
Windows	Hornless 6-, 9-, and 12-pane sash windows
Doors	A six-panel door with raised and fielded panels and fanlight; six-panel doors with sunk beading to doorways in screen walls
Features	Glass clerestory roof of the 1909 extension visible above the east screen wall

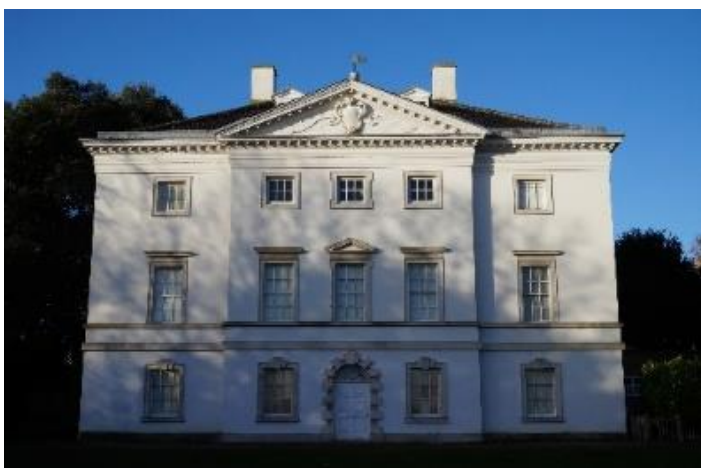
Location: South front

Brief description: This is the 'mirror image' of the north front and, like it, is three storeys high and five bays wide. As built, it overlooked the formally planned Pleasure Ground and, seen from the river terrace, was framed by groves of trees running down either side. The plinth, platbands, cornice and blocking course are carried round from the other elevations. Rustication is confined to the surround of the central doorway, giving access from the Hall, and so the ground floor windows have architraves with proper sills and prominent keystones. The south elevation lacks the portico of the north front but here the central three bays actually break forward. The pattern of the first- and second-floor windows is identical to the north front, but here the middle second-floor window has two pairs of lugs, not one. The central three bays are crowned by a pediment identical in design to that on the north side although here its modillions extend to the flanking sections of cornice. The brick south wall of the 1909 extension is mostly hidden by a hedge.

Notes: The middle three second-floor windows are glazed but effectively dummies since the coving of the Great Room runs continuously behind them and they are not visible from the interior. This front was much altered, probably in the 1810s, when the first floor windows were all extended downwards to the lower platband. The end first-floor windows – i.e. those lighting Lady Suffolk's bedchamber and the Dressing Room – were also widened. Thick mullions and margin lights were inserted and pediments added above. All these changes were reversed in the restoration of 1965-1966 when the pediment cartouche was also renewed in fibreglass. During this restoration traces of cut-back corbels for galleries at second-floor level were discovered.

Element	Description (including history)
Walls	Brick, finished in painted stucco, with stone dressings
Windows	Hornless 6-, 9-, and 12-pane sash windows; the 1909 extension has metal casement windows arranged in a continuous strip.
Doors	A six-panel door with raised and fielded panels and fanlight; the 1909 extension has a central doorway with a simple planked door.
Features	Delicate, presumably metal glazing bars to the fanlight

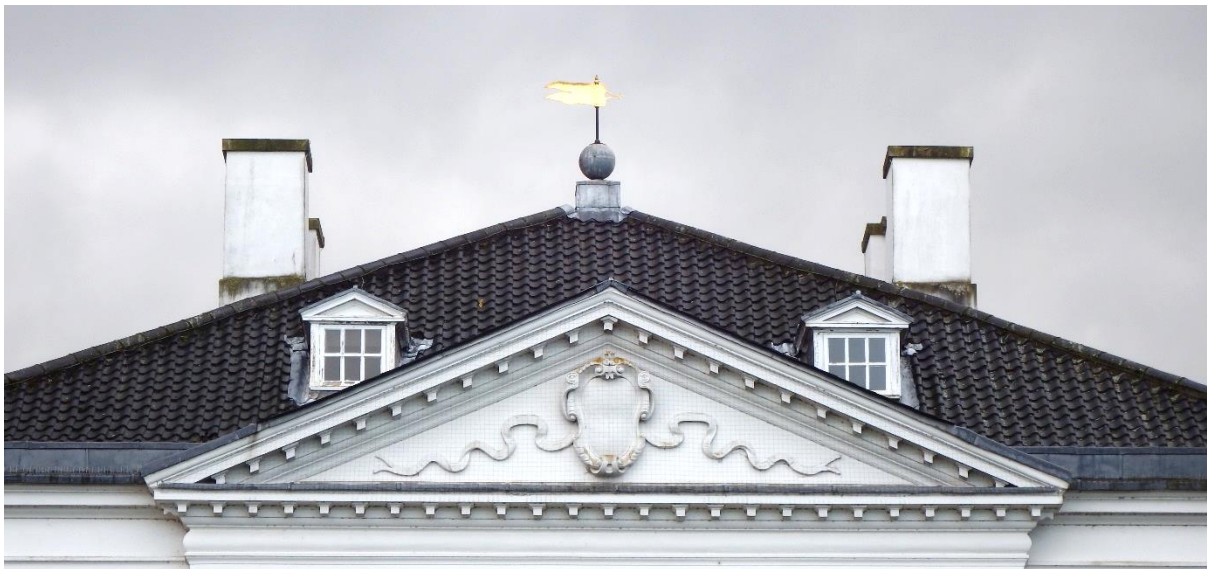
Location: Roof

Brief description: The roof is pyramidal in form and covered in black-glazed pantiles, which were introduced in the 1965-1966 restoration. At its summit is a lead-covered finial, consisting of a cuboid with a sphere on top surmounted by a gilt wind vane. Short sections of roof run out north and south to meet the two pediments, which are slated up to the point where they meet the lead-covered blocking course. Pairs of dormers, which light the garret rooms, emerge from the north and south slopes. These have pitched roofs terminating in pediments echoing those to each of those elevations. The roof of the 1909 extension is finished in rolled and battened lead and hidden from view by a parapet from ground level. Over the shop there is a metal-framed glass clerestory: the sides have louvered openings, the roof is glass and hipped at both ends. There is a modern stainless steel vent adjacent to it.

Notes: Old photographs show that the chimney stacks once had tall pots, removed when they were rebuilt in the restoration of 1965-1966.

Element	Description (including history)
Walls	Chimney stacks are finished in stucco and have stone platband cornices
Windows	Six-pane casements to the dormers
Doors	None
Features	Four chimney stacks emerge from the east and west slopes of the roof. They are aligned with the north-south walls and serve flues running up through them.

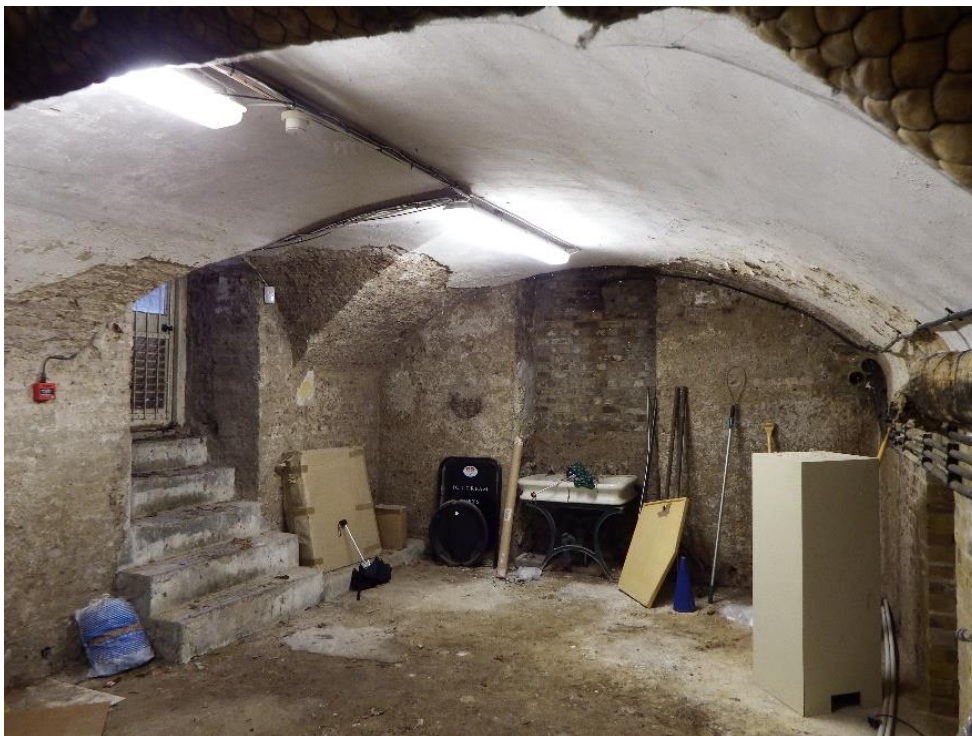
Room: 1

Brief description: This room is directly beneath the Breakfast Parlour and contains the entrance to the basement, accessed by five steps down from a stairwell adjoining the east elevation. It provides access to all the other basement rooms. The original function is unknown.

Notes: This room was formerly divided in two by a partition wall. This has been removed although the difference in flooring materials between the two spaces – stone flags to the north, concrete to the south- is still evident.

Element	Description (including history)
Walls	Plaster, large sections of which have fallen off
Floor	Stone flags and concrete
Ceiling	Segmental barrel vault running north-south
Joinery	Door to exterior: six panels, four glazed and the two lower ones louvered
Features	Chute from outside at south end, blocked with later brickwork; pipework with lagging, suspended from ceiling; area of recent brickwork in west wall, perhaps repairs to a former fireplace

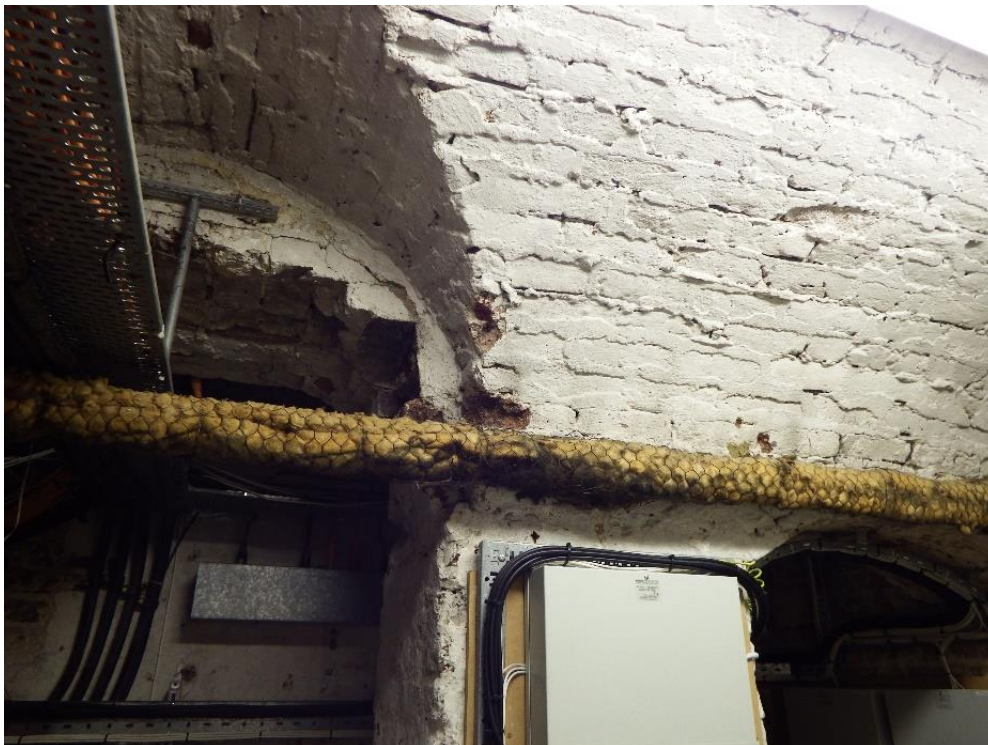
Room: 2

Brief description: A small room reached from Room 2 by a curious oblique opening in the northwest corner of the latter. It is directly beneath the ground-floor landings of the service stair, which is approached by a similar opening. The original function is unknown.

Notes: This room now houses the intakes and control boards for the various utilities and plant equipment

Element	Description (including history)
Walls	Painted brick
Floor	Brick paving
Ceiling	Brick barrel vaults, two running longitudinally and one running laterally, supported on a square pillar
Joinery	None

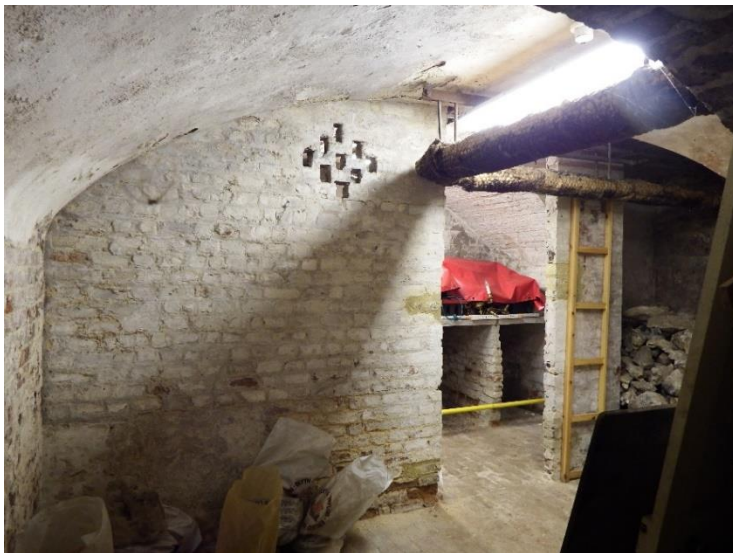
Room: 3

Brief description: This is a northward continuation of Room 1, divided from it by a thick brick wall. It has been divided in two by a partition wall only one brick thick with diamond-shaped groups of vents running through it. This must be secondary as it bisects an arched opening piercing the vault on the east side and then runs into it at an angle. Bins at the north end formed of stone slabs laid on brick walls suggest that this area was once used for storing wine and beer barrels.

Notes: Part of this room is used for storing doors and various items of historic joinery. There is a pile of flint nodules in the split recess on the east side, perhaps from the Grotto.

Element	Description (including history)
Walls	Brick, painted and also plastered in some places
Floor	Brick paving
Ceiling	Segmental barrel vault running north-south
Joinery	None
Features	Segmental arched recesses in the west wall; segmental arched opening in north wall with stepped sill, now split by a secondary brick partition but perhaps originally a window opening into a lightwell; pipework with lagging, suspended from ceiling;

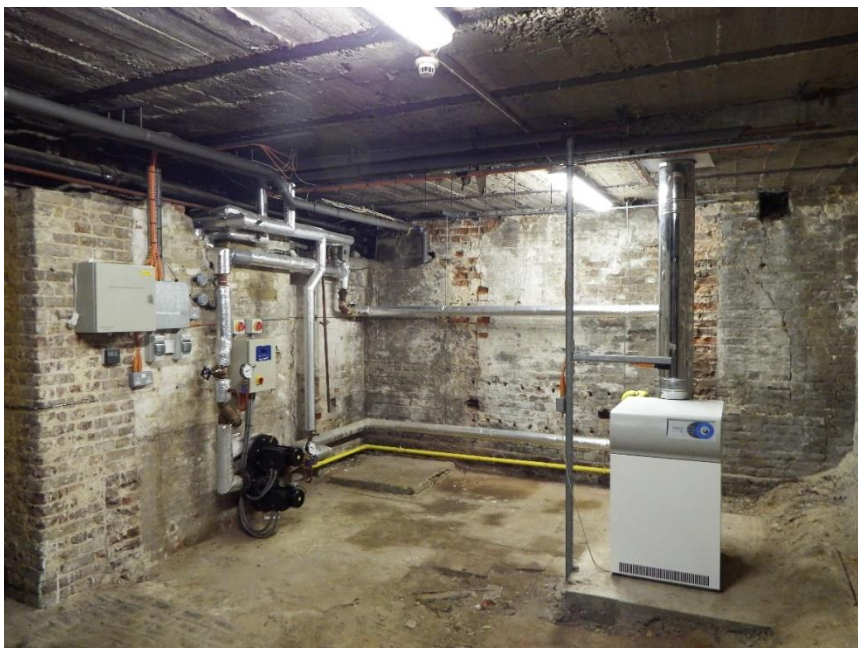
Room: 4

Brief description: This is the largest space in the basement and is directly beneath what is now the shop and toilets. In its present form it must date from 1909 although there are clearly several phases of brickwork and it may incorporate one of the subterranean spaces of the lost Service Wing. There are three compartments at the south end, one of which extends east beyond the line of the east wall of the main space. The openings have concrete lintels. The original function of this room is unknown.

Notes: This room now houses the boiler and associated pipework and controls.

Element	Description (including history)
Walls	Brick
Floor	Brick paving and stone flags
Ceiling	Concrete slabs reinforced by steel girders
Joinery	None
Features

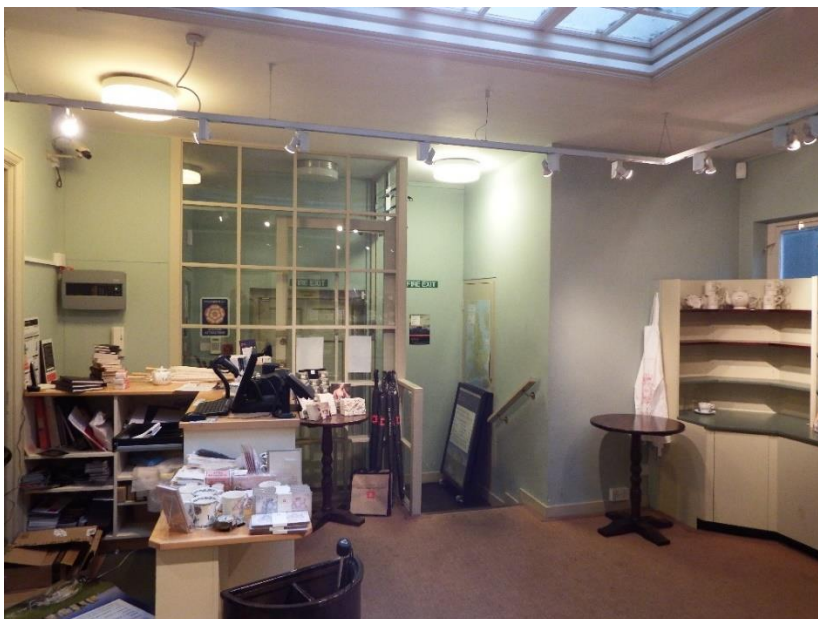
Room: 1

Brief description: This is the largest room in the 1909 extension and is entered through the door in the north screen wall (see entry on North Front). It is now the English Heritage ticket office and shop, and therefore the first part of the interior seen by visitors.

During the second half of the 20th century the room functioned as a male toilet and stores. There was a door through to the house (present Mess room). The threshold from this doorway became rotten and was replaced c.1984. At the same time nos.2 reinforced concrete lintels were inserted. From the mid-80s the space was divided by partition walls to create a shop. Since 1994 the room has remained in its present use combining shop, lobby and store with a door through to the Mess Room behind the counter.

Notes: There are two steps up from the draught lobby, through which the shop is entered from outside.

Element	Description (including history)
Walls	Plastered and painted. The north wall of this room, which forms part of the exterior east curved screen is possibly a remnant of the service wing – it is thicker than the walls of the 1909 extension.
Floor	Carpet
Ceiling	Plaster
Joinery	Skirting, doorways, doors, windows, glazed draught lobby to door to exterior
Features	Flat skylight slightly recessed into ceiling beneath clerestory roof, which is glazed with frosted and wired glass; modern counter and display stands for shop, some of which run across the windows in the east wall; modern lighting, some of it suspended, radiators

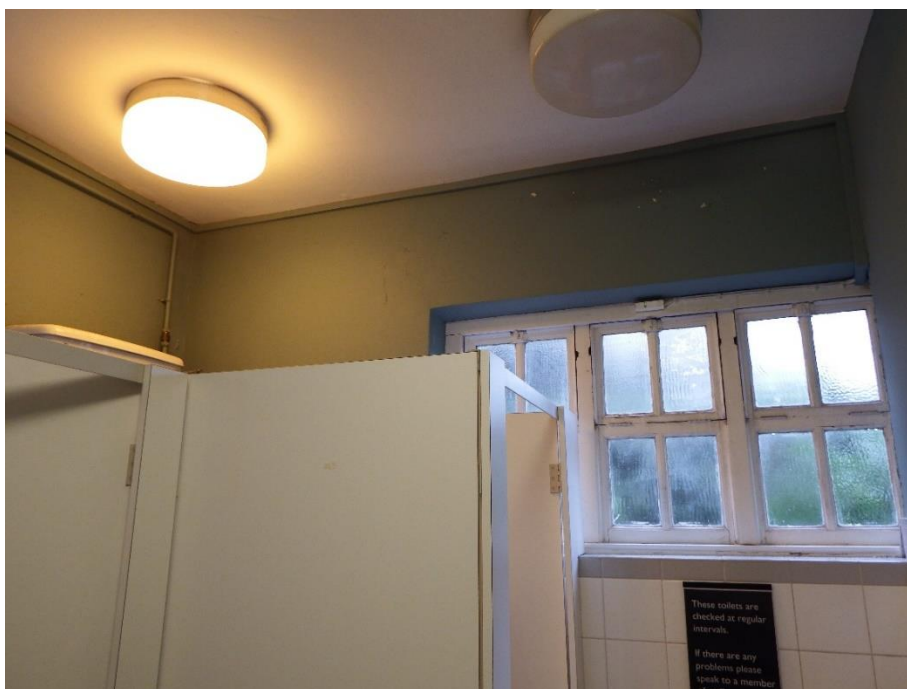
Room: 2

Brief description: This is the rear section of the 1909 extension, which houses the gentlemen's and ladies' toilets and a wheelchair-accessible toilet. It forms part of the visitor entrance route.

Notes: The partition walls are recent - they do not line up with the windows in the south wall and the door in this elevation had been blocked and covered over internally in the gents' toilets.

Element	Description (including history)
Walls	Plastered and painted, tiling to sill height in toilets
Floor	Carpet in corridor, tiling in toilets
Ceiling	Plaster
Joinery	Skirtings, modern architraves and six-panel doors (based on historic examples but clearly recent)
Features	Modern cubicles and sanitary ware in toilets

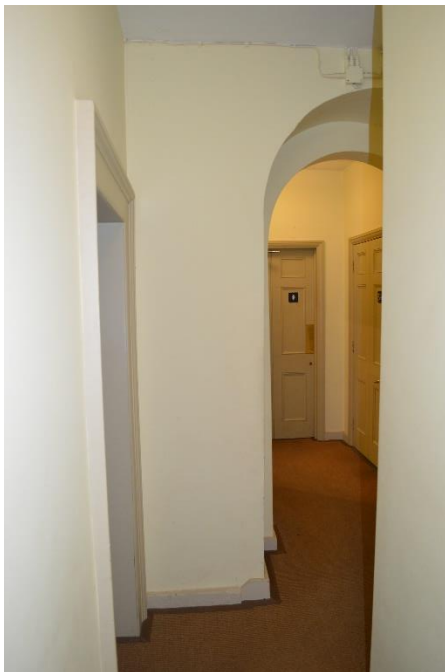
Room: 2a

Brief description: This former service passage connects the corridor in Room 2 to the Service Stair (Room 8) and Entrance Hall (Room 7), meaning that it is now the visitor entrance route. It follows the line of the outer wall of the alcove of the Breakfast Parlour (Room 6) so doglegs and has an alcove in the south wall

Notes: Originally this passage opened onto an external staircase which descended past the kitchen into the sunken courtyard of the service wing.

Element	Description (including history)
Walls	Plastered and painted
Floor	Carpet
Ceiling	Plaster, no cornice
Joinery	Skirtings, architraves to doorways and doors
Features	Arched doorway in east wall marking the division between the 1720s fabric and 1909 extension; modern fire door in doorway to Room 8; obtrusive modern light fittings

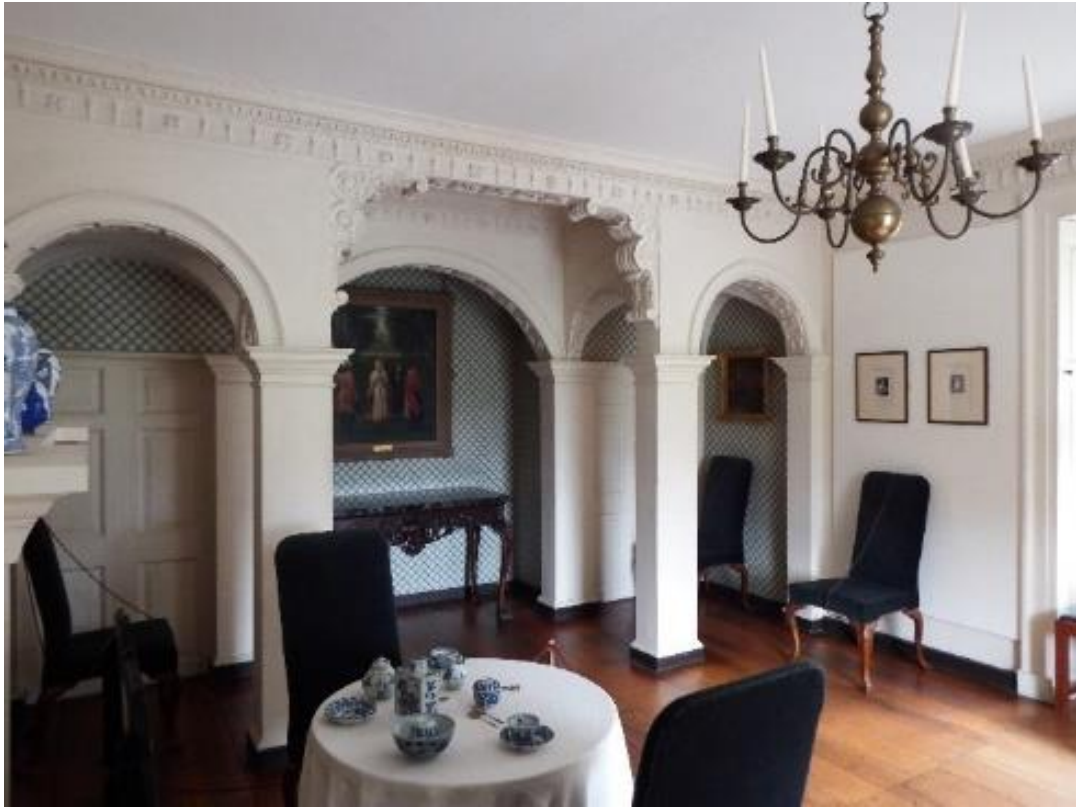
Room: 3

Brief description: Probably originally built as a Dining Parlour – it was formerly adjacent to the Service Wing - this room changed its function when that role was assumed by the new Dining Parlour on the opposite side of the building after that portion of the ground floor was remodelled in 1750. It is dual aspect, looking south towards the river and east towards the site of the service wing. At the north end is a large, tripartite alcove with two doors flanking a central buffet niche. All but one opening is arched and the soffits of the arches and the central flying cornice are moulded in plaster with Greek frets or rosettes in recessed square panels. The central opening to the main room also has pairs of consoles in the upper corners, set at right angles to each other.

Notes: The doors in the alcove are now purely cosmetic as there is no longer any access from the Service Corridor (Room 2a) on the other side of the wall; indeed, one of them may always have been so. The shutters have metal sheeting on the inner face and swinging bars so that they can be locked shut. The fireplace appears to be a vent for a hot air central heating system. In 1950, the room was used described as a “tea room”.

Element	Description (including history)
Walls	Plastered and painted. Wallpaper in the alcove is a replica of the C19 wallpaper, its remnants found during the 1960s restoration. There are exhibition boards fixed to the east and west walls. Drawings from the 1940s show the niche adjacent to the corridor blocked with a partition wall (with no access).
Floor	Boards with vents at the alcove end. Plans from 1905 show a new floor on the south side of the room.
Ceiling	Plaster with elaborate frieze in the main part and the central bay of the alcove; plain plaster in the buffet niche; groined plaster vaults in the side bays of the alcove
Joinery	Skirtings, architrave and lining to door, six-panel door in opening to Room 4 and in the alcove, shutters and window linings, nine-pane sashes. In the mid-C20 there was a counter inserted between the columns of the screen. In 1964, both windows received new timber sashes.

Features	Elaborate chimneypiece fitted to a box-like construction with mouldings and panels against the east wall with a shelf on top. There is a lugged marble surround to the opening with a moulded edge and a prominent mantelpiece with sections breaking forward to the sides which are carried on brackets. Chandelier. Plans from 1905 indicate that there was a sink in this room which was then relocated to the Dining Parlour.
