**Summary history:** The stable block was built in 1825-1827 by Lieutenant General Jonathan Peel (1799-1879), brother of the prime minister, Sir Robert Peel, and owner of Marble Hill from 1825. The architect is not recorded although it has been suggested that Samuel Wyatt (1737-1807) may have been involved in the design. As built, the stable block building included six stalls for carriage and working horses on the ground floor of the main block. In the rear wings were three loose boxes where more valuable horses, perhaps racehorses, were kept as well as a cart shed. In 1905, following the sale of Marble Hill and transformation of the site into a public amenity, the building was adapted to serve a range of new functions. The stalls were removed from the northern half of the ground floor of the main block to turn the space into a bothy and the end room became an office. The southern half seems to have retained its original layout. The first floor was converted into two tenements. One of the loose boxes was converted into a wash house for the tenements and a WC was formed in a corner of the cart shed. In 1964-1965 the GLC converted the southern half of the ground floor into a café, ne

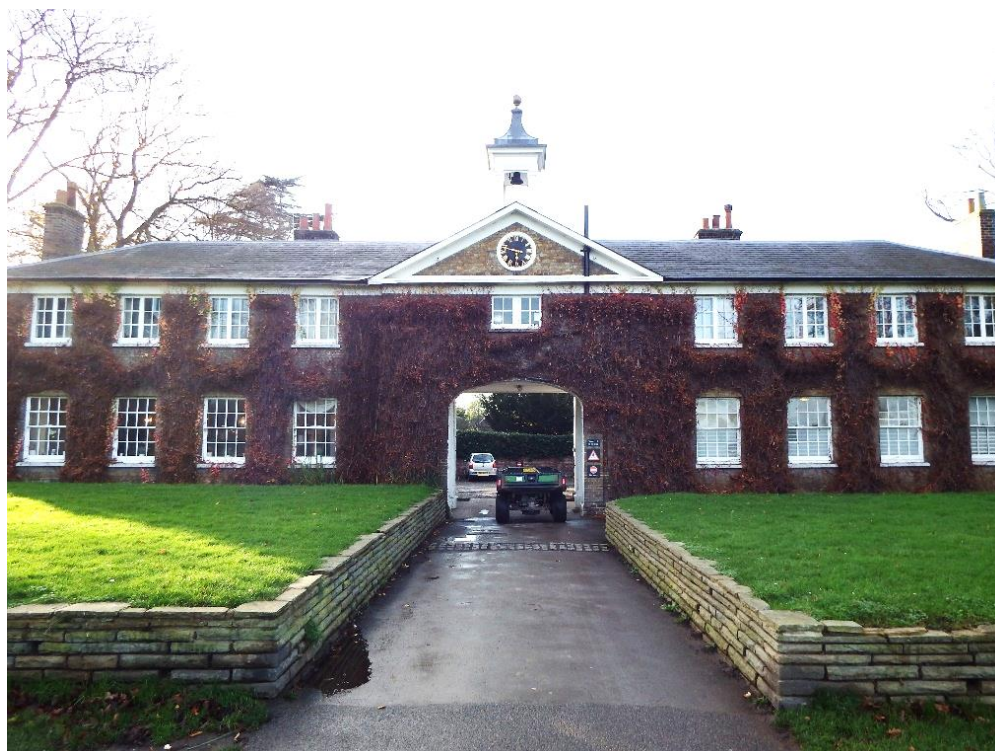
**Location:** East elevation

**Brief description:** This is the principal aspect of the stable block and has the greatest pretensions to formal design, being symmetrically composed about a central bay with a carriage entrance and a pediment, which frames a clock face. Above it is a turret housing the chiming bell. The pediment has a very simple cornice and a plain frieze runs the length of the elevation.

| Element | Description (including history) |
|---|---|
| Walls | Stock brick, mostly obscured by creeper |
| Windows | 16-pane sashes to the ground floor and 12-pane casements to the first floor, with one 8-pane casement in the central bay |
| Doors | Only in the side walls of the carriage entrance, providing access to staircases rising to the residential accommodation on the first floor. |
| Features | Elliptical arch to carriage entrance |

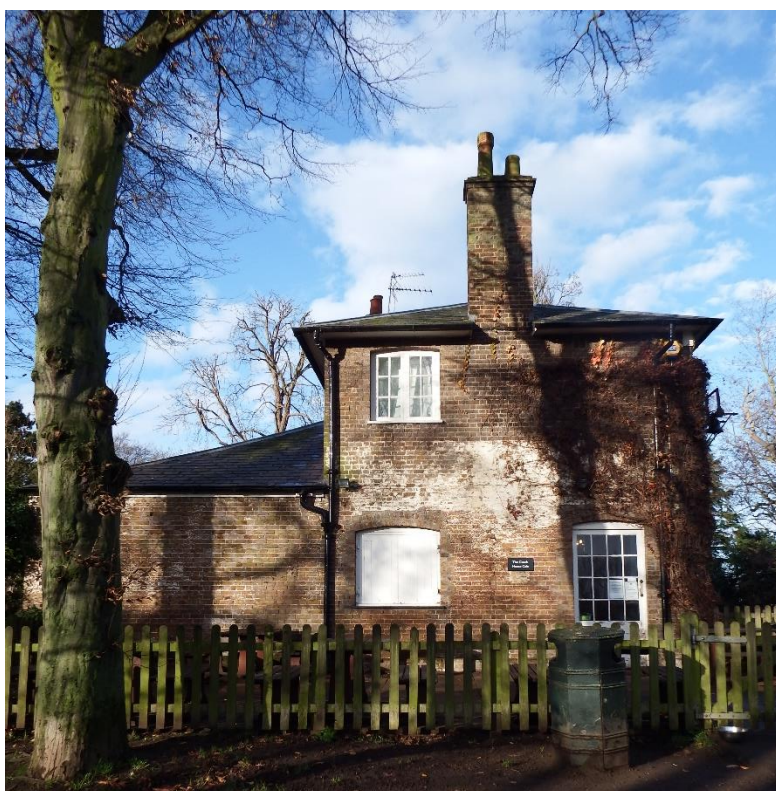
**Location:** South elevation

**Brief description:** This elevation faces the West Meadow and now contains the visitor entrance to the café. The blank section of wall corresponds to the extension that formerly housed the loose boxes, now the kitchen.

**Notes:** The first-floor window dates from the 1905 alterations.

| Element | Description (including history) |
|---|---|
| Walls | Stock brick |
| Windows | One 12-pane casement at first floor level, hatch with shutters for serving refreshments in summer to ground floor |
| Doors | One, with 16-pane window |
| Features | Chimney stack |

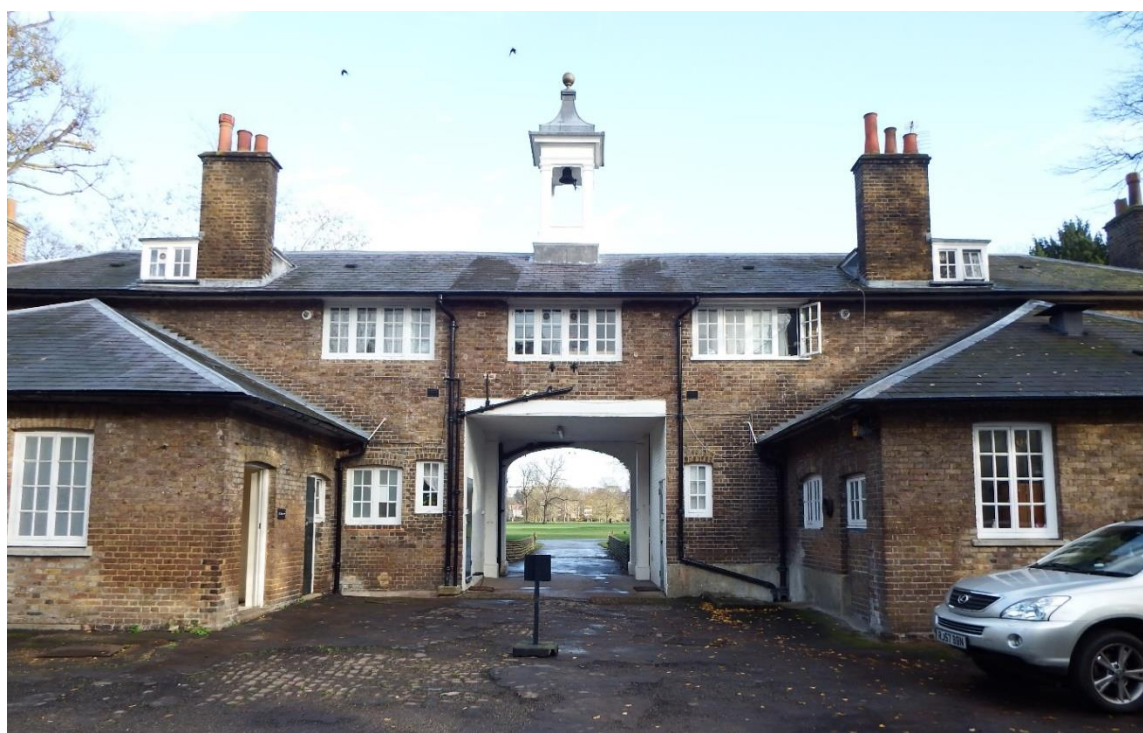
**Location:** West elevation

**Brief description:** This elevation faces the service yard and overlooks the houses at the southern end of Montpellier Row. It is symmetrically composed but otherwise more vernacular than formal in character. It was modified in 1905 when the three four-light casement windows in the centre of the first floor appeared, together with the adjacent chimney stacks. The eastern elevations of the two projecting wings were modified in 1964-1965: two doors in the southern wing were converted to windows and the cart shed, together with its doors, was reduced in size.

| Element | Description (including history) |
|---|---|
| Walls | Stock brick |
| Windows | Casements varying in size from six to 24 lights |
| Doors | Plank and batten doors; double-leaf doors on iron hinges, each with six panels of sunk beading, to former cart shed |
| Features | Flat lintel to carriage entrance |

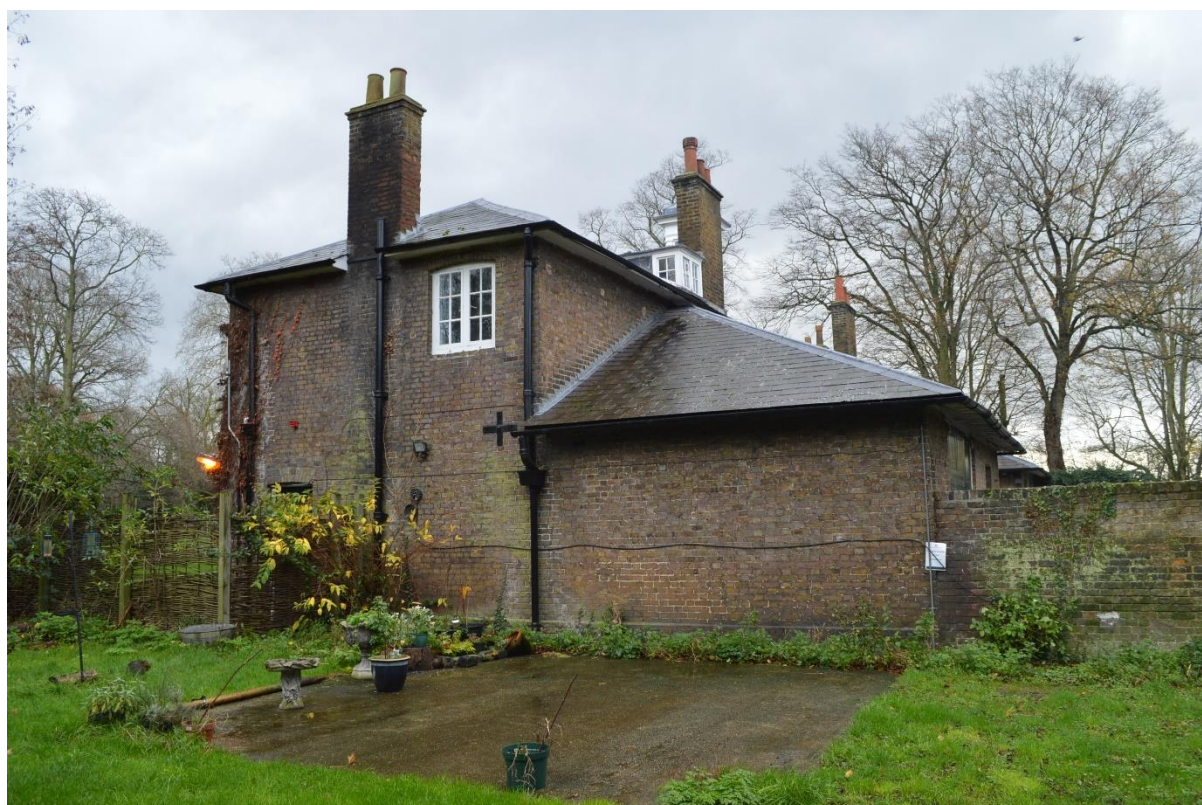
**Location:** North elevation

**Brief description:** This plain elevation faces the shrubbery of the Sweet Walk and overlooks a garden, which has an area of hard standing, and a former changing block erected by the GLC. It was altered in 1905 when the ground floor door and window (the latter since blocked) and first floor window were created.

| Element | Description (including history) |
|---|--|
| Walls | Stock brick |
| Windows | One 6-light casement window |
| Doors | One, from the former office |
| Features | The wall enclosing the service yard abuts the building at this point |

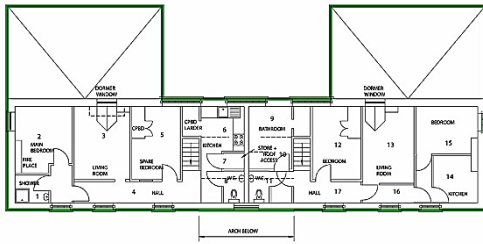
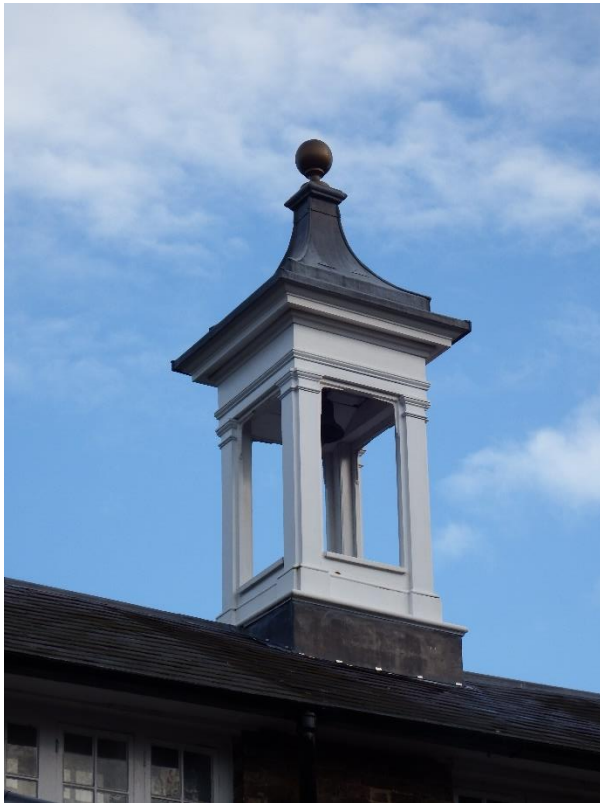
**Location:** Roof

**Brief description:** The roofs of the main block and rear wings of the stable block are hipped and covered in slates throughout. They have broad eaves, although at the north and south elevations the eaves line is broken by the chimney stacks. In the centre of the roof of the main block, aligned with the ridge and pediment on the east elevation, is a wooden turret, square in plan, which houses a chiming bell for the clock. The external faces of each post have Tuscan pilasters, with a frieze and deep cornice above. The turret has a lead-covered roof of truncated pyramidal form with concave faces, rising to another cornice and topped with a gilt ball finial. In 1905 dormers were cut through the western slope of the roof of the main block, abutting the chimney stacks added at the same time.

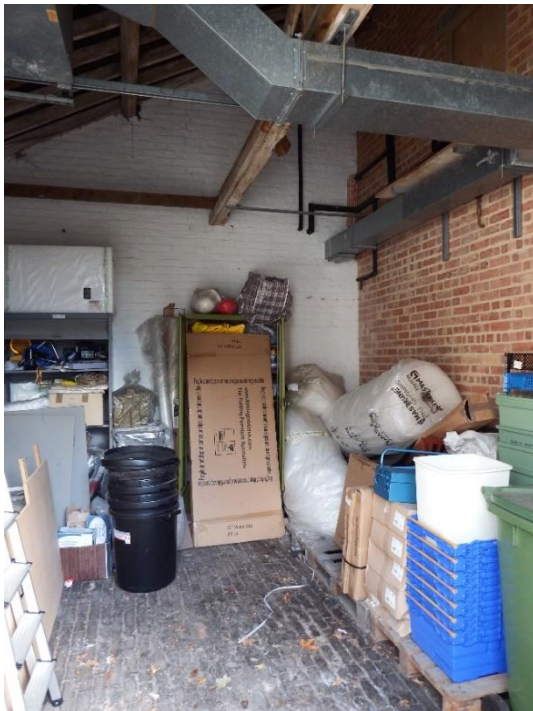
**Room:** G2

**Brief description:** This is the remaining portion of the cart shed, which formerly occupied all of the northern rear wing but was reduced through subdivision to form the male visitor toilets.

**Notes:** Originally there was a double entrance from the yard, with two sets of doors divided by a single pillar. The existing door leaves may well be a surviving component of the original arrangement but a comparison of modern survey drawings with the plans for the 1905 alterations show that the west wall has been rebuilt and the openings reconfigured.

| Element | Description (including history) |
|---|--|
| Walls | Brick – painted on north and east sides, bare to south |
| Joinery | Roof structure, cart doors |

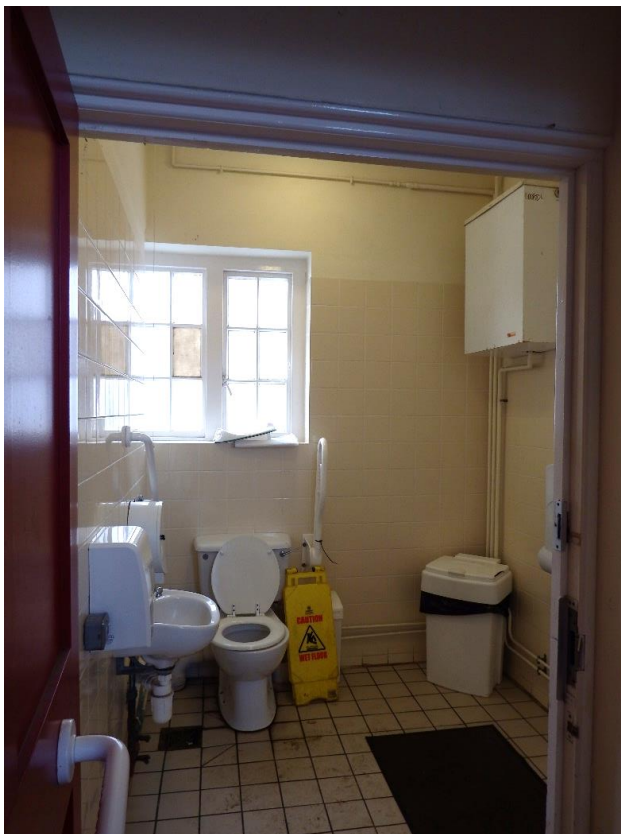
**Room:** G4

**Brief description:** Created through the subdivision of the ground floor space in the northern half of the main block, which was originally occupied by stalls and turned into a bothy during the 1905 alterations. In its current form it dates from the English Heritage guardianship.

**Notes:** A sealed chimney breast survives in the west wall behind a modern lining. The 1905 plan shows posts in this space like those that survive in G5 but they have been removed.

| Element | Description (including history) |
|---|--|
| Walls | Plastered and painted, tiled to head height |
| Floor | Tiled |
| Ceiling | Plaster |
| Joinery | Doorframe, door, windows |
| Features | Modern sanitary ware, partition walls for cubicles |

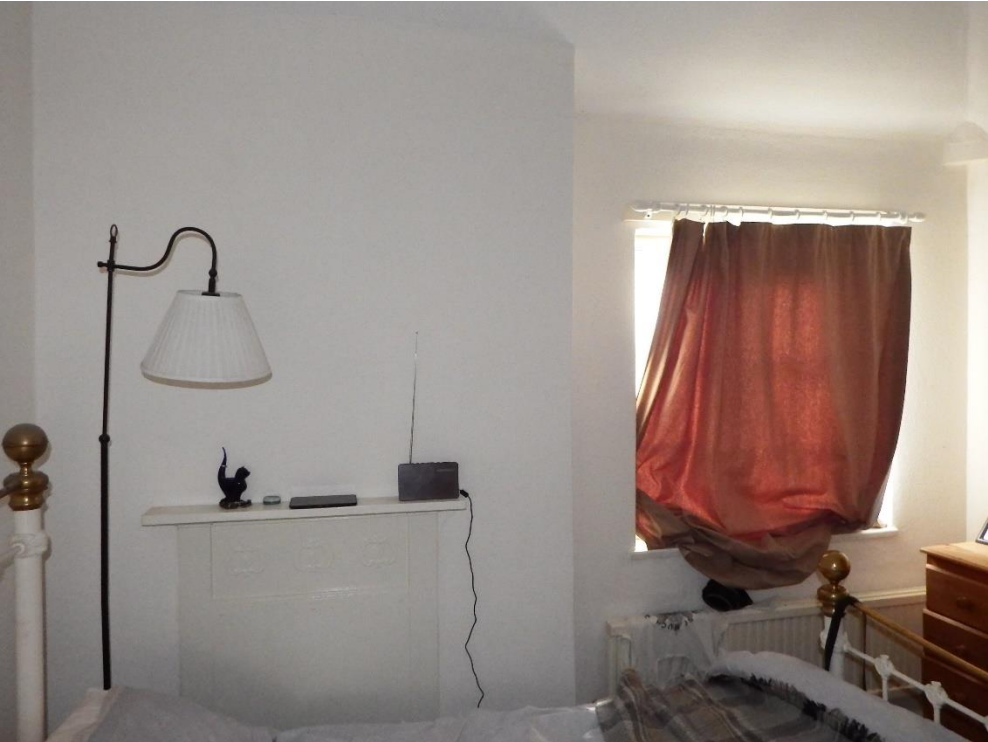
**Room: F2**  
**Name: Master bedroom**  
**Date(s): 1825-1827, 1905, post-1952**  
**Significance: Some significance**

**Brief description:** The southernmost of the three main rooms over the former south stable, reduced in size when part of it was subdivided to form a bathroom in the later C20. Formerly it extended the full depth of the main block.

| Element | Description (including history) |
|---|---|
| Features | Cast fireplace surround with Art Nouveau motifs, opening blocked and sealed |

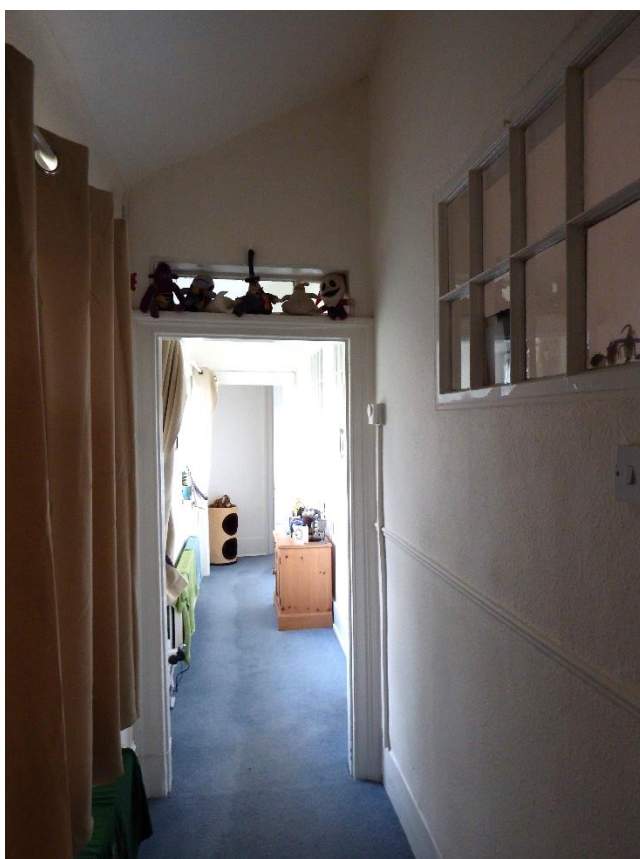
**Room:** F4

**Brief description:** A staircase rises through a quarter turn from a ground-floor lobby opening off the carriage entrance to a corridor running along the eastern side of the southern flat, providing access to all the rooms. The partition wall separating it from the living room is a modern fire wall but the partition wall with a window separating it from F5 is original.

| Element | Description (including history) |
|---|---|
| Joinery | Door frame and overlight (former entrance to living room), window in east wall, dado rail, skirting |

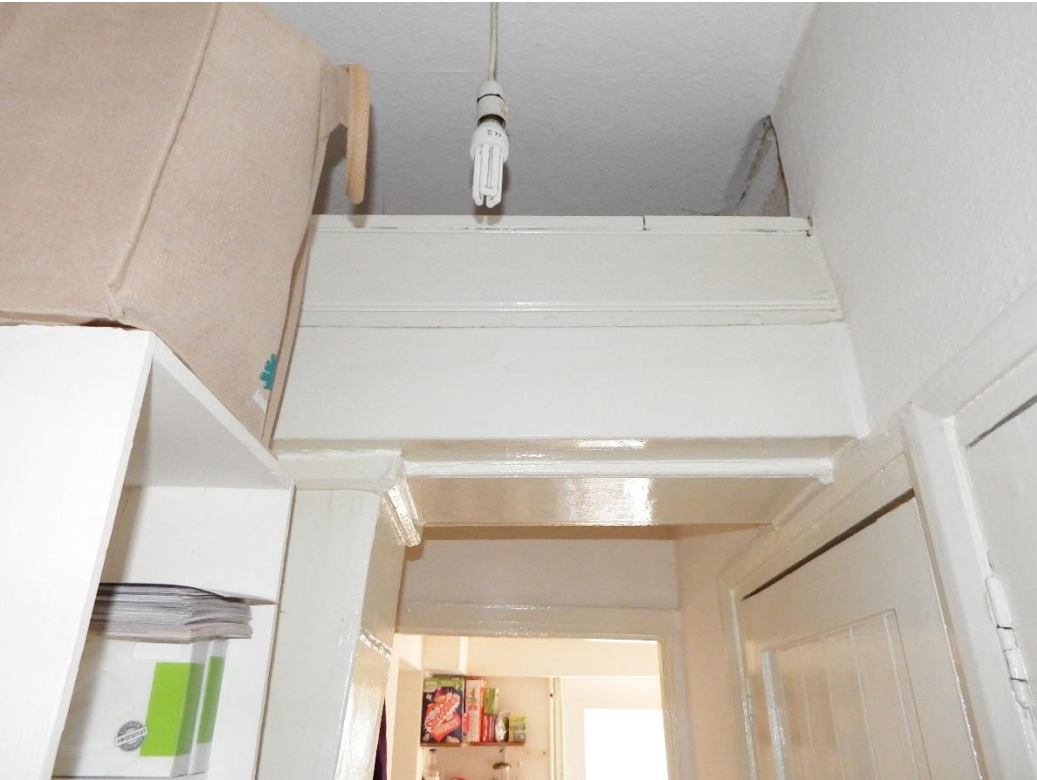
**Room: F7**  
**Name: Storeroom and adjacent lobby**  
**Date(s): 1825-1827, 1905**  
**Significance: Neutral**

**Brief description:** The lobby provides access from the upper landing of the stairs to F6, a tiny storeroom (shown on the 1905 plan as a coal store) and to F8. The storeroom has a hatch in the ceiling that provides access to the roofspace and clock mechanism.

| Element | Description (including history) |
|---|--|
| Features | Wooden housing for clock weights and drive running across the lobby at head height and then vertically downwards against the south wall; clock mechanism in roof space |

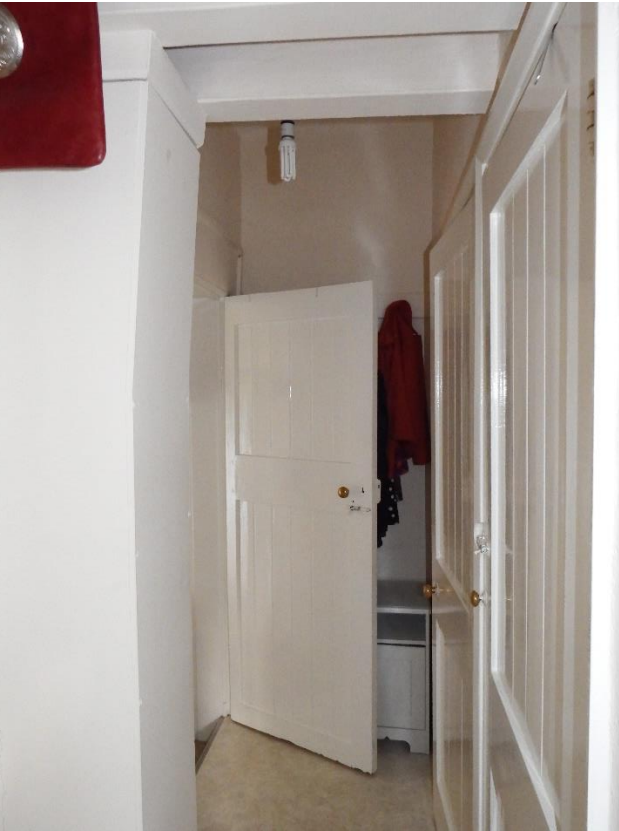
**Room:** F10  
**Name:** Lobby and storeroom  
**Date(s):** 1825-1827, 1905  
**Significance:** Neutral

**Brief description:** This space is the ‘mirror image’ of F7 in the southern flat and, like it, provides access from the upper landing of the stairs to a tiny storeroom (shown on the 1905 plan as a coal store) and to F9, the former kitchen. The storeroom has a hatch in the ceiling that provides access to the roofspace and clock mechanism.

| Element | Description (including history) |
|---|--|
| Features | Wooden housing for clock weights and drive running across the lobby at head height and then vertically downwards against the north wall; clock mechanism in roof space |

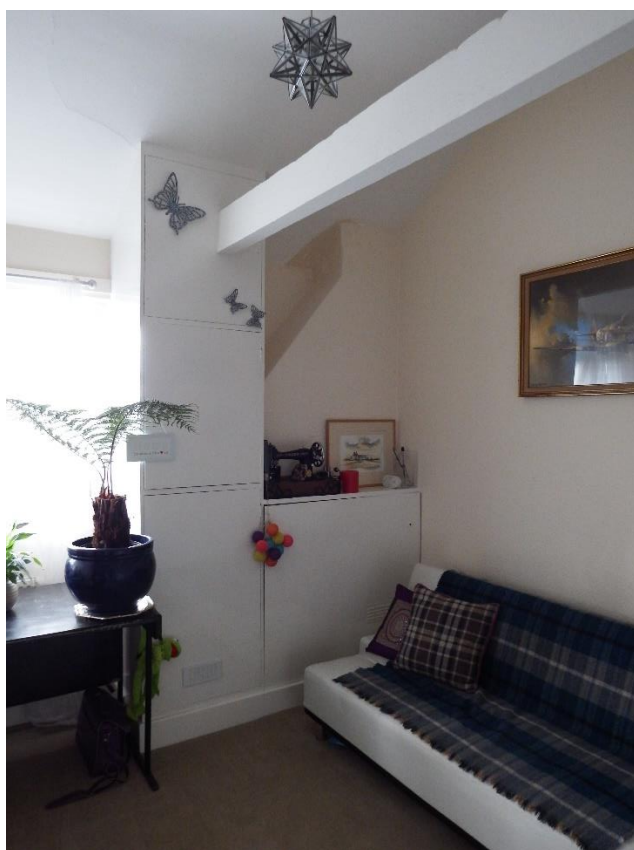
**Room:** F12

**Brief description:** The 'mirror image' of F5 in the southern flat.

| Element | Description (including history) |
|---|--|
| Features | Tie beam of roof truss; historic built-in cupboard; modern cupboards against west wall concealing the chimney breast and fireplace |

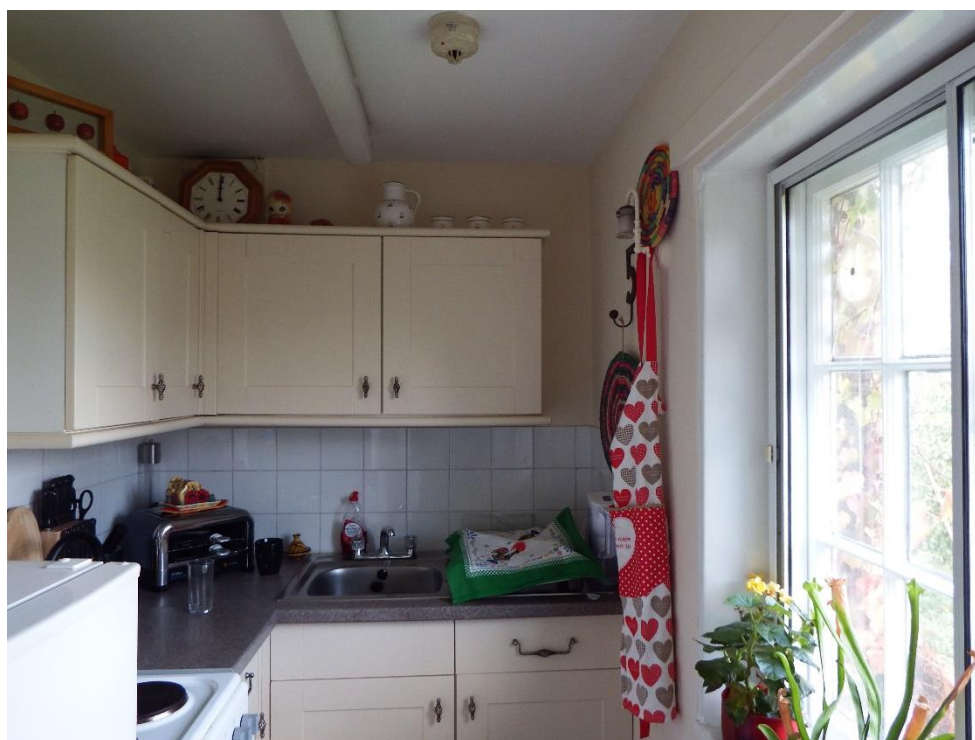
**Room:** F15

**Brief description:** The 'mirror image' of F2 in the southern flat and, like it, shown on the 1905 plan as a bedroom. It has also been subdivided, although in this instance to create a kitchen.

| Element | Description (including history) |
|---|--|
| Features | Secondary glazing; tie beam of roof truss; fireplace with Art Nouveau-style motifs in relief identical to that in F2 |

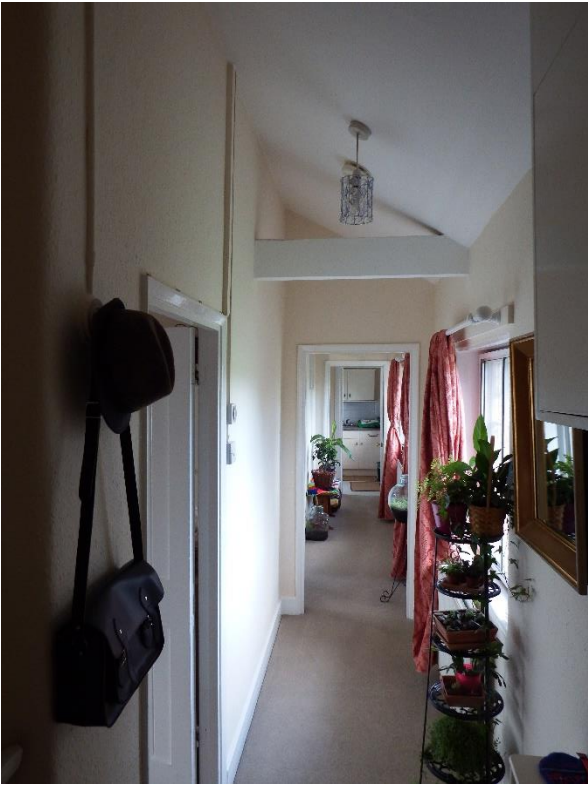
**Room:** F16-17  
**Name:** Corridor and stairs  
**Date(s):** 1825-1827, 1905  
**Significance:** Some significance

**Brief description:** The ‘mirror image’ of F4 in the southern flat - a staircase rises through a quarter turn from a ground-floor lobby opening off the carriage entrance to a corridor running along the eastern side of the flat, providing access to all the rooms. The partition separating it from the living room is modern but the partition wall with a window separating it from F12 is original.

| Element | Description (including history) |
|---|---|
| Features | Secondary glazing; exposed tie beam of roof truss also visible in F12, handrail to stairs |
