2.3.6 Marble Hill House, 1900–1987

2.3.7 Stable Block, 1900–1987

2.3.8 English Heritage Guardianship, 1988 to present

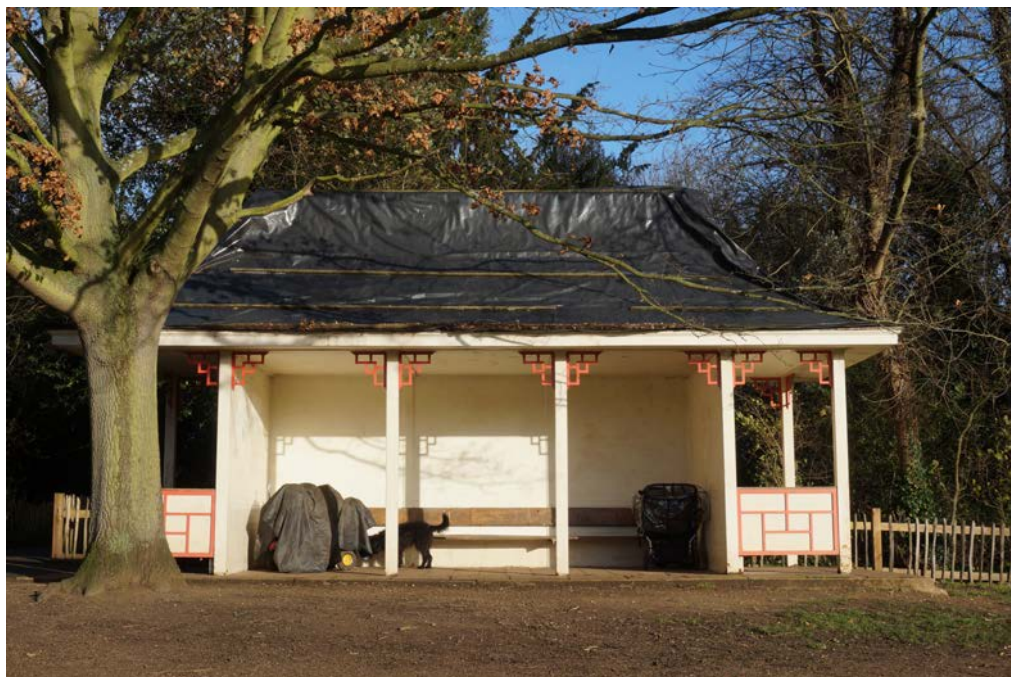
Fig 46 Today the shelter is without its copper roof which was stolen some years ago

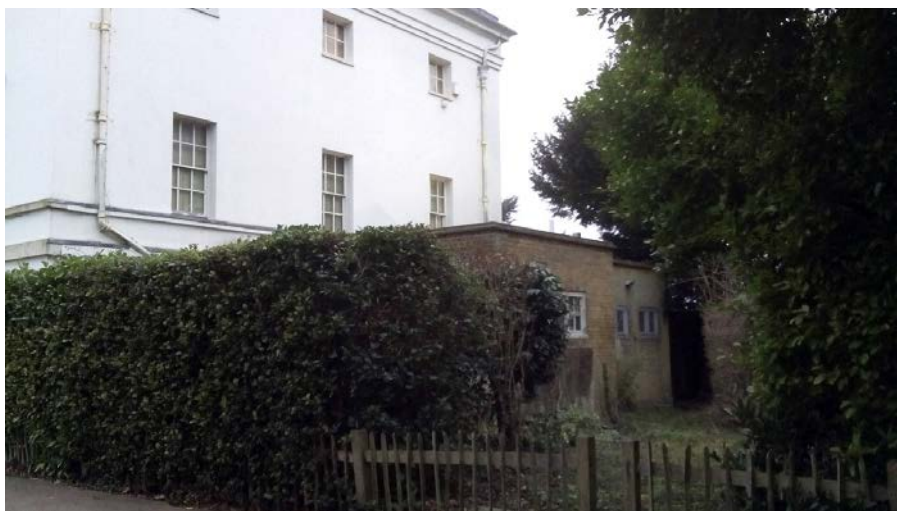
Fig 56 The toilet block built in 1909

The impetus for the London County Council's acquisition of Marble Hill came principally from a wish to preserve the estate as a public open space rather than to conserve the house. Archive plans from 1905 show the layout of the house when it was obtained and some repairs to the floors. The greatest loss was the service wing, including the Countess's 'China Room', which was demolished in 1909. The footprint of the servants' hall was rebuilt at ground level as a toilet block.

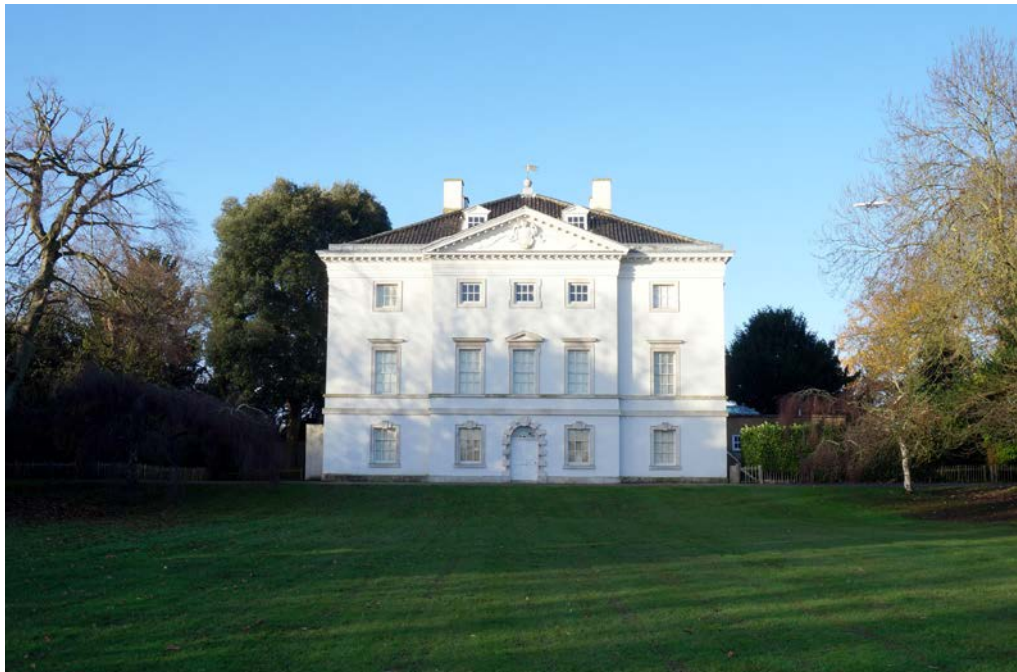
Fig 62 The south front today

Externally the most obvious changes were the alterations to the fenestration of the south front, especially the removal of early 19th-century windows and their replacement with Georgian forms, and the reduction in height of all windows of the first floor, restoring them to their 18th-century proportions, as shown in Campbell's engravings. This work had been recommended by The Georgian Society in 1939. The pediment cartouches, shown in early depictions, were restored in fibreglass, like the modillions, as mentioned above. The works to the exterior of the building also revealed archaeological evidence for changes to the fabric, including cut-back corbels of balconies at attic level on the south elevation, and the remains of a Palladian window on the western side, removed in 1750 by Brettingham. The roof was covered with new tiles and the chimneys were rebuilt.
