Teddington Playing Fields					
Site address	Teddington					
Site address	Greater London					
	TW11 9HZ					
Client	Quantum Land and Property Ltd					
Report title	Soakaway Test Report					
Issue date	06 October 2016					
Report No.	AC/JW/SR/16325/STR					
Revision No.	0

Soakaway Test Report Report Ref: AC/JW/SR/16325/STR

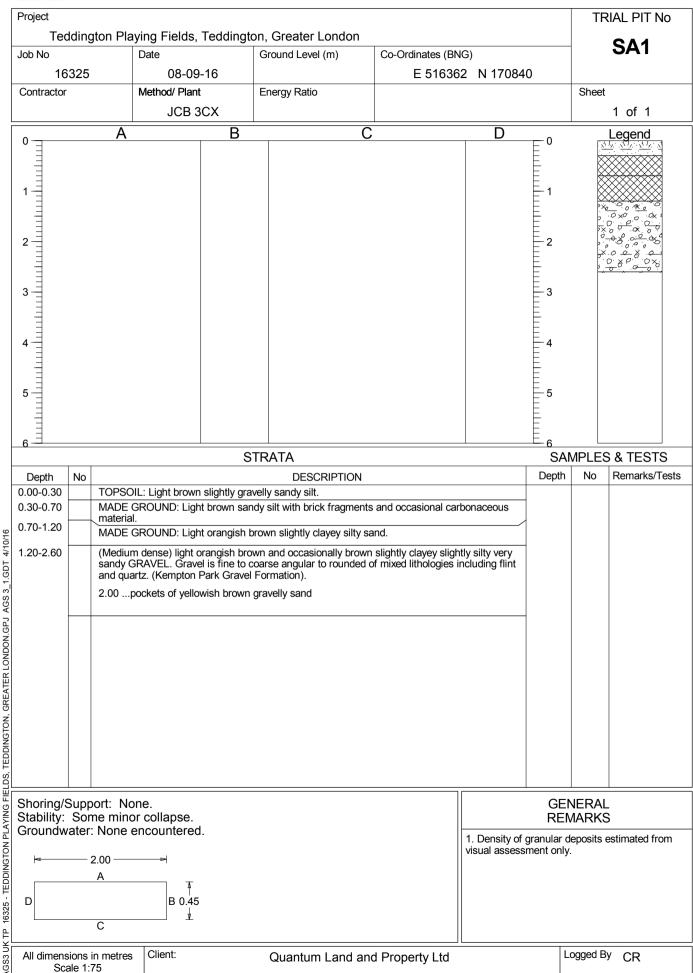
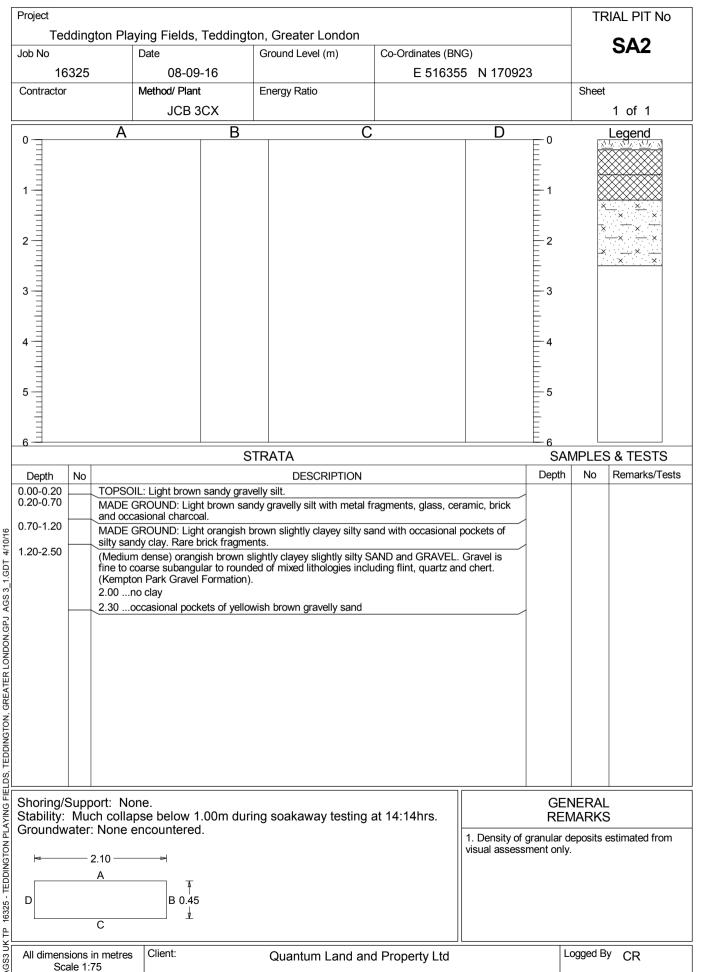
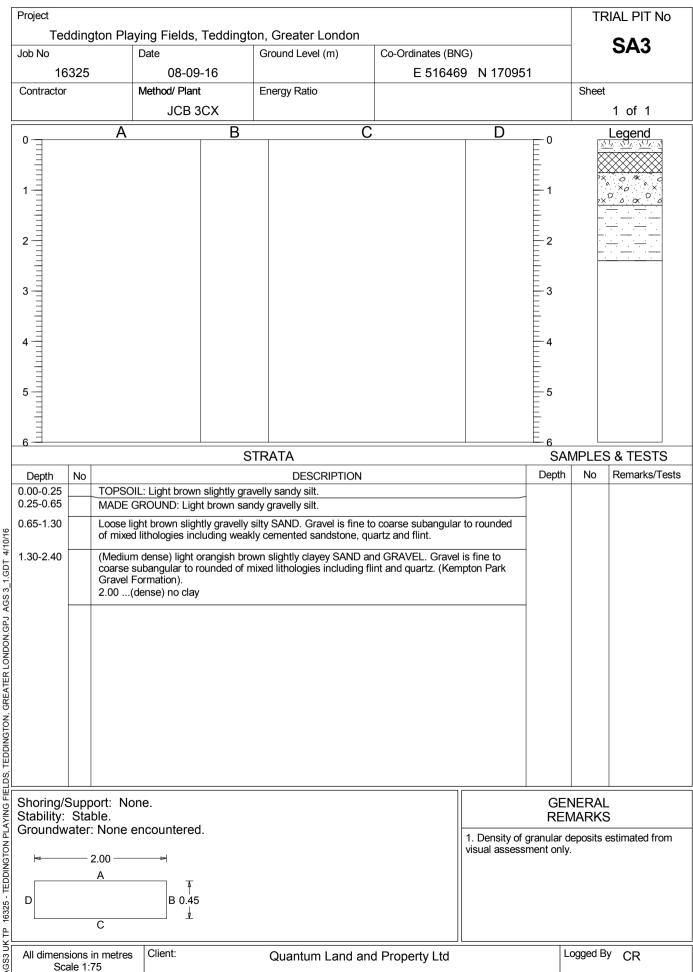
Topsoil was typically encountered to depths of between 0.20m and 0.30m below existing ground levels.

Made ground was encountered at all three test locations, to depths of between 0.65m and 1.20m below existing ground level.

The made ground typically comprised light brown sandy and gravelly silt, with fragments of anthropogenic materials, including metal, glass, brick, ceramic and occasional charcoal.

Beneath the made ground, (medium dense) orange brown slightly clayey slightly silty sand and gravel was encountered to the maximum depth excavated of between 2.40m and 2.60m.

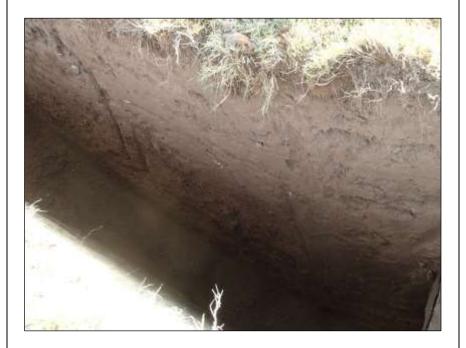
Plate 3
Ground conditions encountered within SA1.

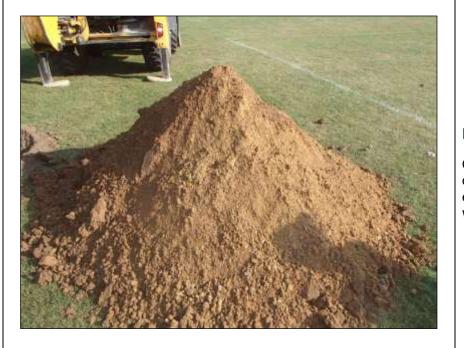
Plate 4
Ground conditions encountered within SA1.

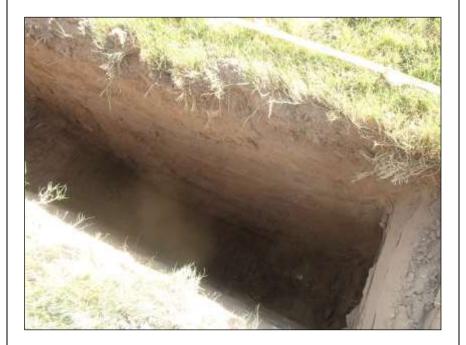
Plate 5
Ground conditions encountered within SA2.

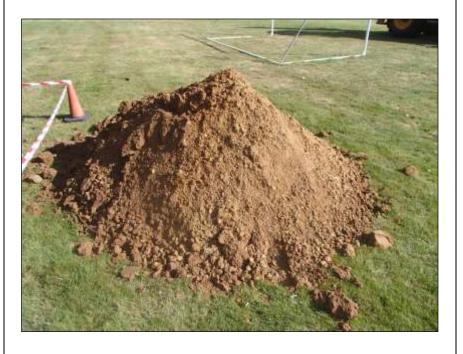
Plate 6
Ground conditions encountered within SA2.

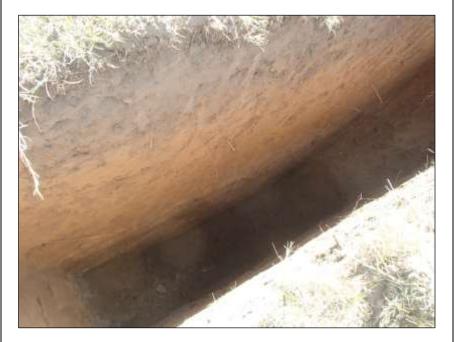
Plate 7
Ground conditions encountered within SA3.

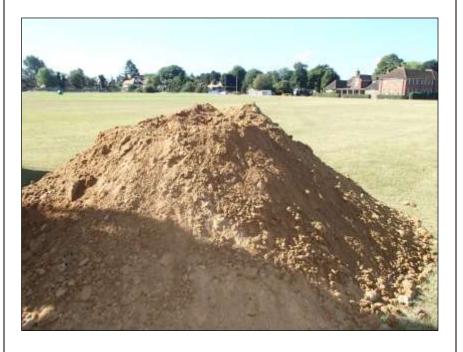
Plate 8
Ground conditions encountered within SA3.

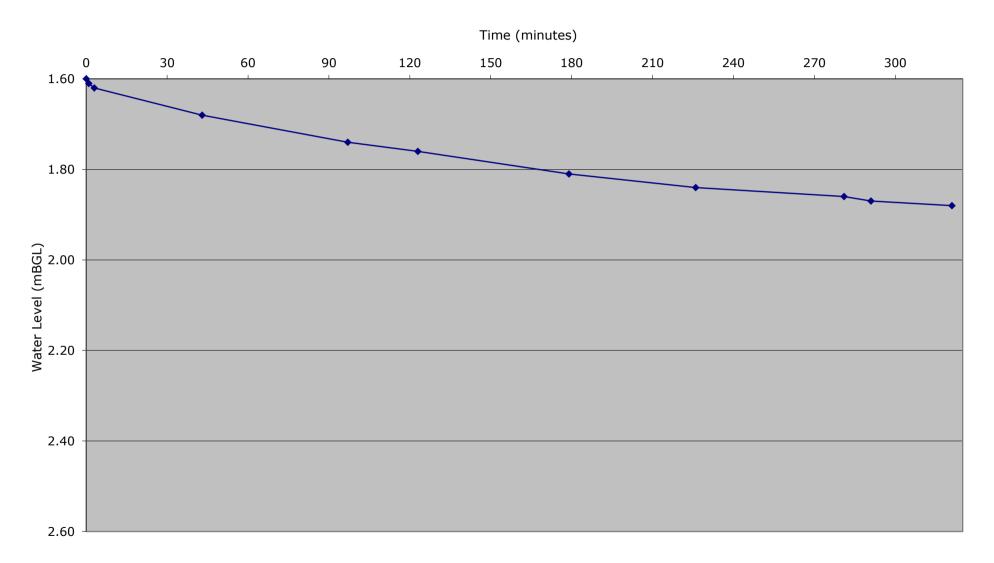
Soakaway Test Results - SA1

Length (m):	2.00
Width (m):	0.45
Depth (m):	2.60
Start Water Level (m):	1.65
Total Depth of Test	0.95

Time (minutes)	Water Level (mBGL)	
0	1.60	
1	1.61	
3	1.62	
43	1.68	
97	1.74	
123	1.76	
179	1.81	
226	1.84	
281	1.86	
291	1.87	
321	1.88

Tubic II Sullillar	or Soundway rest	Itesuits			
Test No.	Total Recorded Fall of Water Level (m)	Duration of Test (minutes)	Soil Infiltration Rate (m/s)		
SA1	0.28	321	*		
SA2	0.55	277	*		
SA3	0.54	226	*

^{*} Test failed to reach 75% of the effective depth. No soil infiltration rate calculation possible.

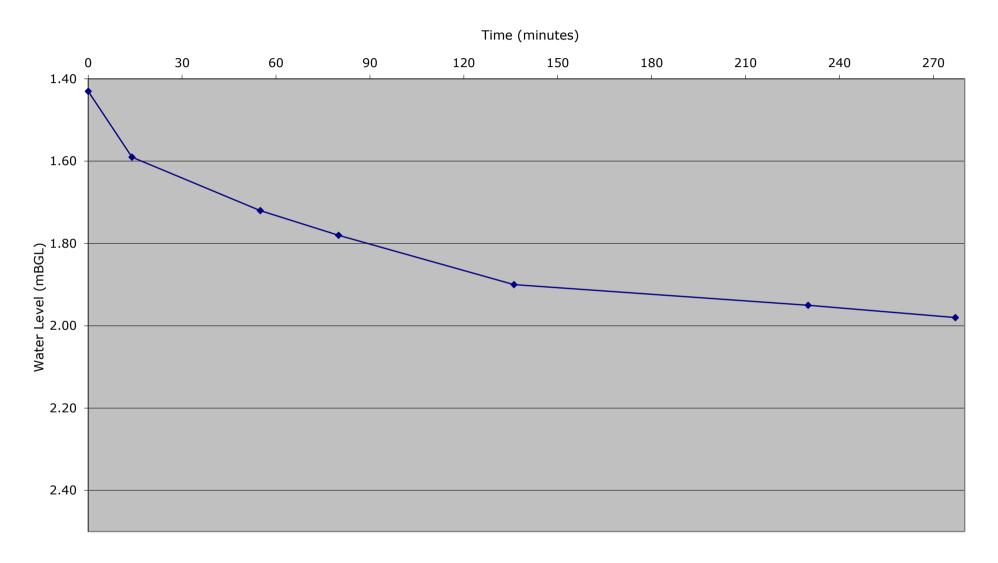
Soakaway Test Results - SA2

Length (m):	2.10
Width (m):	0.45
Depth (m):	2.50
Start Water Level (m):	1.43
Total Depth of Test	1.07

rieiu Resuits		
Time (minutes)	Water Level (mBGL) 1.43 1.59 1.72 1.78	
0	1.43	
14	1.59	
14 55	1.72	
80	1.78	
136	1.90	
230	1.95	
277	1.98

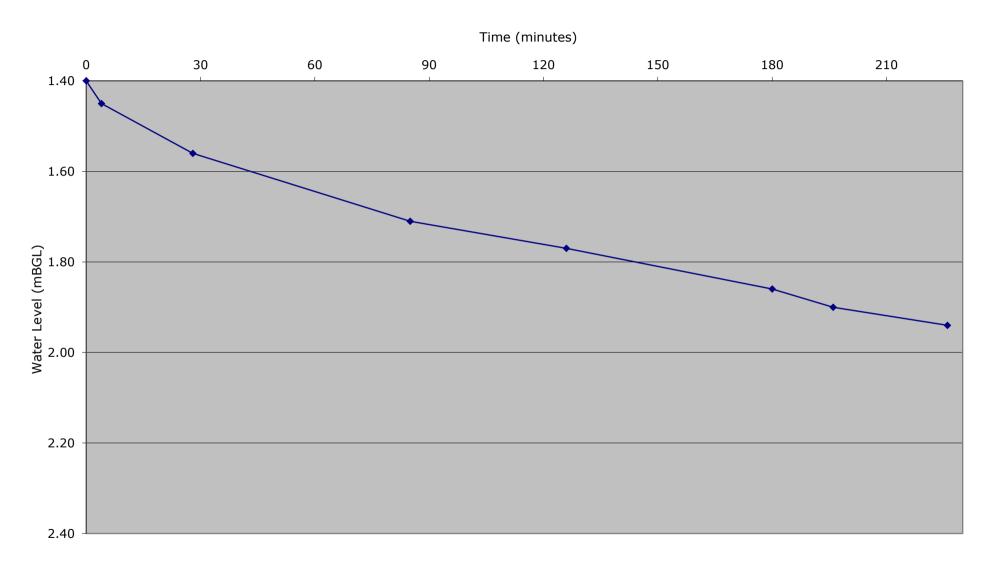
Soakaway Test Results - SA3

Length (m):	2.00
Width (m):	0.45
Depth (m):	2.40
Start Water Level (m):	1.40
Total Depth of Test	1.00

rieiu Resuits		
Time (minutes)	Water Level (mBGL)	
0	1.40	
4	1.40 1.45 1.56 1.71	
28	1.56	
28 85	1.71	
126	1.77	
126 180	1.86	
196	1.90	
226	1.94

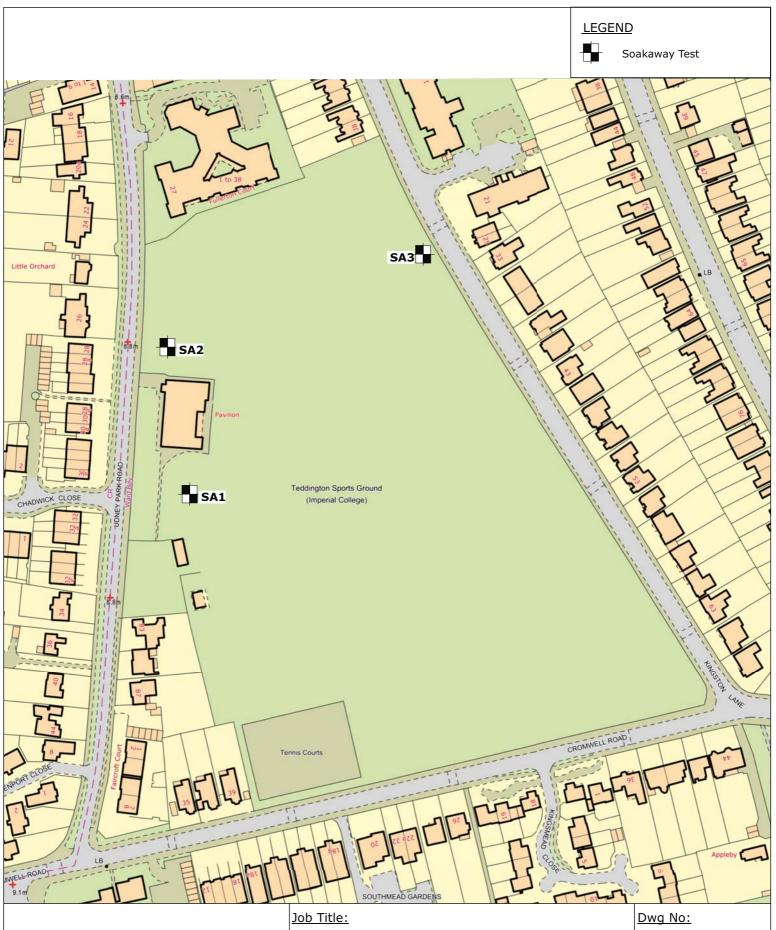
TEDDINGTON PLAYING FIELDS, TEDDINGTON, GREATER LONDON	16325/02
<u>Drawing Title:</u>	<u>Date:</u>
SOAKAWAY TEST LOCATION PLAN	SEPT-16
Client:	Scale:
QUANTUM LAND AND PROPERTY LTD	NTS

It is understood that soakaways are proposed as a means of surface water drainage for the residential development of land at Teddington Playing Fields, Teddington, Greater London. The existing site plan is shown on the soakaway test location plan (Appendix D of this report).
