## **Bat Building Assessment Report**

**All Saints Church  
The Avenue, Hampton TW12 3RS**

January 2018

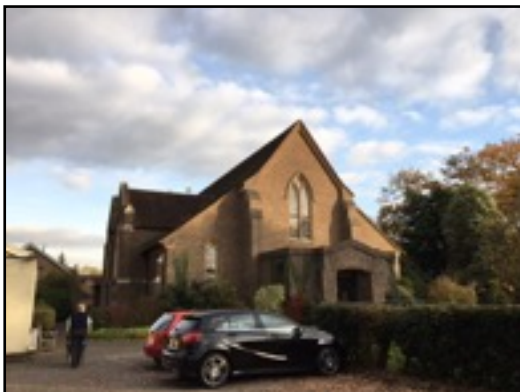
**Image 2:** All Saints Church

- 5.1. The site for development comprises one church, two halls and one bungalow house. The 1908 built church and the bungalow are brick built with clay tiles and the halls are stone and brick with part flat metal roof and part corrugated iron roof (Images 2 - 5).

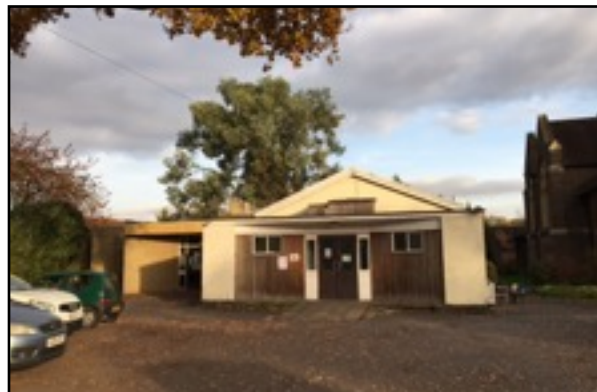
**Image 3:** The existing hall

- 5.3. The halls had no features which would support bats. The hall is assessed as having negligible potential to support roosting bats.
- 5.4. The bungalow has some features including missing tile, raised tile and gaps under the lead flashing that could be utilised by crevice roosting bats or provide access internally, see images 8 and 9. Most of the tiles were in good condition as were the fascia and soffit boards. These features, together with the good quality surrounding landscape for supporting bats such as the River Thames and the Kempton Reservoirs results in the bungalow being assessed as having a low potential for roosting bats.

- 6.3. The demolition of the halls will have no impact on bats as the roosting potential for these buildings externally and internally is negligible. No further mitigation works are necessary.

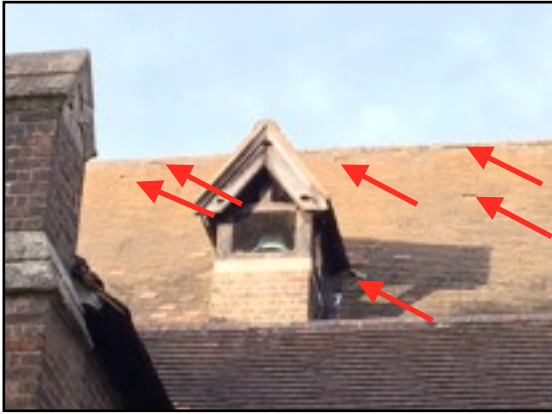
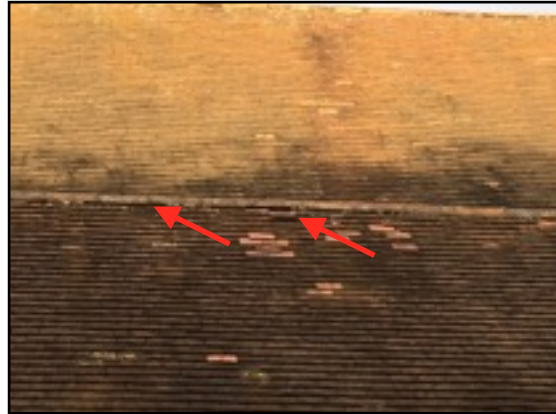
- 5.2. The church had a number of missing tiles and gaps particularly along the apexes, see images 6 and 7 for examples on the east elevation. The church is assessed as having high bat potential.

**Image 6:** Church roof, east elevation. Arrows point to missing tiles and gaps.

**Image 7:** Church roof, east elevation. Arrows point to missing tiles and gaps.

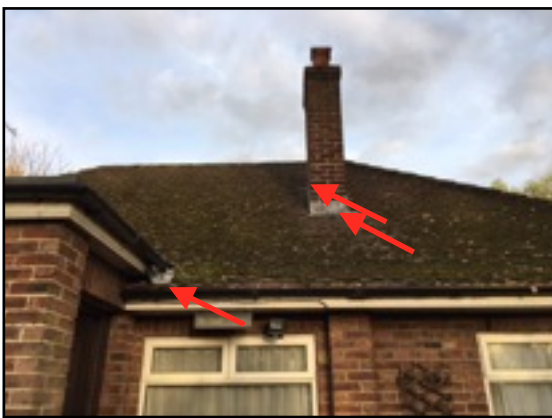
**Image 8:** West facing elevation of the house. Arrows point to missing tile and gaps under the lead flashing.

- 6.4. The demolition of the bungalow would impact bats should they be present in the way of injury, killing and damaging, destroying a bat roost. Due to the low bat roosting potential of this building it is recommended that one bat emergence survey is undertaken between May and September to ascertain if any bats are roosting before the works commence.

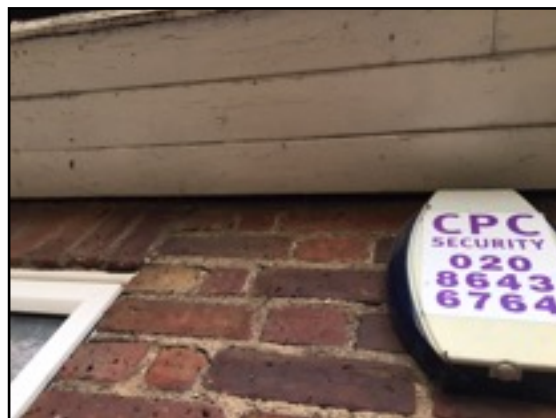
**Image 9:** No gaps visible under the soffit boards of the bungalow.

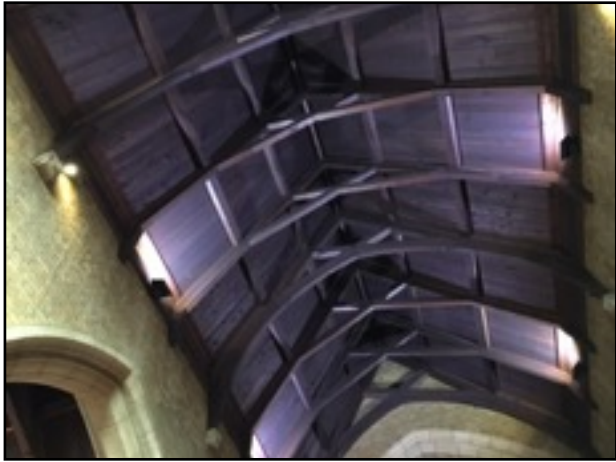
- 5.5. The church internal roof was overlaid with timber. No potential roosting locations or access could be observed due to the height of the roof (see image 10). No bats or signs of bats were observed in the church itself, on any window ledges, walls or seating areas. The church is in use and was in clean, good condition.

**Image 10:** Internal rafters of the church.

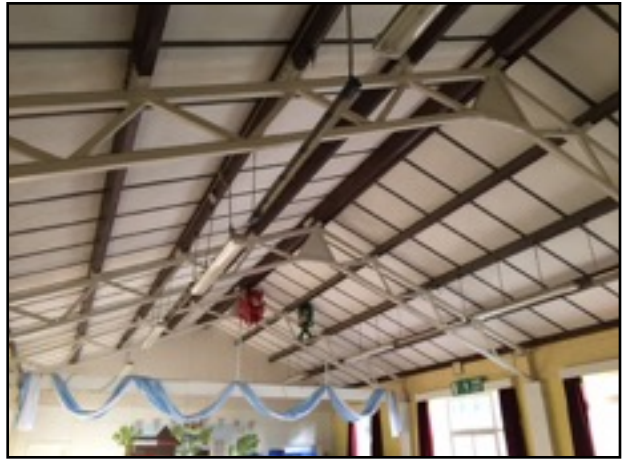
- 5.6. The hall was a modern building in comparison to the church. It had no internal roosting voids or locations and no access to the building could be seen. The hall was assessed as having negligible roosting potential for bats. See image 11.

**Figure 11:** Internal roof of the hall, other sections of the building had no voids only plastered ceilings.

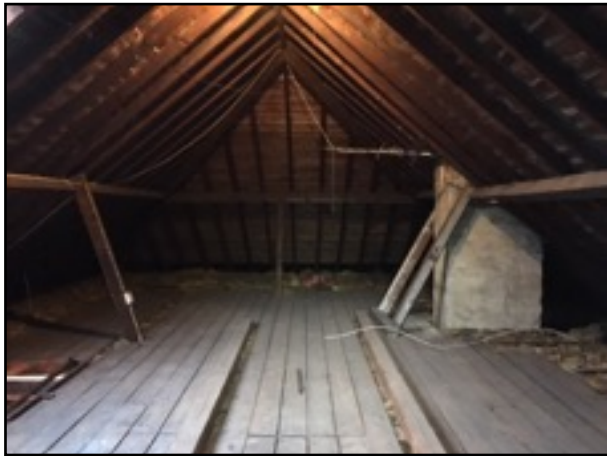
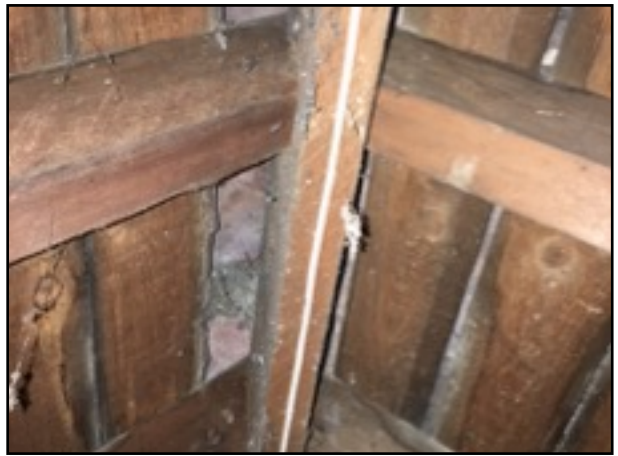
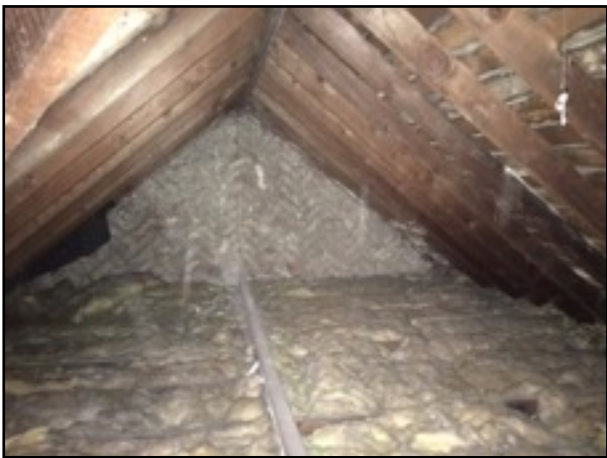
- 5.7. The bungalow had one roof void measuring approximately 12m by 7m and had an apex 3m high. It had a window, chimney, 2 water tanks and a section of roof over the bricked gable end addition of the house. The void was open to the rafters with timber lying directly behind the tiles and on the most of the floor with insulation underneath. No liner was present therefore the void was cool and draughty. No access points could be seen. No evidence

was found of bats or bats themselves. A few mouse droppings were present. See images 12-14.

**Image 12:** Internal roof void of the bungalow.

**Figure 13:** Timber behind the tiles with some cobwebs.

**Image 14:** Section of roof void over the gable addition to the house.

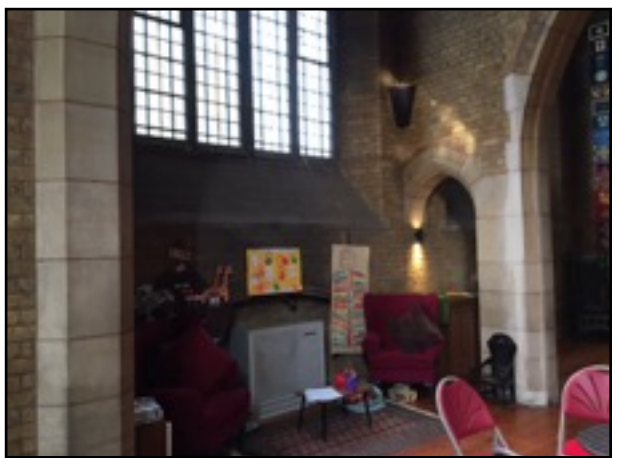
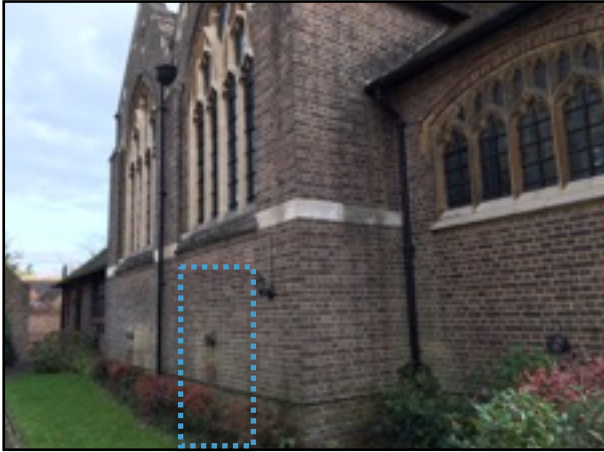
**Figure 15:** The internal wall where the church will be linked to a new corridor linking it to the hall. No evidence of bats was found in this area.

**Figure 16:** The external section of the wall whereby the corridor will enter the church.

- 5.8. Images 15 and 16 show the internal and external areas where the halls will be linked to the church via a corridor.
- 5.9. No confirmed evidence of bats was found during the external or internal inspection. Overall, the buildings have the following assessments for bat roost potential; the church has high potential, the hall has negligible potential and bungalow has low potential.

- 6.2. The proposed works to demolish part of the wall on the north side of the church for a corridor will involve no impacts to the roof of the church or the windows and will therefore be small scale on one area of the brick wall. It has been assessed that there will be no impacts for any potential roosting bats proposed by these works and no further mitigation is necessary.
