Drawing 4: Proposed Chalkers Corner Landscape GA Plan (Gillespies drawing no. P10736-00-001-111 Revision D03)

Drawing 5: Tree Removal and Protection Plan (Sheet 1 of 2) (ref.10667-WIE-ZZ-XX-DR-L-7703-P02)

Drawing 6: Tree Removal and Protection Plan (Sheet 2 of 2) (ref. 10667-WIE-ZZ-XX-DR-L-7704-P02)

## APPENDICES

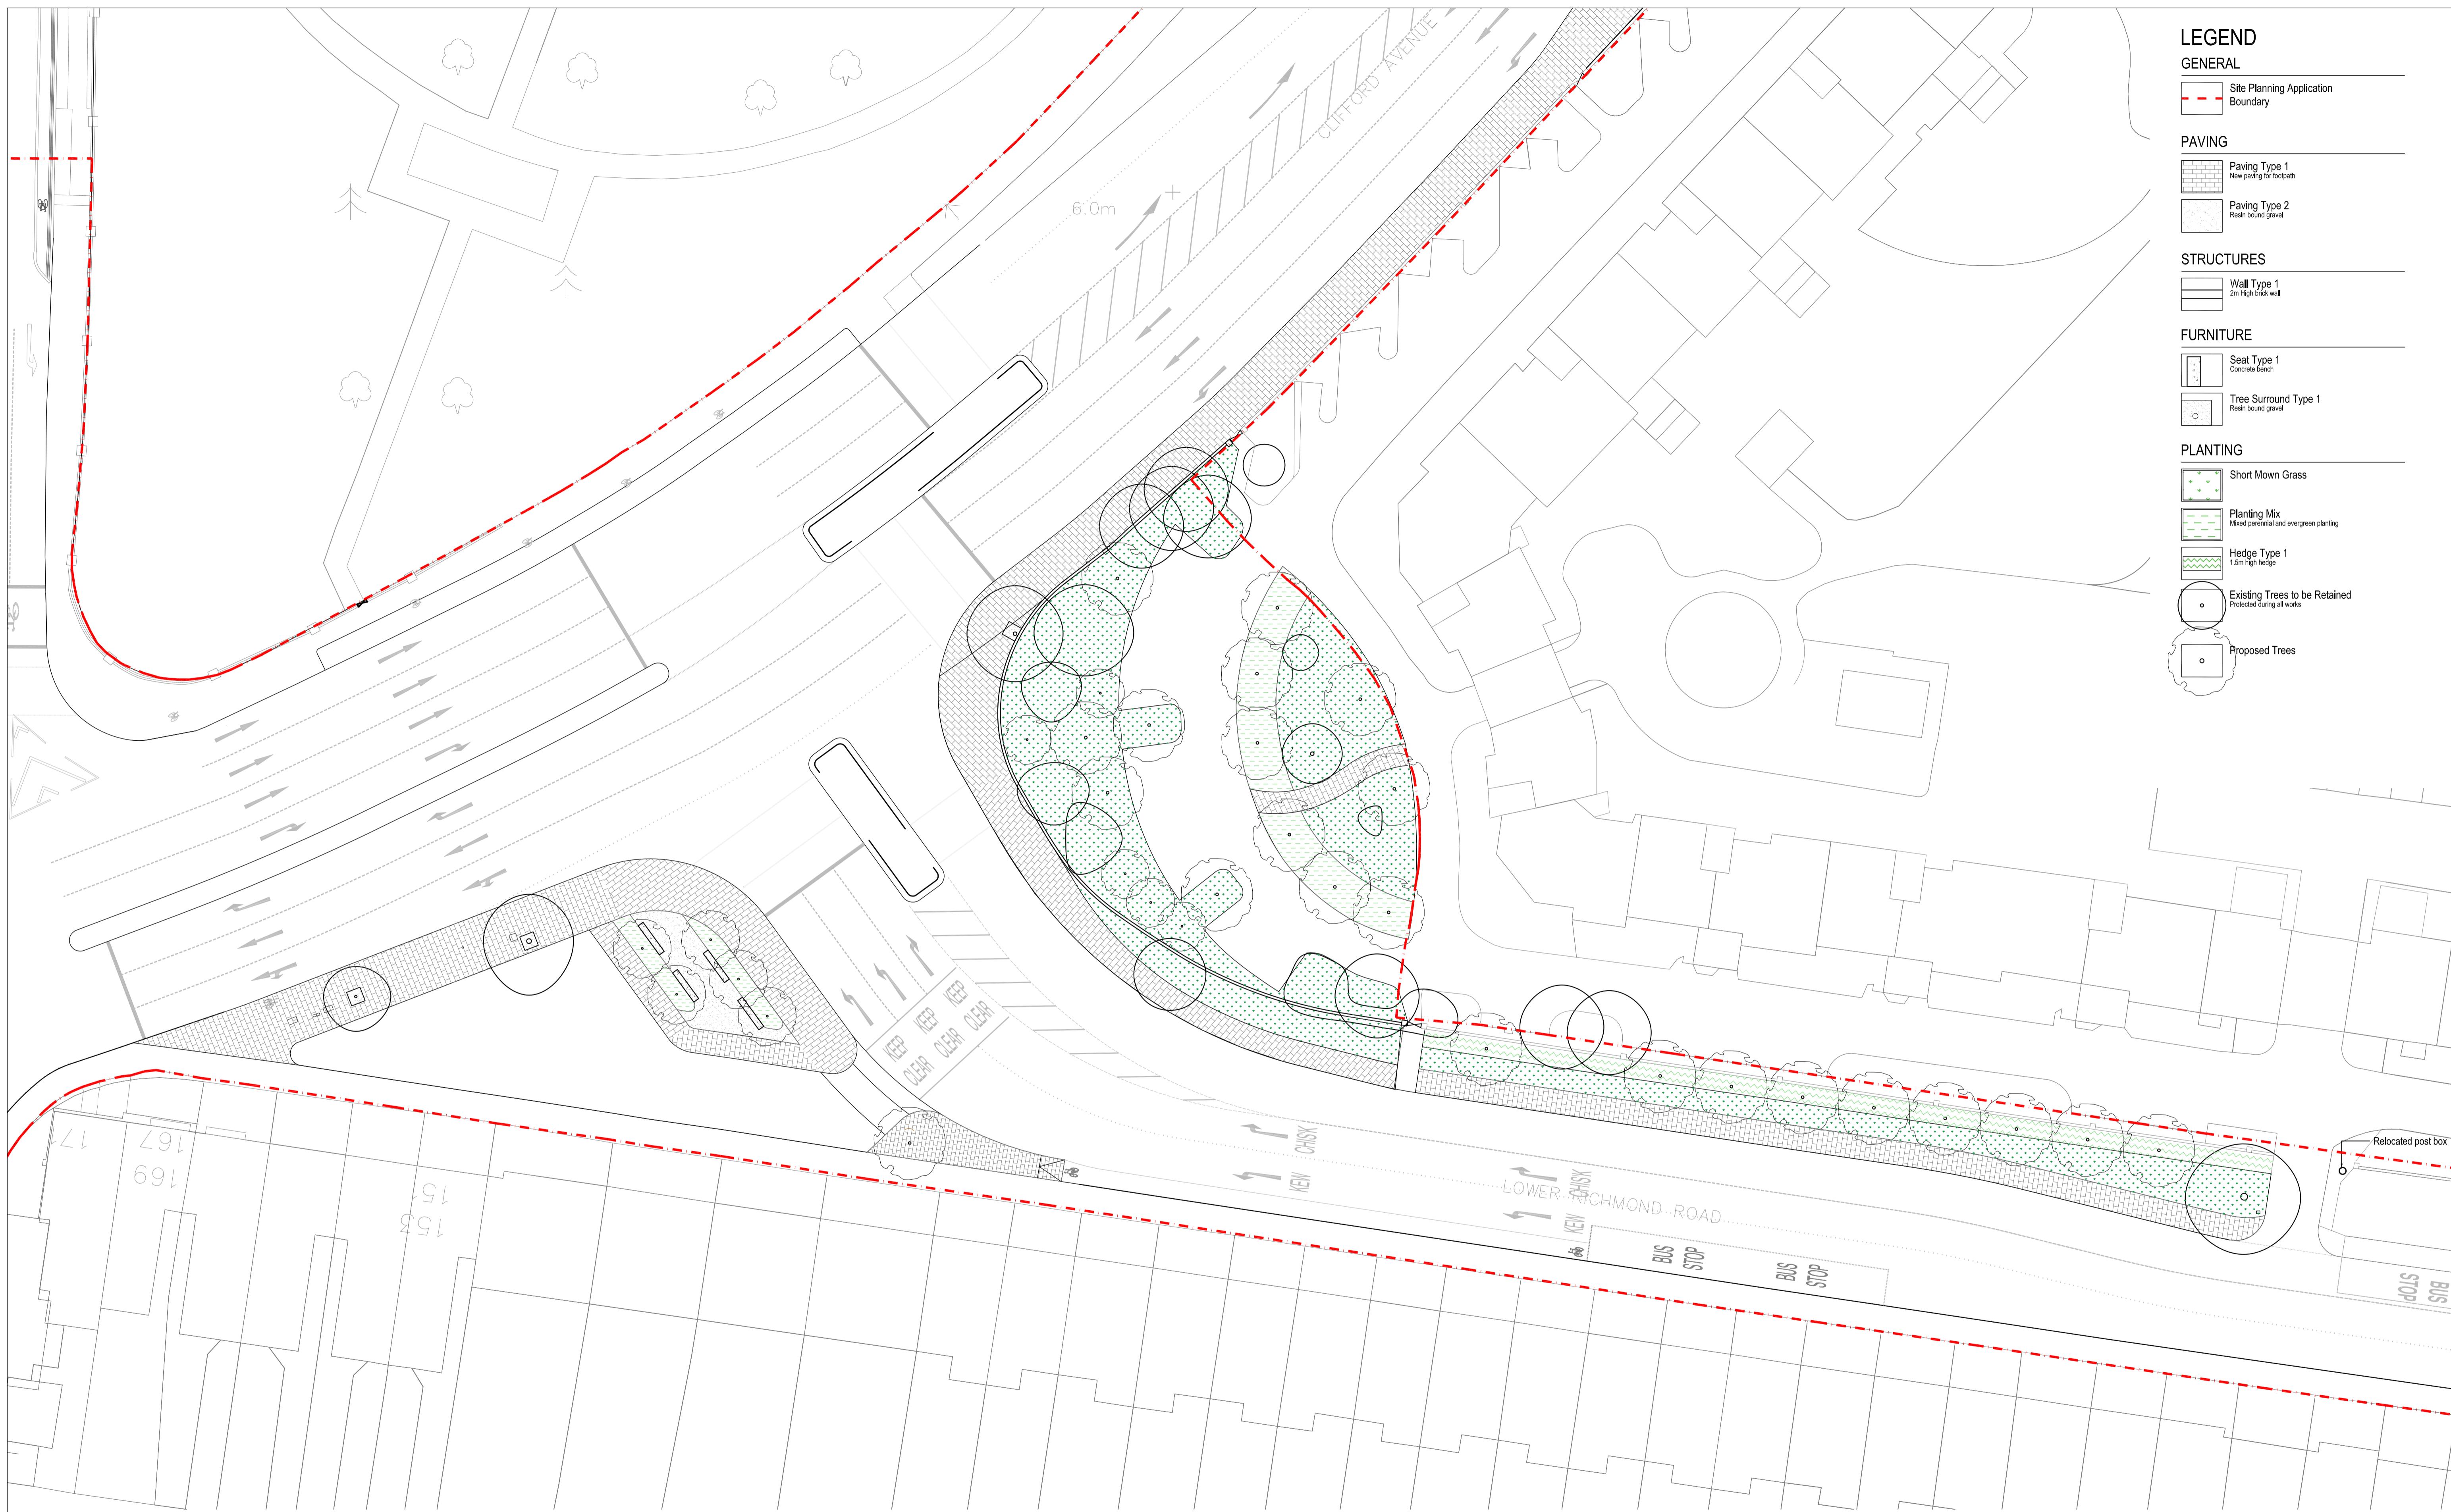
Drawing number  
**P10736-00-001-111**  
Drawing Status Revision  
**DESIGN** D03  
Drawing title  
**Proposed Chalkers Corner Landscape GA Plan**

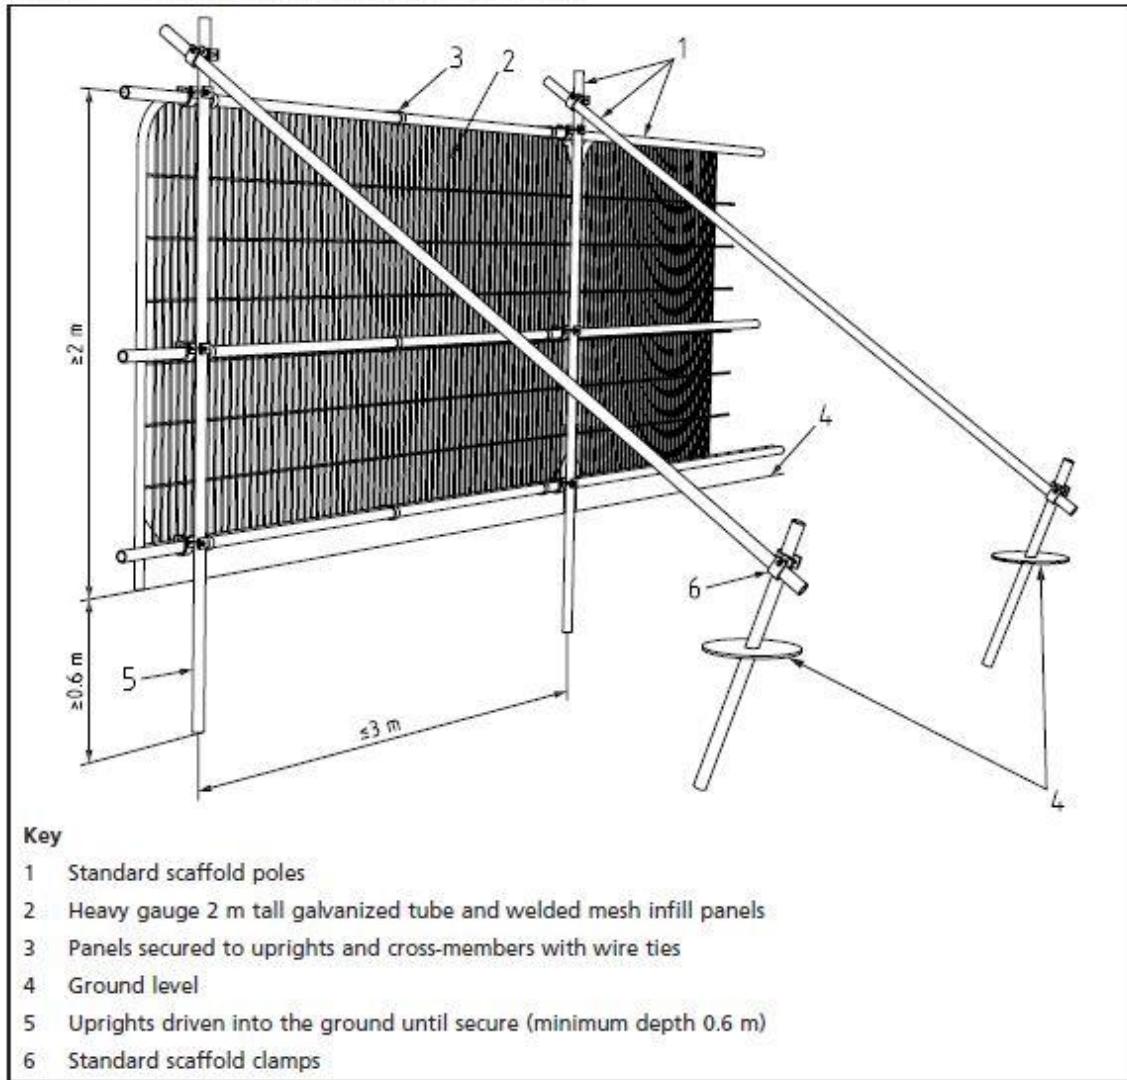
Figure 2 Default specification for protective barrier

### C. Extract from BS5837:2012 – Default Specification for Protective Barrier

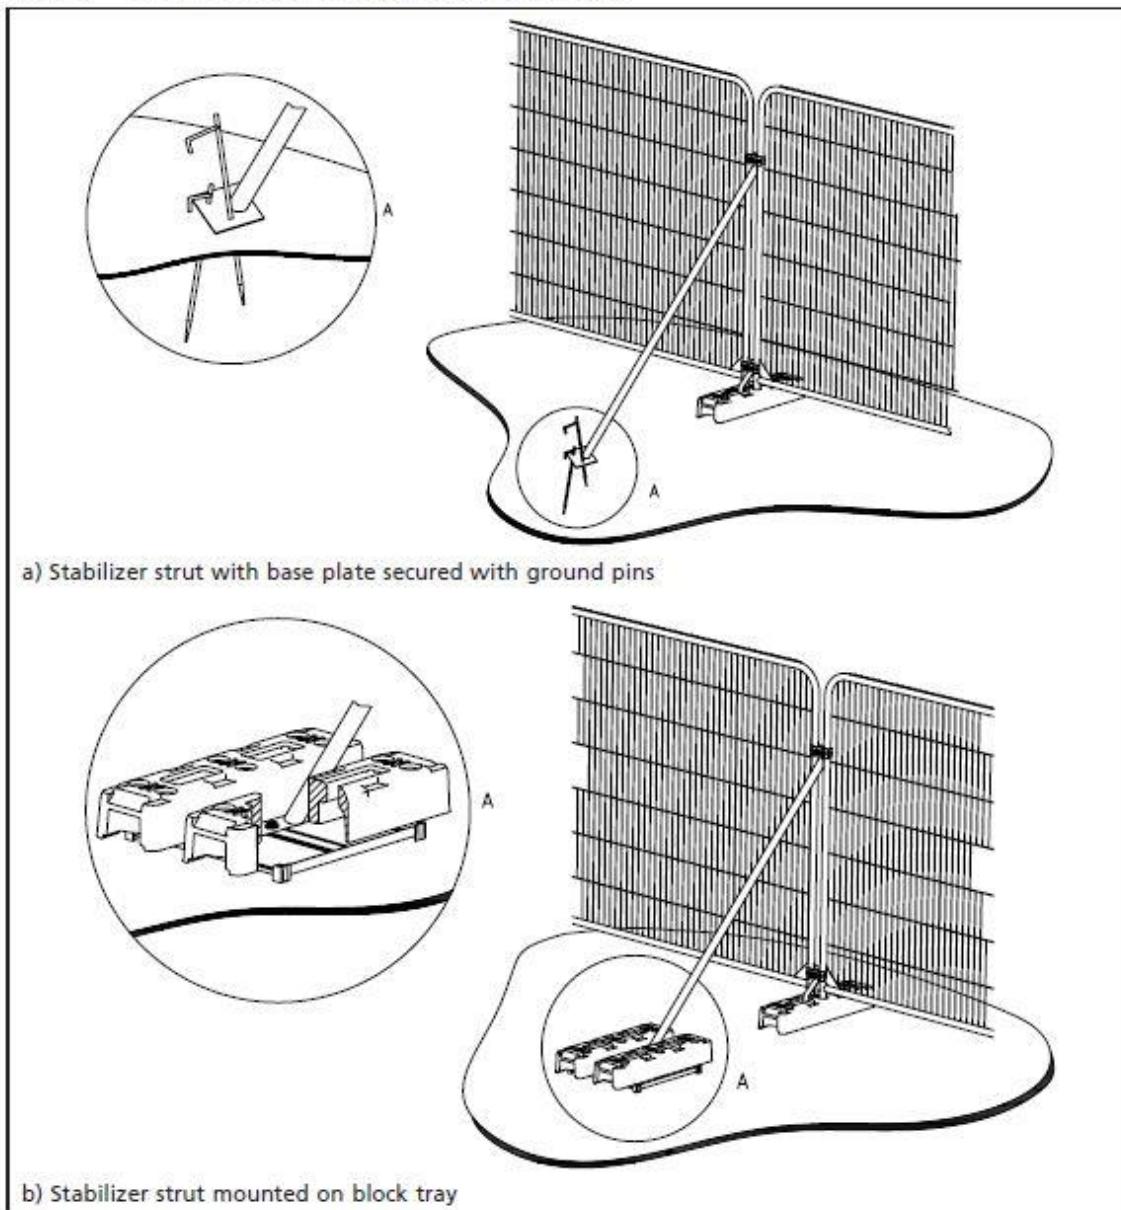
Figure 3 Examples of above-ground stabilizing systems

#### D. Extract from BS5837:2012 – Examples of Above-Ground Stabilizing Systems

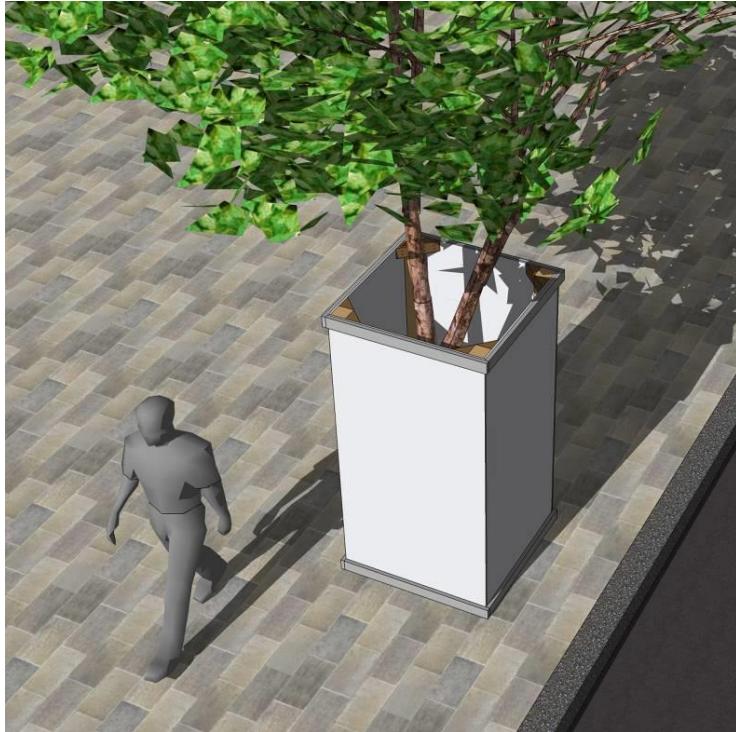
## F. Tree-Box Barrier Protection (Example)

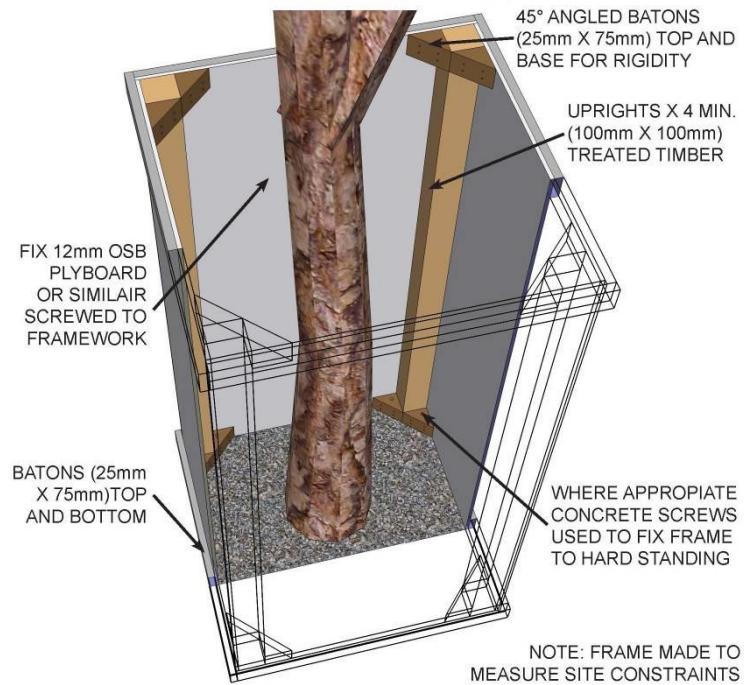
### TREE PROTECTION BOX FRAME SPECIFICATION
