ENGLISH HERITAGE
INTERVENTION AND ANALYSIS
ARCHAEOLOGICAL PROJECTS AND ARCHAEOLOGICAL SCIENCE TEAMS

Evaluation of the grounds at Marble Hill House, Twickenham, London Borough of Richmond

Site Archive Completion Report

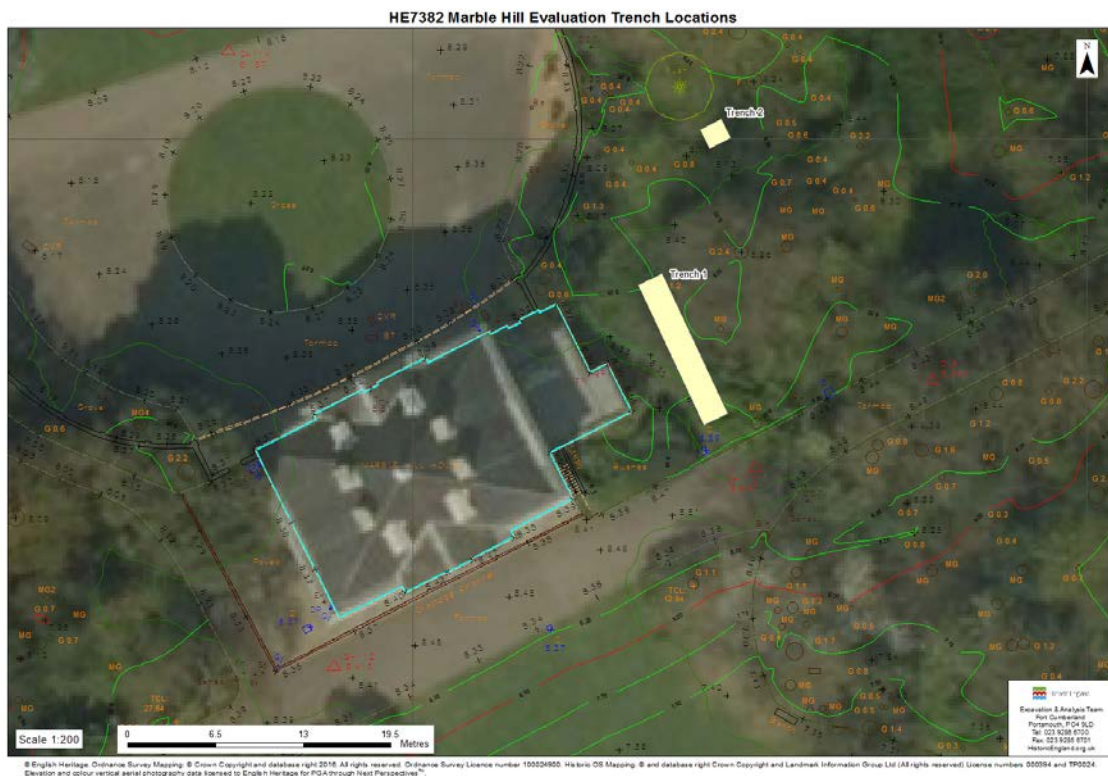
Figure 1 showing the trench locations

1.2 Trench locations (fig 1)

Trench 1 was designed to be located over the site of the Service Wing of Marble Hill House. The Service Wing was constructed in the first half of the 18th century and was demolished in 1909. The trench was planned to measure 11m long and 2m wide. The area where the trench was placed (fig 3) was one of the less densely covered areas of shrub and therefore no mature trees were at risk from the work. Access was from the tarmac path running in front of Marble Hill House after the removal of a fencing panel. A mini digger was used, under archaeological supervision, to remove topsoil and expose the highest surviving archaeological levels.

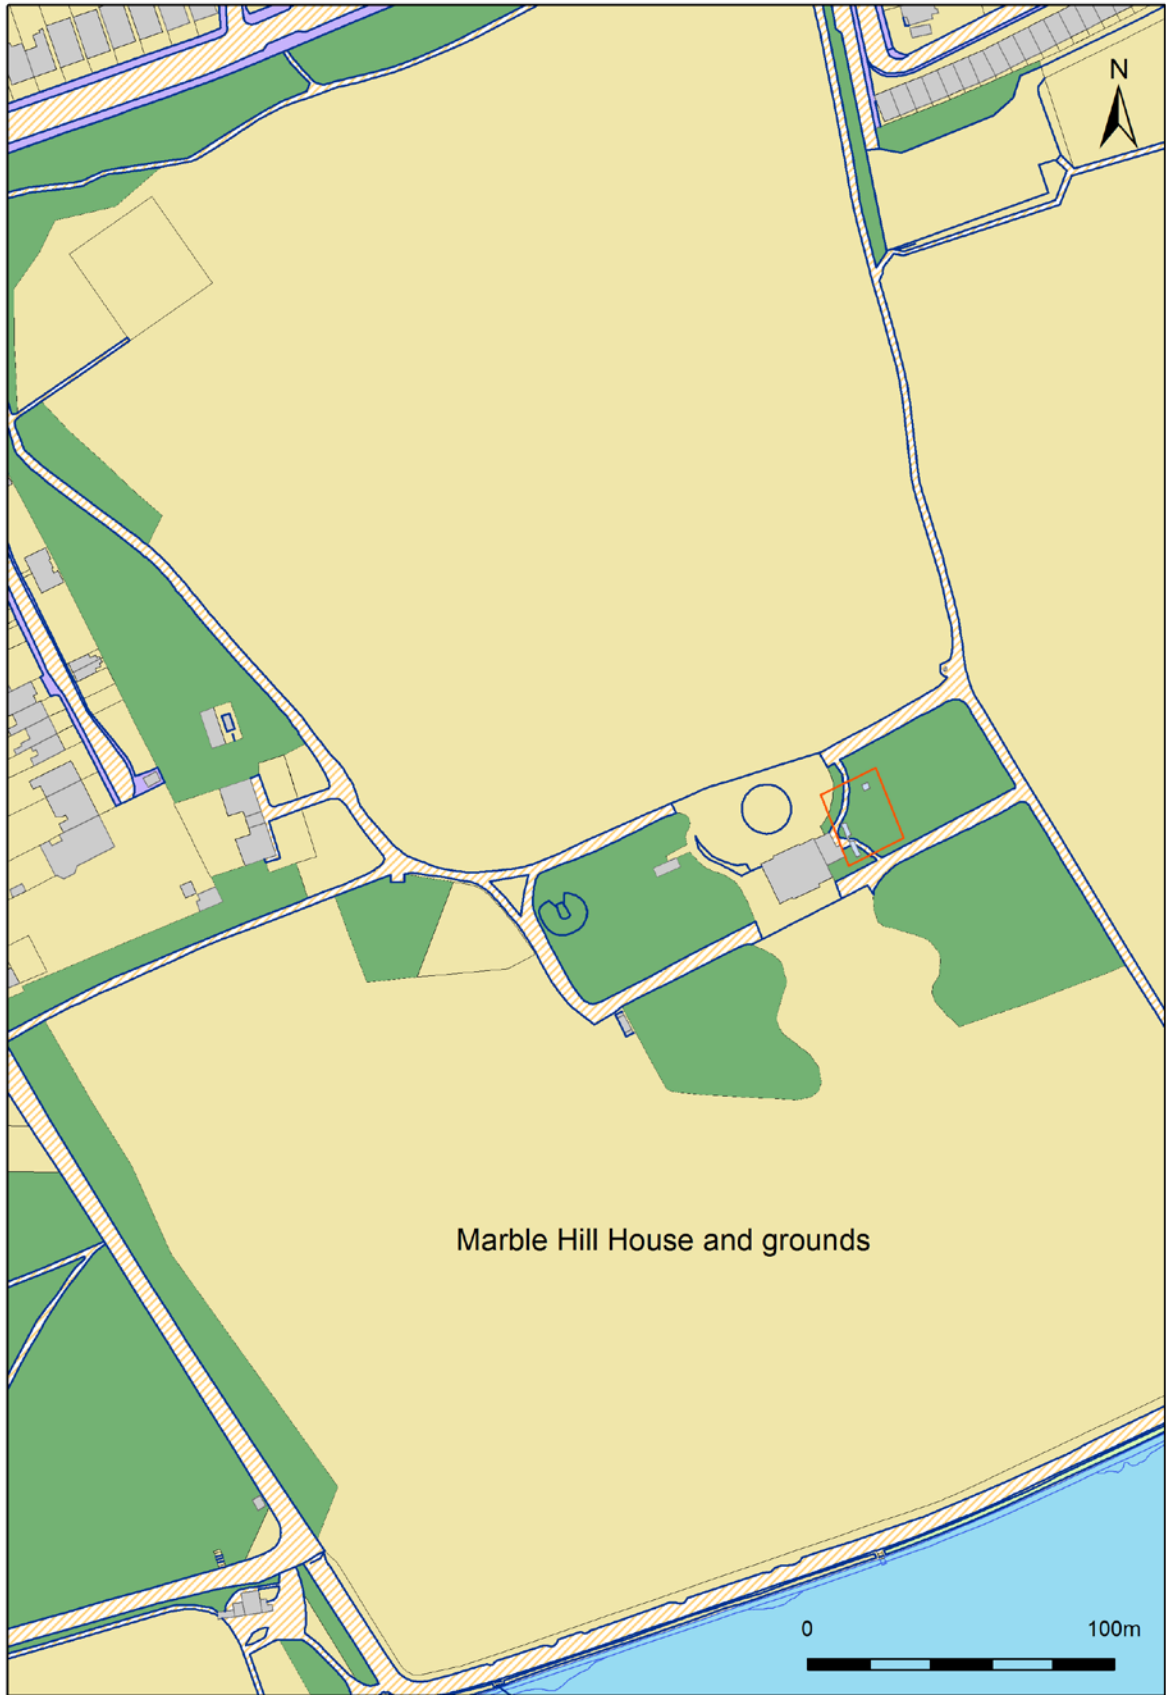
Figure 2 showing the project area location (see red outline)

Trench 2 measured 2m x 2m and was hand dug as it was not possible to gain access for the mini digger to this area due to the thickness of the undergrowth and location of mature trees (fig 2) . The trench was located at the junction where the wall of the Service Wing drying area met the wall of the China Room as it was anticipated that this would catch internal floor surfaces, if they survived. Unfortunately whilst removing the topsoil from this area, a white fibrous mineral deposit was encountered and excavation was halted to allow sampling and testing. Subsequent analysis confirmed that the material was a mixture of both white (chrysotile) and brown (amosite) asbestos. No further archaeological work was undertaken in trench 2 and a small amount of finds material recovered from the topsoil was disposed of as hazardous waste.

Trench 2 was located in the wooded area to the northeast of Marble Hill House. The trench was located so as to catch the interface between the eastern arm of the Service Wing and a building described as the China Room. The trench measured 2m x 2m and was hand dug as it was not possible to gain access for the mini digger to this area due to the thickness of the undergrowth and location of mature trees (Figure 2).

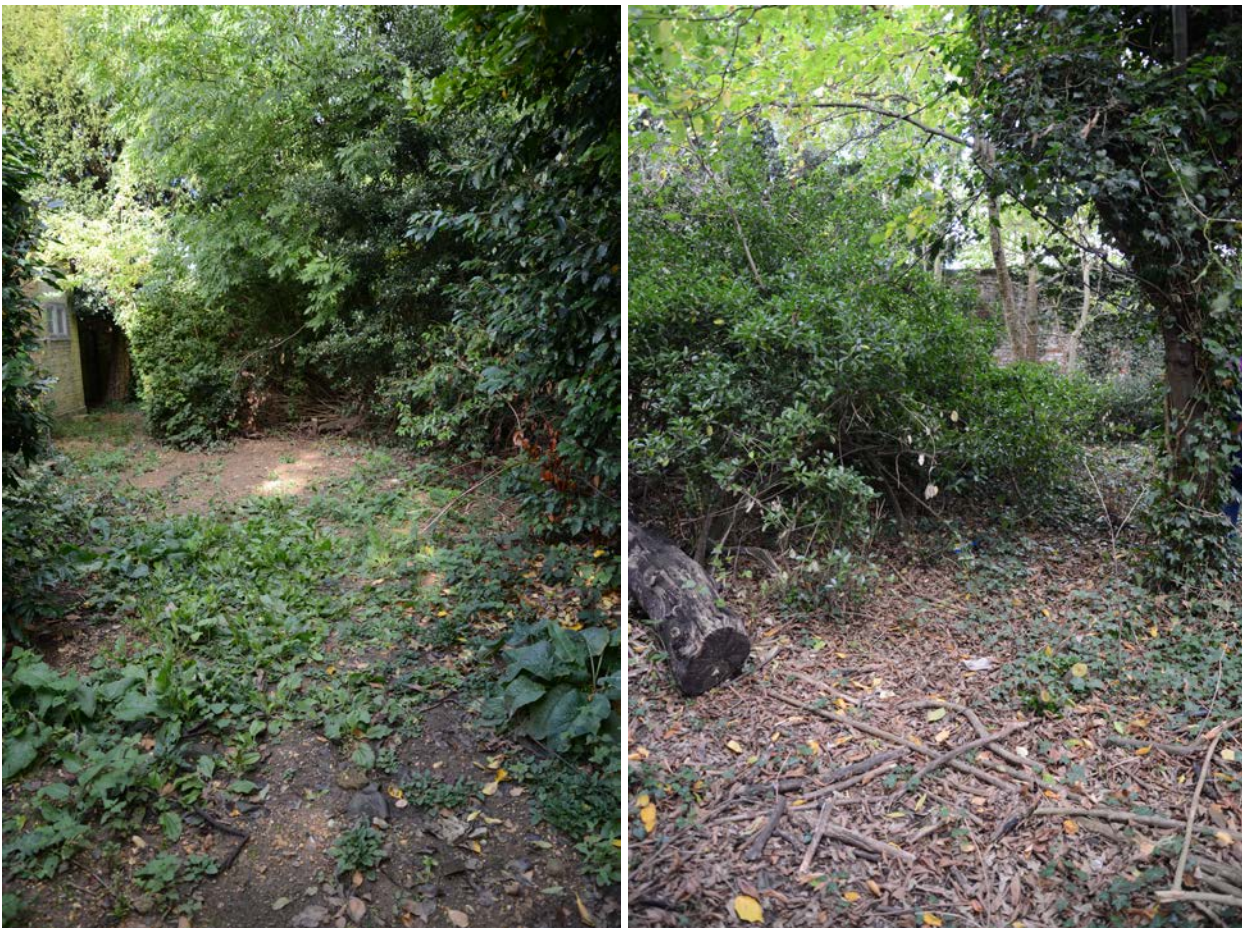
Figure 3 showing the pre-excitation trench locations (Trench 1 left and Trench 2 right)

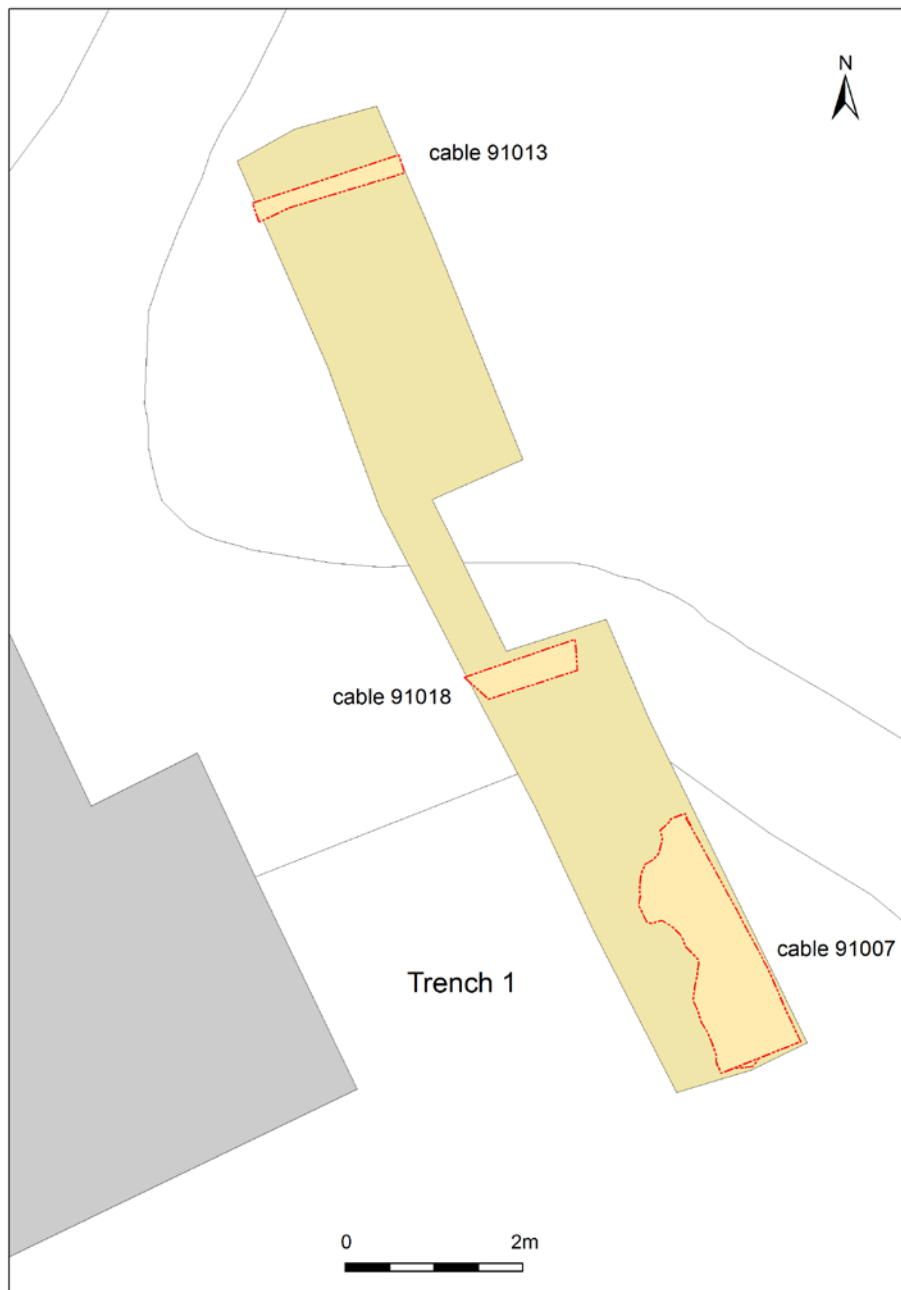
Three unmapped electrical cable trenches (Figure 10) were encountered during the course of the machining of the trench. These are numbered 91007, 91013, 91018, but only one (91007) was recorded in detail (cut 91007 and fills 91005 and 91006). Although these services were unknown, the nature of the exposed cables (and the covering including modern hazard tape) suggested they were of relatively recent date and probably serviced the security cameras and monitors surrounding the house. In all instances the services were reburied by hand and with replacement hazard warning tape. Needless to say the location of the buried cables restricted any deeper excavation in these areas.

Figure 10 Cable trenches 91007, 91013, 91018

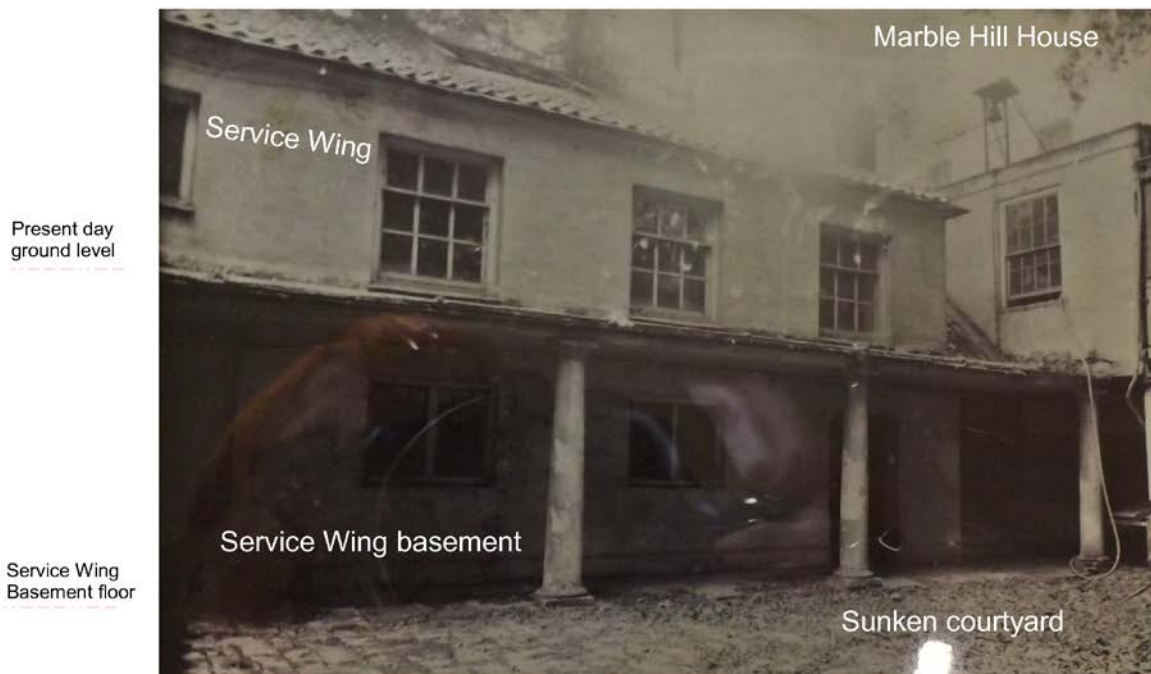
No in-situ remains of the buildings comprising the Service Wing of Marble Hill House were found during the excavation of trench 1. The location of the demolition backfill 91012 however seems likely to confirm the location of the basement of that building and the sandy fill 91002 the location of the sunken courtyard area to the north of the Service Wing. The excavations concentrated on the northern end of the Service Wing where it met the sunken area and no walls or foundations were seen in this area. The southern edge of the basement would appear to have been located in the area taken up by the later concrete drain 91003 and no excavation below the level of the drain was possible in this area. A photograph (fig 11) dating from before the 1909 demolition, shows the depth of the sunken courtyard and the equally deep basements of the Service Wing.

Figure 12 Pre-1909 photograph showing depth of sunken courtyard area and Service Wing basement

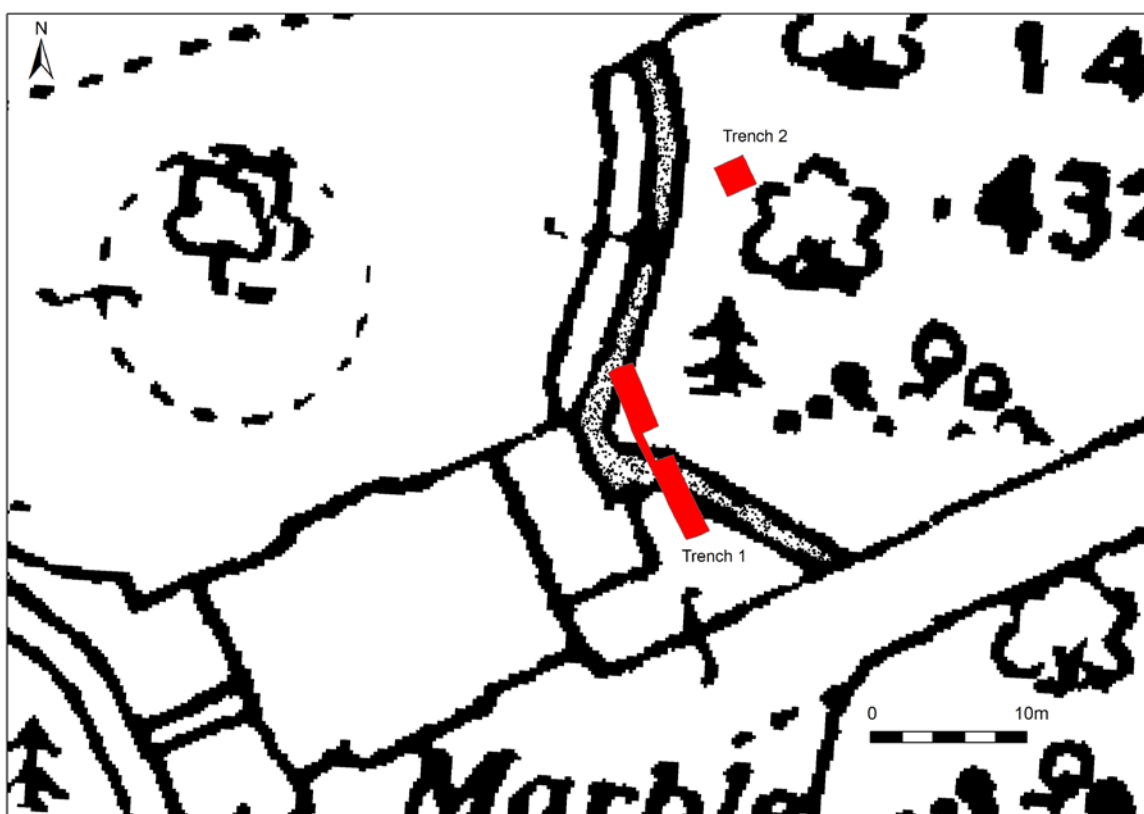
Figure 14 Ordnance Survey map showing location of gravel path (stippled) relative to locations of trenches 1 and 2

The gravel and tarmac trackway 91016 observed cut by the cable trench 91018, but surviving undisturbed in the area immediately north, would appear to be part of the feature shown on the mid-20th century Ordnance Survey map of this area. (fig 13). This track clearly post-dates the 1909 demolition of the Service Wing, but has ceased to be maintained in modern times as no obvious signs of its existence are currently observable.
