**MARBLE HILL HOUSE, TWICKENHAM**

**ARCHITECTURAL PAINT RESEARCH - ARCHIVE REPORT**

**MISS HOTHAM'S BEDCHAMBER AND EXTERIOR ELEMENTS**

**FEBRUARY 2004**

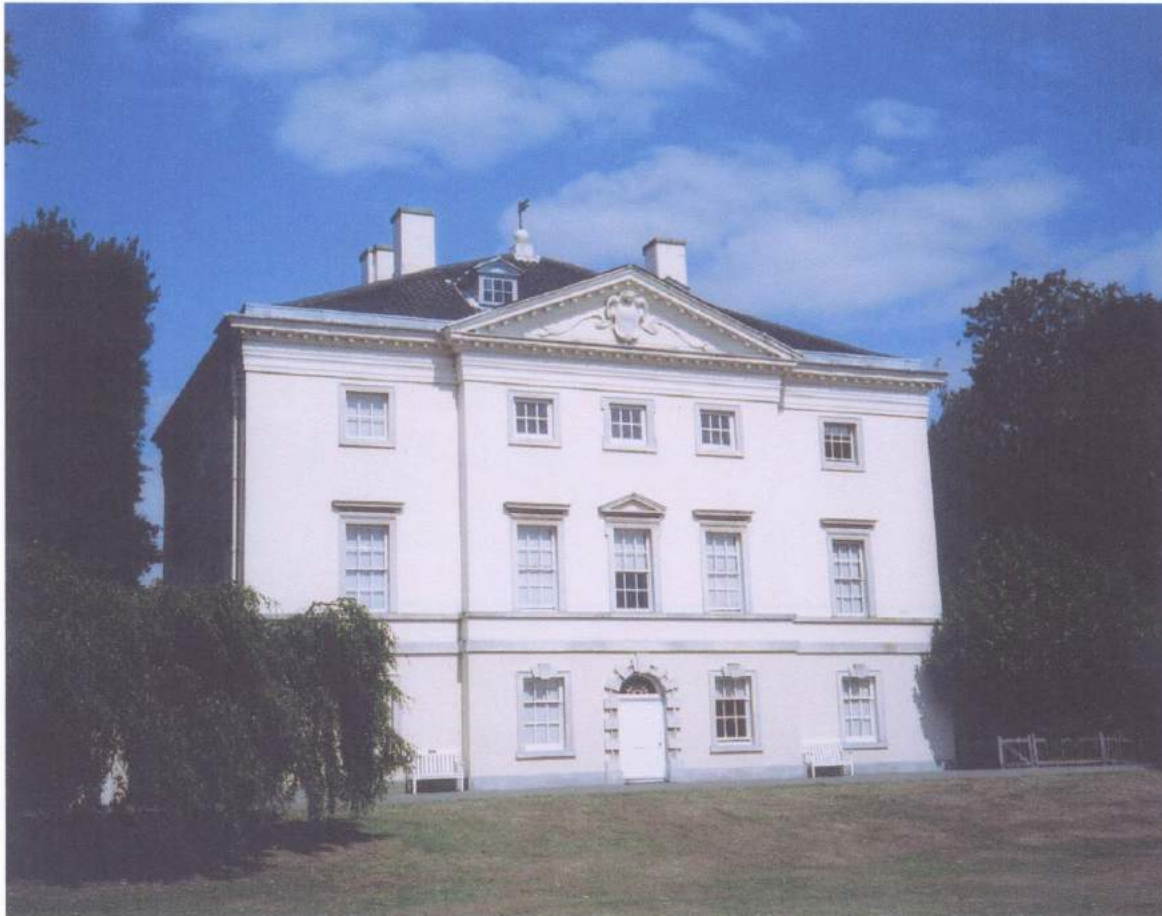
Figure 1). External view of Marble Hill House, South elevation, February 2004

The house is stuccoed with stone dressing, with a projecting central bay on the north and south façades. The north façade also has Ionic pilasters above a rusticated basement storey. The roof is pyramidal with a modillion cornice.

The exterior of the building was extensively re-rendered and repairs made to the cornice and window treatments during the repairs of 1965-66.

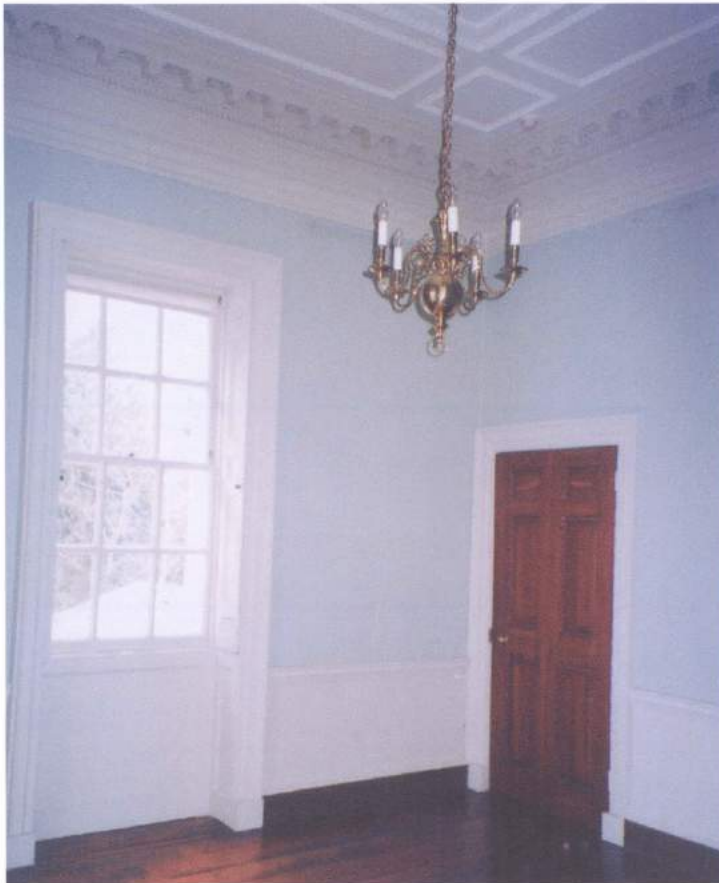
Figure 2). View of Miss Hotham's Bedchamber – March 2004

At the time of sampling the interior had very recently been redecorated in modern alkyd resin oilpaints. The joinery was decorated in a murky pale cream oilpaint with a grey/green applied to the upper wallfaces.

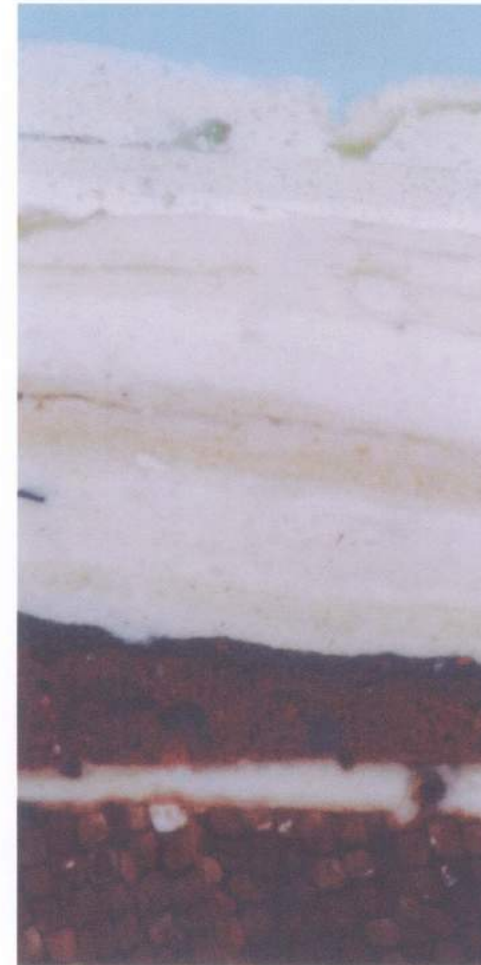
Figure 5). Sample no. Mar.Hi.Ho/MHB/2.17

Door architrave plinth block leading to Lady Suffolk's Bedchamber

Schemes 13-15, modern murky pale cream alkyd oilpaints

No schemes 11 or 12

Scheme 10, blued white lead oilpaint. (containing French ultramarine, post 1830)

Scheme 9, pale cream lead oilpaint

Schemes 7 & 8 return to plain lead white oilpaints

No scheme 6

Scheme 4, mid pink lead oilpaint

Schemes 2 & 3, both of these schemes are in plain lead white opts

The first two decorations applied to the architrave plinth blocks are both in dark red/brown lead oilpaints. The earliest of which is applied over a plain lead white undercoat. Both of these decorations are part of scheme 1. Presumably the second application was to repair damage to the plinth block.

Softwood

*The dark red/brown seen in the sample above is a typically Palladian treatment commonly applied to skirting risers, plinth blocks and door leaves. The colour suggested mahogany or another exotic hardwood.*

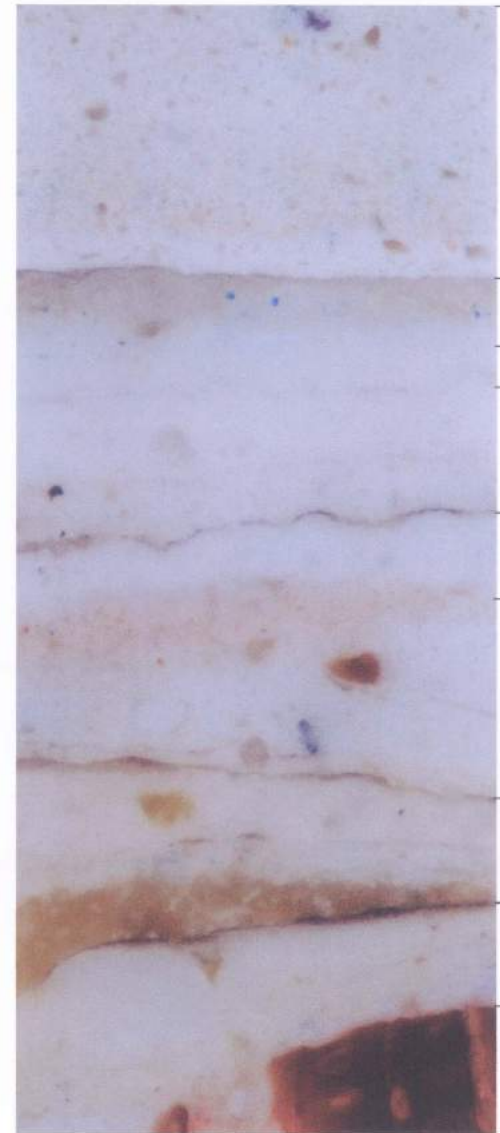
Figure 7) Sample no. Mar.Hi.Ho/MHB/1.8

Shutter stile

Schemes 13 – 15, murky pale cream  
modern alkyd oilpaint

*No scheme 12*

Scheme 10 pale blue lead oilpaint  
(contains French ultramarine, post 1830)

Scheme 9, pale cream lead oilpaint

Schemes 6, 7 & 8, plain lead white oilpaint

Scheme 5 plain lead white oilpaint

Scheme 4 mid pink lead oilpaint

Schemes 2 & 3, two schemes of basic lead  
white oilpaint

Original scheme of plain lead white oilpaint

**Substrate**  
Softwood

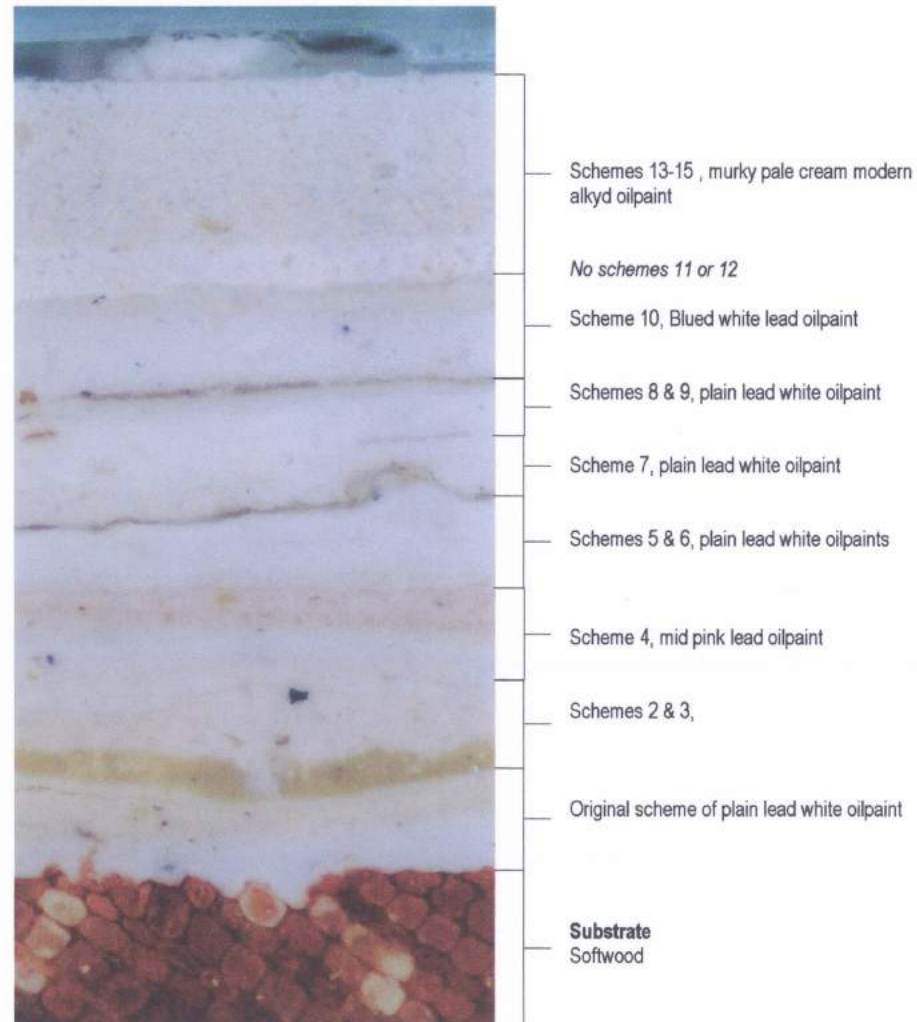
**Figure 8).** Sample no. Mar.Hi.Ho/MHB/1.10

Shutter Panel Bed

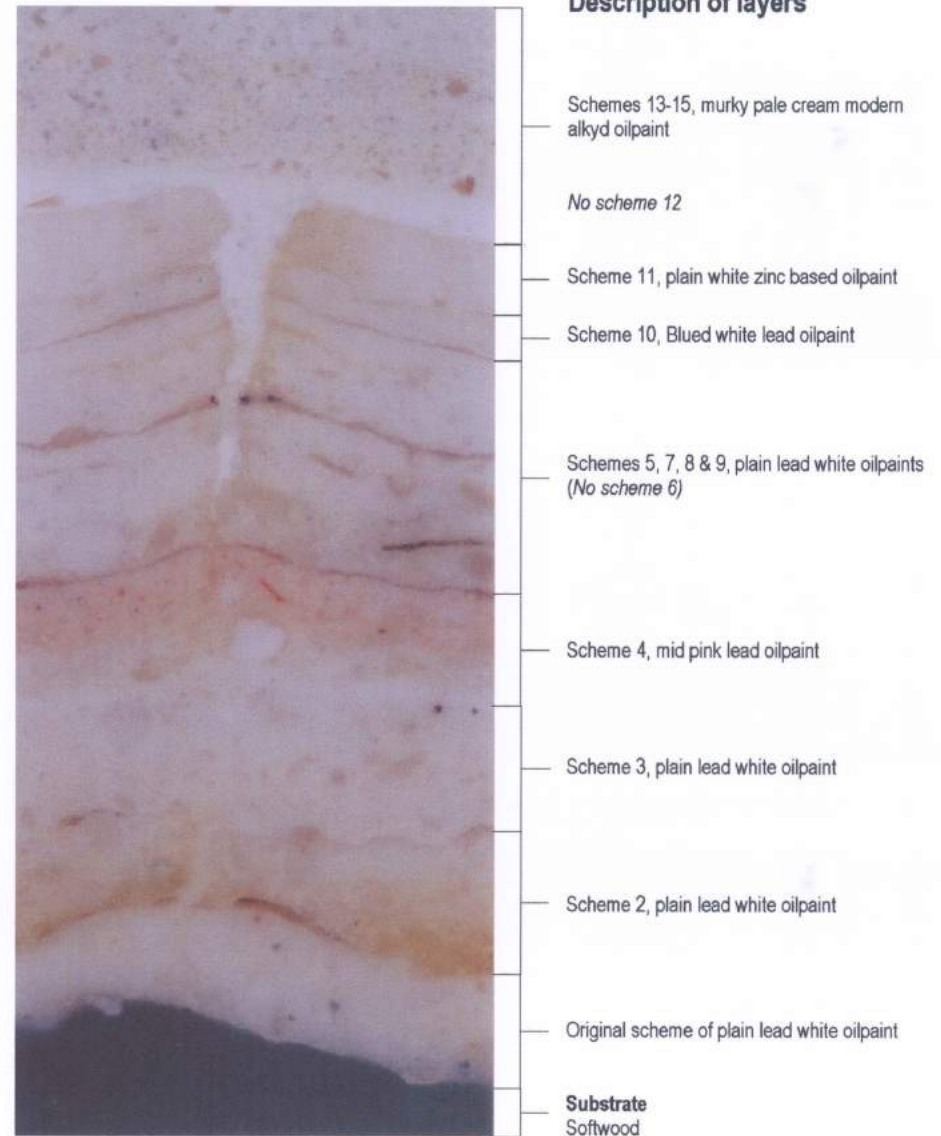
**Figure 9).** Sample no. Mar.Hi.Ho/MHB/3.34

Wall face window sash

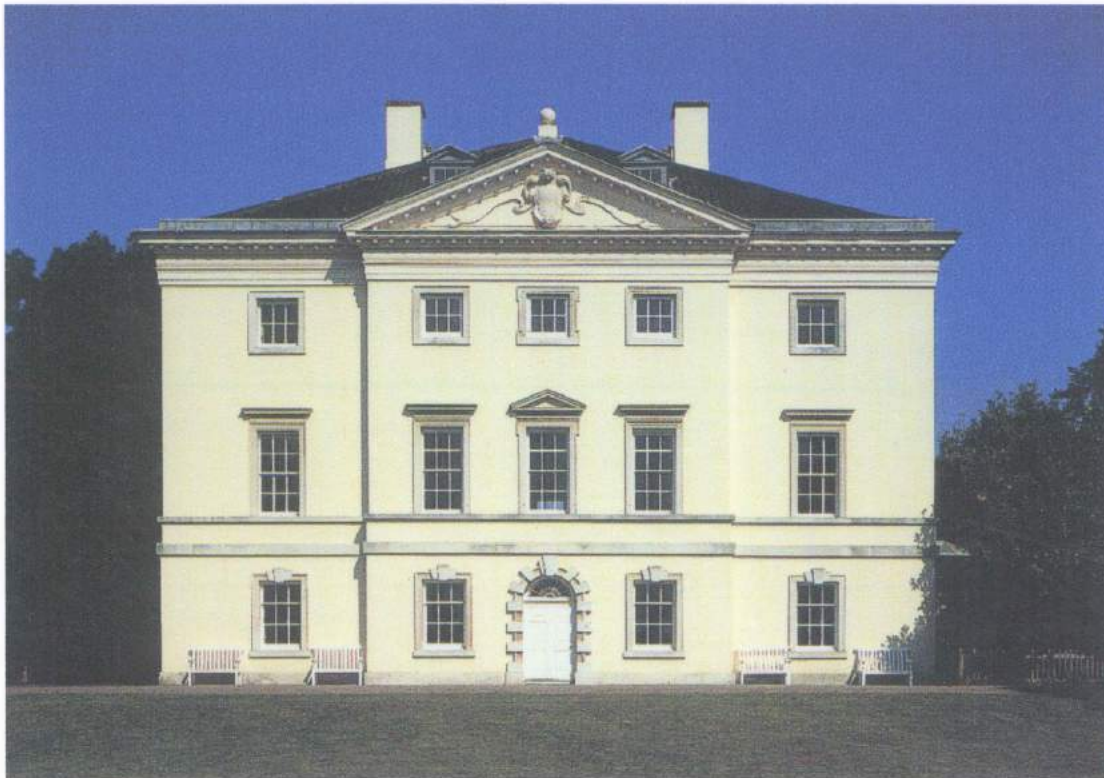
The scheme current at time of sampling consisted of modern alkyd oilpaints. The joinery was painted plain white with modern yellow/cream (warm stone colour) applied to the render and composite elements.

**Figure .10).** . View of the South façade of Marble Hill House, showing the modern scheme as it appeared in February 2004

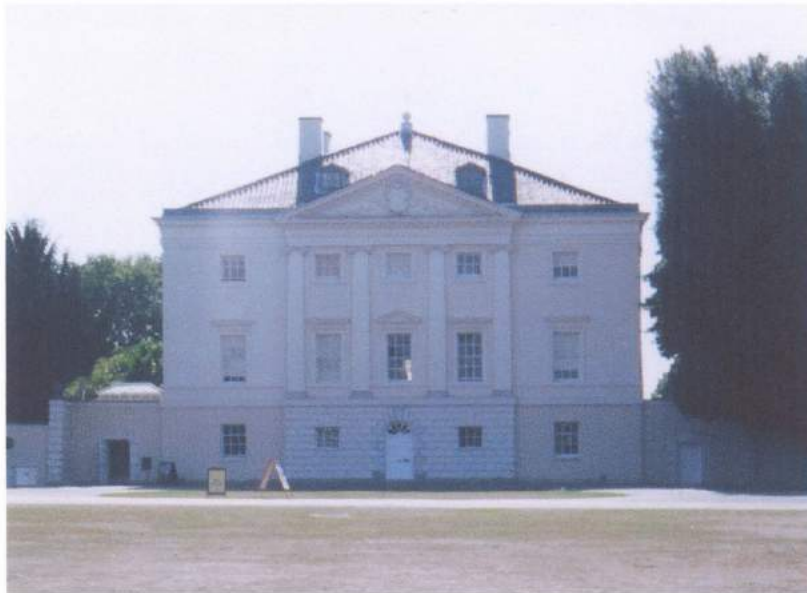
**Figure 12).** Exterior North façade, September 2003

The photograph above, (figure 12), shows the scheme current at time of sampling. This plain cream and white scheme is very similar to the original finish, although the evidence suggests that at that time the joinery and wallface elements were painted in the same lead white colour. At the present time the wallfaces are distinctly yellow/cream in tone and the joinery is brilliant white.

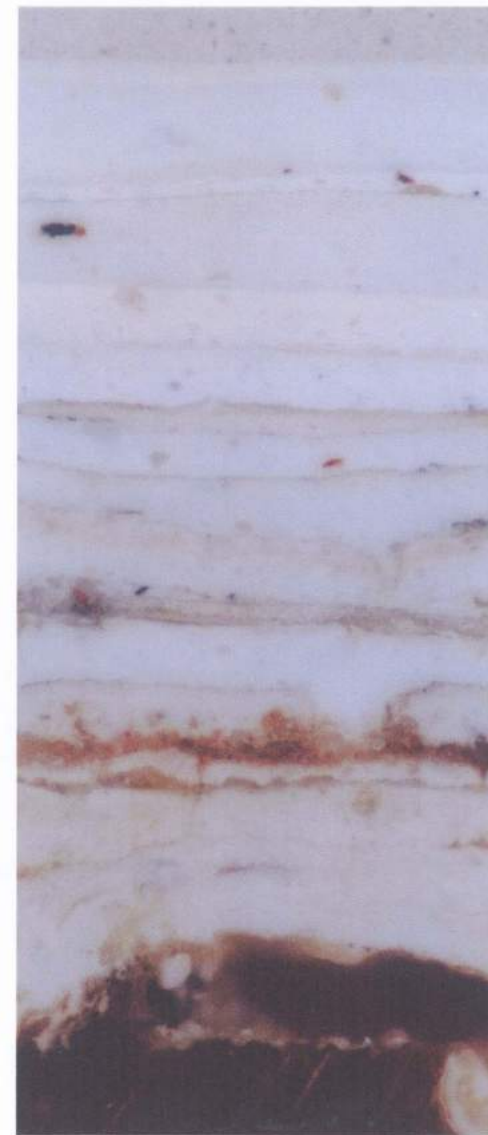
Figure 15). Sample no. Mar.Hi.Ho/Ext/2.44

Exterior North elevation central block, first floor exterior window joinery (representative)

— Scheme 21, modern mid stone coloured alkyd oilpaint. (schemes 22-27 in white alkyd oilpaints are not shown)

— Scheme 17-20.  
Four schemes returning back to plain lead white oilpaint

— Scheme 16, a single scheme of plain zinc white oilpaint. This is distinctly early C20th in appearance

— Schemes 1 - 15  
The first phase of decoration covers the major part of the buildings early history. The original intention of lead white windows was continued for a total of fifteen schemes. There is of course a slight variation on tone between these schemes, however it is unlikely that this was intentional.

— **Substrate**  
Softwood

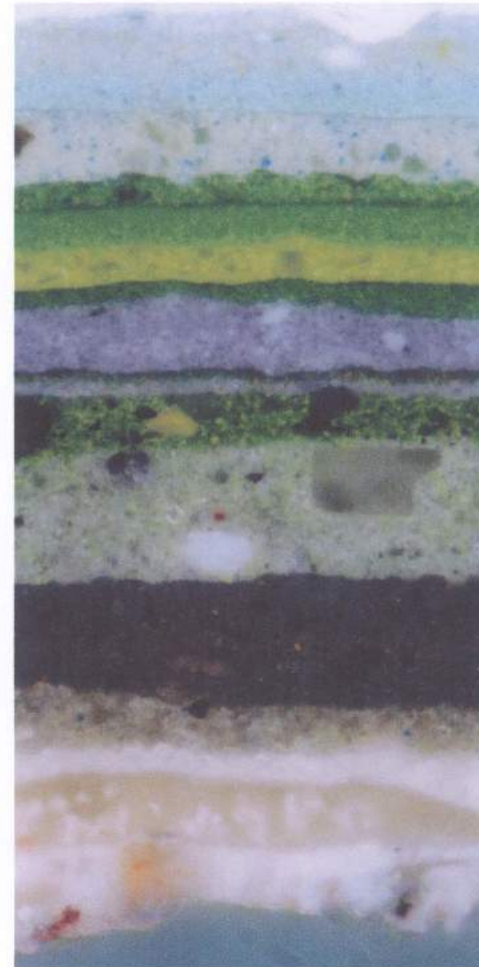
Figure 17). Sample no. Mar.Hi.Ho/Ext/1.40

Exterior North Façade Main Door

*Later schemes not shown*

Scheme 15, pale blue/green lead based oilpaint

Scheme 14, pale blue/green lead based oilpaint

Schemes 12 & 13, mid yellow/green lead based oilpaint

Schemes 10 & 11, two schemes dark yellow/green lead based oilpaint

Scheme 9, very dark yellow/green lead oilpaint

The earliest scheme in evidence on the door is scheme 8. This consists of plain lead white oilpaints.

**Substrate**  
Softwood (not shown)

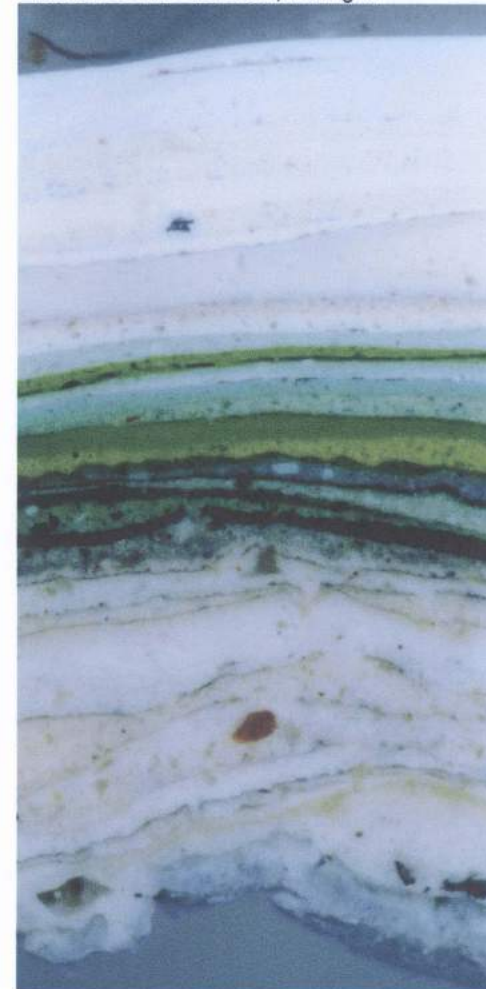
Figure 19). Sample no. Mar.Hi.Ho/Ext/2.48

Exterior South Elevation, Fanlight

Seven schemes of modern white alkyd oilpaints

Scheme 20, plain lead white oilpaint

Scheme 19. Pinky cream lead based oilpaint

Schemes 9-18, various green lead oilpaint schemes as seen in figure 17 (previous page).

Schemes 1-8, all plain lead white oilpaints. These vary in tone from pale cream to a mid cream, however there is no distinct evidence for pigmentation. This suggests that the effect is due to contaminants within the oil drier and subsequent discoloration.  
Scheme 7, blued white oilpaint (contains French ultramarine, post 1830)

Lead (traces of oxidation)
