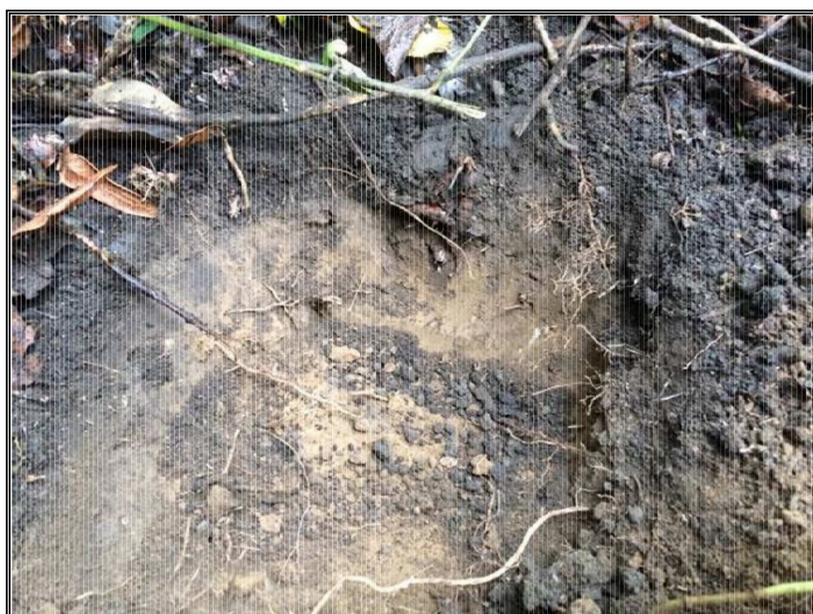
P2 Topsoil	Humus Layer	Very dark brown to black, (Munsell Colour 10YR 2/2 to 10YR 2/1) partially to fully decomposed litter.
	Mineral Layer	Brown (Munsell Colour 10YR 5/3), dry to slightly moist, friable, non-calcareous, fine SANDY LOAM, with a weakly-developed, fine to medium granular structure. Slightly stony. Occasional glass fragments were recorded within the woodland topsoil.
P2 Subsoil		Dark yellowish brown to strong brown (Munsell Colour 10YR 4/4 to 7.5YR 4/6), slightly moist, non-calcareous, fine SANDY LOAM with a single grain and weakly developed granular structure. Slightly stony. No evidence of impeded drainage was observed.

Plate 15: *Profile 2 Topsoil* with darker coloured humic layer on surface

Provided their physical condition is satisfactory and suitable species are selected, the *texture* of the *Profile 1* and *Profile 2 Soils* should be suitable for most general landscape applications, including shrub planting, native transplants and grass establishment. The *Profile 1* and *Profile 2 Topsoils* should also be suitable for smaller sized rootballed tree planting, provided their physical condition is maintained. A suitable imported topsoil would be recommended for larger rootballed trees (e.g. extra heavy standard or semi-mature).

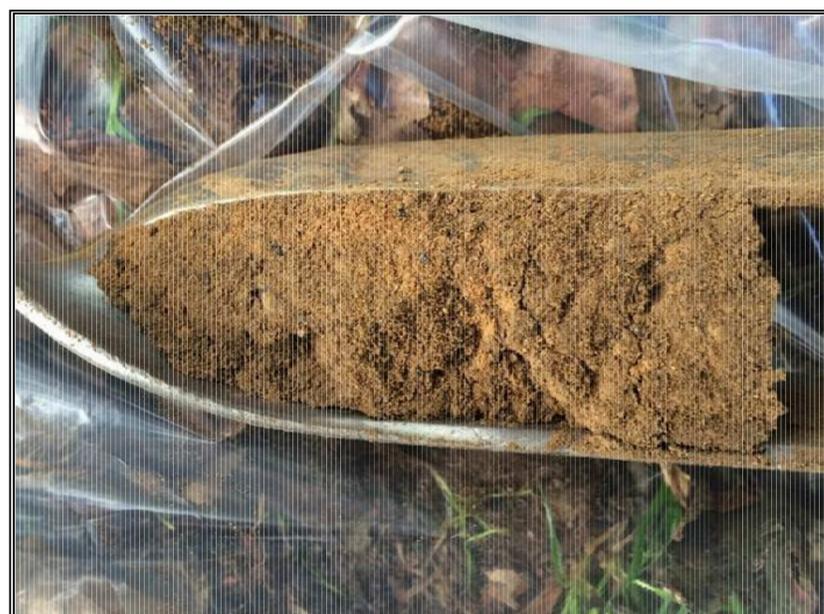
Plate 16: *Profile 2 Subsoil*

The *Profile 1* and *Profile 2 Subsoils* could be prone to self-compaction if placed below the weight of a tree root ball and so are not considered suitable for use as backfill in tree pits for large rootballed trees. An appropriate free-draining, coarser textured sand or sandy subsoil is recommended for backfilling the lower portion of these tree pits.

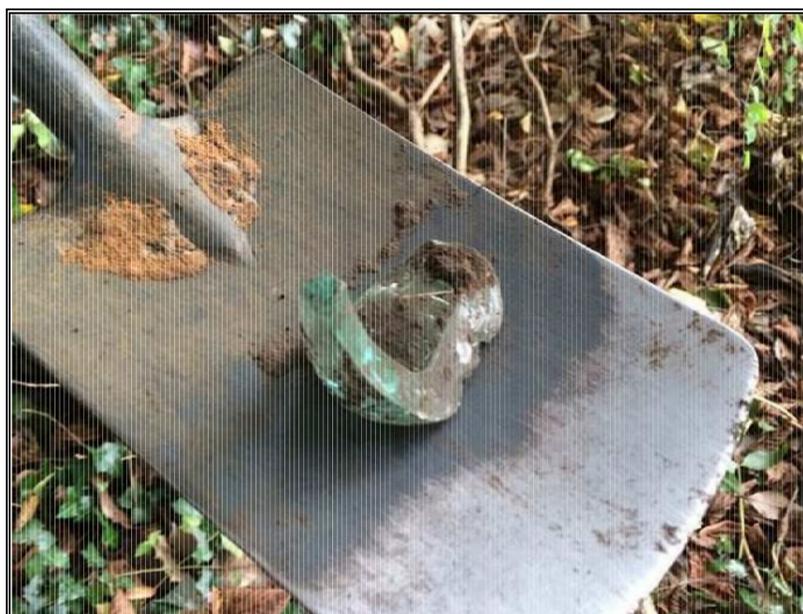
Plate 17: Glass fragment observed within *Profile 2 Topsoil* at TH18

The presence of glass within the *Profile 2 Topsoil* inspected could present a safety risk to end users. Appropriate safety precautions would need to be adhered to with regard to presence of glass during any vegetation clearance and subsequent cultivation/planting works. If any of these areas are to be converted to amenity grass, the presence of glass should be considered as the risk of injury to end users may be higher in such areas.

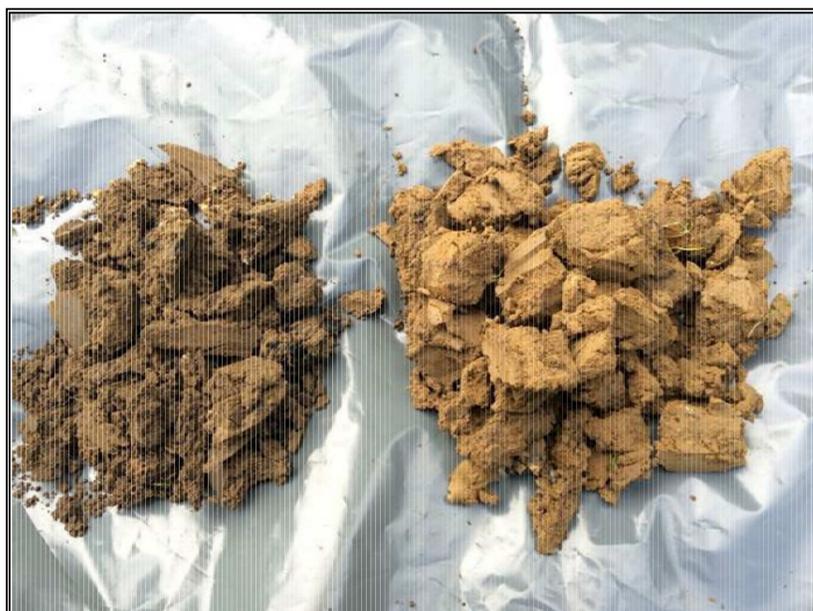
P3 Topsoil	Very dark greyish brown (Munsell Colour 10YR 3/2) to dark greyish brown (Munsell Colour 10YR 4/2), slightly moist to moist, firm to plastic, slightly calcareous HEAVY CLAY LOAM. The topsoil typically has a moderately-developed blocky structure. Virtually stone-free to slightly stony. No foreign matter observed.
P3 Subsoil	Dark yellowish brown to strong brown (Munsell Colour 10YR 5/4 to 10YR 5/6), slightly moist, firm to plastic, slightly calcareous HEAVY CLAY LOAM to CLAY with a moderately developed structure. Virtually stone-free. Common ochreous mottling was recorded, indicating impeded drainage and seasonal waterlogging.

Plate 18: *Profile 3 Topsoil* (left) and *Subsoil* (right) at TH10

The heavy texture of the *Profile 3* soils and presence of mottling in the subsoil indicates that this soil profile type will be prone to seasonal waterlogging following periods of prolonged or heavy rainfall. It is also likely that these soils will be prone to structural degradation during landscape preparation and planting works which will further reduce their permeability, particularly if they are handled when wet and plastic in consistency. As such, the physical condition of these soils will need to be maintained by careful handling and sensitive soil management to ensure they are fit for planting or seeding.

The heavy texture of the *Profile 3 Soils* is not ideal for large rootballed tree planting and as such, suitable imported soils are recommended for this purpose.

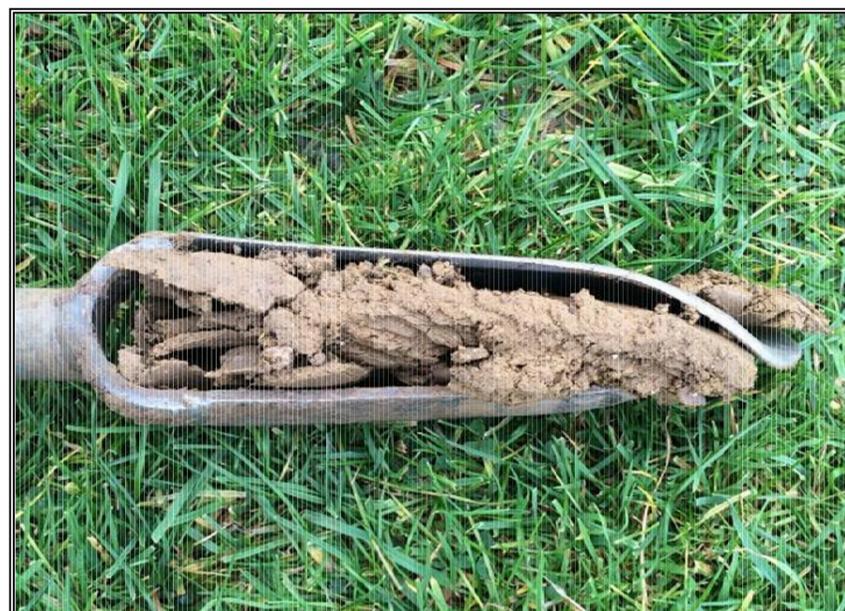
Plate 19: *Profile 3 Subsoil* at TH11

The subsoil samples from TH2, TH3 and TH11 contained moderate levels of organic matter, above levels typically recorded in subsoil material. These trial holes were constructed within areas that are understood to flood periodically and as such, the increased levels are likely to be due to accumulation of organic matter within the flooded alluvial environment.
