Marble Hill House and Park,
London
Conservation Management
Plan
Volume 2: Gazetteer

January 2017

Conservation Management Plan Volume 2: Gazetteer

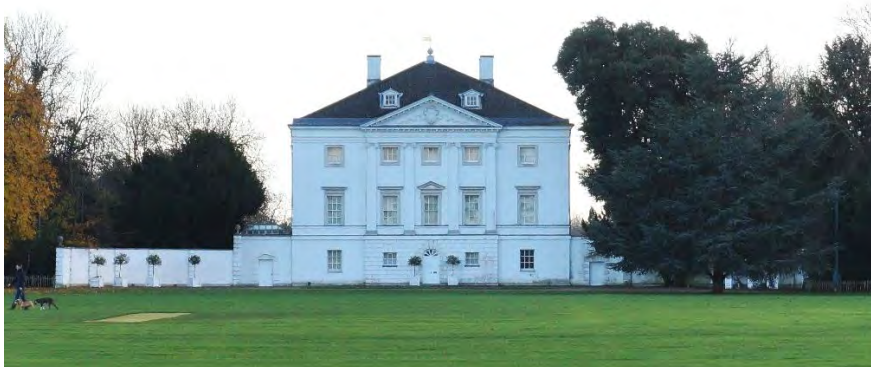
Location: North front

Brief description: This is the entrance front of the mansion and the most ornately treated of any of its elevations. It is five bays wide and three storeys high. The ground floor is treated as a basement in architectural terms – the windows have no architraves - with the *piano nobile* occupying the first floor above. A thick platband marks the division between the ground and first floors, and a thinner one runs above it at the level of the first-floor window sills. The windows have moulded architraves; those of the central bay have lugs (the central window at first-floor level has a pediment as well) to give them greater emphasis. The wall surface is, in fact, almost uniform: the rusticated base of the attached, tetrastyle giant order ionic portico is created by thickening the middle three bays of the wall. The portico has an entablature with a pulvinated frieze and a cartouche in the middle of the pediment. There is a lead-clad blocking course. To either side of the front are screen walls, whose cornices are extensions of the lower plat band, with returns terminating in rusticated piers carrying stone spheres. Both screen walls have doorways with rusticated surrounds. The north door now opens into the shop and serves as the visitors' entrance, while that to the west opens into the terrace by the west elevation. Lower, curved extensions run out from the end piers of both screen walls to create a cour d'honneur. These have rusticated intermediate piers and rusticated end piers crowned by stone spheres. A low, unmoulded stone plinth runs continuously the whole length of the screen walls and the whole width of the north front.

Notes: The modillions are made of fibreglass and were introduced during the 1965-6 restoration, replacing concrete predecessors which had been introduced in a restoration of 1951 and were incorrectly spaced. At the same time the pediment cartouche was renewed in fibreglass. The design of the fanlight is crude, lacking any mouldings, and it looks as though it may be a C20 replacement.

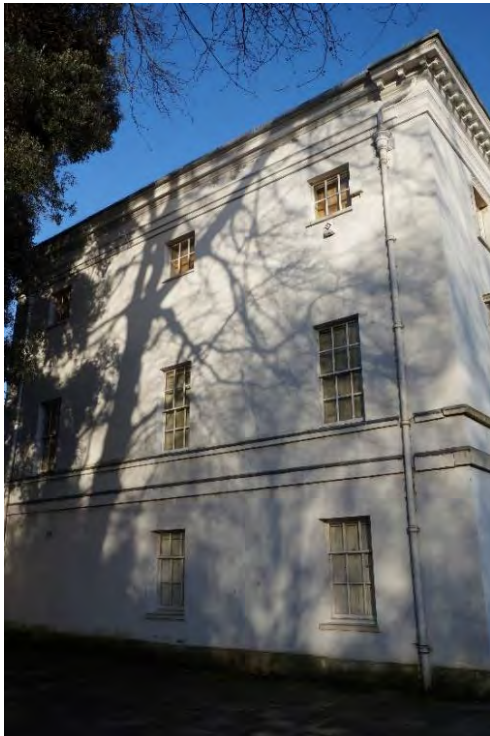
Location: West elevation

Brief description: The three-bay side elevation of the mansion forms the shorter side of the oblong. The plinth, platbands and cornice are carried round from the north front and at the southern end a short section of the modillion cornice from the south front is also carried round, but otherwise this elevation is very plainly treated. It is adjoined by a paved area.

Notes: The completely plain rear side of the west screen wall can be seen here. As built, there was a Palladian window at ground floor level, removed by Matthew Brettingham in 1750 when the Dining Parlour was created. Traces of it were discovered during the 1965-6 restoration.

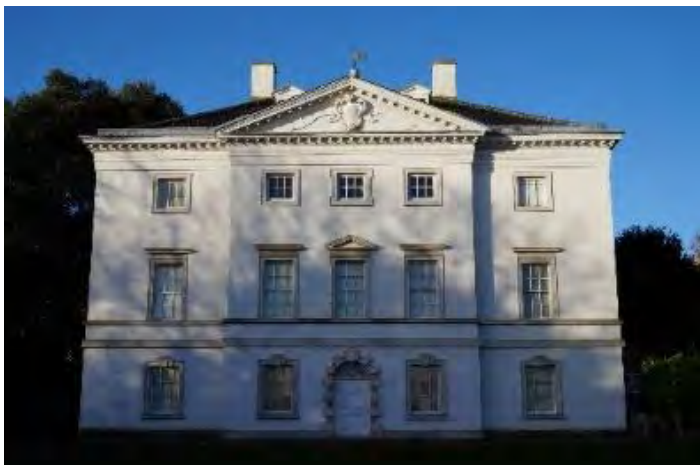
Location: South front

Brief description: This is the 'mirror image' of the north front and, like it, is three storeys high and five bays wide. As built, it overlooked the formally planned Pleasure Ground and, seen from the river terrace, was framed by groves of trees running down either side. The plinth, platbands, cornice and blocking course are carried round from the other elevations. Rustication is confined to the surround of the central doorway, giving access from the Hall, and so the ground floor windows have architraves with proper sills and prominent keystones. The south elevation lacks the portico of the north front but here the central three bays actually break forward. The pattern of the first- and second-floor windows is identical to the north front, but here the middle second-floor window has two pairs of lugs, not one. The central three bays are crowned by a pediment identical in design to that on the north side although here its modillions extend to the flanking sections of cornice. The brick south wall of the 1909 extension is mostly hidden by a hedge.

Notes: The middle three second-floor windows are glazed but effectively dummies since the coving of the Great Room runs continuously behind them and they are not visible from the interior. This front was much altered, probably in the 1810s, when the first floor windows were all extended downwards to the lower platband. The end first-floor windows – i.e. those lighting Lady Suffolk's bedchamber and the Dressing Room – were also widened. Thick mullions and margin lights were inserted and pediments added above. All these changes were reversed in the restoration of 1965-1966 when the pediment cartouche was also renewed in fibreglass. During this restoration traces of cut-back corbels for galleries at second-floor level were discovered.

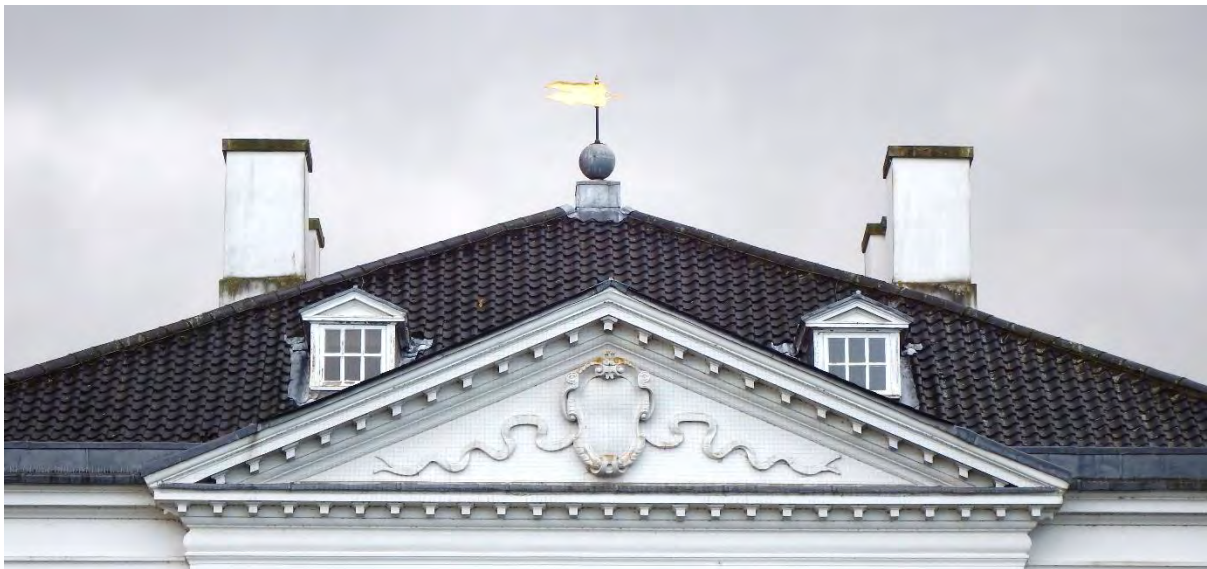
Location: Roof

Brief description: The roof is pyramidal in form and covered in black-glazed pantiles, which were introduced in the 1965-1966 restoration. At its summit is a lead-covered finial, consisting of a cuboid with a sphere on top surmounted by a gilt wind vane. Short sections of roof run out north and south to meet the two pediments, which are slated up to the point where they meet the lead-covered blocking course. Pairs of dormers, which light the garret rooms, emerge from the north and south slopes. These have pitched roofs terminating in pediments echoing those to each of those elevations. The roof of the 1909 extension is finished in rolled and battened lead and hidden from view by a parapet from ground level. Over the shop there is a metal-framed glass clerestory: the sides have louvered openings, the roof is glass and hipped at both ends. There is a modern stainless steel vent adjacent to it.

Element	Description (including history)
Walls	Chimney stacks are finished in stucco and have stone platband cornices
Windows	Six-pane casements to the dormers
Doors	None
Features	Four chimney stacks emerge from the east and west slopes of the roof. They are aligned with the north-south walls and serve flues running up through them.

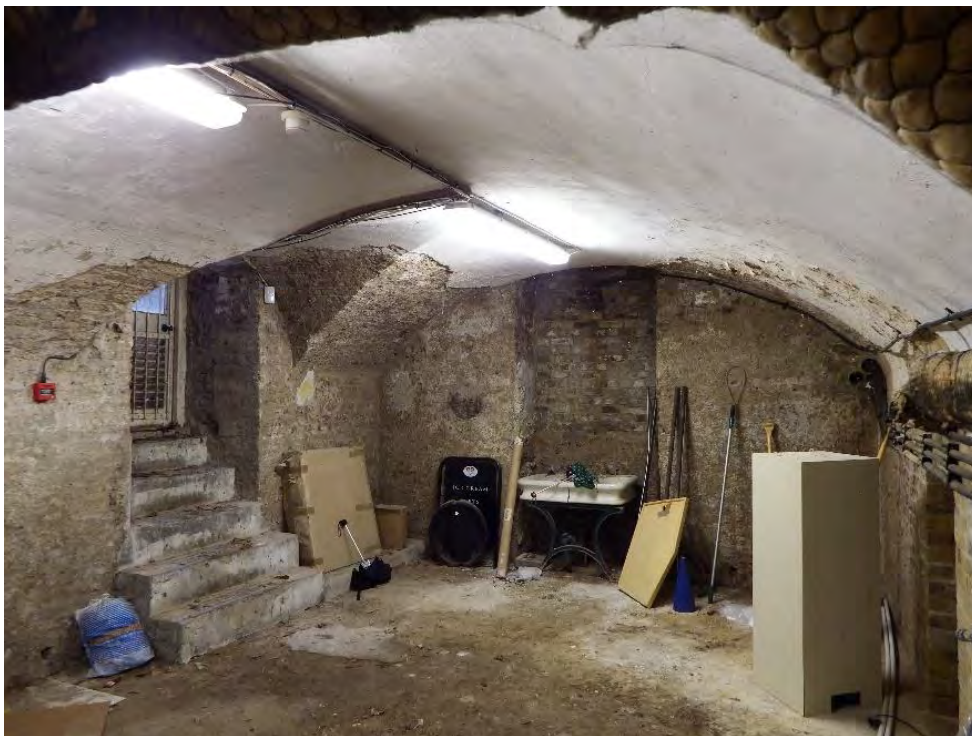
Room: 1

Element	Description (including history)
Walls	Plaster, large sections of which have fallen off
Floor	Stone flags and concrete
Ceiling	Segmental barrel vault running north-south
Joinery	Door to exterior: six panels, four glazed and the two lower ones louvered
Features	Chute from outside at south end, blocked with later brickwork; pipework with lagging, suspended from ceiling; area of recent brickwork in west wall, perhaps repairs to a former fireplace

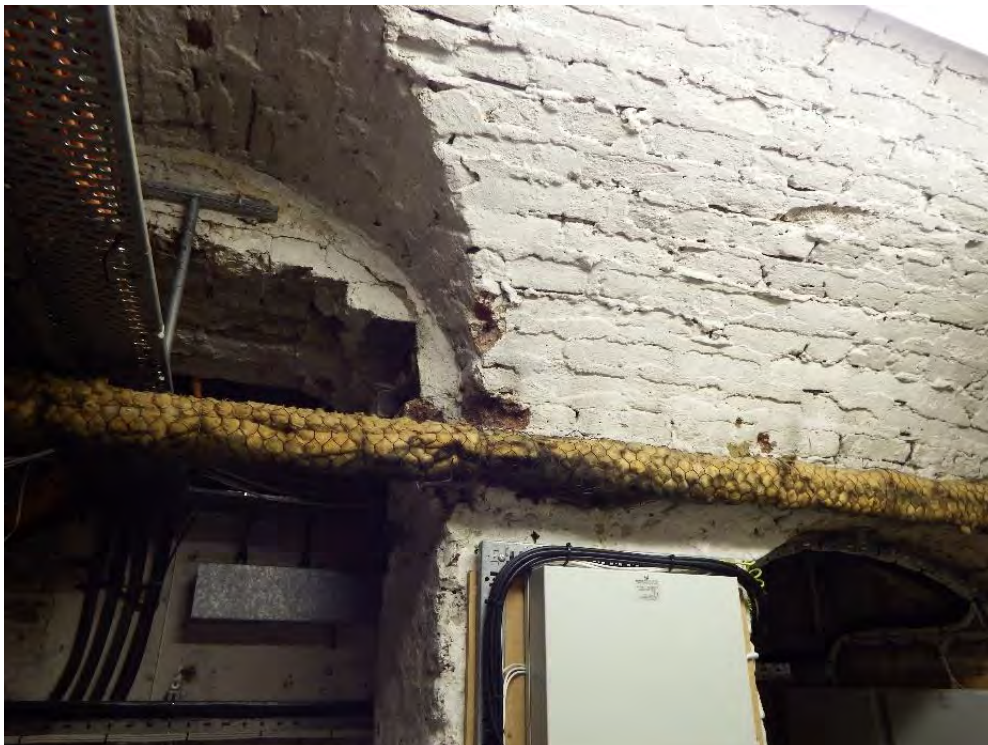
Room: 2

Element	Description (including history)
Walls	Painted brick
Floor	Brick paving
Ceiling	Brick barrel vaults, two running longitudinally and one running laterally, supported on a square pillar
Joinery	None

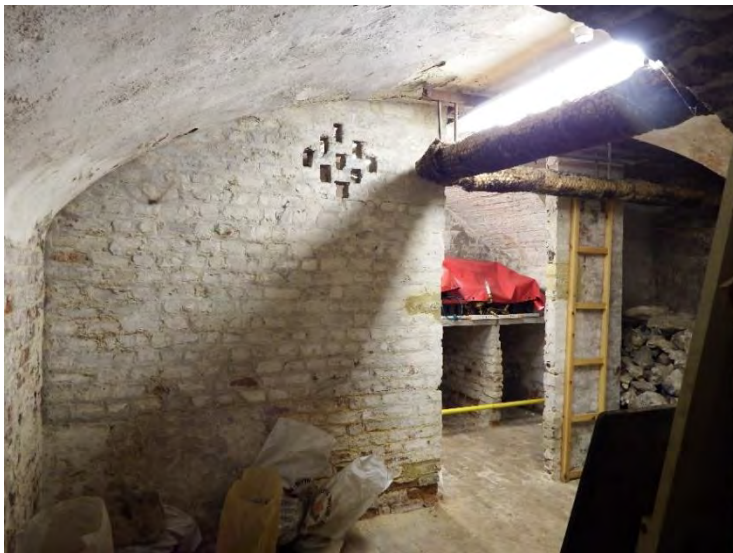
Element	Description (including history)
Walls	Brick, painted and also plastered in some places
Floor	Brick paving
Ceiling	Segmental barrel vault running north-south
Joinery	None
Features	Segmental arched recesses in the west wall; segmental arched opening in north wall with stepped sill, now split by a secondary brick partition but perhaps originally a window opening into a lightwell; pipework with lagging, suspended from ceiling;

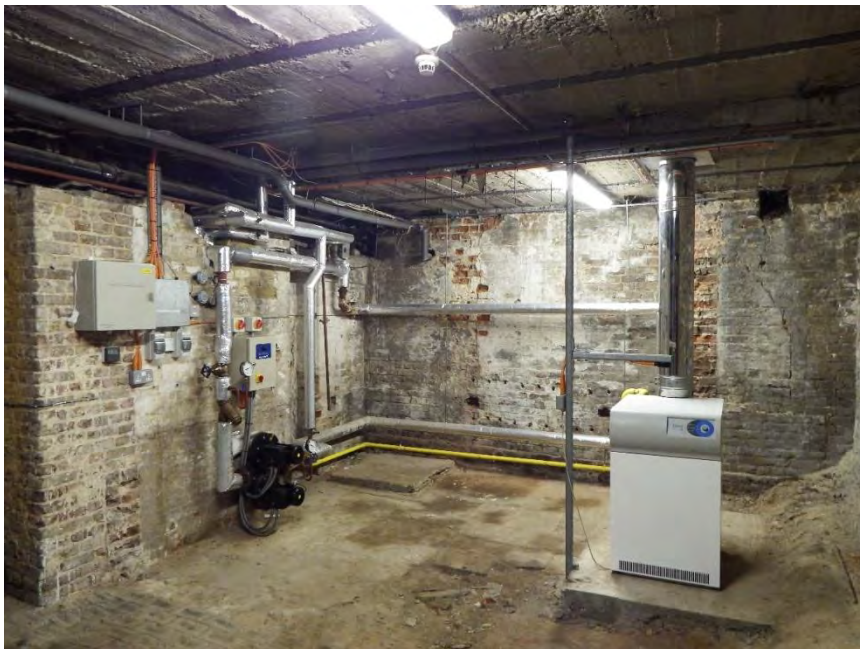
Element	Description (including history)
Walls	Brick
Floor	Brick paving and stone flags
Ceiling	Concrete slabs reinforced by steel girders
Joinery	None
Features

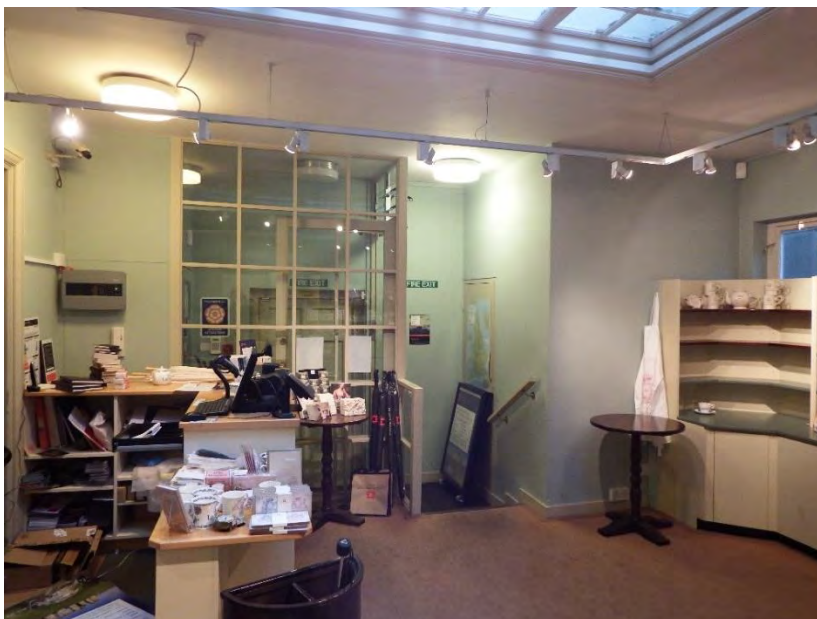
Room: 1

During the second half of the 20th century the room functioned as a male toilet and stores. There was a door through to the house (present Mess room). The threshold from this doorway became rotten and was replaced c.1984. At the same time nos.2 reinforced concrete lintels were inserted. From the mid-80s the space was divided by partition walls to create a shop. Since 1994 the room has remained in its present use combining shop, lobby and store with a door through to the Mess Room behind the counter.

Element	Description (including history)
Walls	Plastered and painted. The north wall of this room, which forms part of the exterior east curved screen is possibly a remnant of the service wing – it is thicker than the walls of the 1909 extension.
Floor	Carpet
Ceiling	Plaster
Joinery	Skirting, doorways, doors, windows, glazed draught lobby to door to exterior
Features	Flat skylight slightly recessed into ceiling beneath clerestory roof, which is glazed with frosted and wired glass; modern counter and display stands for shop, some of which run across the windows in the east wall; modern lighting, some of it suspended, radiators

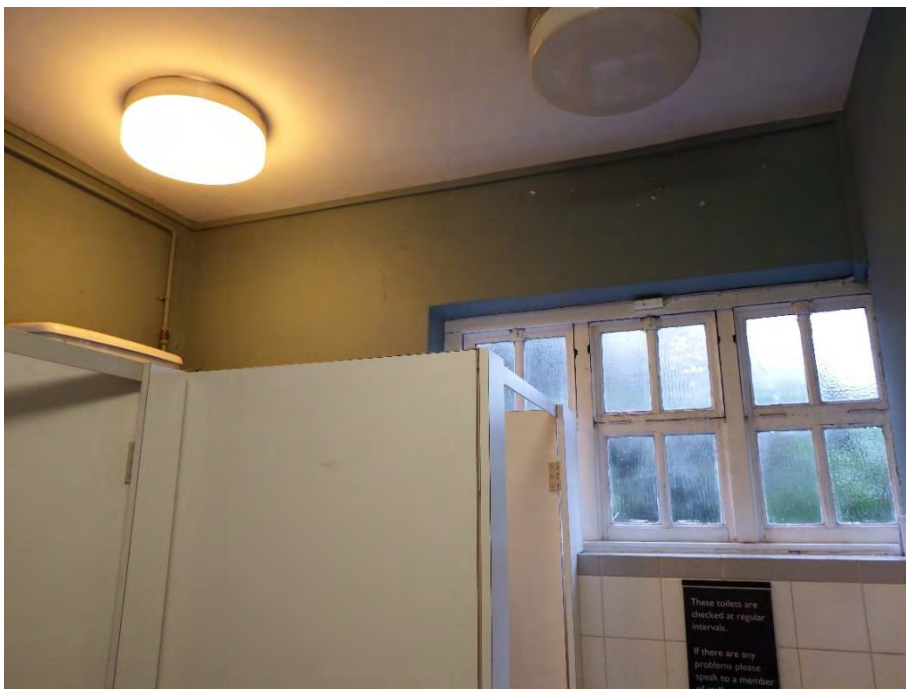
Brief description: This is the rear section of the 1909 extension, which houses the gentlemen's and ladies' toilets and a wheelchair-accessible toilet. It forms part of the visitor entrance route.

Element	Description (including history)
Walls	Plastered and painted, tiling to sill height in toilets
Floor	Carpet in corridor, tiling in toilets
Ceiling	Plaster
Joinery	Skirtings, modern architraves and six-panel doors (based on historic examples but clearly recent)
Features	Modern cubicles and sanitary ware in toilets

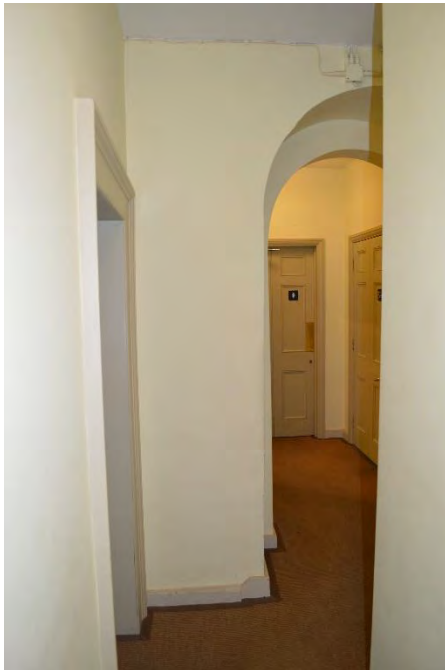
Brief description: This former service passage connects the corridor in Room 2 to the Service Stair (Room 8) and Entrance Hall (Room 7), meaning that it is now the visitor entrance route. It follows the line of the outer wall of the alcove of the Breakfast Parlour (Room 6) so doglegs and has an alcove in the south wall

Element	Description (including history)
Walls	Plastered and painted
Floor	Carpet
Ceiling	Plaster, no cornice
Joinery	Skirtings, architraves to doorways and doors
Features	Arched doorway in east wall marking the division between the 1720s fabric and 1909 extension; modern fire door in doorway to Room 8; obtrusive modern light fittings

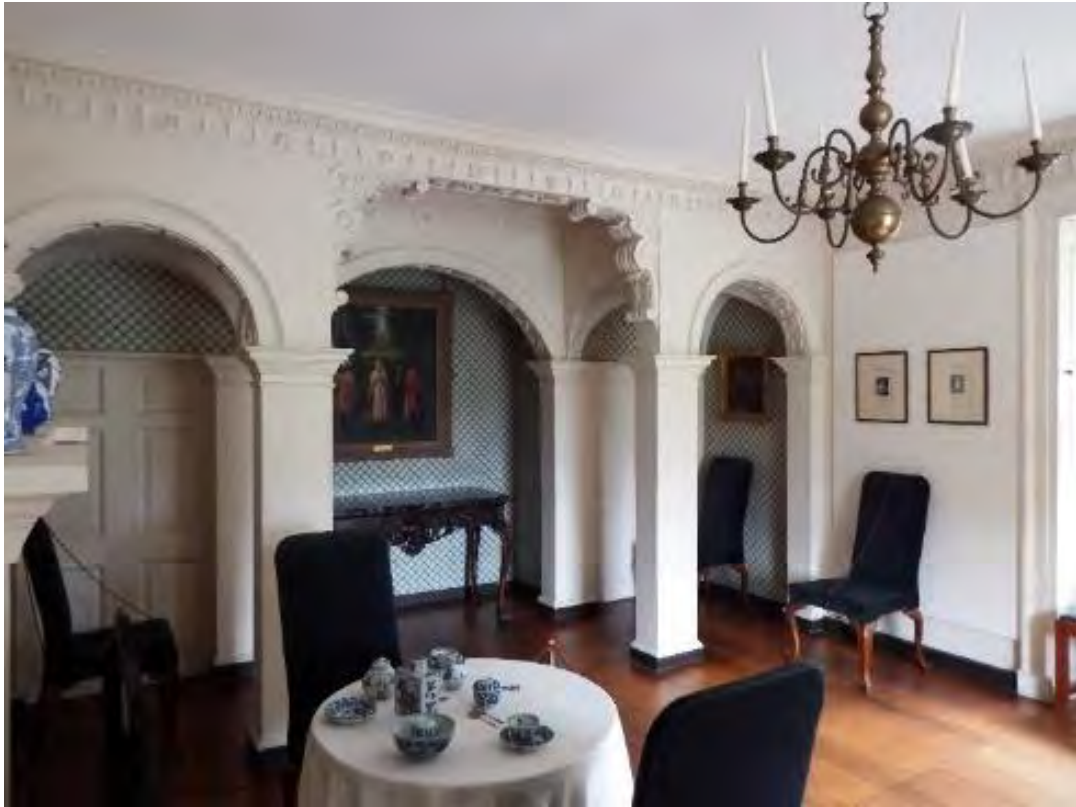
Brief description: Probably originally built as a Dining Parlour – it was formerly adjacent to the Service Wing - this room changed its function when that role was assumed by the new Dining Parlour on the opposite side of the building after that portion of the ground floor was remodelled in 1750. It is dual aspect, looking south towards the river and east towards the site of the service wing. At the north end is a large, tripartite alcove with two doors flanking a central buffet niche. All but one opening is arched and the soffits of the arches and the central flying cornice are moulded in plaster with Greek frets or rosettes in recessed square panels. The central opening to the main room also has pairs of consoles in the upper corners, set at right angles to each other.

Element	Description (including history)
Walls	Plastered and painted. Wallpaper in the alcove is a replica of the C19 wallpaper, its remnants found during the 1960s restoration. There are exhibition boards fixed to the east and west walls. Drawings from the 1940s show the niche adjacent to the corridor blocked with a partition wall (with no access).
Floor	Boards with vents at the alcove end. Plans from 1905 show a new floor on the south side of the room.
Ceiling	Plaster with elaborate frieze in the main part and the central bay of the alcove; plain plaster in the buffet niche; groined plaster vaults in the side bays of the alcove
Joinery	Skirtings, architrave and lining to door, six-panel door in opening to Room 4 and in the alcove, shutters and window linings, nine-pane sashes. In the mid-C20 there was a counter inserted between the columns of the screen. In 1964, both windows received new timber sashes.

Features	Elaborate chimneypiece fitted to a box-like construction with mouldings and panels against the east wall with a shelf on top. There is a lugged marble surround to the opening with a moulded edge and a prominent mantelpiece with sections breaking forward to the sides which are carried on brackets. Chandelier. Plans from 1905 indicate that there was a sink in this room which was then relocated to the Dining Parlour.

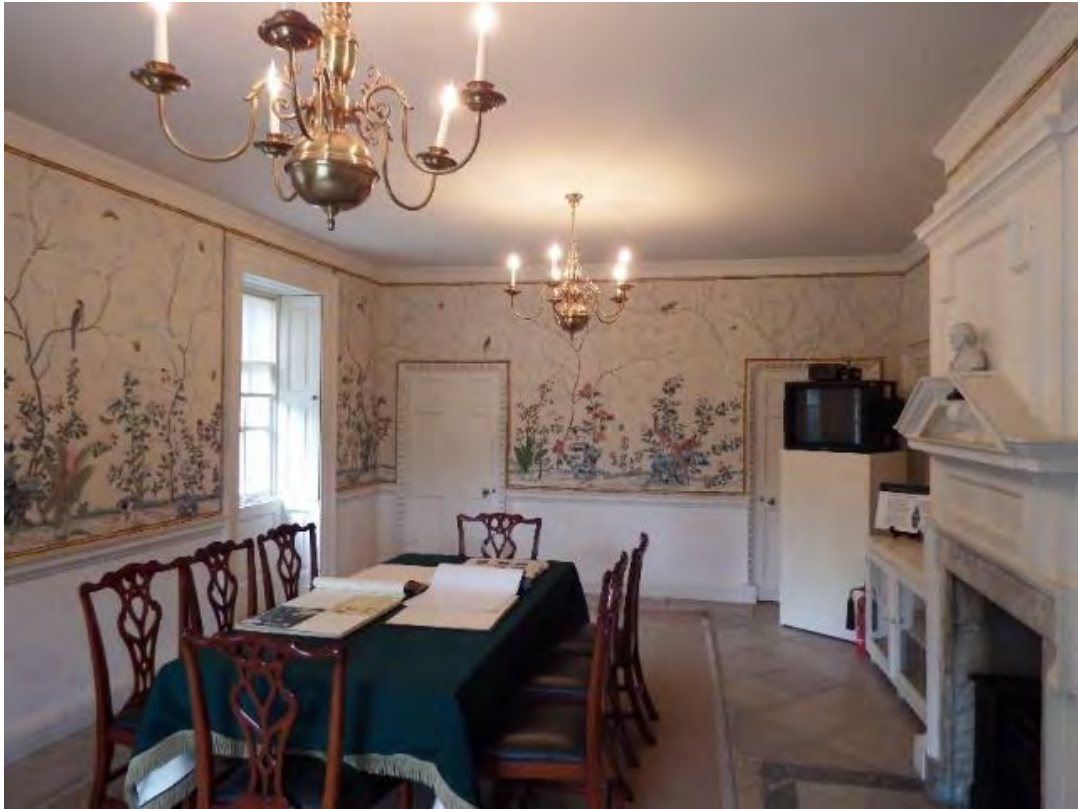
Element	Description (including history)
Walls	Plastered and painted to dado height, wallpaper (see above) mounted on battens above. In 1926 an opening was created to the north of the fireplace on the east wall. In 1926, room records indicate that there were no doors between the Paper Room and Dining Parlour.
Floor	Portland stone paving, marble hearth
Ceiling	Plaster with simple moulded cornice – the latter dates from 1955 and is based on that in the staircase hall
Joinery	Dado rail; four six-panel doors with their architraves and linings; three windows with linings, shutters and nine-pane sashes
Features	Chimneypiece with lugged marble surround to opening and split pediment mounted on a projection from the chimney breast on the east wall; bust in centre of pediment; cast-iron grate; modern audio-visual equipment

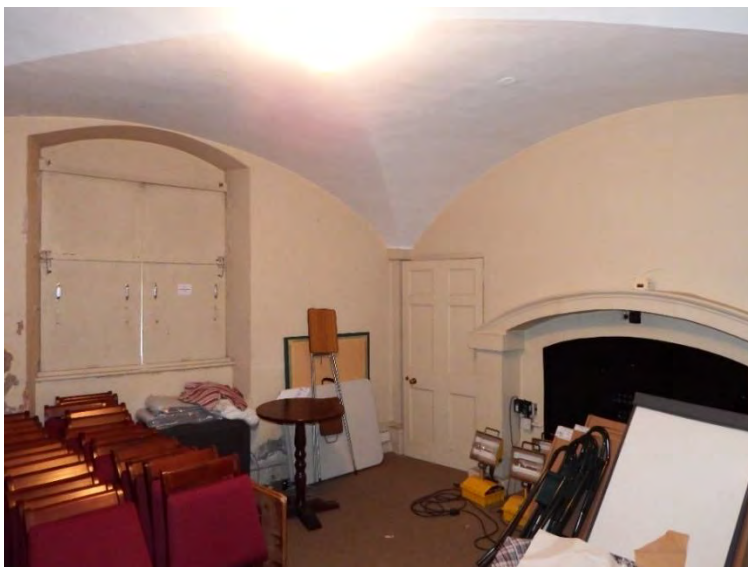
Notes: The Paper Room is not open to the public, it is currently used for storage. In 1926, records indicate that it was used as a kitchen and store. By 1962, drawings indicate that all kitchen furniture and partitions have been removed. The 1964 restoration included the removal of all remaining kitchen equipment, storage racks and M&E services. In 1987, it is recorded as being the “custodians room”. In 1994, it is recorded as being used as an office / control room.

Element	Description (including history)
Walls	Plastered and painted. At the start of the C20, there were no door linking the Paper Room to the Dining Parlour, with these being created in c.1953. IN 1964, a new door formed to the cupboard to the north of the fireplace.
Floor	Carpet
Ceiling	Segmental groin vault, plastered and painted; it springs from pillars partly buried in the corners with thick platbands to the top and bottom, like much simplified paraphrases of classical orders
Joinery	Nine-pane sash window; six-panel doors with architraves, those leading to the Dining Parlour larger and more elaborate than the others
Features	Stone skirtings; fireplace with segmental arch flanked by pillars with broad platbands to top and bottom carrying a cornice that follows the line of the arch; cupboard to north of fireplace lined with modern tiling; arches recess in thickness of north wall; modern security shutters

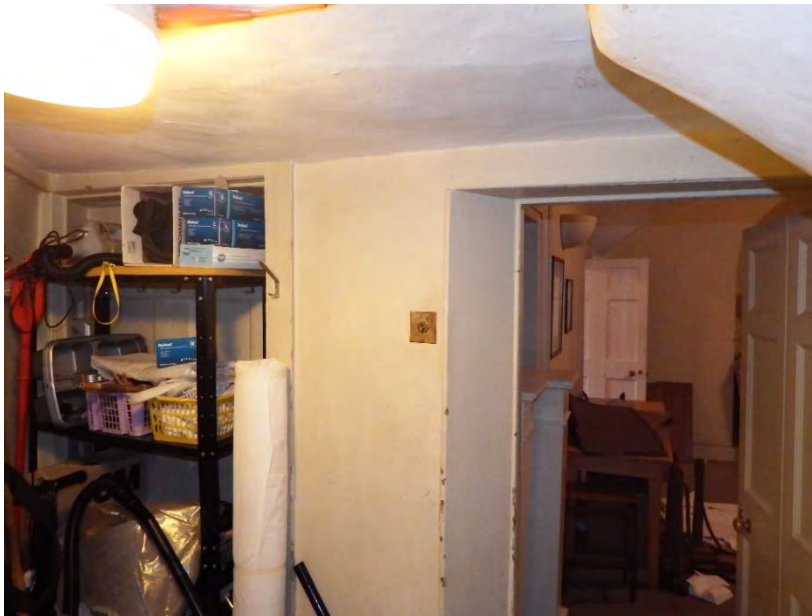
Room: 6a

Notes: The space beneath the lower flight of the main stairs is now used to house a server and electrical services. The door to the Dining Parlour is currently out of use. This space is not open to the public.

Element	Description (including history)
Walls	Plastered and painted
Floor	Stone flags
Ceiling	Plaster, no cornice
Joinery	Doorframes, doors – that to the Paper Room is modern and that to the Main Hall has been split and the front appears to have been renewed.
Features	Modern lighting unit mounted on ceiling

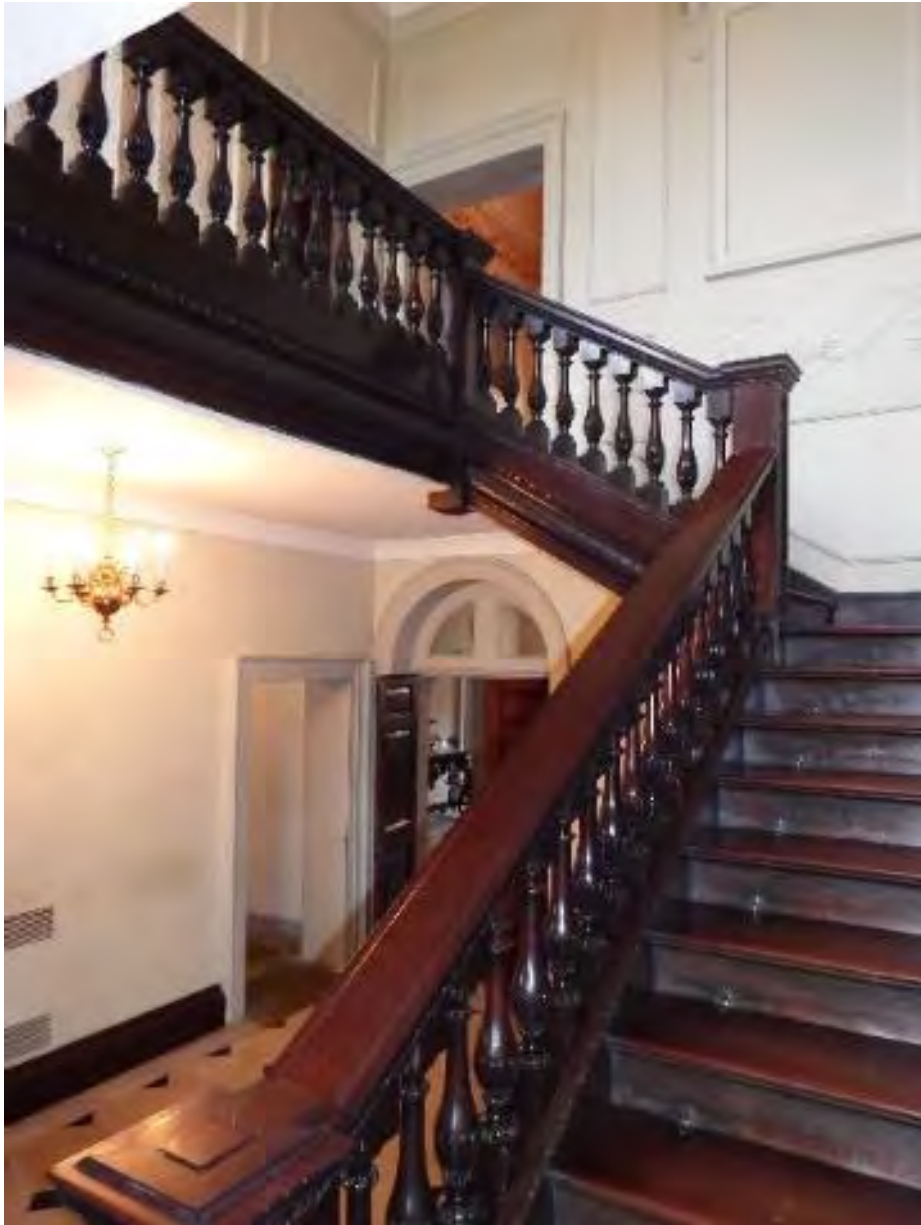
In 1957, records indicate that a new ceiling was installed to the area under the landing and 3 new newels added to the start of second flight of stairs. Works during the 1964 restoration included removing cupboards under the stairs. During the early 1990s, a shop was located in the hall.

Element	Description (including history)
Walls	Painted flat plaster to the north, east and south walls at ground floor level
Floor	Paved in square stone flags with diamond-shaped (?)slate inserts at interstices, centre replaced; mahogany boards to treads of stair. Records indicate that the hall was repaved during the 1964 restoration.
Ceiling	Flat plaster with moulded cornice beneath landing; the bottoms of the newel posts protrude below the line of the plaster surface and carry carved ornament
Joinery	Doors (that to the Service Stair is a fire door), architraves, door linings, overlight to door to Hall, fanlight to north door, nine-pane sash in north wall with shutters, raised and fielded panelling enclosing space below stairs
Features	Picture rail on east wall; frames with moulded plaster borders on the west wall, the lower part of a larger scheme extending to first floor level; fixings for stair rods; modern grills in east wall

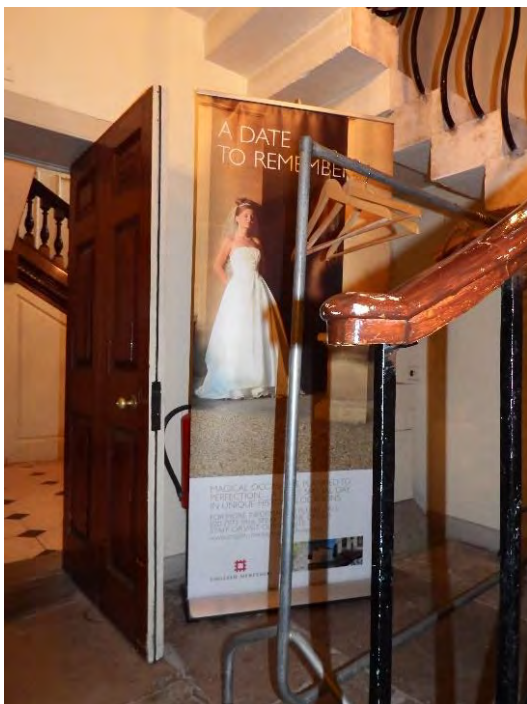
Notes: The swell in the iron banisters may have been intended to accommodate wide dresses. In 1964, works were undertaken to increase the fire resistance to the door through to the south Hall and a door created to the corridor to the east (removing 4.5" wall, provide new door and frame without lock). In 1975, the banister railing was overhauled and stone treads made good where necessary, and corner ducts were added on all levels.

Element	Description (including history)
Walls	Plastered and painted with stone skirting
Floor	Stone flags and stone treads to stair, the latter incorporating new fabric inserted to replace worn sections
Ceiling	None
Joinery	Handrail to banisters
Features	Heating unit against west wall added in 1964

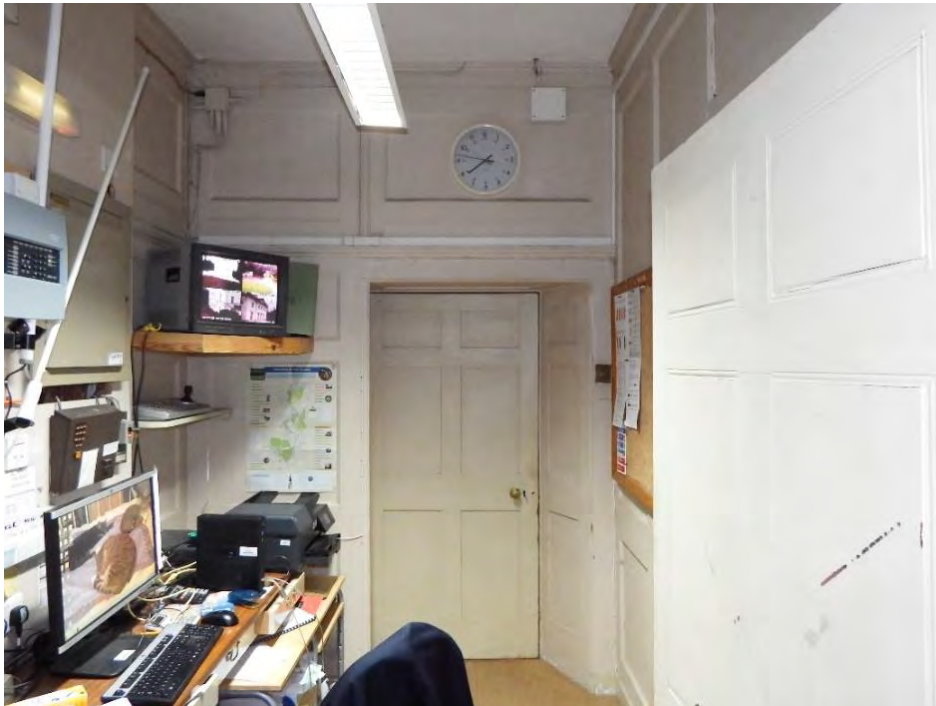
Notes: Some of the equipment is mounted on a board fixed to the south wall. The historic panelling continues behind it. Between 1905 and 1994, records indicate that the room was used as a toilet and cloakroom with no door through to the Mess Room to the east. In 1994, the current Control Room was created and an access provided through to the Mess Room.

Element	Description (including history)
Walls	Panelled throughout – the panels are sunk and the mouldings to the arrises have a simple profile
Floor	Carpet
Ceiling	Plaster
Joinery	Panelling, skirting, doors, nine-pane sash window, door and window linings, shutters (historic security shutters with a metal lining)
Features	Large historic strap hinges to door to Mess Room

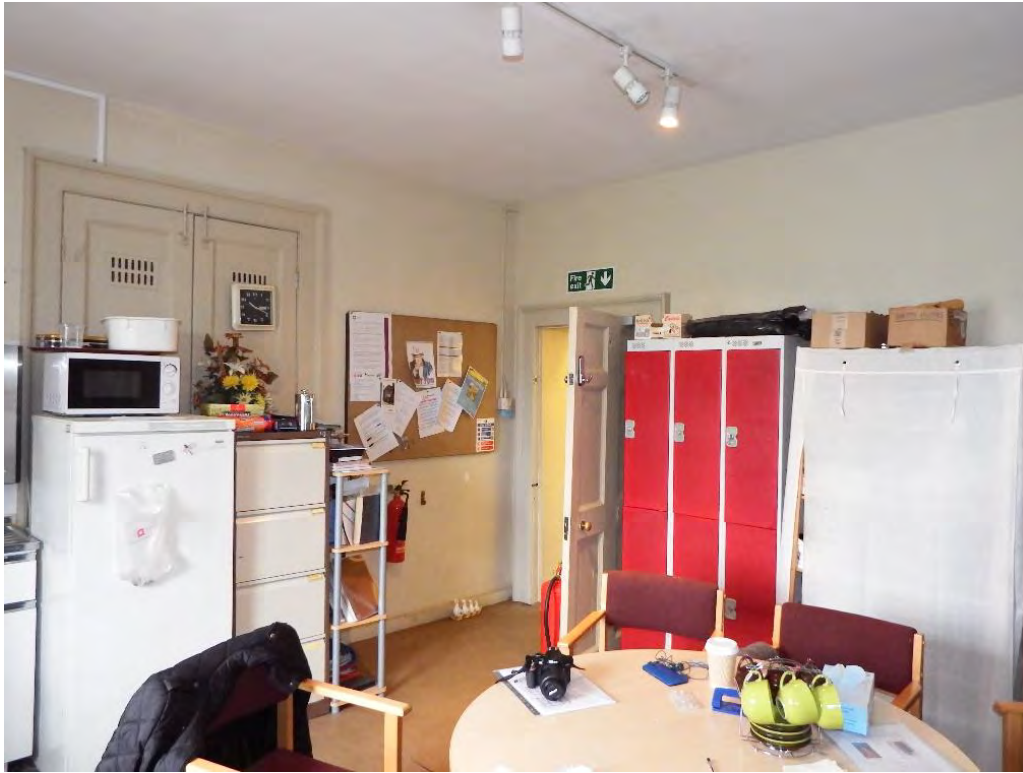
By 1994, the room is referred to as the Mess Room but with no door through to the Control Room, as found now. The blocked corridor outside had been returned to its historic passageway function.

Element	Description (including history)
Walls	Plastered and painted
Floor	Carpet
Ceiling	Plaster
Joinery	Skirting; architraves; panelled double doors in doorway leading to Control Room, with overdoor cupboard having panelled doors and narrow margin panels – all this is mirrored by the cupboard on the opposite side of the fireplace, which forms a symmetrical composition with it; lining to window, historic security shutters and nine-pane sash window; doors to Shop; historic six-panel door to Room 2a, the former Service Passage.
Features	Fireplace in west wall with veined marble surround; cupboard in recess to south of fireplace; double doors in east wall communicating with Shop; the shutters retain historic 'H'-hinges

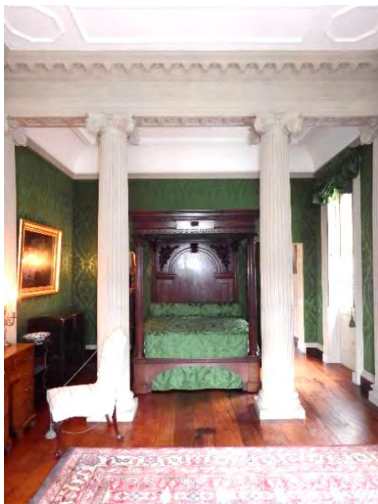
Notes: The mahogany four-poster bed of c.1740 is on loan from the Victoria & Albert Museum. In 1953, the room was referred to as the Blue Room. The 1964 restoration included removal of the external balconies and drawings included the following notes: "take out window frames; replaced reveals and form new windows with width to match those of Room 1.02 (Grt Room) and cill level at upper stringcourse provide new window framing complete; new fir floor boarding tarred internally".

Element	Description (including history)
Walls	Plastered and painted light stone – the original colour scheme - in lead-based paint in 1998. The green, hand-woven silk damask hangings in the bed alcove were introduced at the same time. In 1964, a fire seal was established at the foot of the walls panel framing cavity to isolate cavity from floor framing space.
Floor	Mahogany boards, repaired following dry rot damage in 1955
Ceiling	Deeply coved above bed chamber with dentilled cornice; plaster, divided into oblong and octagonal panels, with bead and reel and egg and dart frames, and a Greek fret border to the central panel, dentilled modillion cornice continuing the entablature of the screen
Joinery	Skirting; dado rail; Ionic columns and pilasters; twelve-pane sashes, window linings and shutters; doorway to Great Room with moulded architrave and six-panel door. In 1905, records indicate new floor and timbers to the north of the alcove / columns. In 1964, new sashes were fitted, floor boarding renewed in Mahogany and doors fire lined.

Features	Chimneypiece of 1720s salvaged from 29 Clapton Common at demolition in 1954 – marble surround and plinth, split pediment and central section breaking forward; cast-iron grate; jib doors to Miss Hotham's Bedchamber and the landing of the Stone Staircase; picture rails

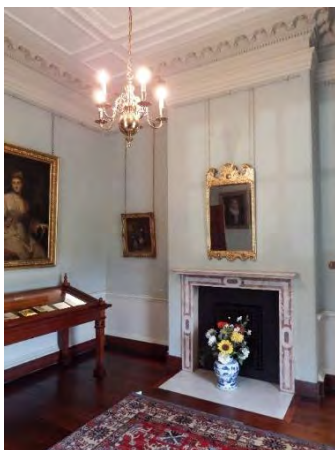
Notes: The 1767 inventory says that the room was panelled at that point, perhaps as insulation since it is north-facing. IN 1905, records indicate that the room was partitioned as a toilet. Drawings from the 1964 restoration included the following caption: "Dry rot – in the intermediate beam in north-east corner; infection from above with external W.P and leadwork; no immediate insecurity; ceiling joists and other members infected along front wall; joists shown which may indicate repairs; on the E wall to the R of the window – caption: "end of main beam rotted. Part cut away? Cause – faulty leadwork at upstairs outside? No immediate insecurity."

Element	Description (including history)
Walls	Plastered and painted – white below dado rail, pale green above
Floor	Mahogany boards
Ceiling	Plaster, divided into oblong panels, with bead and reel and egg and dart frames, and a Greek fret border to the central panel; elaborate dentilled modillion cornice with a frieze and stepped and moulded cornice below
Joinery	Skirting, dado rail, architraves and panelled linings to the two windows and two doorways, twelve-pane sashes, six-panel doors
Features	Chimneypiece against west wall of grey, veined marble red marble inlay and projecting mantelpiece, not supported on brackets; picture rails

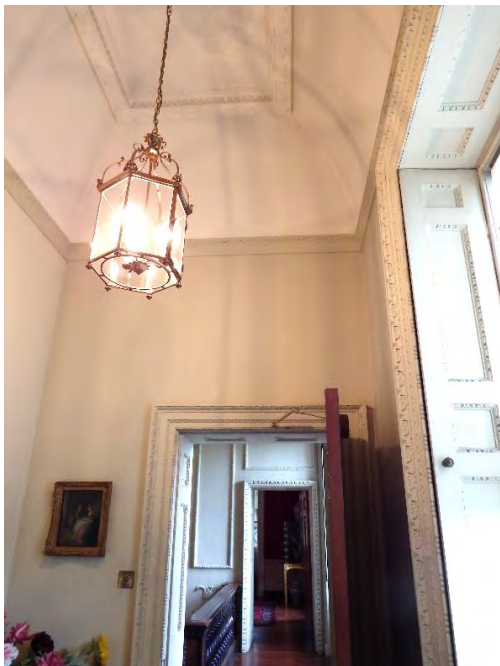
Notes: An east-west partition was removed and the door to Lady Hotham's bedchamber blocked in 1905. In 1926, the room was converted into a toilet with sink with a partition orientated north-south. By 1950, the room is shown as a kitchen with access to a bathroom created in the south-west corner. Later in 1905, a cupboard was created access from Lady Hotham's bedchamber. There is a long history of blocking and unblocking this doorway from 1905 onwards. The 1964 restoration included the removal of the door linking it and the bedchamber and its surround.

Element	Description (including history)
Walls	Plastered and painted
Floor	Mahogany boards. Records indicate that the floor was replaced in 1905.
Ceiling	Plastered: moulded cornice with shallow frieze, deeply coved with recessed central panel having a moulded border and arabesque frame
Joinery	Skirting, dado rail, architraves and panelled linings to the window and two doorways, twelve-pane sash, six-panel doors
Features	Large hexagonal lantern hung from middle of ceiling

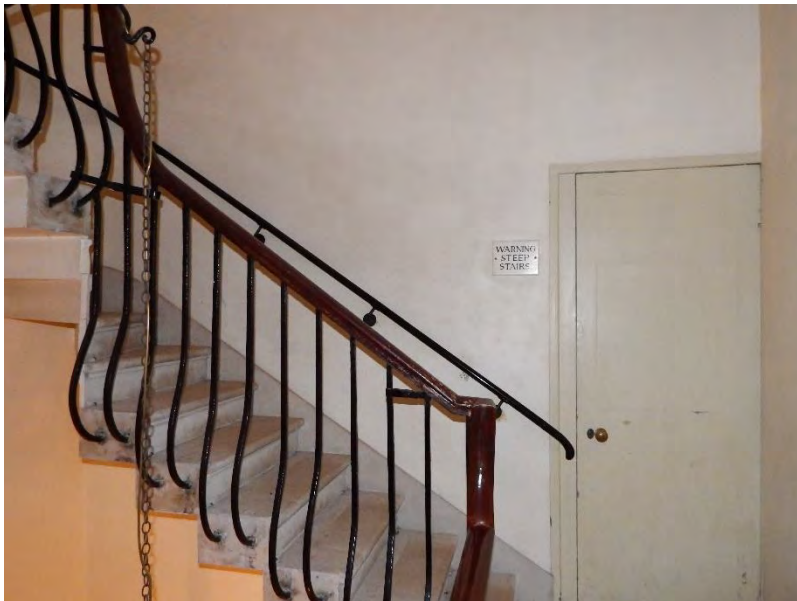
Room: 14

Brief description: The first-floor landing of the stone stair has doors to Lady Suffolk's Bedchamber (via one of the jib doors) and the first-floor landing of the main stair.

Element	Description (including history)
Walls	Plastered and painted
Floor	Stone flags to floor of landing, stone blocks forming treads of stairs
Ceiling	None
Joinery	Handrail to banister, doorways with simple door frames and six-panel doors
Features	Curved iron bracket emerging from one of the treads for suspending lantern in central well

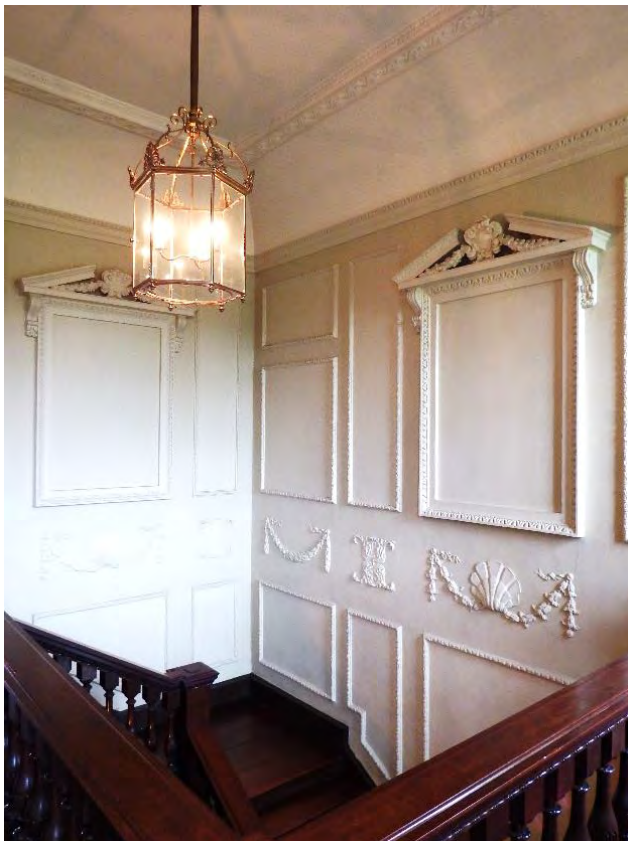
Room: 15

Brief description: The upper landing is part of the approach from the north entrance of the House to the Great Room, whose door is nearest to the top of the stairs. There are also doorways to the Stone Staircase, the Closet and the Damask Room.

Element	Description (including history)
Walls	Plastered and painted, the walls are adorned by panels and pedimented frames – the latter are just architectural features and seem never to have held paintings
Floor	Mahogany boards
Ceiling	Plaster, deeply coved with recessed central panel surrounded by a frame
Joinery	Skirting; newels and baluster of upper landing of main stair; architraves and panelled linings to the two windows and three doorways, twelve-pane sashes, six-panel doors
Features	Hexagonal brass-framed lantern suspended from ceiling

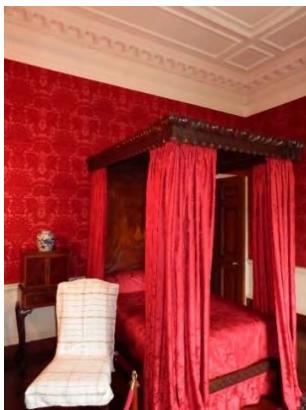
Room: 16

Notes: The four-poster bed was purchased during the guardianship and installed here by English Heritage. In 1926, and until 1950 when plans were prepared, the room functioned as a kitchen. The 1964 restoration plans noted that “6”x2.5” (average) floor joists at 15” centres. No apparent main or intermediate beams. Setting out may be irregular. Propped up from brick deck at centre of room. Brick deck 9” down from floor level. New marble slab for the hearth to the chimney piece on the east wall”. By 1973 the room was referred to as the Damask Room.

Element	Description (including history)
Walls	Plastered and painted up to dado rail, papered above
Floor	Mahogany boards, white marble hearth. A new floor and timbers in the south-east corner installed in 1905.
Ceiling	Plastered: dentilled modillion cornice with frieze, divided into oblong panels with bead and reel frames, that to the central panel being an egg and dart ovolo moulding with a Greek fret inner border
Joinery	Skirting, dado rail, architraves to windows and doors, twelve-pane sashes, panelled lining and folding shutters to windows. In 1964, new sash in west wall and works to make the door to the staircase hall self-closing.
Features	Chimneypiece (a C20 recreation of a lost original) against east wall with lugged marble surround to the opening, mantelpiece with sections breaking forward on either side and supported on consoles, overmantel with split pediment flanked by consoles; cupboard on the south side of the chimneypiece with a door treated like the entrance from the landing to maintain symmetry

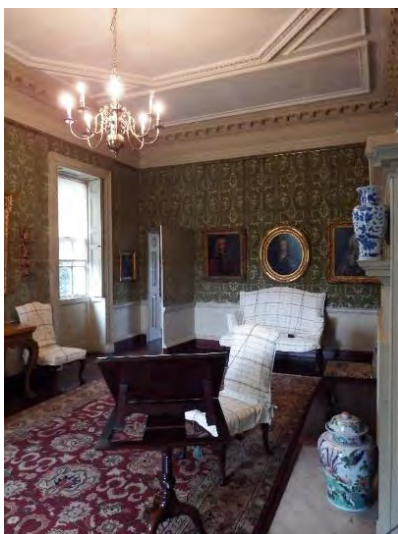
Brief description: This room is the counterpart on the western side of Lady Suffolk's bedchamber (Room 12). It probably originally contained a bed, although more for the sake of symmetry, display and guests promenading around the piano nobile; it would have been used by Henrietta Howard for her levée. According to the 1767 inventory the room had red damask curtains and hangings (thought to refer to a curtain fringe made of the same material rather than separate wall hangings). It was subdivided at a later date but its original dimensions were reinstated by the GLC in the restoration of 1950. During the 1964 restoration works, the window dimensions were altered and external balconies removed.

Element	Description (including history)
Walls	Plastered and painted up to dado rail, papered above with green flock wallpaper
Floor	Mahogany boards, white marble hearth
Ceiling	Plaster, with dentilled modillion cornice and deep frieze; large octagonal central panel with triangular panels in spandrels and ceiling rose, all framed by elaborate mouldings to a variety of designs
Joinery	Skirting, dado rail, architraves to windows and doors, twelve-pane sashes, panelled lining and folding shutters to windows
Features	Jib door in doorway to neighbouring Damask Room, six-panel on its outer face; chimneypiece (a C20 recreation of a lost original) against west wall with lugged white marble surround to opening, deep mantelshelf and split pediment to overmantel but lacking a grate; cupboard on the north side of the chimneypiece with a door treated like the entrance to the Great Room in order to maintain symmetry

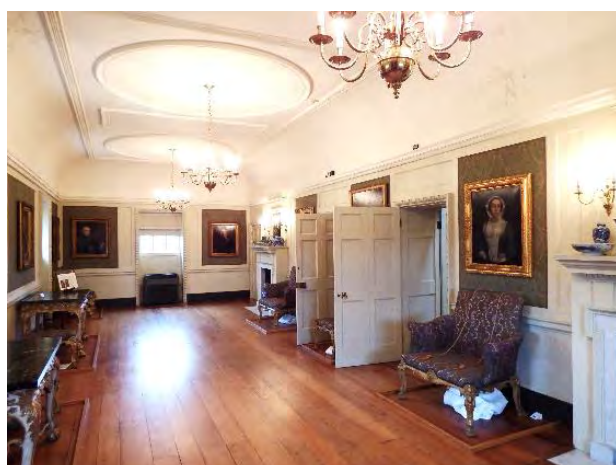
Room: 18

Notes: The suite of furniture here was originally made in 1722 for Glemham Hall in Suffolk and is on long-term loan from the Victorian and Albert Museum.

Element	Description (including history)
Walls	Plastered and painted up to dado height; above, panelled, although framing sections of green flock wallpapers in alternate bays
Floor	Wide boards, a modern replacement, marble hearths to fireplaces
Ceiling	Dating from 1975 - deeply coved, with moulded cornice border to central flat, which is divided into thirds
Joinery	Skirting, dado rail, architraves to windows and doors, six-pane sashes, wall panelling, panelled lining and sash shutters to windows, six-pane sashes
Features	Two identical fireplaces against west wall with lugged marble surrounds and prominent cornice breaking forward to each side and overmantels incorporating mirrors with flanking consoles and prominent cornices; two cupboards (positioned to maintain symmetry with doors), now with glass fronts and used for display; free-standing heaters

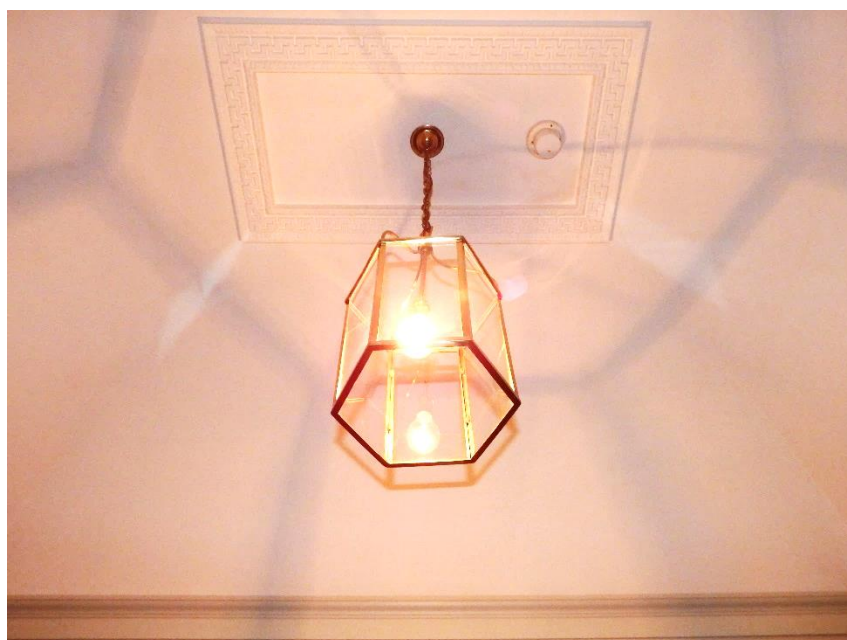
Notes: According to the inventory of 1767 this closet was hung with watercolours and pastels. This room is used for displaying part of the Rosemary and Monty Lazenby bequest.

Element	Description (including history)
Walls	Flock wallpaper – green decorative motif on gold background
Floor	Modern boards
Ceiling	Plaster, deeply coved – plain moulded cornice, Greek fret frame to central flat with moulded edges
Joinery	Skirting, architraves to windows and doors (simple, unadorned mouldings), six-pane sashes, sash shutters to windows, six-pane sashes
Features	Hexagonal brass-framed lantern hanging from centre of ceiling
