Marble Hill House and Park,
London
Conservation Management
Plan
Volume 2: Gazetteer

January 2017

Conservation Management Plan Volume 2: Gazetteer

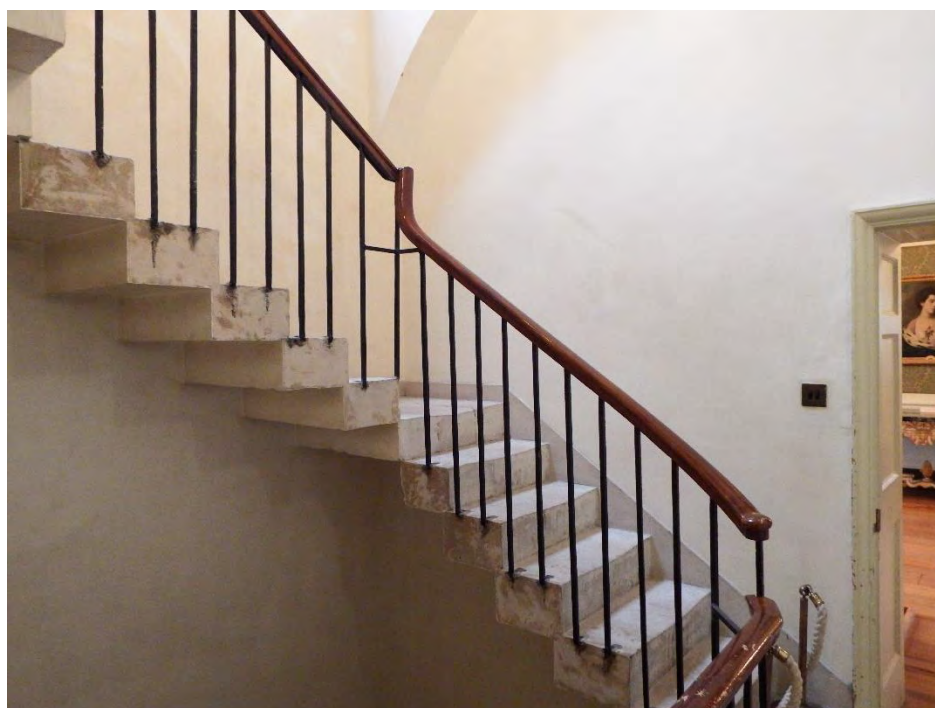
Room: 19

Brief description: This landing of the Stone Staircase opens out onto a corridor (Room 21a) that runs east-west

Element	Description (including history)
Walls	Plastered and painted
Floor	Stone slabs of landing and stone treads of stair
Ceiling	None
Joinery	Handrail to banister, doorways with simple door frames and six-panel doors

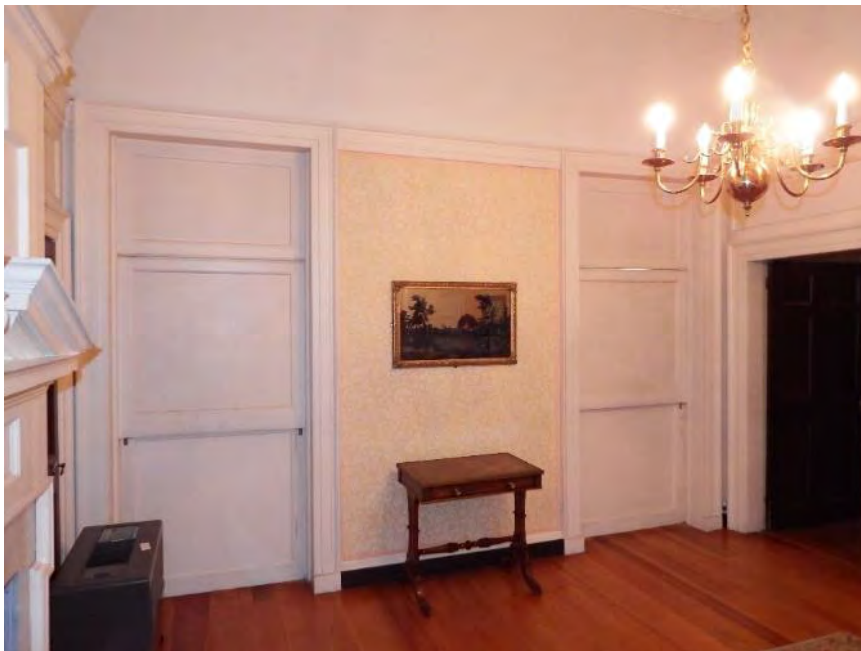
Room: 20

Brief description: Located directly above the Stair Hall this room may derive its name from the plain woven case covers once used on the furniture. As well as having a doorway from the Corridor (21a) it also provides through access from the Wrought Room via the Closet to the Gallery. The original interior of this room, like that of all the others on the second floor, was removed after an outbreak of dry rot in 1951 caused severe damage and restored in the 1980s.

Notes: This room is used for displaying part of the Rosemary and Monty Lazenby bequest.

Element	Description (including history)
Walls	Finished to full height in yellow wallpaper, a modern reproduction based on fragments of c.1770 found in the room
Floor	Modern boards
Ceiling	Plaster, deeply coved – plain moulded cornice, Greek fret frame to central flat with moulded edges
Joinery	Skirting; architraves to windows and doorways (simple, unadorned mouldings), six-panel doors, panels above doors flanking alcove; six-pane sashes, sash shutters to windows
Features	Chimneypiece against west wall with lugged grey marble surround and cornice above with central section breaking forward and carrying a split pediment with an inverted console in the centre; cupboard in thickness of wall on north side of chimneypiece; Dutch-style chandelier hung from centre of ceiling

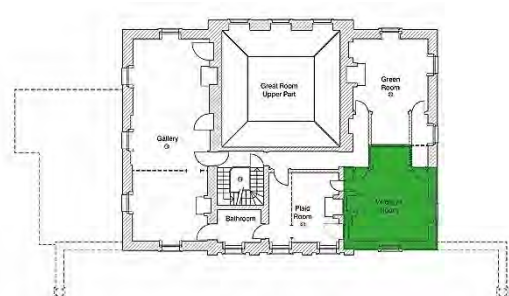
Brief description: This is a dual-aspect former bedroom in the northwest corner. The name of this room derives from the ‘wrought’ or embroidered hangings of the four-poster bed. There is a prominent alcove on the south side flanked by doorways opening into corridors formed by the lateral partition walls enclosing this alcove and an even deeper one in the Green Room immediately to the south. The original interior of this room, like that of all the others on the second floor, was removed after an outbreak of dry rot in 1951 caused severe damage and restored in the 1980s.

Element	Description (including history)
Walls	Finished to full height in green wallpaper, a modern reproduction based on fragments of c.1770 found in the room
Floor	Boards – those in the corridor on the east side of the alcove leading to the Green Room are of deal and the only original ones on this floor
Ceiling	Plaster, deeply coved – plain moulded cornice, Greek fret frame to central flat with moulded edges; segmental groin vault over bed alcove - the soffit of the arch to the room has square panels filled with rosettes
Joinery	Skirting; architraves to windows and doorways (simple, unadorned mouldings), and six-panel doors; panels above doors flanking alcove; six-pane sashes, sash shutters to windows
Features	Chimneypiece against east wall with lugged marble surround, mantelshelf breaking forward at both end and overmantel flanked by consoles with a split pediment, cast-iron grate; Dutch-style chandelier hung from centre of ceiling

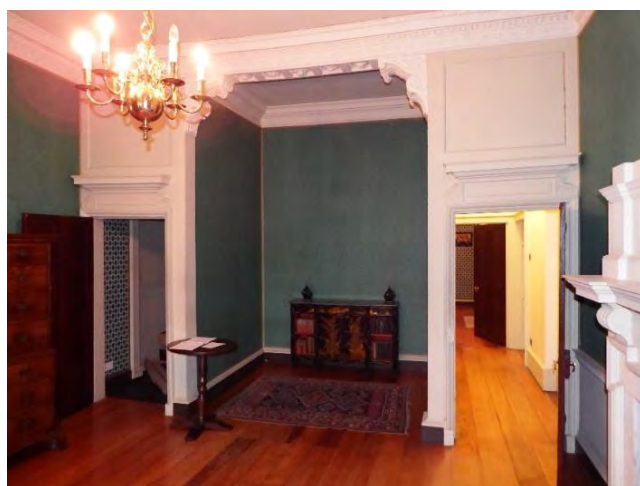
Element	Description (including history)
Walls	Plastered and painted up to dado; above it finished in green wallpaper. In the east passage there is no dado and the wallpaper is of the same pattern as that in the Wrought Room. The alcove was restored in 1953 as were all of the plaster walls.
Floor	Modern boards, marble hearth and some joists and beams were replaced in 1964/5
Ceiling	Plaster with elaborately moulded cornice and decorative frieze, which extends across the opening to the bed alcove where there are pairs of consoles set at a right angle to each other in each of the upper corners. The cornice is simpler in the bed alcove and the frieze there lacks any decoration. The ceiling in the east passage is much lower and lacks any cornice.
Joinery	Skirting; architraves to windows, doorcases and six-panel doors; panels above doors flanking alcove; six-pane sashes, sash shutters to windows. New door added from Wrought Room added 1953. All the sashes replaced in 1965.

Features	Chimneypiece against east wall (restored 1953), mantleshef with sections to both ends breaking forwards and supported on consoles, overmantel with plinth, cornice and shelf above

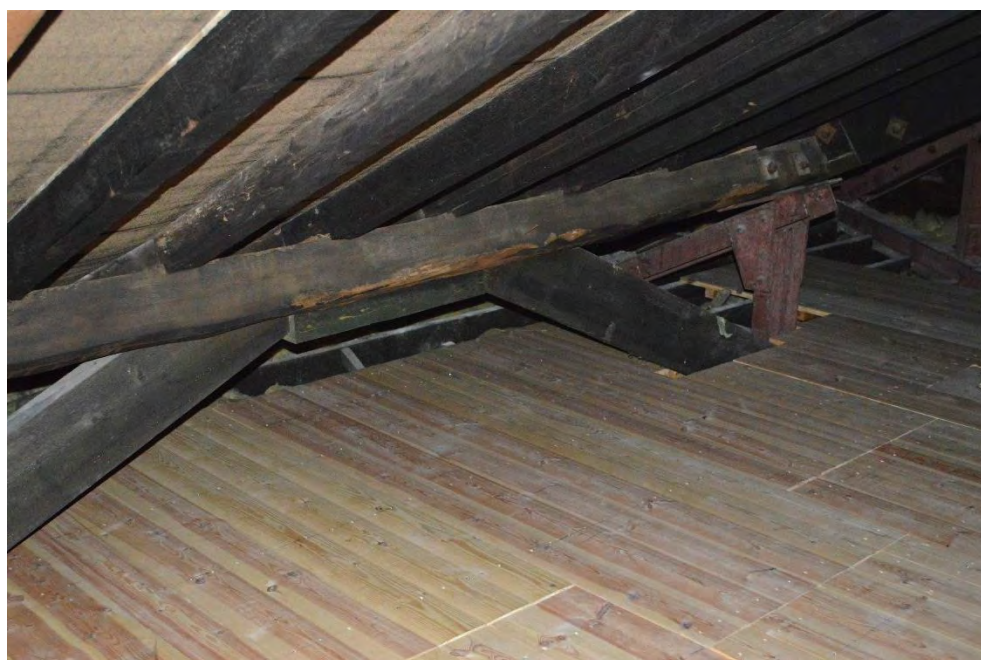
Brief description: This occupies part of the roofspace on the east side. Some of the rafters have been replaced and steel reinforcements running from the principals to the tie beam have been added.

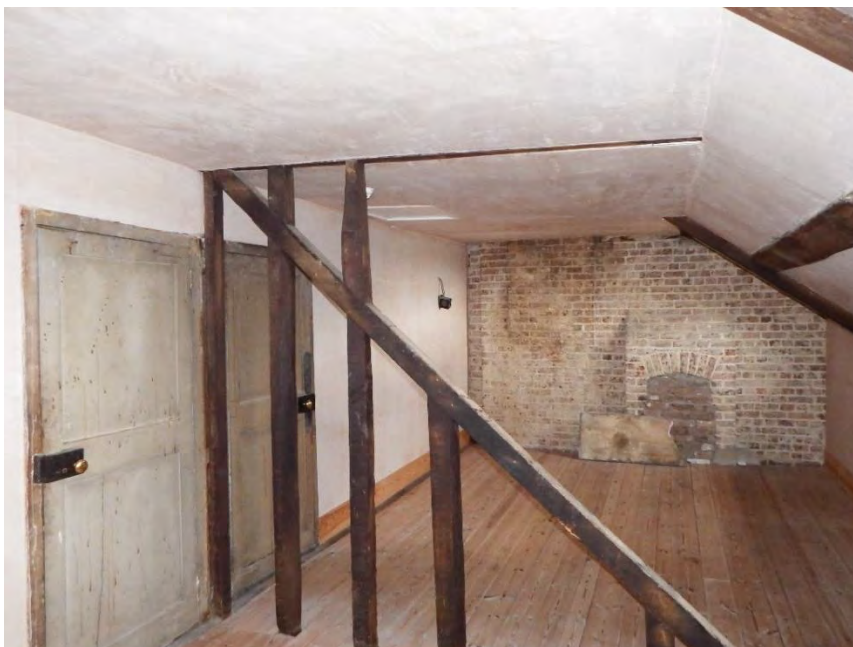
Element	Description (including history)
Walls	Bare brick to east and west, plaster to north and south
Floor	Narrow modern boards
Ceiling	Plaster – partly sloped on the south side because of the pitch of the roof; the principals and purlin protrude through the surface
Joinery	Modern skirtings, original two-panel doors with no mouldings, six-pane casements with modern frames in the two dormers, whose wooden construction is left exposed
Features	Remains of framework of timber stud wall running north-south in the centre; hatch in south wall for access to roofspace beyond, through which one of the middle three second-floor windows in the South Front can be seen; blocked fireplace in east wall

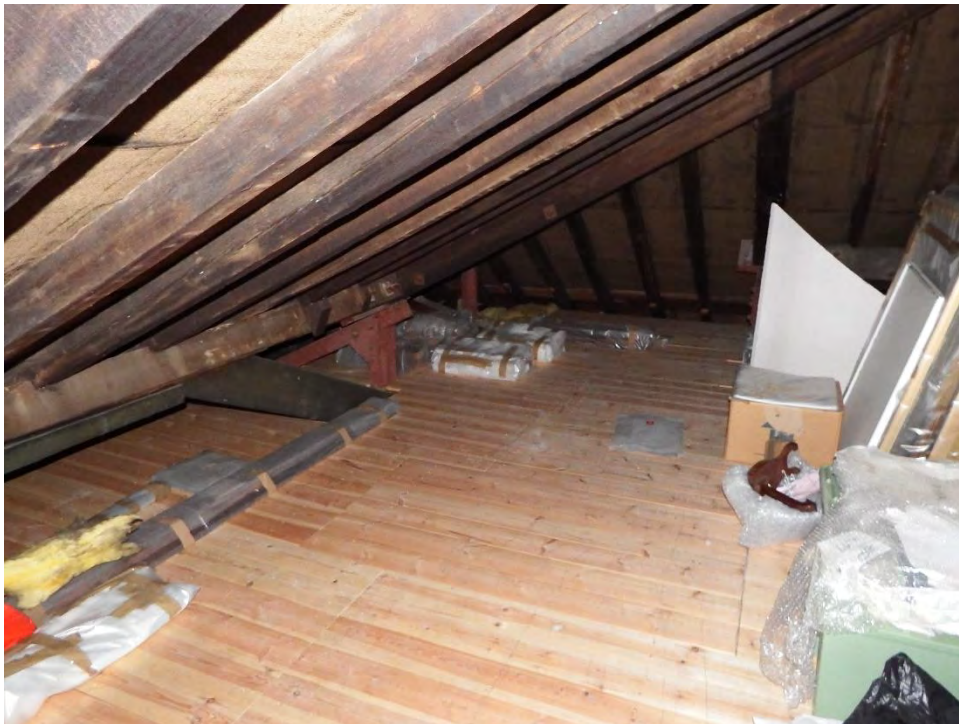
Brief description: This occupies part of the roofspace on the west side. Some of the rafters have been replaced.

Element	Description (including history)
Walls	Brick
Floor	Narrow modern boards
Ceiling	Underside of roof
Joinery	Double doors in the doorway from the Corridor

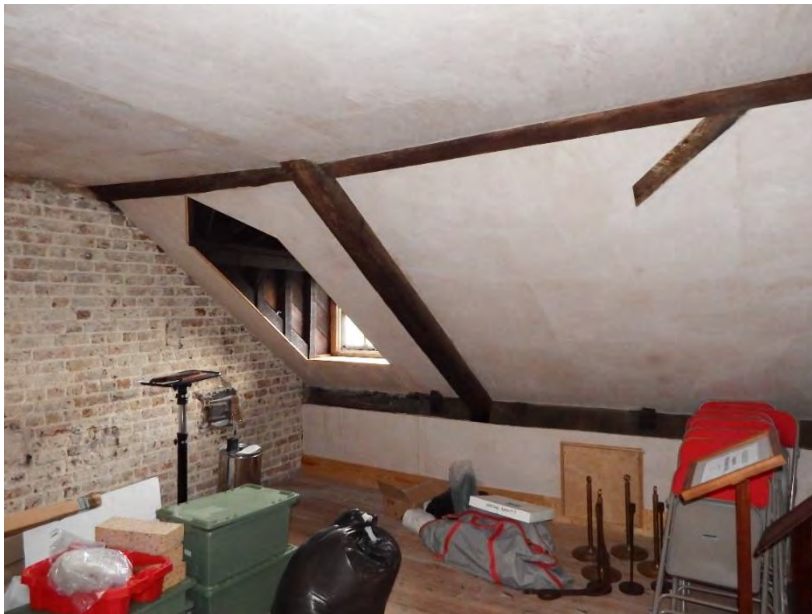
Element	Description (including history)
Walls	Plastered and painted except for brick west wall
Floor	Modern boards
Ceiling	Plaster – partly sloped on the north side because of the pitch of the roof and a principal, the purlin and part of a diagonal brace protrude through the surface
Joinery	Modern skirtings and hatch in north wall for access to roofspace beyond; six-pane casement in the dormer, whose wooden construction is left exposed
Features	Iron hatch in the west wall, perhaps some sort of vent or inspection hatch for a flue
