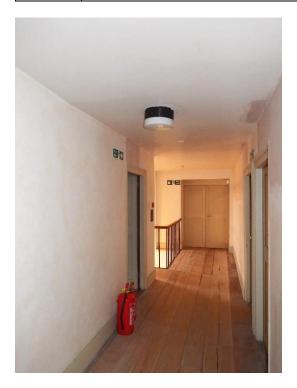
Room: 26a

Brief description: The Stone Staircase terminates in the roofspace, where the top landing forms part of a corridor running east-west across the garret between the two north-south spine walls that carry the flues. The only source of natural light is the eastern dormer in the north slope of the roof.

Element	Description (including history)
Walls	Plaster
Floor	Boards, partly historic; stone treads of stair
Ceiling	Plaster
Joinery	Skirting, door frames, two-panel doors, six-pane casement to dormer, handrail to stair and
	landing balustrade
Features	The roof of the dormer is glazed to provide extra light; hexagonal, brass-framed lantern hanging
	from ceiling

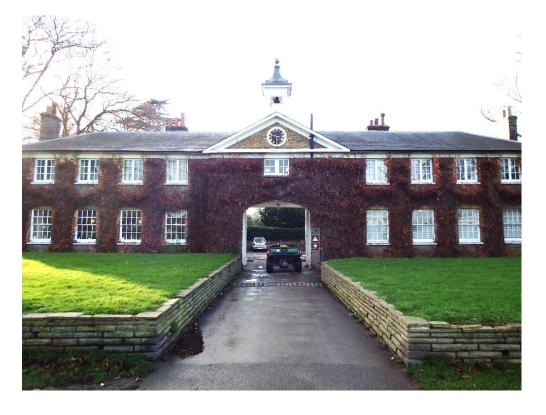
Location: East elevation

Brief description: This is the principal aspect of the stable block and has the greatest pretensions to formal design, being symmetrically composed about a central bay with a carriage entrance and a pediment, which frames a clock face. Above it is a turret housing the chiming bell. The pediment has a very simple cornice and a plain frieze runs the length of the elevation.

Element	Description (including history)
Walls	Stock brick, mostly obscured by creeper
Windows	16-pane sashes to the ground floor and 12-pane casements to the first floor, with one 8-pane casement in the central bay
Doors	Only in the side walls of the carriage entrance, providing access to staircases rising to the residential accommodation on the first floor.
Features	Elliptical arch to carriage entrance

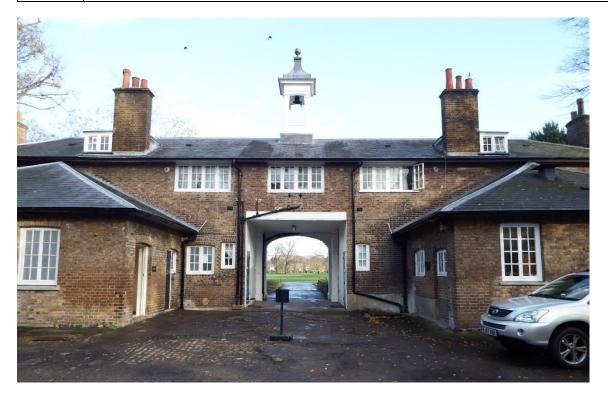
Location: West elevation

Brief description: This elevation faces the service yard and overlooks the houses at the southern end of Montpelier Row. It is symmetrically composed but otherwise more vernacular than formal in character. It was modified in 1905 when the three four-light casement windows in the centre of the first floor appeared, together with the adjacent chimney stacks. The eastern elevations of the two projecting wings were modified in 1964-1965: two doors in the southern wing were converted to windows and the cart shed, together with its doors, was reduced in size.

Element	Description (including history)
Walls	Stock brick
Windows	Casements varying in size from six to 24 lights
Doors	Plank and batten doors; double-leaf doors on iron hinges, each with six panels of sunk beading,
	to former cart shed
Features	Flat lintel to carriage entrance

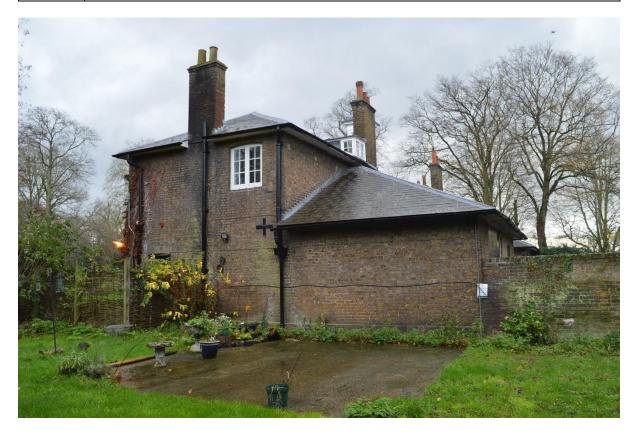
Location: North elevation **Date(s):** 1825-1827, 1905

Brief description: This plain elevation faces the shrubbery of the Sweet Walk and overlooks a garden, which has an area of hard standing, and a former changing block erected by the GLC. It was altered in 1905 when the ground floor door and window (the latter since blocked) and first floor window were created.

Element	Description (including history)
Walls	Stock brick
Windows	One 6-light casement window
Doors	One, from the former office
Features	The wall enclosing the service yard abuts the building at this point

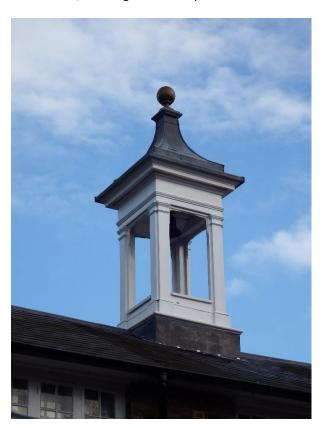
Location: Roof

Brief description: The roofs of the main block and rear wings of the stable block are hipped and covered in slates throughout. They have broad eaves, although at the north and south elevations the eaves line is broken by the chimney stacks. In the centre of the roof of the main block, aligned with the ridge and pediment on the east elevation, is a wooden turret, square in plan, which houses a chiming bell for the clock. The external faces of each post have Tuscan pilasters, with a frieze and deep cornice above. The turret has a lead-covered roof of truncated pyramidal form with concave faces, rising to another cornice and topped with a gilt ball finial. In 1905 dormers were cut through the western slope of the roof of the main block, abutting the chimney stacks added at the same time.

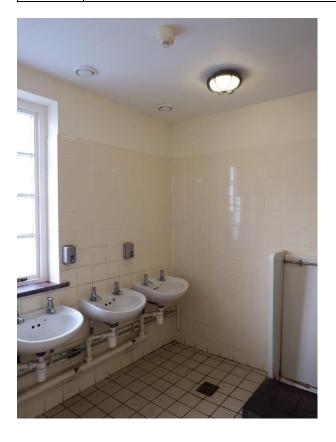
Room: G1

Brief description: A toilet was created in this location during the 1905 modifications and survives in the form of the single-cubicle staff toilet, which can be reached only from a separate door in the south wall. The visitors' male toilet was created in latter half of the twentieth century by subdividing the southern half of the former cart shed. In its current form it dates from the English Heritage guardianship.

Element	Description (including history)
Walls	Plastered and painted, tiled to head height
Floor	Tiled
Ceiling	Plaster
Joinery	Door, windows, hatch to roofspace
Features	Modern sanitary ware, partition walls for cubicles

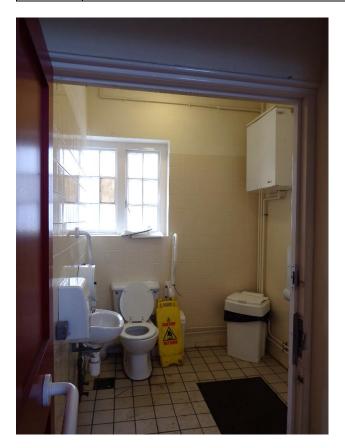
Room: G3

Brief description: This cubicle was created through the subdivision of the ground floor space in the northern half of the main block, which was originally occupied by stalls and turned into a bothy during the 1905 alterations. In its current form it dates from the English Heritage guardianship.

Element	Description (including history)
Walls	Plastered and painted, tiled to head height
Floor	Tiled
Ceiling	Plaster
Joinery	Doorframe, door, window
Features	Sanitary ware

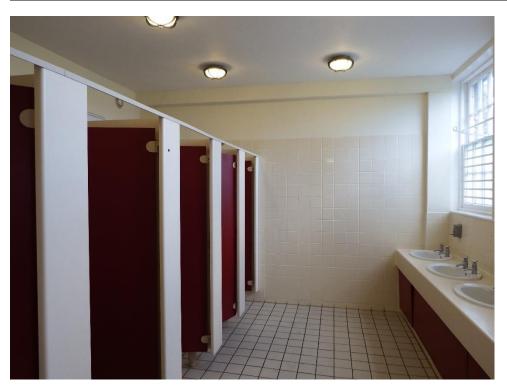
Room: G4

Brief description: Created through the subdivision of the ground floor space in the northern half of the main block, which was originally occupied by stalls and turned into a bothy during the 1905 alterations. In its current form it dates from the English Heritage guardianship.

Notes: A sealed chimney breast survives in the west wall behind a modern lining. The 1905 plan shows posts in this space like those that survive in G5 but they have been removed.

Element	Description (including history)
Walls	Plastered and painted, tiled to head height
Floor	Tiled
Ceiling	Plaster
Joinery	Doorframe, door, windows
Features	Modern sanitary ware, partition walls for cubicles

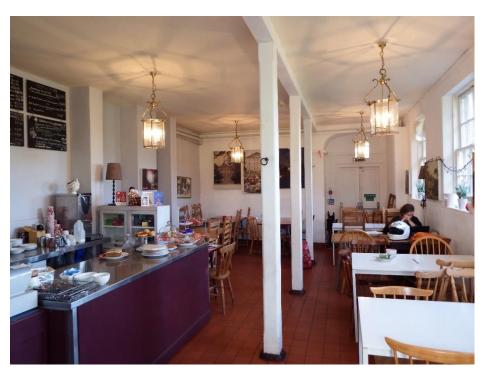
Room: G5 Name: Café

Brief description: This space was originally a stable, divided into four stalls by wooden stall dividers. There was a room at the southern end with a fireplace separated from it by a brick wall. At a date no earlier than 1964-1965 it was converted into a seating area for the café and the stall dividers were removed, leaving only the posts with which they terminated that rise from floor to ceiling and support a beam running the length of the space. The brick partition wall was removed to unite the stable with the adjoining room and a doorway was created communicating with the kitchen in the southern rear wing.

Element	Description (including history)
Walls	Plastered and painted with roll moulding at dado height
Floor	Red quarry tiles
Ceiling	Plaster
Joinery	Doors
Features	Chimney breast in south wall (grate and fireplace surround removed, opening sealed); elliptical- arched recess for door at north end; counter for serving food and catering equipment; iron tether rings attached to posts

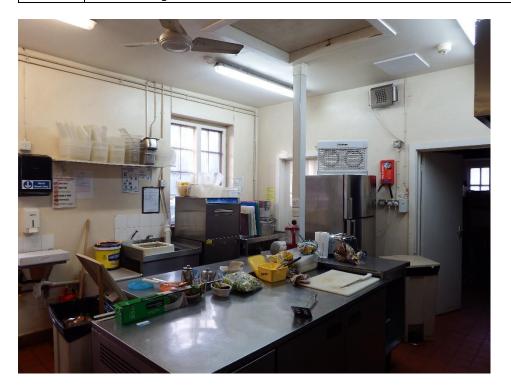
Room: G6
Name: Kitchen

Brief description: This space occupies all of the southern rear wing, which formerly housed the three loose boxes. At a date no earlier than 1964-1965 it was converted into a kitchen for the café through the removal of the internal partition walls and creation of a doorway in the east wall to communicate with the seating area. A partition wall was erected at the north end to form G7 and G8.

Element	Description (including history)
Walls	Plastered and painted
Floor	Red quarry tiles
Ceiling	Plaster
Joinery	Windows, doors
Features	Kitchen fittings

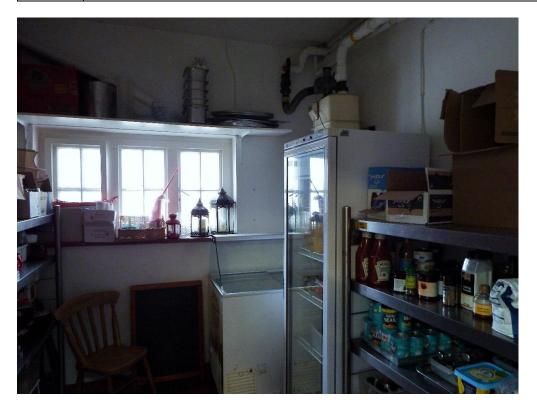
Room: G7

Brief description: One of the two spaces at the north end of the southern rear wing, currently used for storing food for the café.

Element	Description (including history)
Walls	Plastered and painted
Floor	Red quarry tiles
Ceiling	Plaster
Joinery	Window, doorframe, door
Features	Storage cabinets and shelving

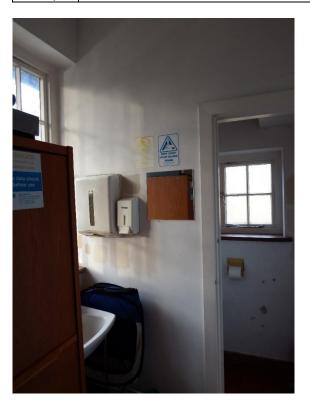
Room: G8

Brief description: The second of the two spaces at the north end of the southern rear wing, which consists of a storeroom subdivided at its north end to form a toilet cubicle.

Element	Description (including history)
Walls	Plastered and painted
Floor	Red quarry tiles
Ceiling	Plaster
Joinery	Windows, doorframes, door

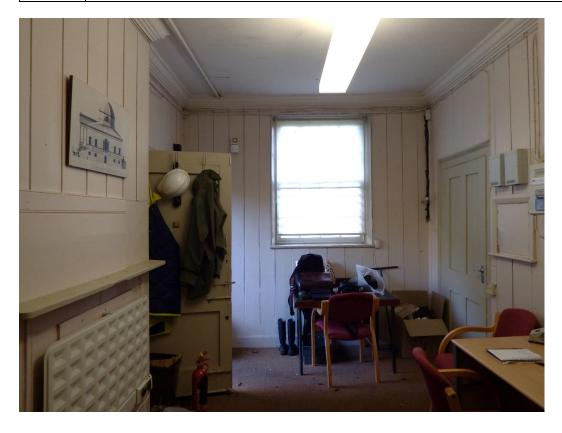
Room: G9

Brief description: This space is located at the north end of the main block. It once communicated with the adjacent former stable (the door is still intact but the doorway has been sealed off) and may have once been a tack room. In 1905 it was converted into an office.

Element	Description (including history)
Walls	Covered in vertical boarding with a moulded ceiling cornice
Floor	Carpet
Ceiling	Plaster
Joinery	Windows, doorframes, four-panel doors, mantelshelf, full-height built-in cupboard located in southwest corner
Features	Fireplace still intact although hidden from view by electric heater mounted in front of it

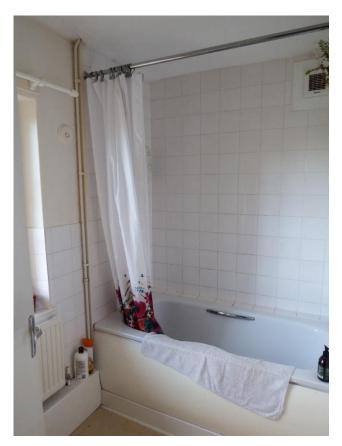
Name: Bathroom

Brief description: Created through subdivision of a larger bedroom

Element	Description (including history)
Walls	Plastered and painted, partly tiled
Floor	Linoleum
Ceiling	Plaster
Joinery	Window, doorframe, door
Features	Sanitary ware

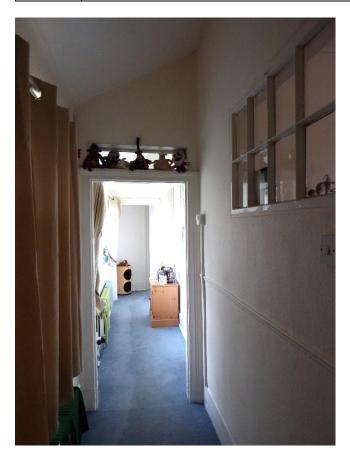
Brief description: A staircase rises through a quarter turn from a ground-floor lobby opening off the carriage entrance to a corridor running along the eastern side of the southern flat, providing access to all the rooms. The partition wall separating it from the living room is a modern fire wall but the partition wall with a window separating it from F5 is original.

Element	Description (including history)
Walls	Plastered and painted, stairwell wallpapered
Floor	Carpet
Ceiling	Plaster
Joinery	Door frame and overlight (former entrance to living room), window in east wall, dado rail,
	skirting

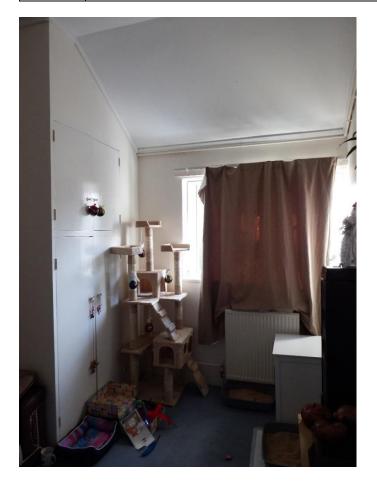
Name: Spare bedroom

Brief description: The northernmost of the three main rooms over the former south stable, shown as a bedroom on the plans for the 1905 alterations

Element	Description (including history)
Walls	Painted and plastered
Floor	Carpet
Ceiling	Plaster, partly extending into roofspace and following pitch of roof
Joinery	Doorframe, 4-panel door, window,
Features	Modern cupboard in SW corner, probably concealing a fireplace

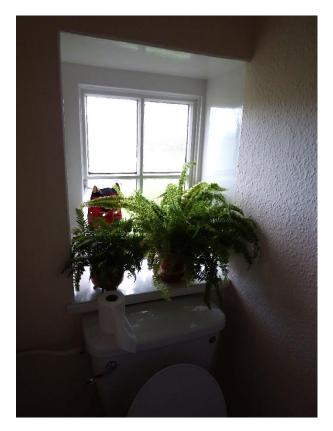
Brief description: On plan, the 'mirror image' of the toilet in the southern flat

Element	Description (including history)
Walls	Plastered and papered
Floor	Linoleum
Ceiling	Plaster
Joinery	Window, doorframe, door

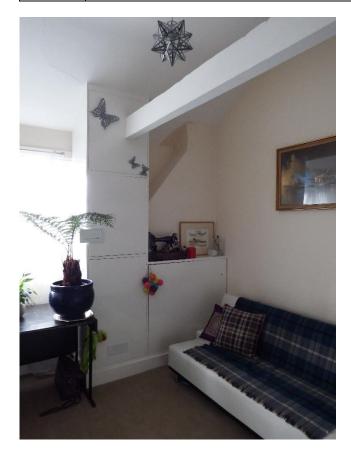
Name: Bedroom

Brief description: The 'mirror image' of F5 in the southern flat.

Element	Description (including history)
Walls	Plastered and papered
Floor	Carpet
Ceiling	Plaster, partly extending into roofspace and following pitch of roof
Joinery	Windows, door, skirting
Features	Tie beam of roof truss; historic built-in cupboard; modern cupboards against west wall
	concealing the chimney breast and fireplace

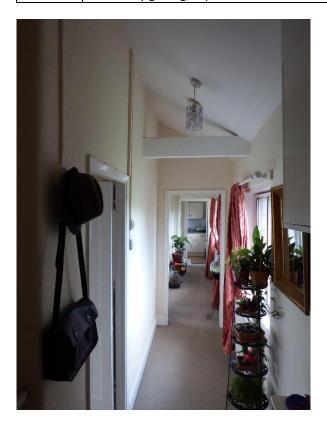
Brief description: The 'mirror image' of F4 in the southern flat - a staircase rises through a quarter turn from a ground-floor lobby opening off the carriage entrance to a corridor running along the eastern side of the flat, providing access to all the rooms. The partition separating it from the living room is modern but the partition wall with a window separating it from F12 is original.

Element	Description (including history)
Walls	Plastered and painted
Floor	Carpet
Ceiling	Plaster, partly extending into roofspace and following pitch of roof
Joinery	Windows, doorframes, skirtings, doors
Features	Secondary glazing; exposed tie beam of roof truss also visible in F12, handrail to stairs
