English Heritage Estates Department

Marble Hill Sports Building Refurbishment

North West & North East Elevations As Proposed

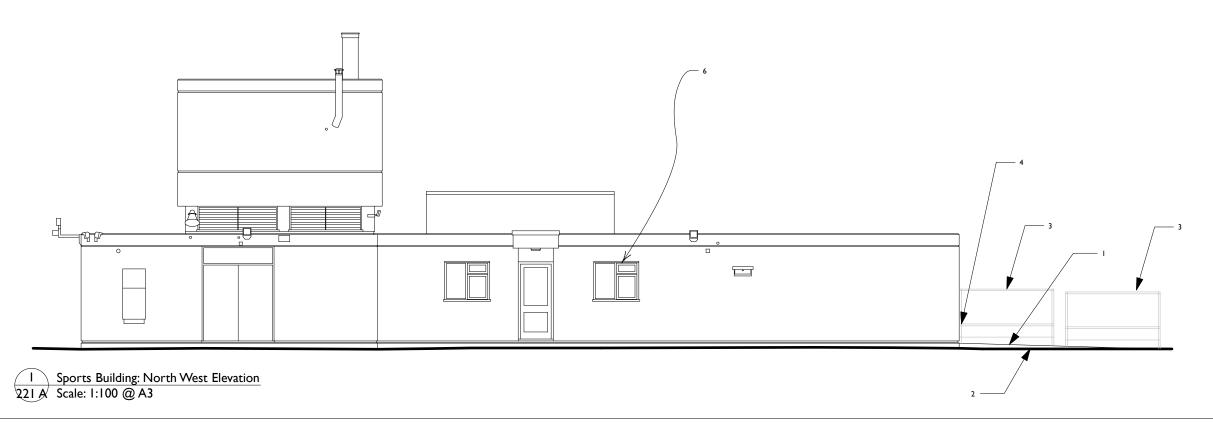
- Notes

I. Main Entrance Area; paving lifted and relaid to a minimum 1:25 fall to provide level access to the
- To the left of the door, the kerb to the road is to be removed to allow equal access for users who come to the Sports Building via the access road.

Existing Railing Boot Scrapers; reset to suit the new paying level.

- 4. New External Tap; for cleaning mud from wheelchair wheels.
  5. New external window, style to match existing.
  6. Existing window fitted with opaque film.
