South West London and St George's  
Mental Health NHS Trust

**Barnes Hospital**

Phase 1 Ground Contamination Desk  
Study

Issue 4 | 30 October 2018

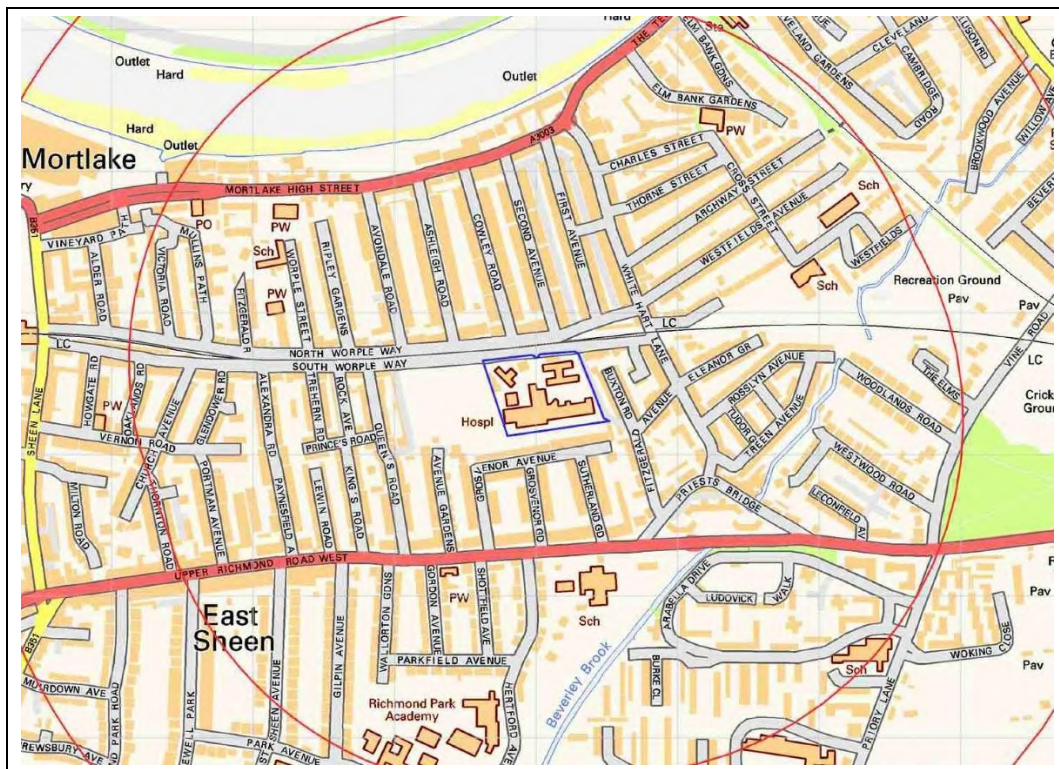
Plate 1 Site Location

The site is located on South Worple Way in Barnes, London, SW14 8SU. The National Grid Reference for the site is TQ 212 756 and the location is illustrated in Figure 1 and Plate 1 below. The site is bounded by South Worple Way to the north, a cemetery to the west and residential properties to the south and east. The location of the site is shown (with a blue outline) below.

The site is roughly square in shape and is located in a residential area between Barnes, Mortlake and East Sheen. The River Thames is located around 340m to the north.

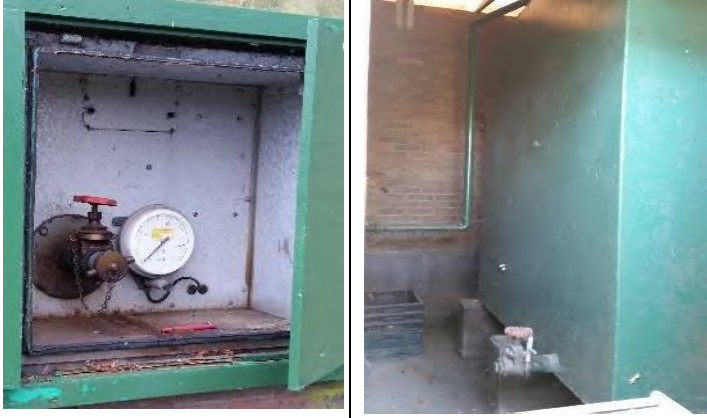
Description	Photograph
<p>13,600 litre diesel tank and filling point, located in the <i>Generator House</i> in building M in the northeast of site.</p> <p>The tank was observed to be in good condition, and the hardstanding beneath it was observed to be intact and unstained, although there was a general smell of diesel in the vicinity of the tank.</p>

Prior to demolition all potential contamination sources including fuel tanks such as the 3,000 gallon diesel tank, identified during the site reconnaissance visits, should be safely decommissioned and removed from site. If tank removal is necessary, it should be undertaken by a specialist contractor and would likely include emptying residual fuel or water, degassing and additional ventilation measures. The decommissioning and removal of fuel storage tanks is described in Environmental Agency guidance PPG27 [8]. It is noted that this guidance has been removed from the gov.uk web site, although it does contain useful procedures. It is available from other related websites, such as Netregs [9] for

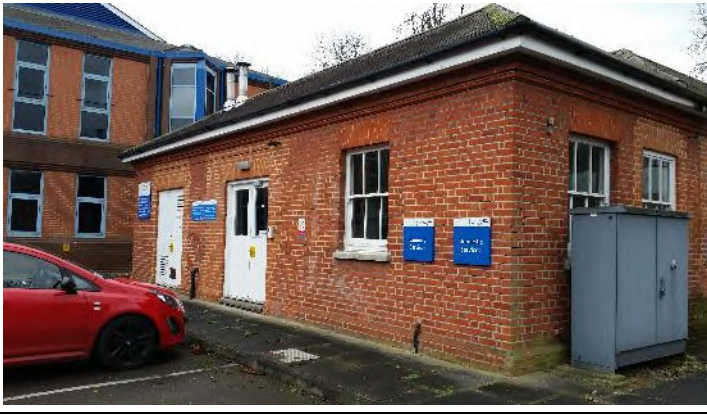
<p>Building D: <i>Laundry House</i>.</p> <p>Large washing machines were observed inside, along with sewing machines and ironing boards. No industrial scale laundry activities or chemical storage were observed.</p>

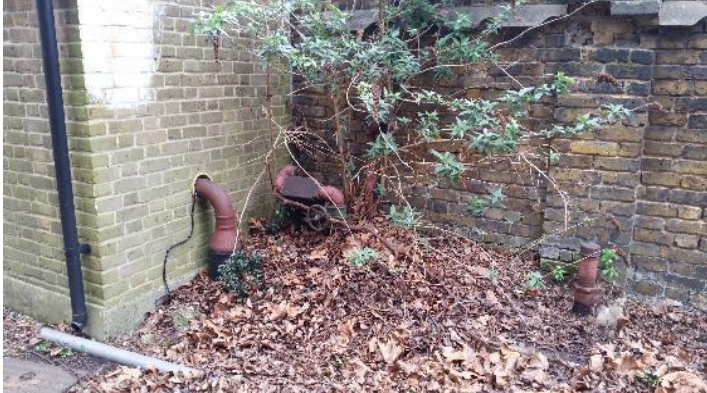
<p>Suspected tank base alongside the gas service cupboard on the north boundary of the site. The area was inferred to be an old tank base due to its accessible location near the site boundary, and was observed to have old pipe connections and to be raised on a brick plinth.</p>

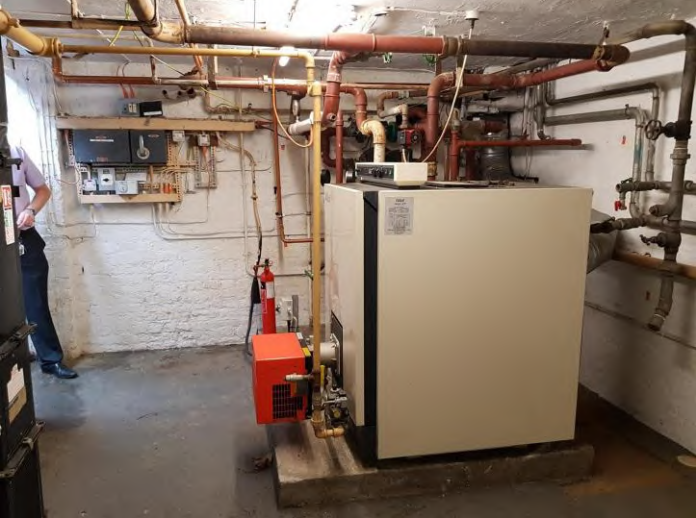
Description	Photograph
Symmetrically located basement plant room at <i>Beatrice Lodge</i> (building E), with modern plant installed. The former tank or generator base plinth is visible.

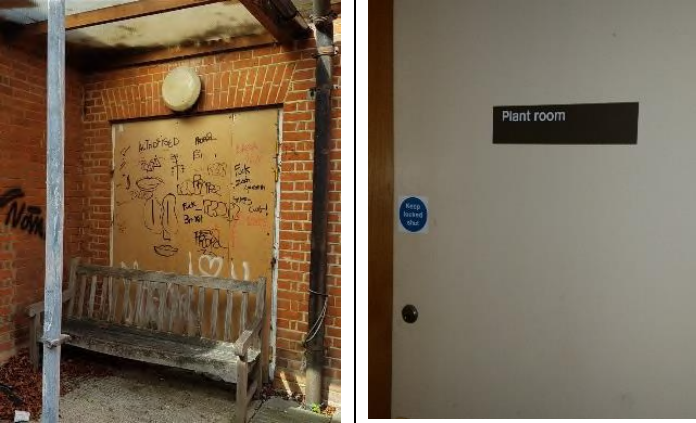
Doors to locked plant rooms in Building D the <i>Laundry House</i> (left) and Building C (right).

Other plant rooms were located on the ground floors of buildings C and D. Access to these was not possible, the site contact stated that these contained gas fired boilers only. Given the ages of the buildings it is possible that other fuels may have been used in the past.

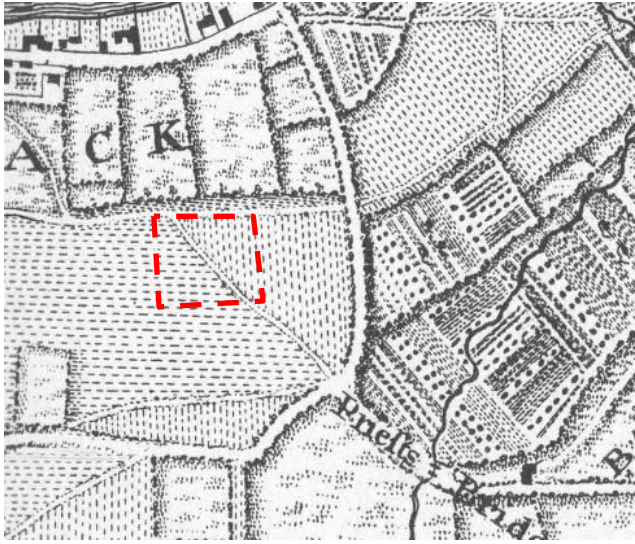
<p><b>John Roque Map 1746</b></p> <p><b>Onsite:</b> The approximate location of the site is highlighted in red.</p> <p>The site was open fields, and the map pre-dates the development of the cemetery and railway, which are both shown on the earliest available OS mapping from 1866.</p> <p><b>Offsite:</b> The surrounding area was also largely comprised of open fields. The footpath passing diagonally through the site from Priests Bridge remains today to the south east of the site.</p>
<p><b>1869 1:2,500.</b> No significant change on or offsite</p>

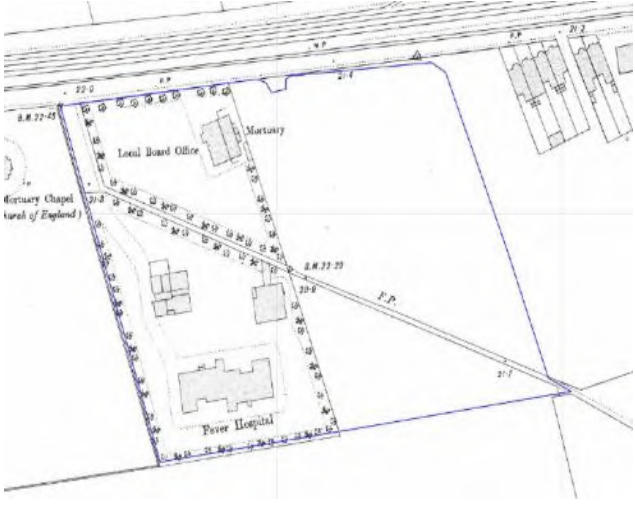
<p><b>1896 1:1,056</b></p> <p><b>Onsite:</b> The western half of the site was originally developed with the fever hospital, mortuary and offices in the late 19<sup>th</sup> century.</p> <p>The office and mortuary building is still present today as building K. The building in the west of site is still present as the laundry, building D.</p> <p><b>Offsite:</b> Residential development to the north east and south west of the site had occurred but the immediate vicinity of the site remains undeveloped, except for the railway adjacent to the north.</p>

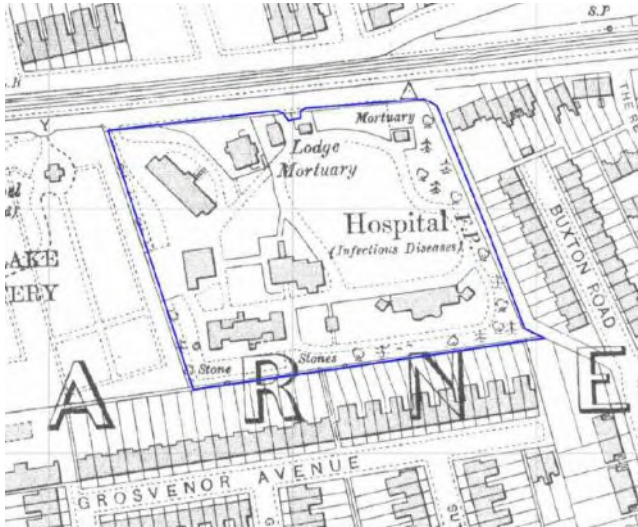
<p><b>1913 1:2,500</b></p> <p><b>Onsite:</b> The hospital had expanded to occupy the entire site. Buildings I, J and parts of buildings C and L had been constructed. An additional mortuary in the northeast of site was also developed with further buildings in the far south of site that would be subsequently redeveloped.</p> <p><b>Offsite:</b> Residential properties adjacent to the site in the east (Buxton Road) and south (Grosvenor Avenue) had been built.</p>
<p><b>1919 1:2,500.</b> No significant change on or offsite.</p>

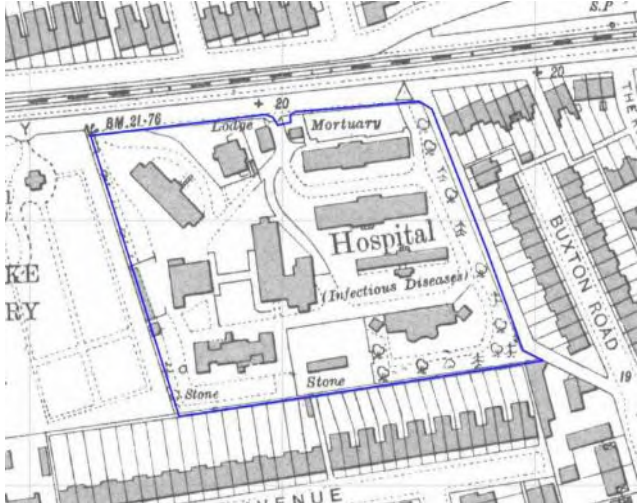
<p><b>1933 1:2,500</b></p> <p><b>Onsite:</b> Further buildings had been built including buildings E and G (Fleming and Beatrice Lodges) and most of building C. The building in the northeast is no longer shown. Other small buildings are shown in the west, south and east that will be subsequently redeveloped.</p> <p><b>Offsite:</b> A site, shown on later maps as a garage, has been built to the southeast of site and an omnibus depot is shown approximately 120m to the north-west.</p>

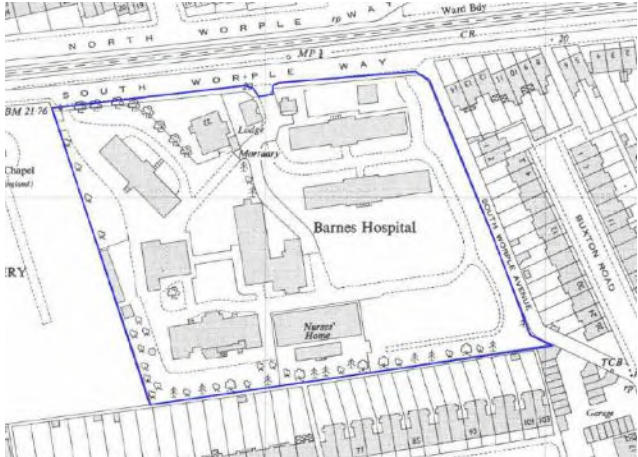
<p><b>1951 1:1,250</b></p> <p><b>Onsite:</b> A Nurses' Home had been developed in the south of site, a small square building had been constructed in the northeast, and other buildings in the east of site had been demolished.</p> <p><b>Offsite:</b> A garage is shown approximately 20m to the south east.</p>
<p><b>1966 1:1,250.</b> <b>Onsite:</b> the only change is the addition of building F, linking the two lodges (E and G). <b>Offsite:</b> no significant change</p>

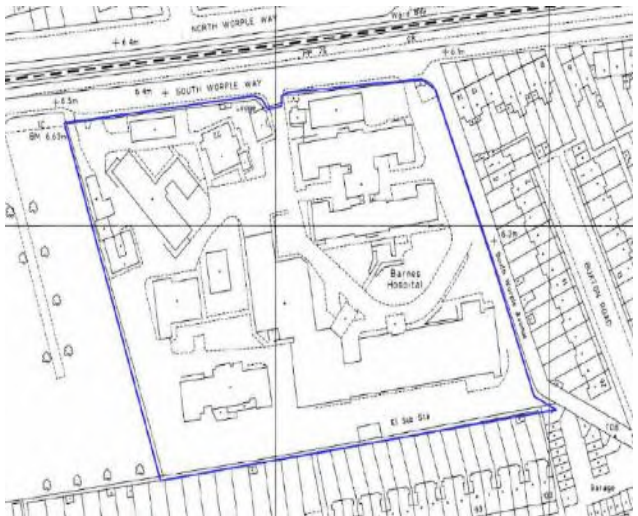
<p><b>1991 1:1,250</b></p> <p><b>Onsite:</b> Development of: the current mortuary and generator house (building M), <i>Fleming Dining Area</i> (building H, recently demolished), building A, and two buildings which have since been demolished in the northwest and centre of site.</p> <p>The electricity substation on the southern site boundary is shown.</p> <p><b>Offsite:</b> The omnibus depot to the north west is now labelled as a bus station.</p>
<p><b>1994 1:1,250. Onsite:</b> The recent site layout is shown including development of building B.</p> <p><b>Offsite:</b> No significant change.</p>

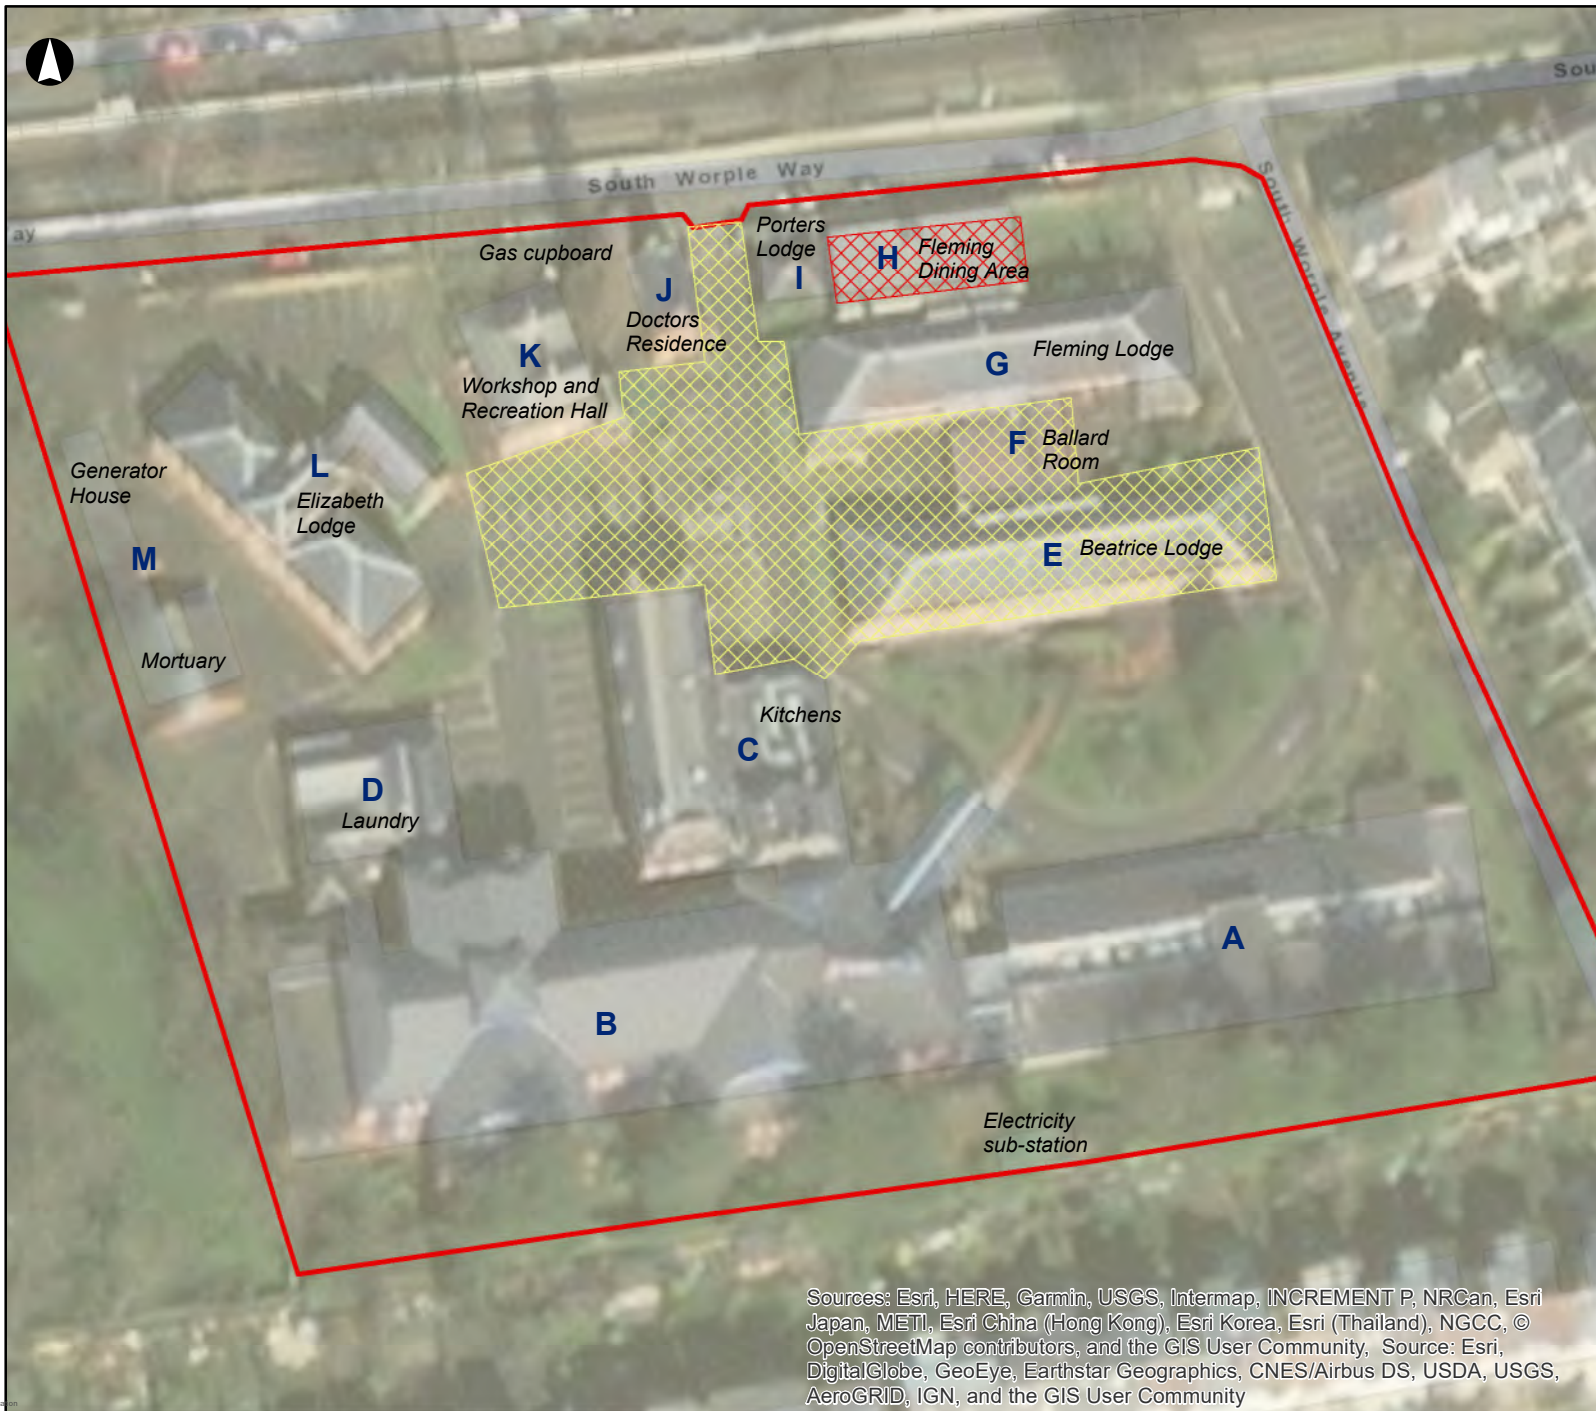
Drawing No <b>Figure 2</b>	Issue <b>F1</b>
-------------------------------	--------------------

- Demolished building
- Site zone in use
- Site boundary
- A** Building labels

The site comprises a number of predominantly brick built one to two storey buildings varying in age from the late 19<sup>th</sup> century to 1990s. The buildings are surrounded by areas of car parking and soft landscaping. The site layout is illustrated in Figure 2 and Plate 2. Buildings have been labelled for ease of reference throughout the report.
