Detailed Unexploded Ordnance (UXO) Threat and Risk Assessment

Detailed Unexploded Ordnance (UXO) Threat & Risk Assessment

The Client has defined the Study Site as “Homebase Ltd, 84, Manor Road, Richmond, TW9 1YB”. The Site is located at NGR 518920, 175460.

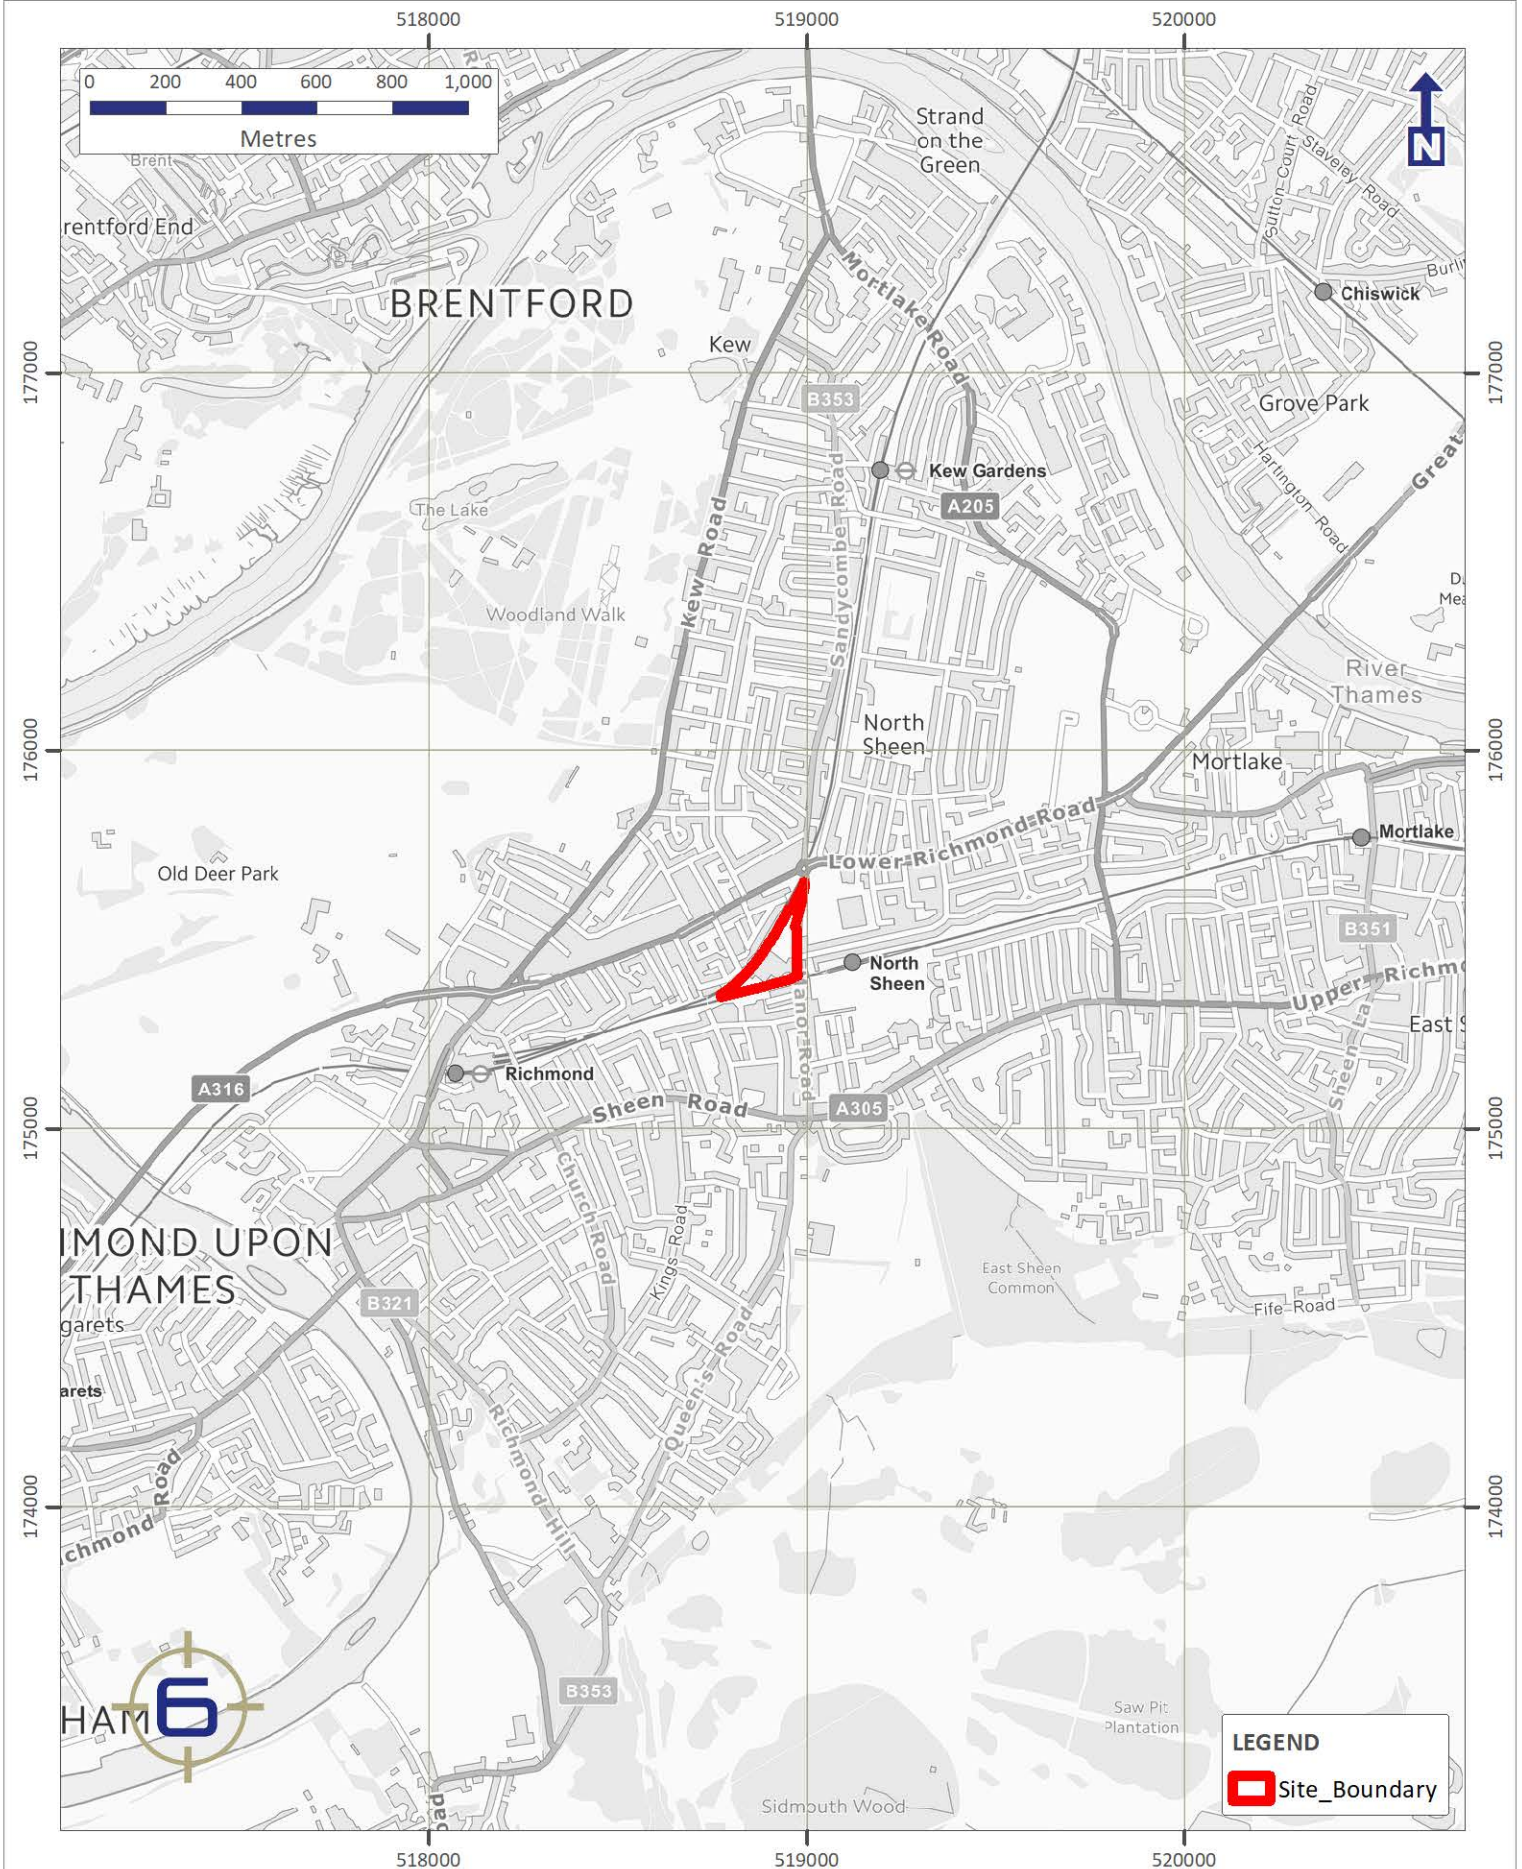
The Client has defined the Study Site as “Homebase Ltd, 84, Manor Road, Richmond, TW9 1YB”. The Site is located at NGR 518920, 175460. The Site location and Site boundary are presented at *Figures 1* and *2* respectively.

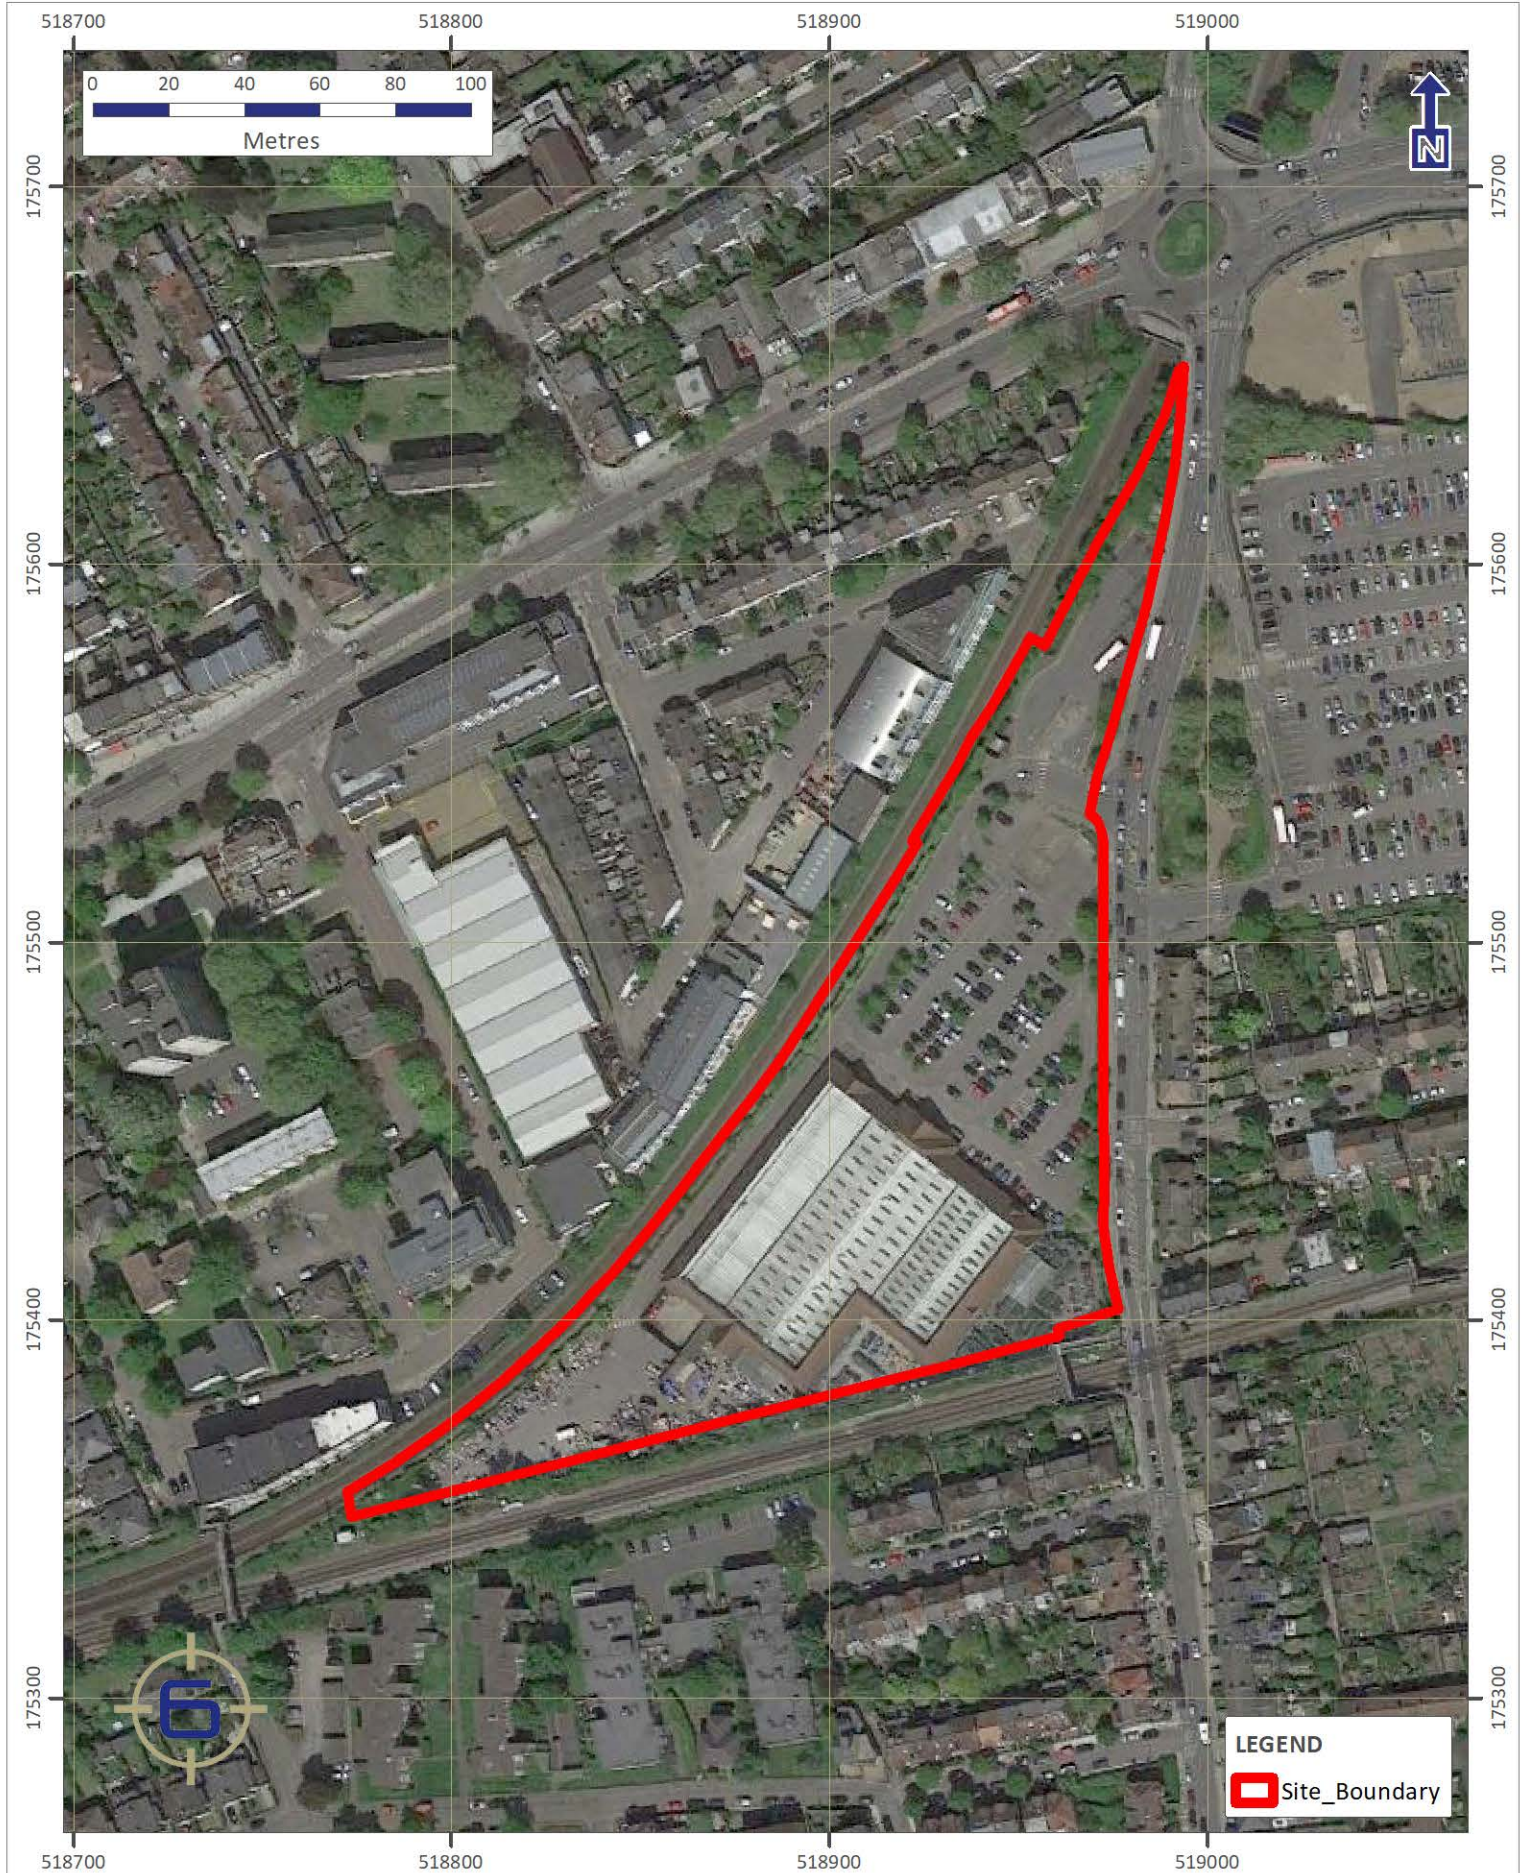
Figure Three - Aerial Photography (2018)

Aerial photography (2018) corroborates the information above and shows that the Site is situated within a densely developed urban area. The Study Site itself consists of a large industrial building, hard-standing and a large Hard-standing car park.

Aerial Photography (2018)

Aerial Photography (2018) (*Figure 3*)

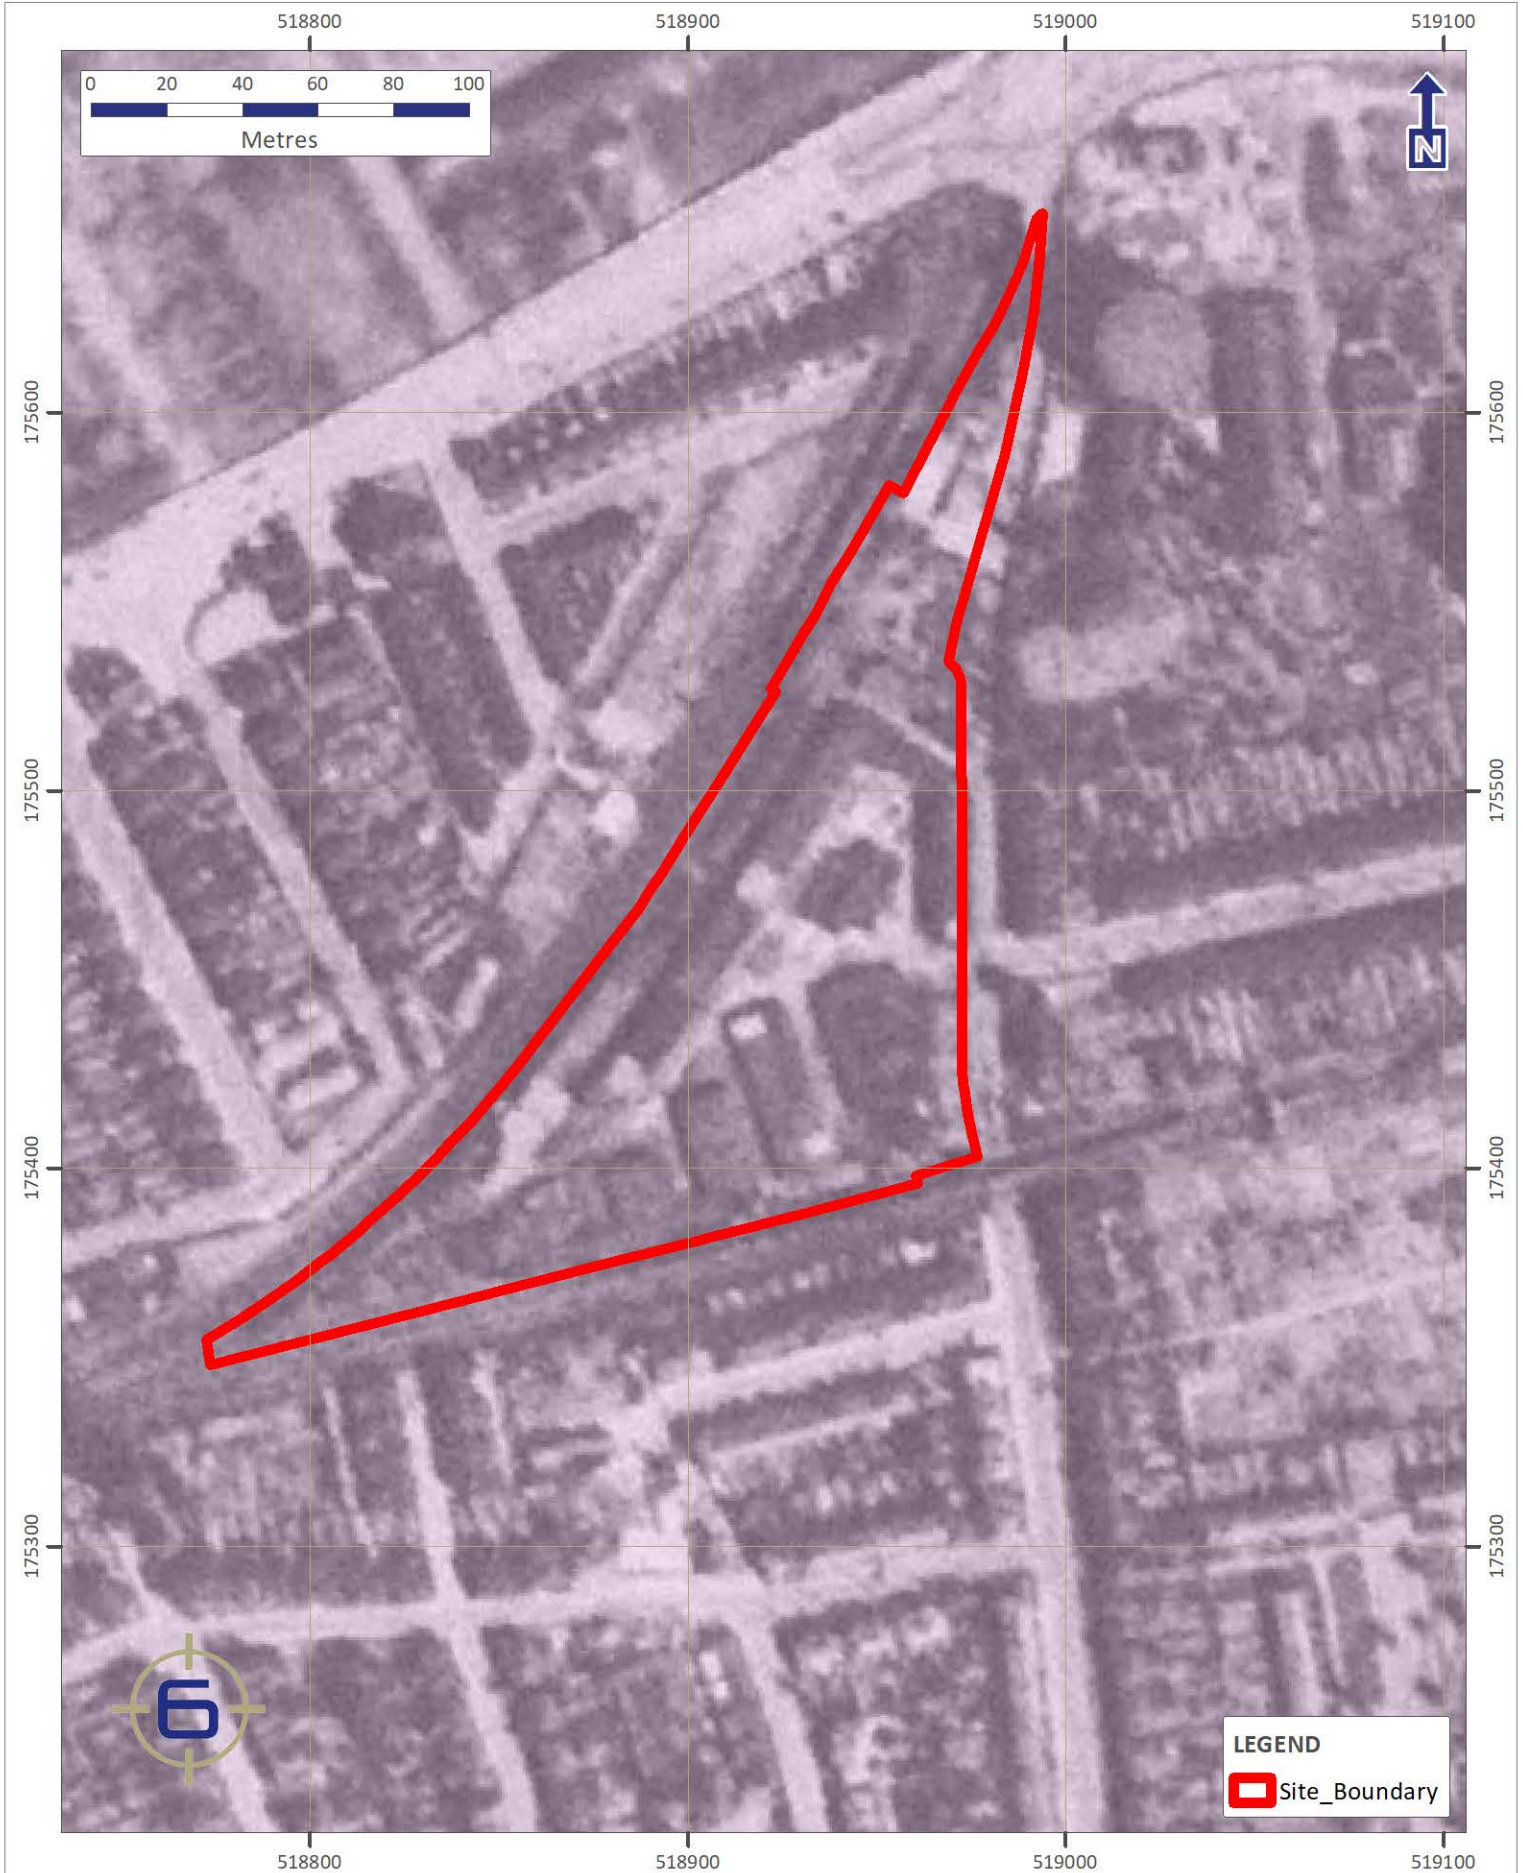
Pre-WWII mapping (1934 - 1936) and aerial photography (1945) associated with the Site shows that it was located within a densely developed urban area during WWII, with the Site itself consisting of a timber yard and several small structures. As a result, it is considered likely that employees from the timber yard may have observed and reported any UXB entry holes which would have been dealt with at the time. However, given the trajectory of incoming weapons this in fact may not have been the case.

Aerial Photography (1945)

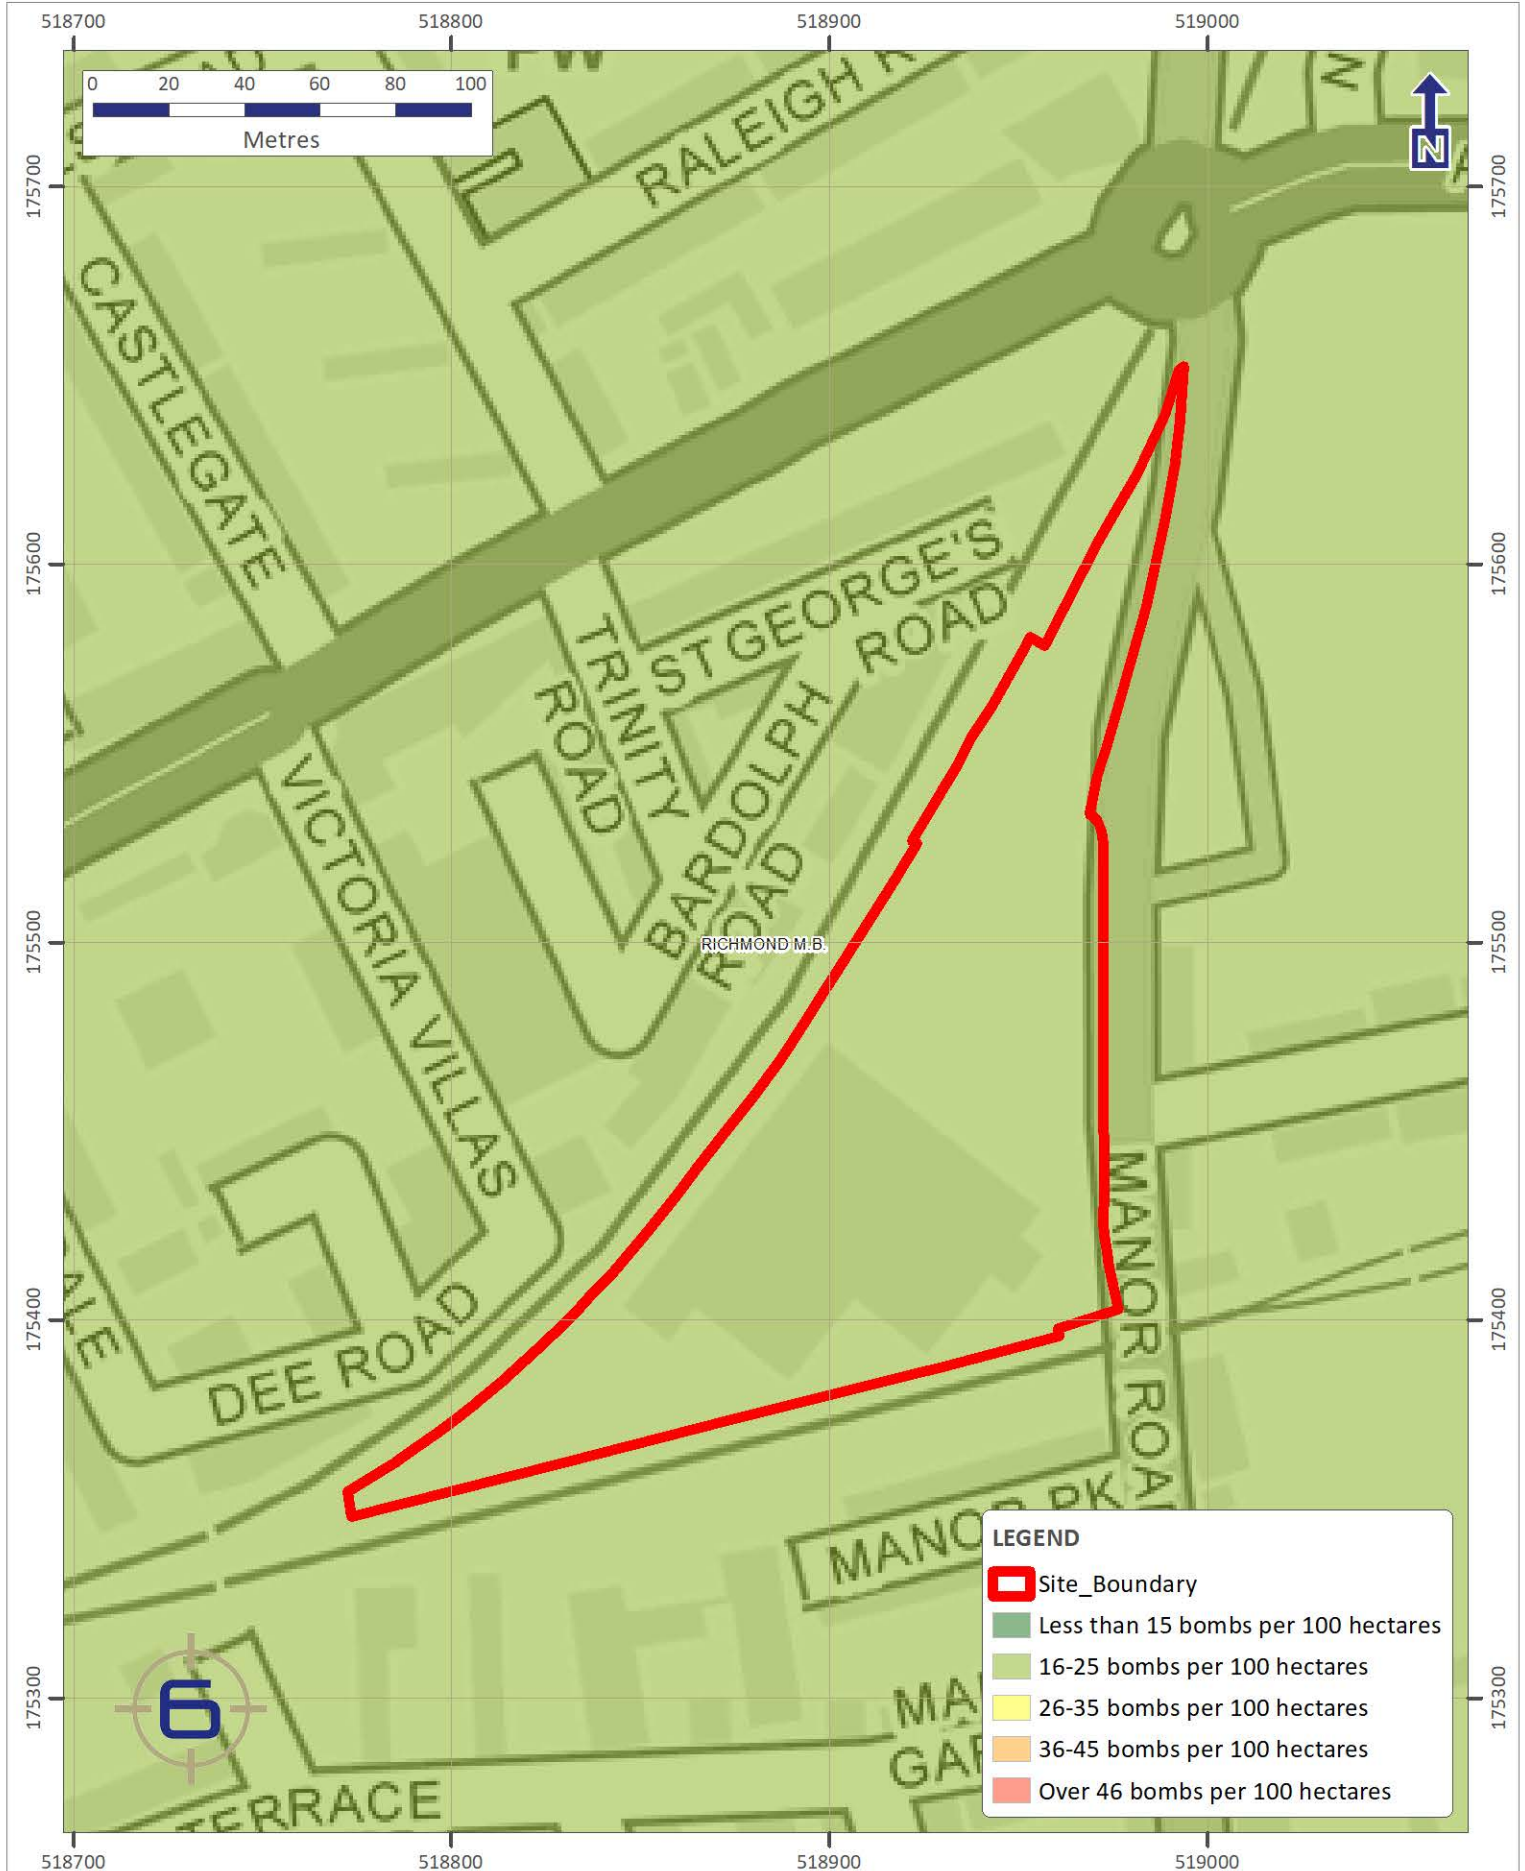
During WWII, the Study Site was situated within *Richmond Municipal Borough*, which recorded 22 HE bomb strikes per 100 hectares, a low level of bombing.

WWII High Explosive Bomb Density
