# Greggs Bakery / Twickenham

## Phase I, Environmental Assessment

**FORMER GREGGS BAKERY  
GOULD ROAD  
TWICKENHAM  
TW2 6RT**

**Phase I  
Environmental Assessment**

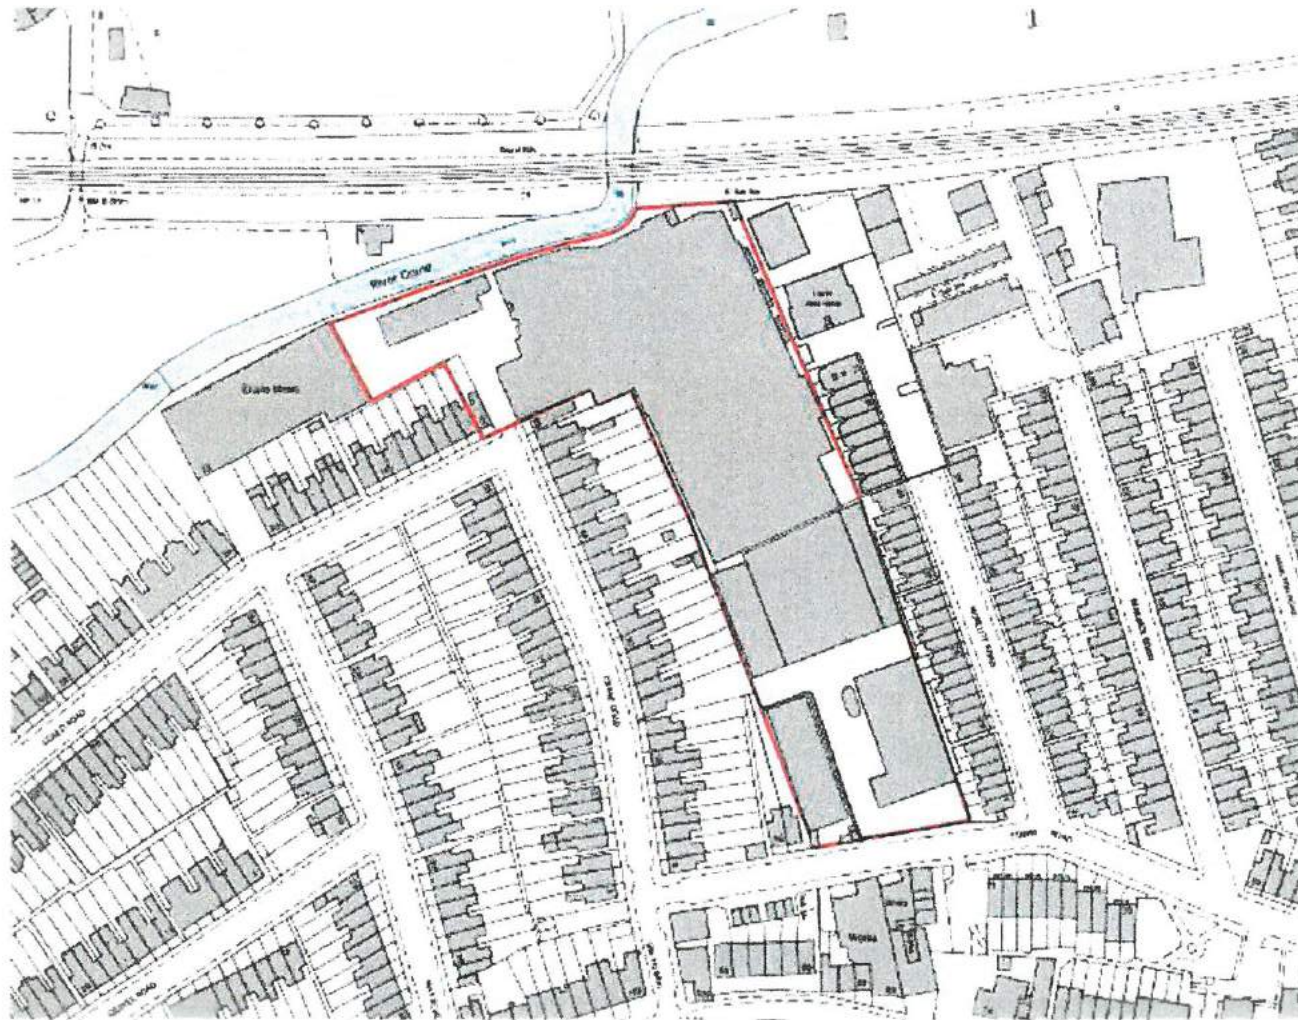
The area under investigation is an approximate 'L' shaped plot of land extending to some 1.12 hectares, as shown on Figure 1 at Appendix A. The site was, from 1953 until November 2016, a bakery and distribution depot for Greggs.

Existing site plan

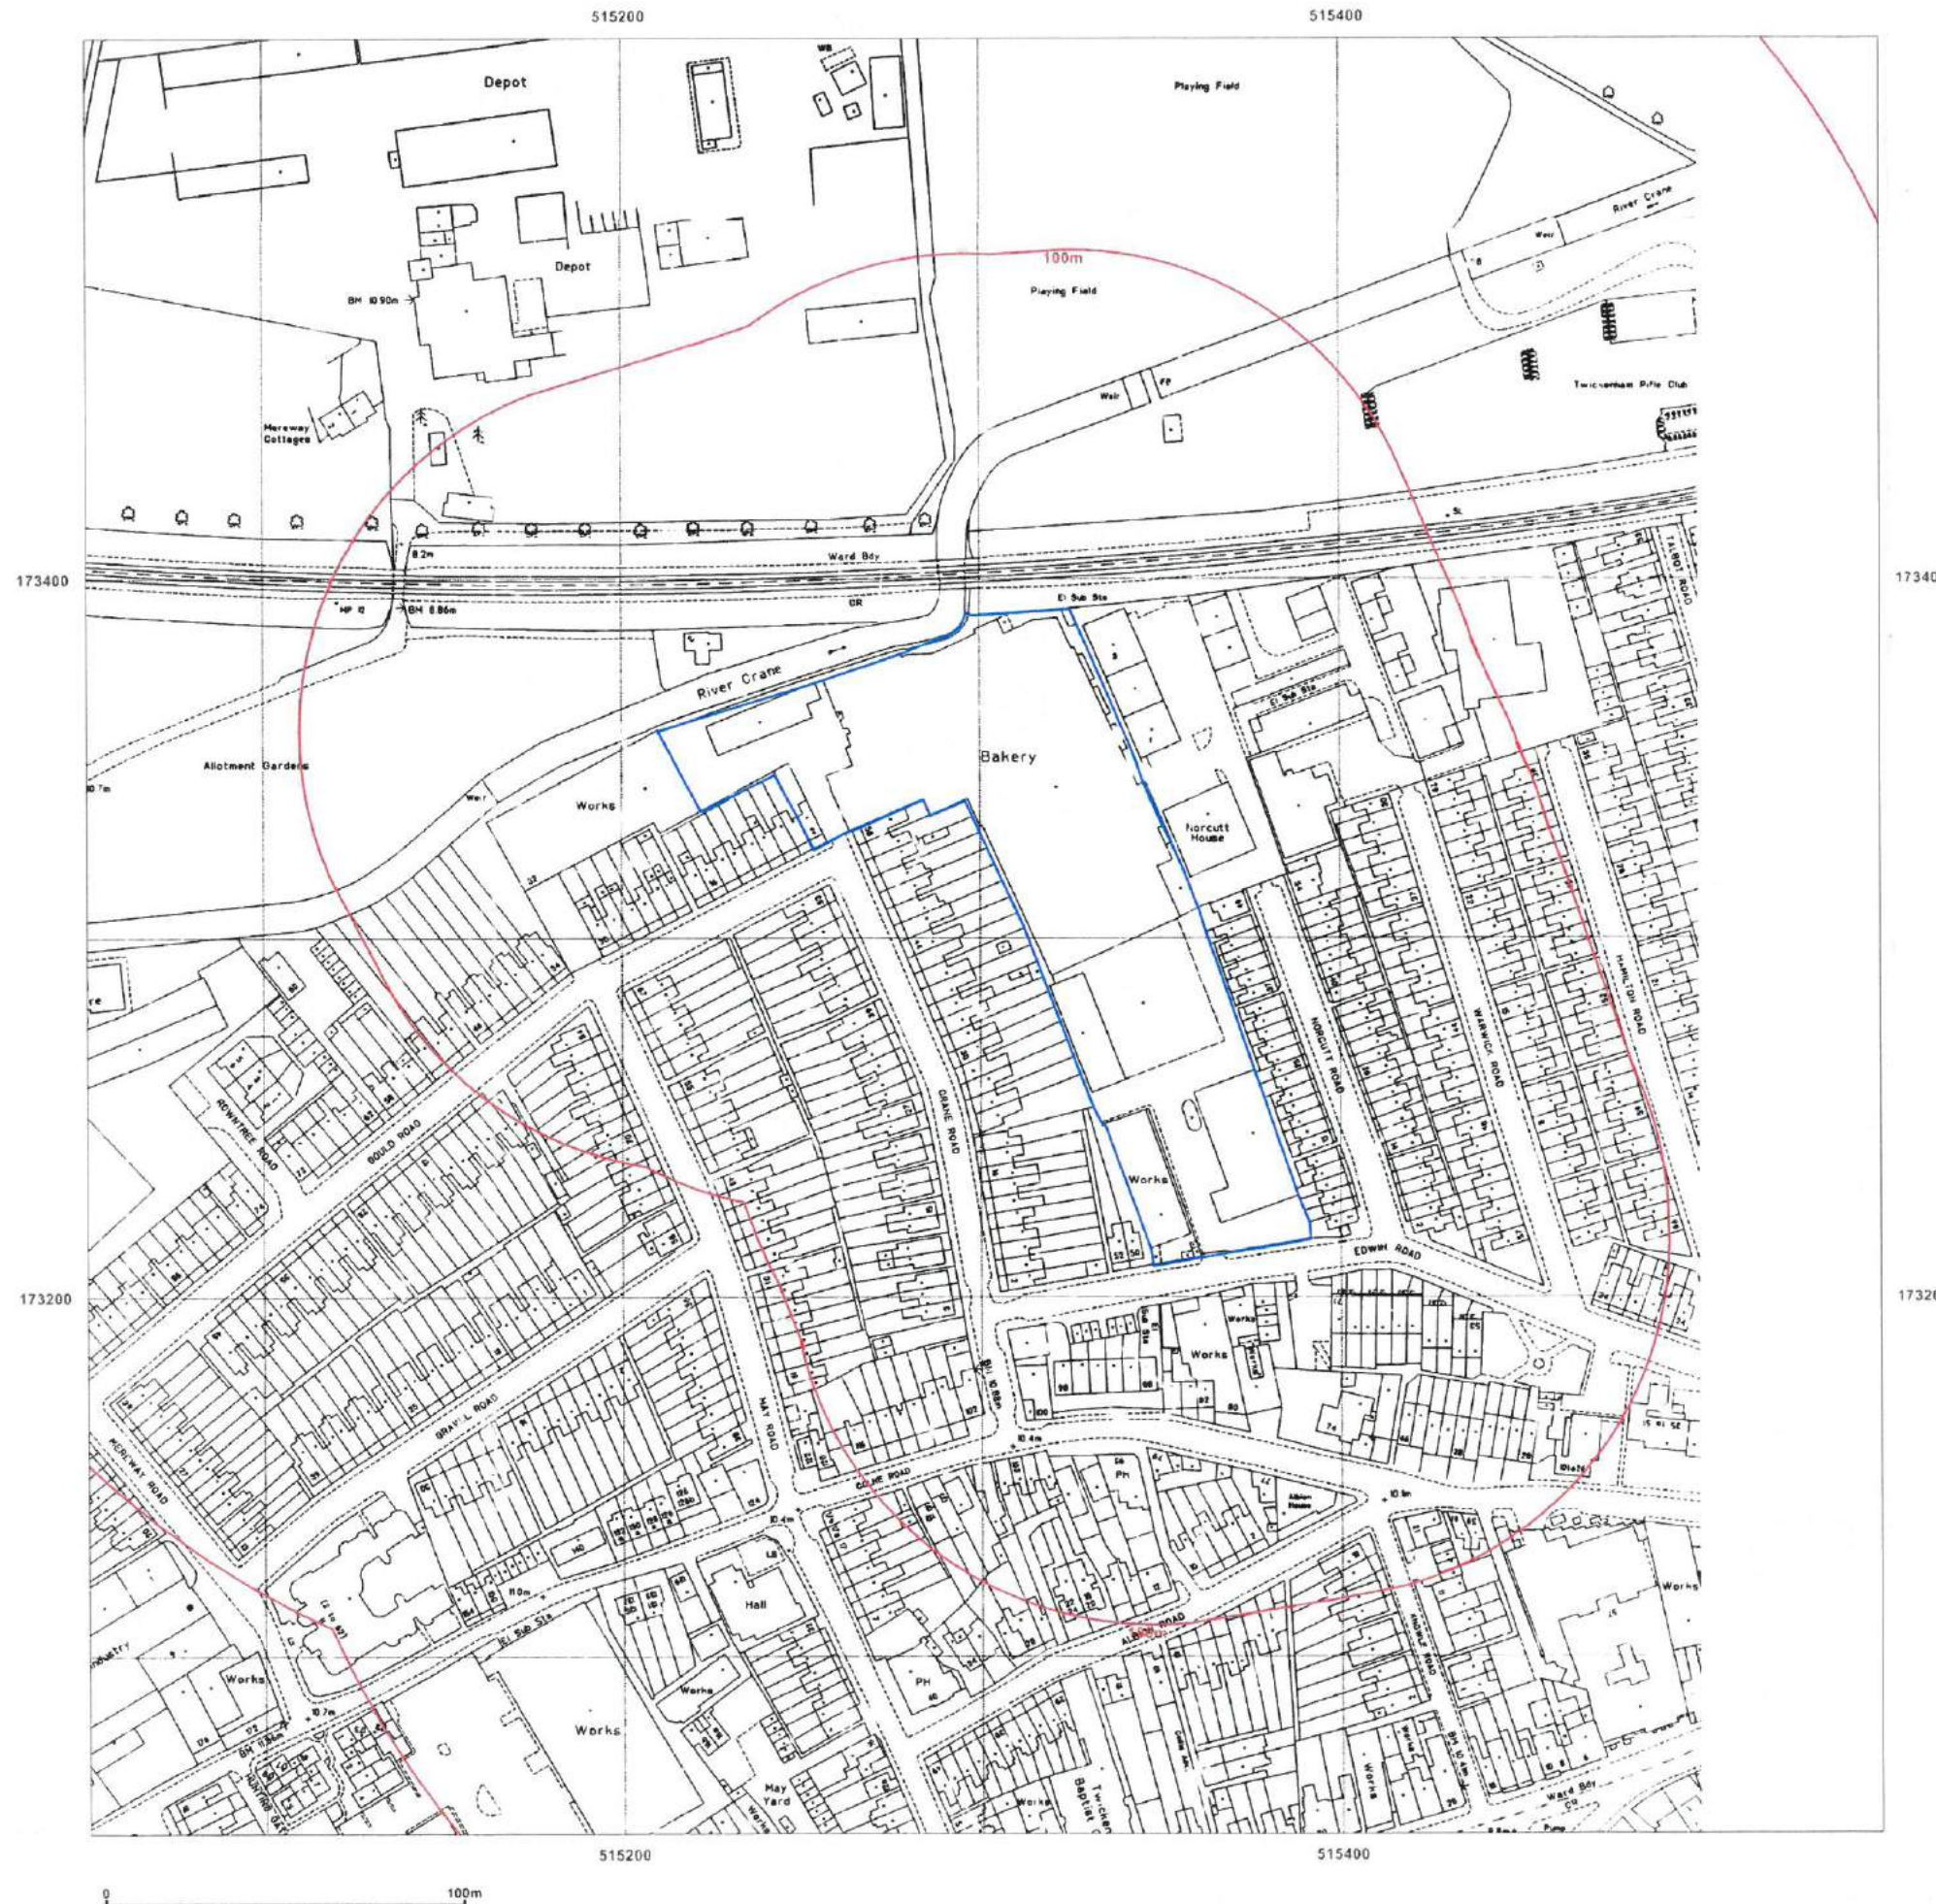
Figure 9

The majority of the site remains unchanged although the main Bakery outline has changed and a rectangular building is shown in the north west. The Printing Works immediately to the east have been demolished and replaced by Norcutt House and three square structures.

Extract from Ordnance Survey Map  
National Grid: 1993-1994

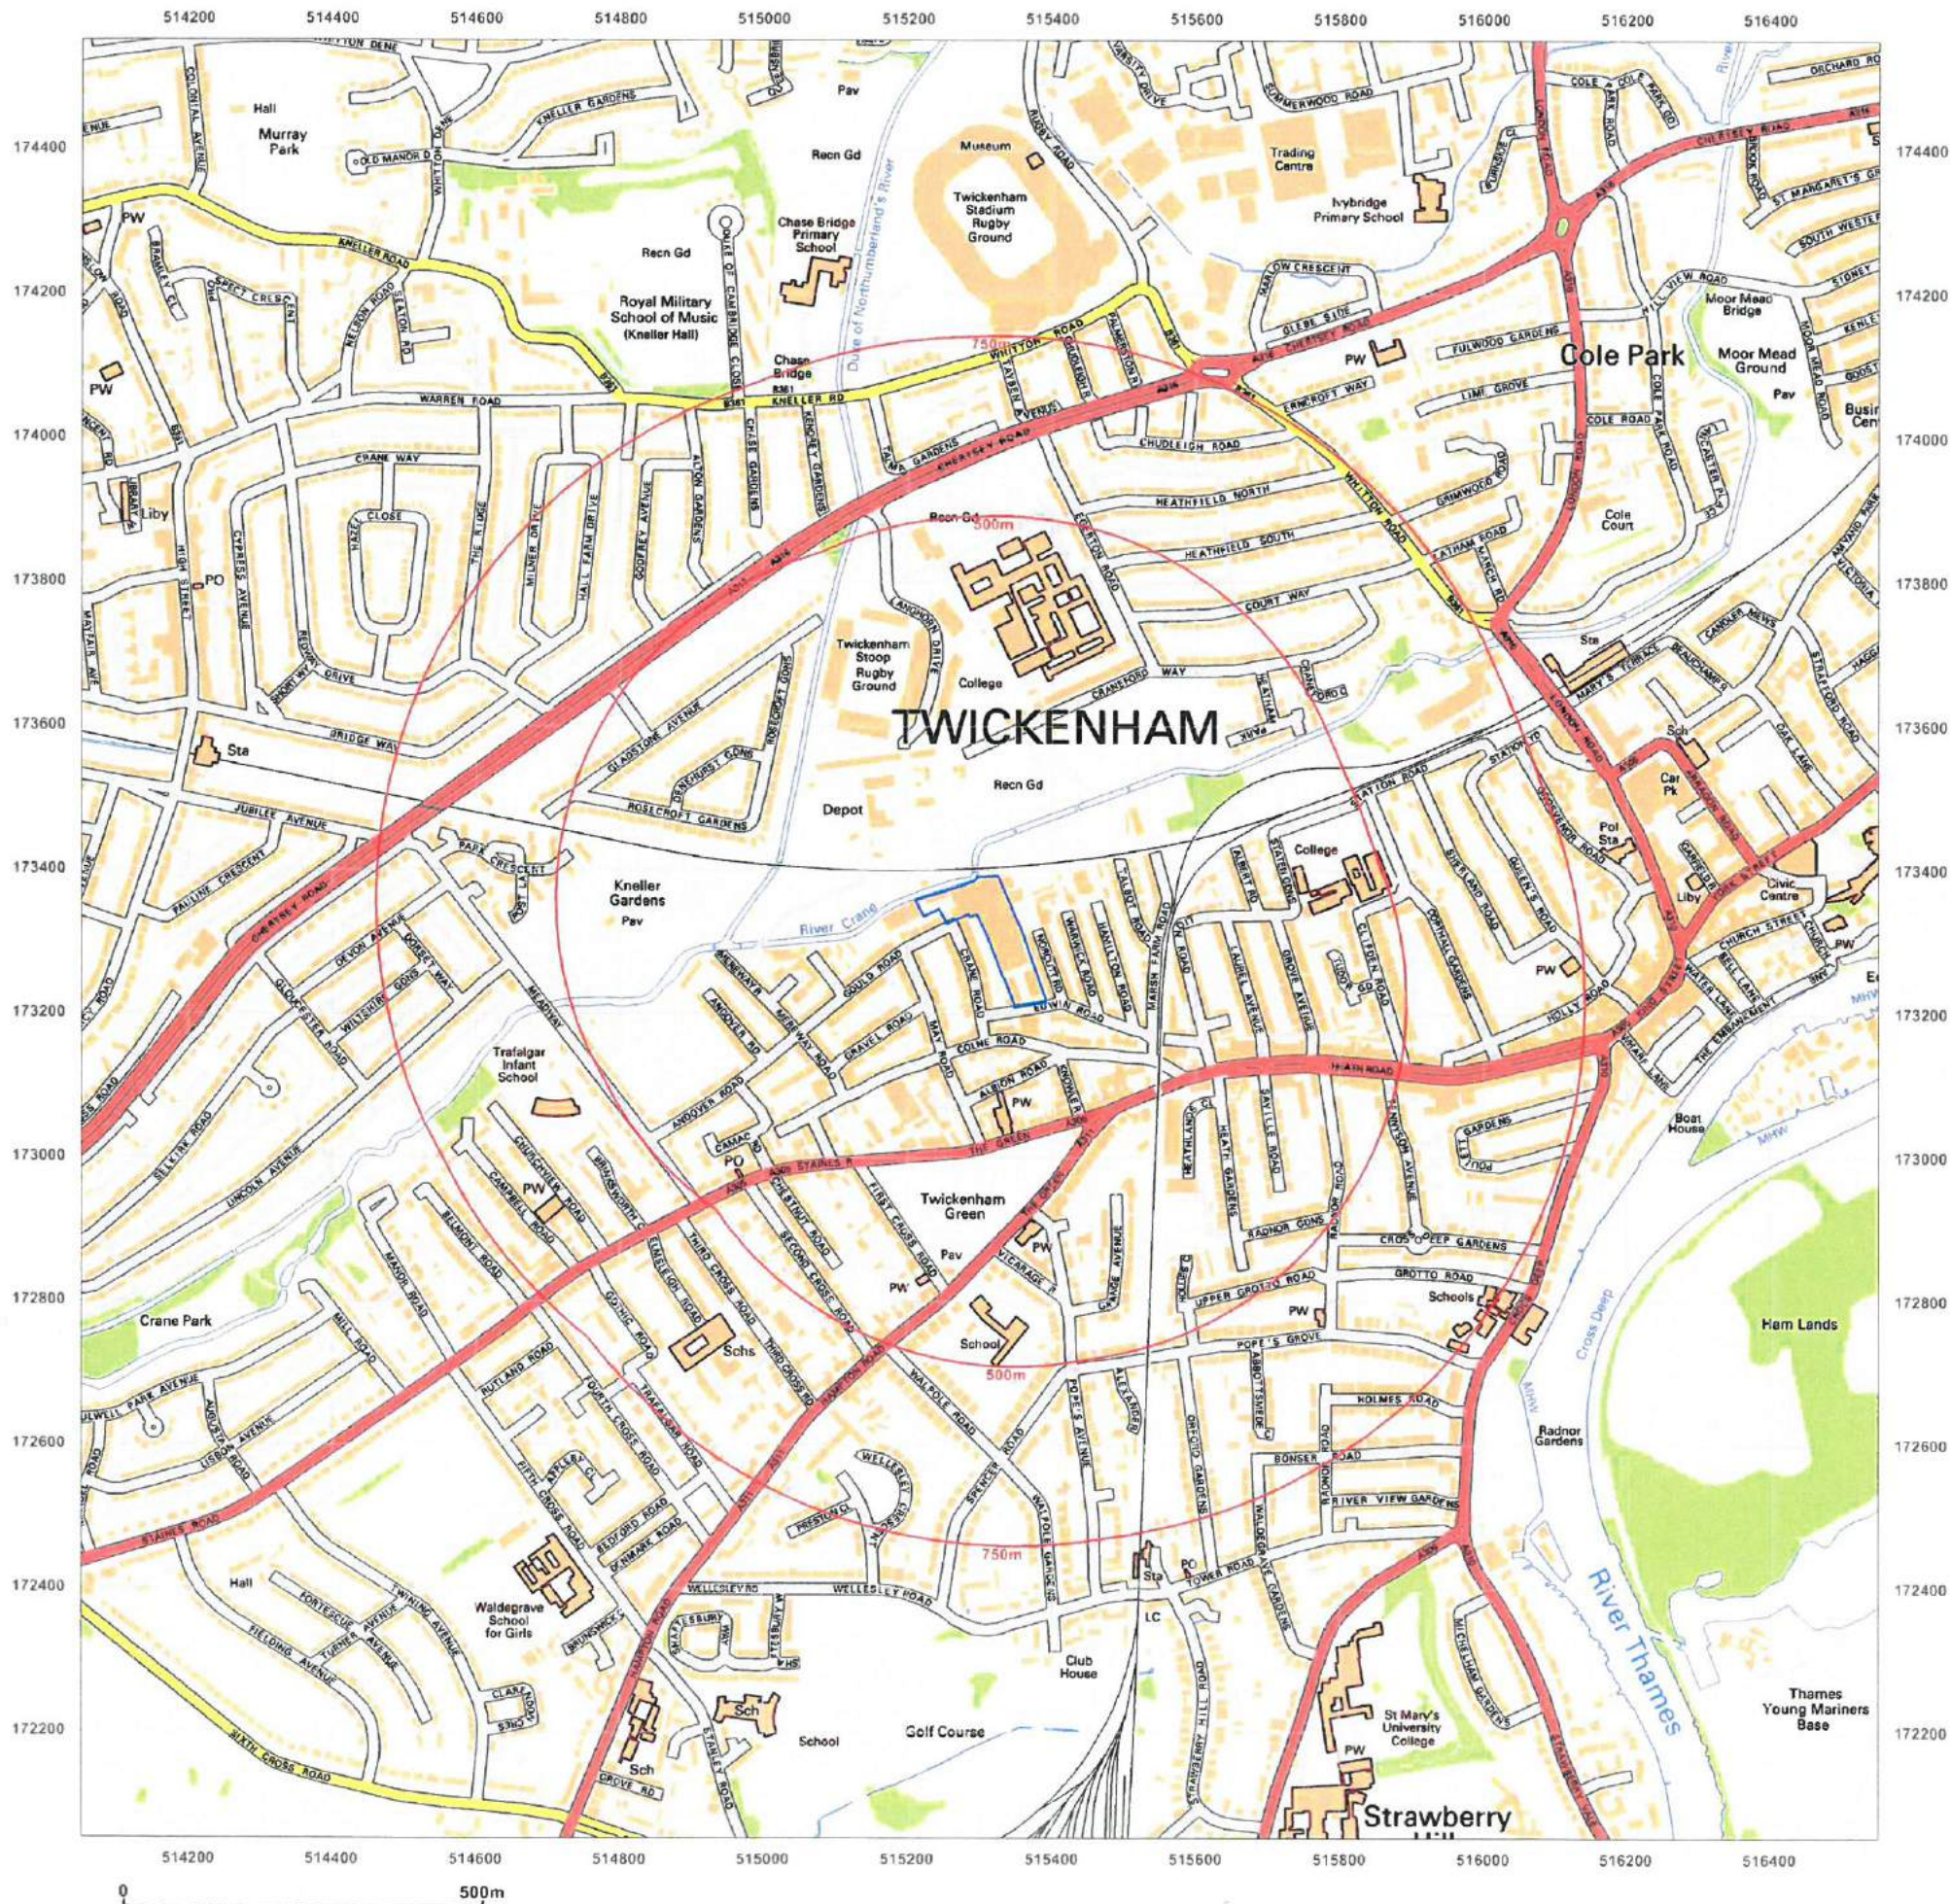
Figure 11 at Appendix A shows the site and surrounding area much as it is today and no significant changes are evident.

Extract from Ordnance Survey Map  
National Grid: 2014

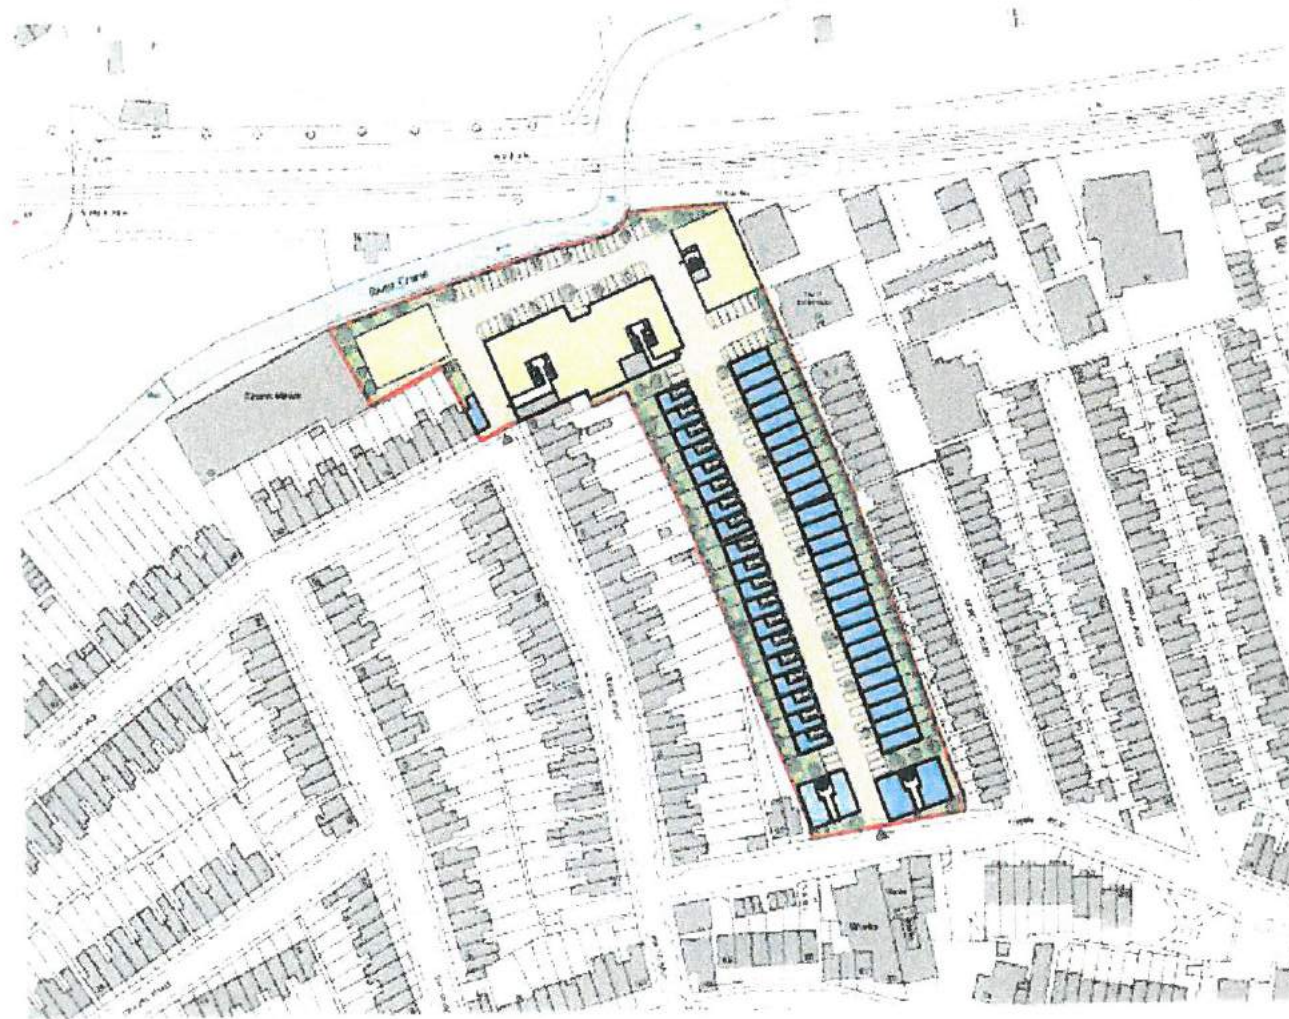
It is intended to demolish all buildings and construct a new residential street on the main body of the site comprising houses with private gardens. The north and north west parts of the site are likely to be mixed use.

The proposed general arrangement is given at Figure 12 of Appendix A.

Proposed ground floor plan
