Proposed redevelopment
Richmond Upon Thames College
Egerton Road
Twickenham

Ground Investigation Report

**GROUND INVESTIGATION REPORT
Revision 02**

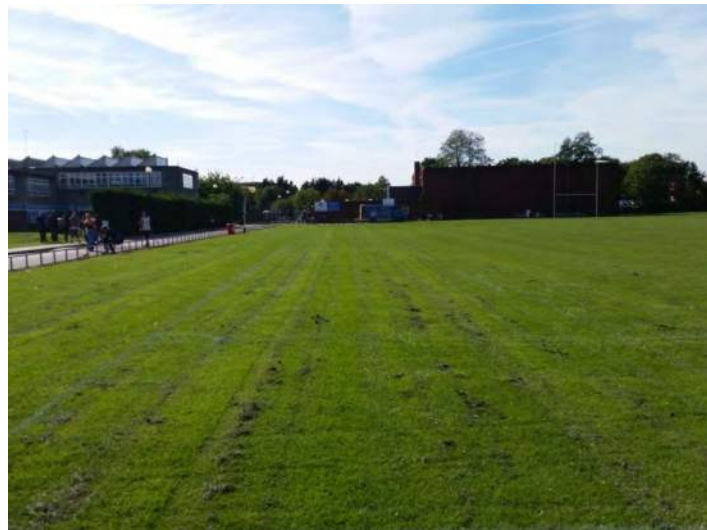
3.2.3.1 The northern area of the site is predominantly flat and occupied by open space surfaced in bituminous bound materials in the north eastern corner and laid to grass in the remaining area, forming a car park and playing field respectively. One masonry building is present in this area and is currently utilised as a sports hall.

Photograph of northern field, showing sports hall in background

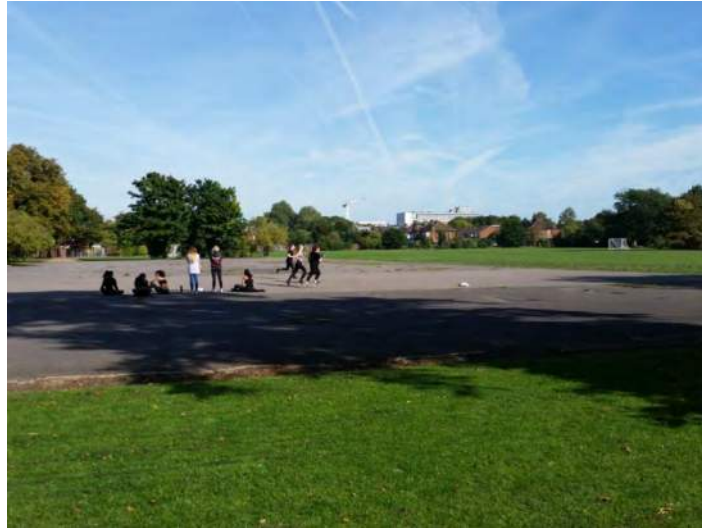
- 3.2.5.1 The southern area of the site slopes gently to the south (~1:150) and is separated from the central area of the site by Craneford Way and a row of residential properties. This area is occupied by playing fields, laid to grass, and an area of hardstanding (likely former tennis courts) surfaced in bituminous bound materials.

Photograph of southern playing field with hard standing area

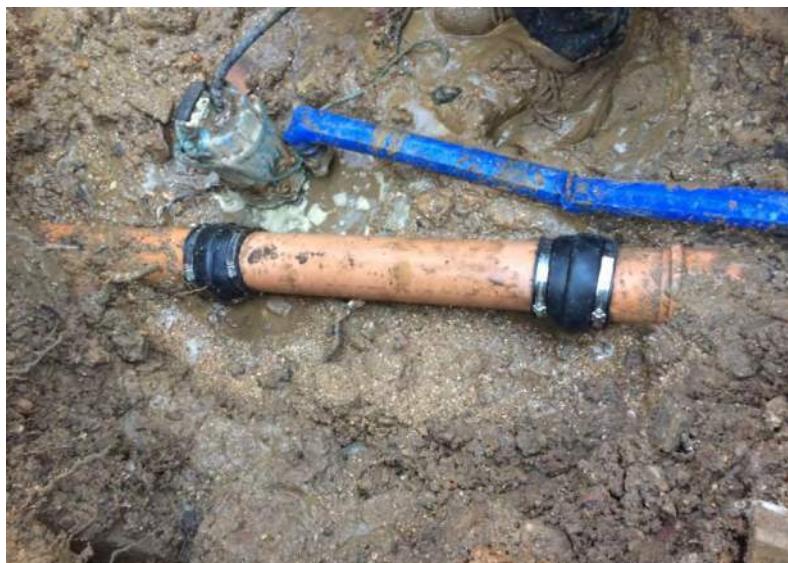
- TP305 was terminated at 1m depth due to the presence of a foul water pipe which was damaged as part of our investigation. The pipe was repaired, as evidenced by the following photograph:
