For the Site of: Collis Primary School, Fairfax Road, TW11 9BS

Date: 13/08/2018

Preliminary Roost Assessment (PRA)

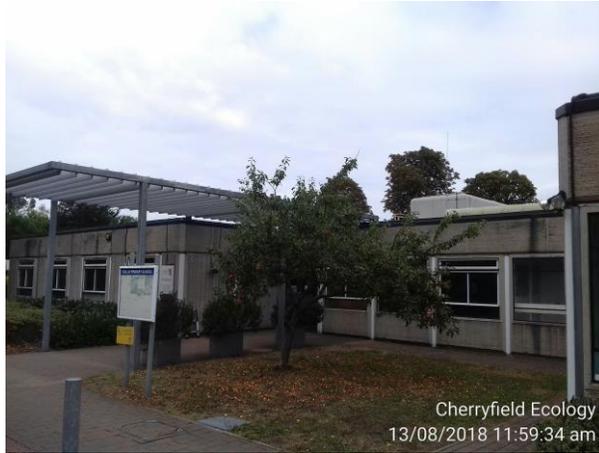
Figure 2: Front elevation of B1.

B1 is a brick-built structure with concrete render with a flat roof design. Plastic rain water goods were found and metal framed windows. B1 has no chimneys and a mixture of PVC and wooden framed doors. B2 is a brick-built building with a mono pitch roof design. Plastic rain water goods were found and wooden framed windows.

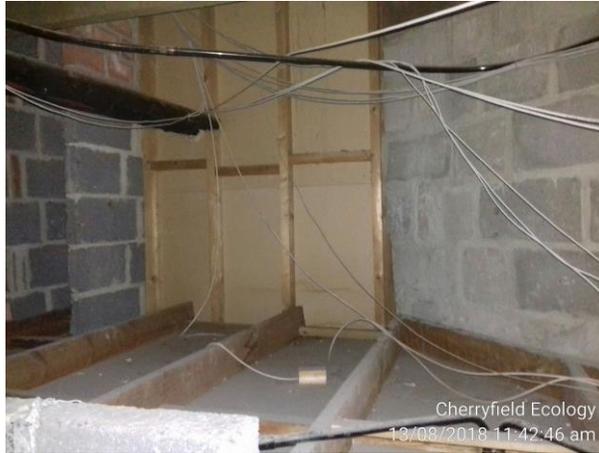
Figure 7: Example of loft space found in B1.

Three loft spaces were found in B1, with a small amount of connectivity between them. All loft spaces in B1 have fully boarded floors. All loft spaces in B1 are currently used for storage. B2 has one small loft space/void, this area was heavily cobwebbed.

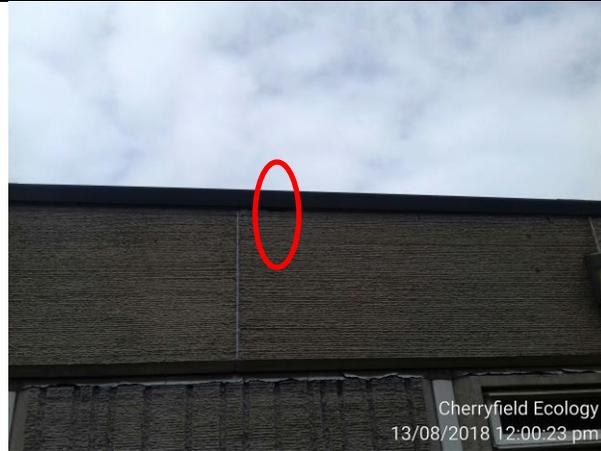
Bats found	No bats found.
Evidence of bat use	No evidence found.
Potential for bat use	Level of likelihood of presence - negligible. There were two small gaps found on the wall plate of B1 however these gaps did not provide suitable roosting potential as the gaps provided no cavity in which bats could roost. B2 did not exhibit any suitable roosting features.

Figure 9: Example of gap found on B1, highlighted in red.

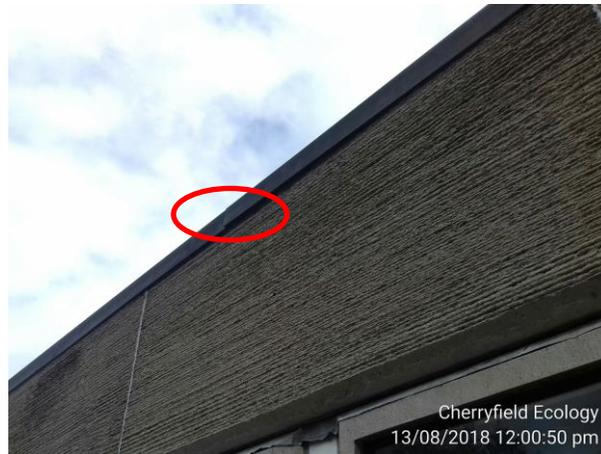
Figure 10: Example of another gap found on B1 highlighted in red.
