66 STATION ROAD, HAMPTON, LONDON

**PRELIMINARY BAT ROOST
ASSESSMENT**

Report No: RT-MME-150446-02

Date: August 2019

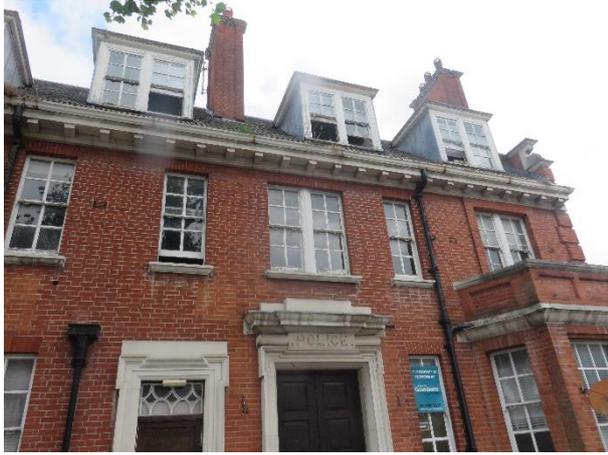
Building 1 was a Victorian era, three-storey, brick-built building with pitched slate tile roofs (Plate 4.1 and 4.2). The roofs had brick-built gable ends and lead flashing along the ridges. There was wooden fascia present in sections and the windows were single glazed set in wooden frames. The building was generally in a good condition with no notable vegetation growth recorded.

Plate 4.1: Building 1, South-facing Aspect

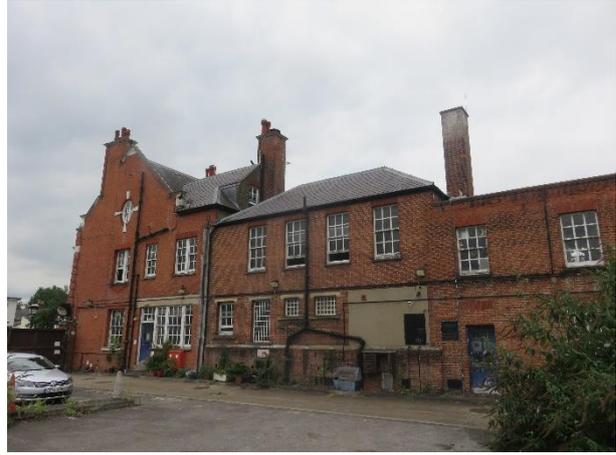
Plate 4.2: Building 1, East-facing Aspect

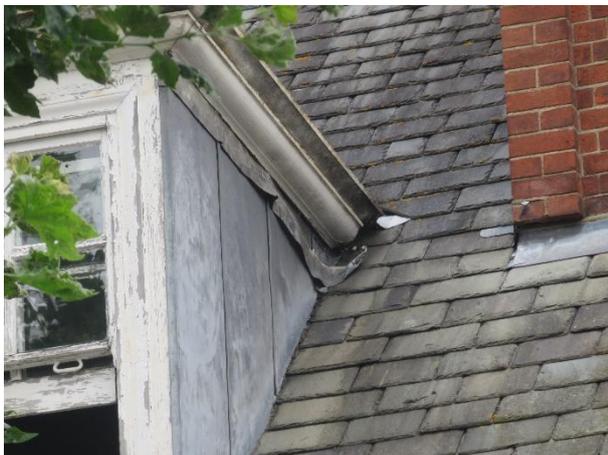
Plate 4.3: Lifted Lead Flashing

Building 1 had several features which might be utilised as bat roosts including holes in brickwork, lifted lead flashing around dormer windows and gaps between window frames and brickwork. As such, and with consideration to its surroundings, the building was assessed as having high potential to support roosting bats. While no evidence of roosting bats was recorded during the internal assessment of the main loft space, sections of the brickwork were concealed by wooden boarding and it was not possible to access half of the loft space. Consequently, a full assessment was not possible, and it was not appropriate to rule out the presence of roosting bats.

The main buildings on site – the former police station and adjoining garages – have been identified as having high potential to support roosting bats. Bat Surveys: Good Practice Guidelines published by the Bat Conservation Trust (Collins, 2016) recommends that for structures with high bat roosting potential at least three dusk emergence and/or dawn re-entry surveys be undertaken during the bat emergence/re-entry survey season to determine the presence/absence of roosting bats within the structures. The bat emergence/re-entry survey season extends from May to September. At least two of the surveys should be undertaken during the peak season for emergence/re-entry surveys between May and August and one of the three surveys should be a dawn re-entry survey. If a roost is discovered during these surveys, a Natural England licence application may be required.

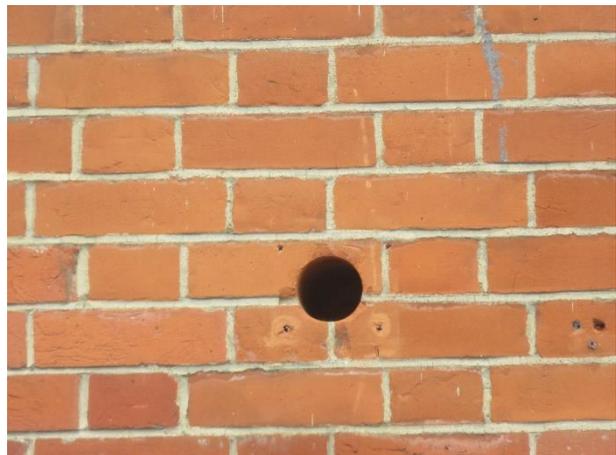
The roof was in a good condition with no lifted tiles noted nor features associated with the concrete soffit. There were multiple brick-built chimneys present, also in a good state of repair. Some lifted lead flashing was recorded where the dormer windows met the roof tiles on the south-facing aspect of the building (overlooking Station Road, Plate 4.3). There were also multiple holes in the walls of the building on the east-facing aspect (Plate 4.4). Both these features potentially led to internal cavities/crevices suitable for roosting bats.

Plate 4.4: Hole in Brick Wall

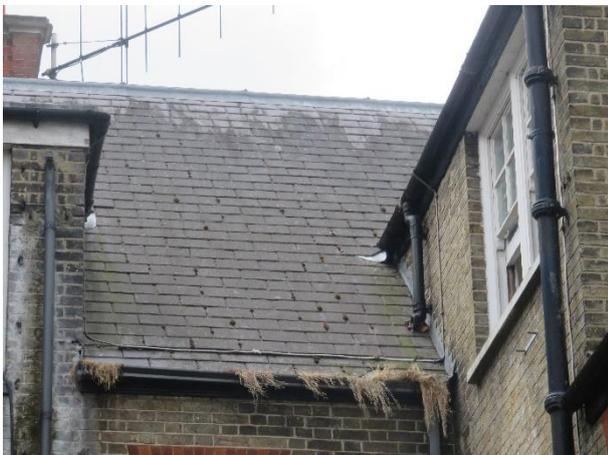
Plate 4.5: Typical Slate Roof (No Lifted Tiles)

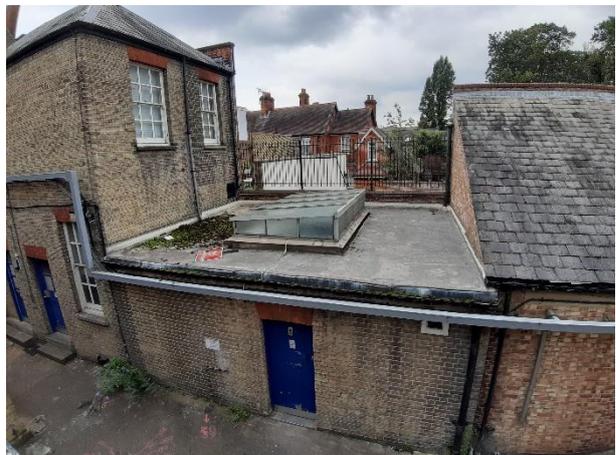
Flat roofs were present on the northern aspect of Building 1 (Plate 4.6). No suitable roosting features for bats were recorded on these roofs. On the west-facing aspect of the building there were holes in the brickwork potentially leading to a cavity, crevice or other similar space suitable for roosting bats. These holes were situated underneath an external concrete walkway running much of the length of the building, in the northerly corner (Plate 4.7). Gaps were also recorded above windows, between window frames and brickwork (Plate 4.8).

Plate 4.6: Flat Roof Section, Building 1

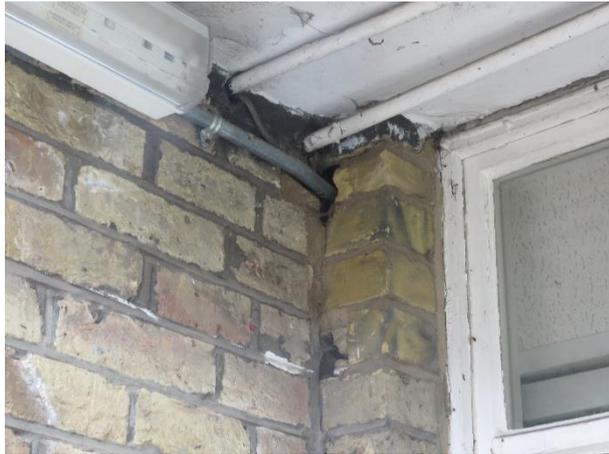
Plate 4.7: Holes in Brickwork

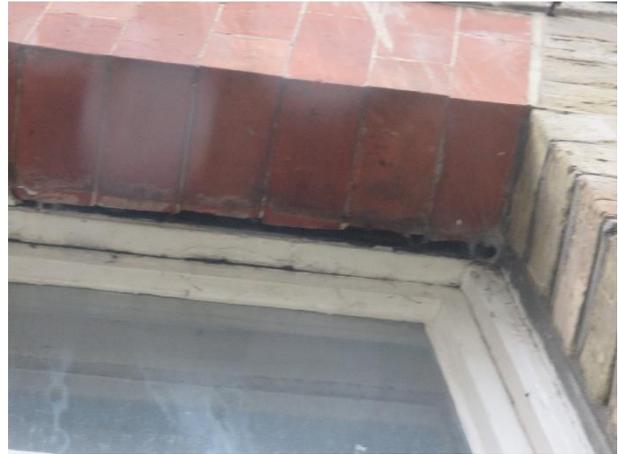
Plate 4.8: Gap Above Window

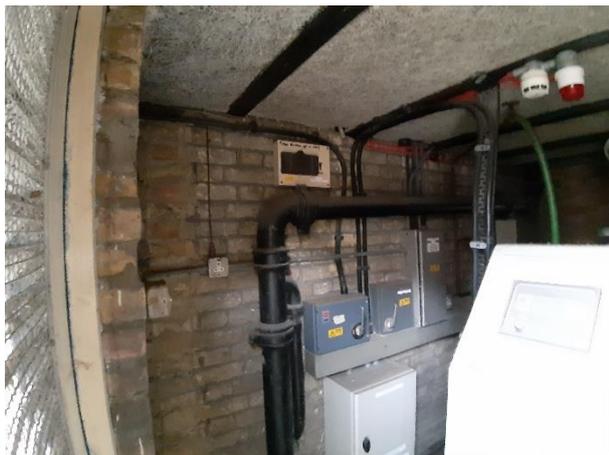
A boiler room and brick-built generator room on the ground floor of the western aspect of the building were internally inspected. The boiler room consisted of concrete flooring and walls, boilers and associated pipework, which were in good condition. The generator room was also made of a concrete roof and walls, with associated wires and parts (Plate 4.9). No features suitable for roosting bats were identified in either of the rooms. The internal hallways and residential rooms of Building 1 were considered unsuitable for roosting bats due to the absence of features and persistent human activity (Plate 4.10).

Plate 4.9: Generator Room Interior

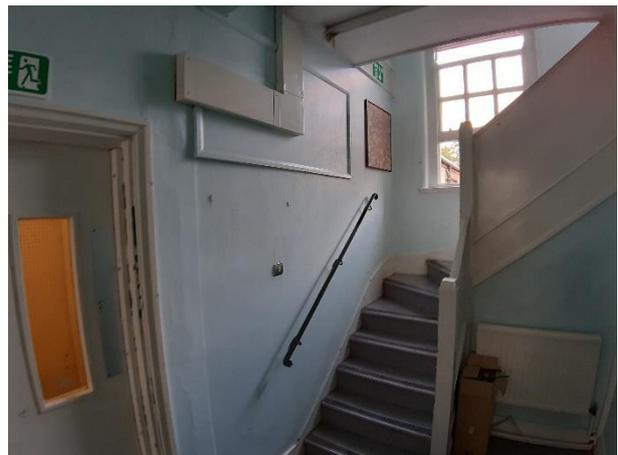
Plate 4.10: Typical Interior, Building 1

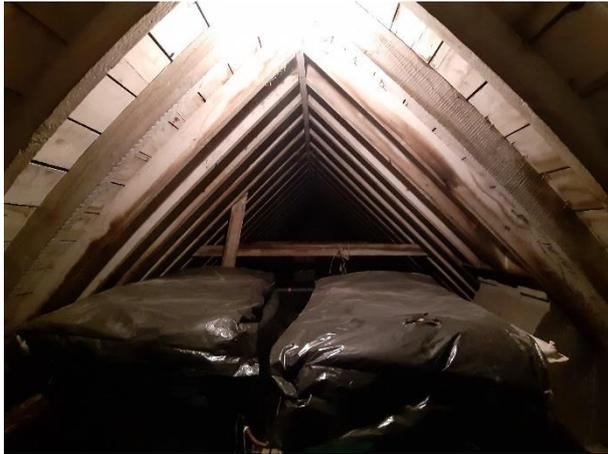
The loft space of Building 1 was subject to an internal inspection. Two large water tanks prevented safe access to the entire loft space and as such only a partial assessment was carried out (Plate 4.11). The space was approximately two metres tall, 6 metres wide and 20 metres long. A wooden ridge beam was present and flush wooden boarding in a good state of repair. The loft was “L” shaped, uncluttered and had no sarking. While no roofing insulation was recorded, the space felt warm and there was no draught. No light was recorded entering at the eaves. Two rendered chimneys were present within the loft space. There were large sections of brickwork concealed from inspection by wooden boarding and beam structures (Plate 4.12). No evidence of roosting bats, e.g. droppings, urine staining, feeding remains or scratch marks, was recorded within these features.

Plate 4.11: Loft Space, Building 1

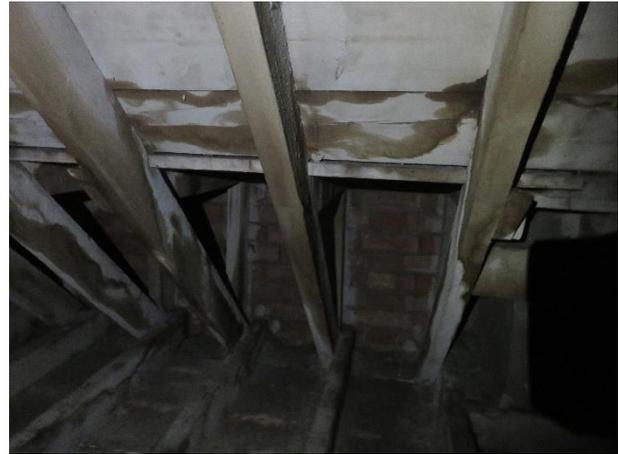
Plate 4.12: Boarding Concealing Brickwork

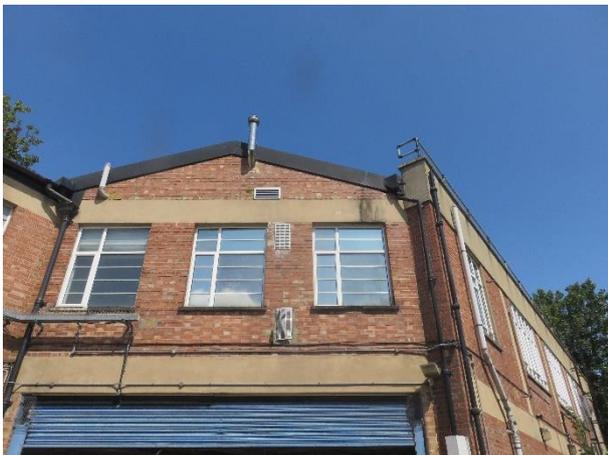
Building 2 consisted of multiple adjoining single and two-storey car garages, with associated rooms, hallways and staircases (Plate 4.13). The buildings were brick-built with large metal roller doors. The roofs were a mix of pitched slate tile and pitched corrugated metal.

Plate 4.13: Building 2, Southwest-facing Aspect

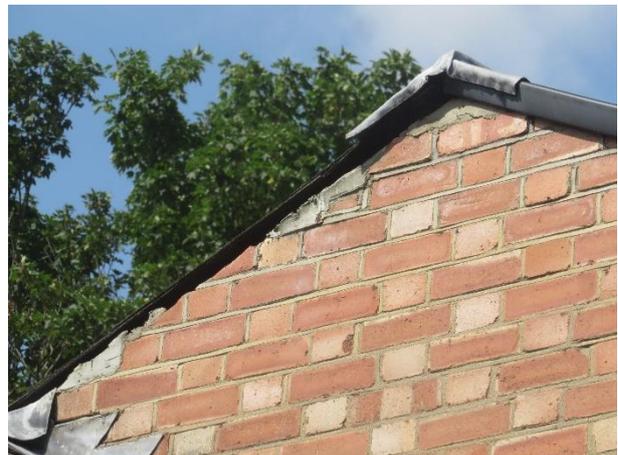
Where Building 2 adjoined Building 1 there was a brick-built gable end, and beneath the tiles of this gable end there was missing mortar creating a highly suitable potential roosting feature for bats (Plate 4.14). A similar feature was present on the larger section of Building 2, with missing mortar and brickwork present where metal fascia/guttering met brickwork at a gable end (Plate 4.15).

Plate 4.14: Missing Mortar at Gable End

Where Building 2 adjoined Building 1 there was a significant amount of missing mortar at the gable end of the roof, creating a highly suitable roosting feature bats. Further features included missing brickwork under fascia/guttering and a gap above a roller door leading to a room containing potentially suitable roosting features.

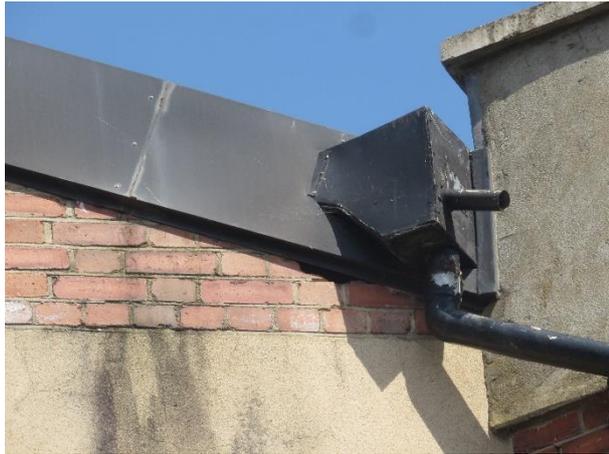
Plate 4.15: Missing Brickwork/Mortar

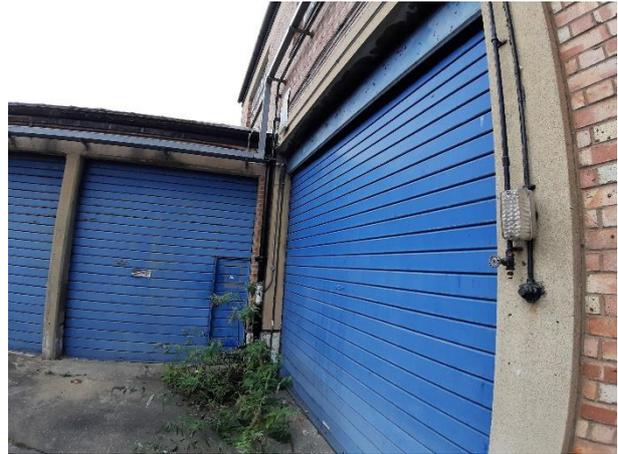
It was further possible for bats to gain access to Building 2 via large gaps at the tops of the various roller doors (Plate 4.16). No evidence of roosting bats, e.g. droppings, urine staining, feeding remains or scratch marks, was recorded within the features that could be fully inspected during the survey.

Plate 4.16: Gaps Above Roller Doors

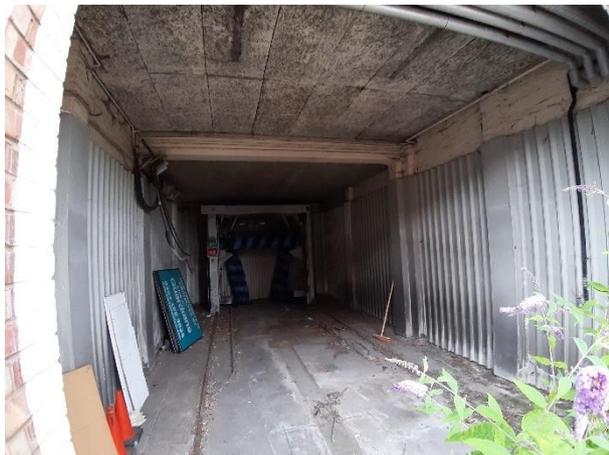
Building 2 mostly consisted of large car rooms previously used for vehicle storage, maintenance and washing. Potential roosting features for bats were limited due to the prevalence of concrete floors, ceiling and brick walls in a good state of repair (Plate 4.17). One of the rooms, situated to the west of the building, did however have a ceiling lined with wooden boarding which may have concealed potential features (Plate 4.18). Numerous access points to potential crevices and cavities behind this wooden boarding were recorded, and the room was easily accessible to bats via a large continuous gap at the top of the roller door (Plate 4.19). The gap between the false ceiling and the real ceiling may also contain a cavity potentially suitable for roosting bats.

Plate 4.17: Typical Interior (Disused Carwash)

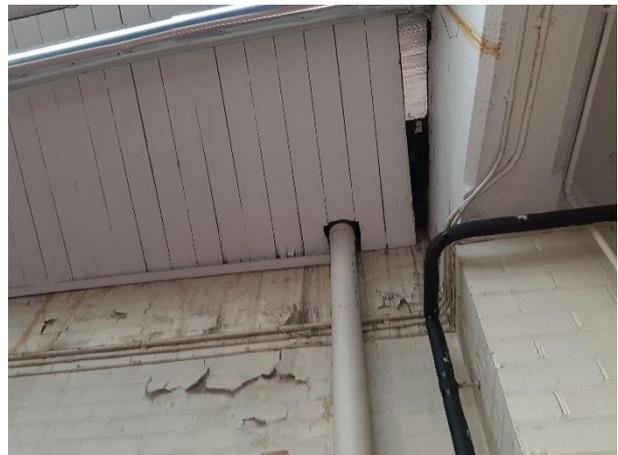
Plate 4.18: Wooden Boarded False Ceiling

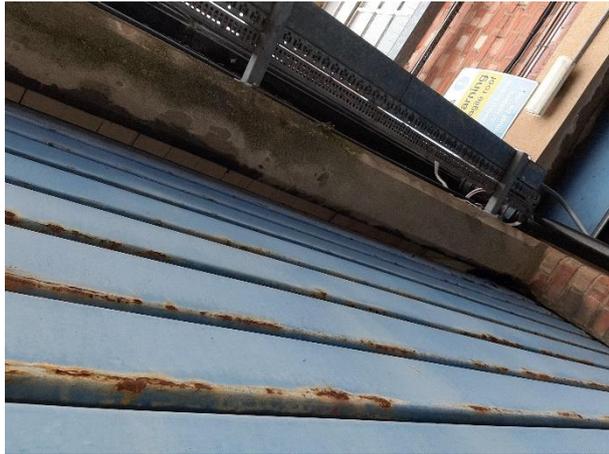
Plate 4.19: Entry Point Above Roller Doors

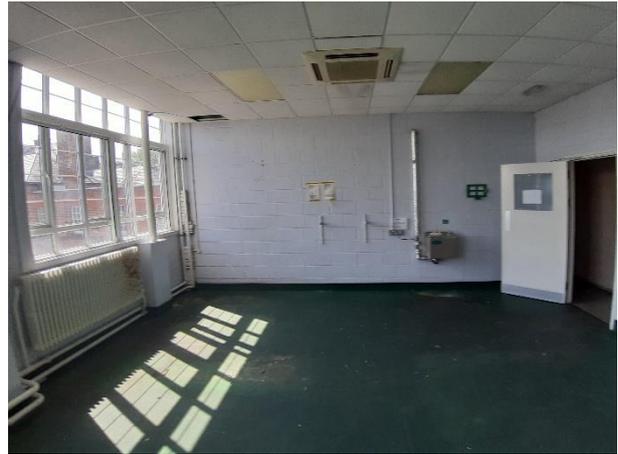
A false office ceiling was recorded throughout much of the second floor of the building, again potentially concealing roosting features associated with the ceiling (Plate 4.20). Access to the internal spaces of the second floor was however considered very limited and no enclosed loft spaces were recorded.

Plate 4.20: Typical Interior with False Ceiling

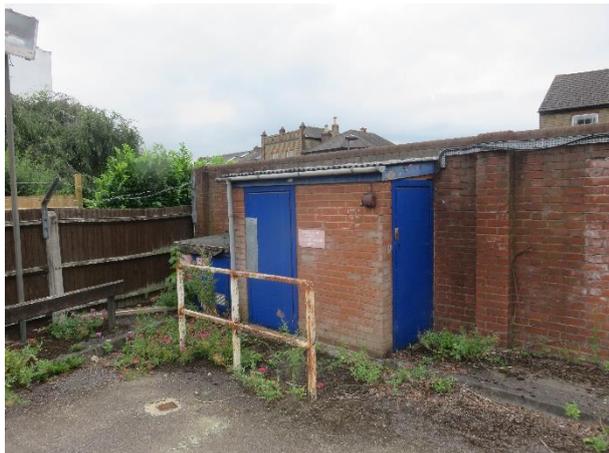
Building 3 was a small, windowless brick-built structure with two wooden doors and a corrugated asbestos roof (Plate 4.21). The building was generally in a good state of repair however it was locked shut preventing an internal inspection. A gap was present above one of the doors surrounding a cable inlet, providing potential internal access to the building to a roosting bat (Plate 4.22).

Plate 4.21: Building 3

Building 3 was potentially accessible to roosting bats and locked shut at the time of survey. Due to the height of the building and low number of potential features for roosting, it was assessed as having low potential to support roosting bats.

The small storage building situated in the southeast corner of the site has been identified as having low potential to support roosting bats. Bat Surveys: Good Practice Guidelines, published by the Bat Conservation Trust (Collins, 2016), recommends for structures with low bat roosting potential that at least one survey (consisting of either a dusk emergence survey or a dawn re-entry survey) be undertaken during the peak season for emergence/re-entry surveys (May to August) to determine the presence/absence of roosting bats within the structure. Should this survey confirm the presence of roosting bats, it will be necessary to undertake additional surveys in order to inform a Natural England licence application. In addition, should the survey identify the presence of significant levels of bat activity at the site, it may be necessary to undertake further survey visits to comprehensively assess the value of the site to bats.

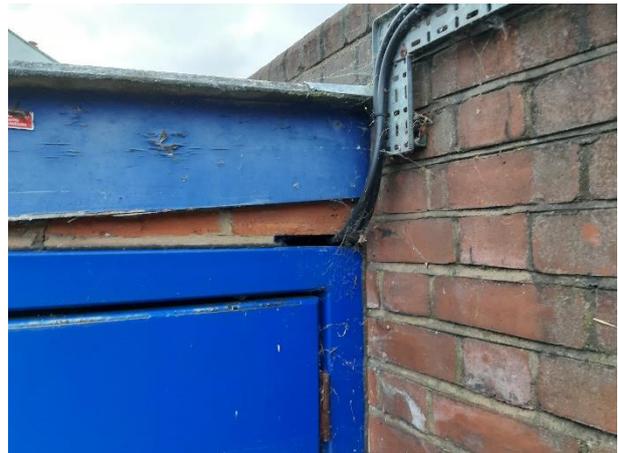
Plate 4.22: Cable Inlet Above Door

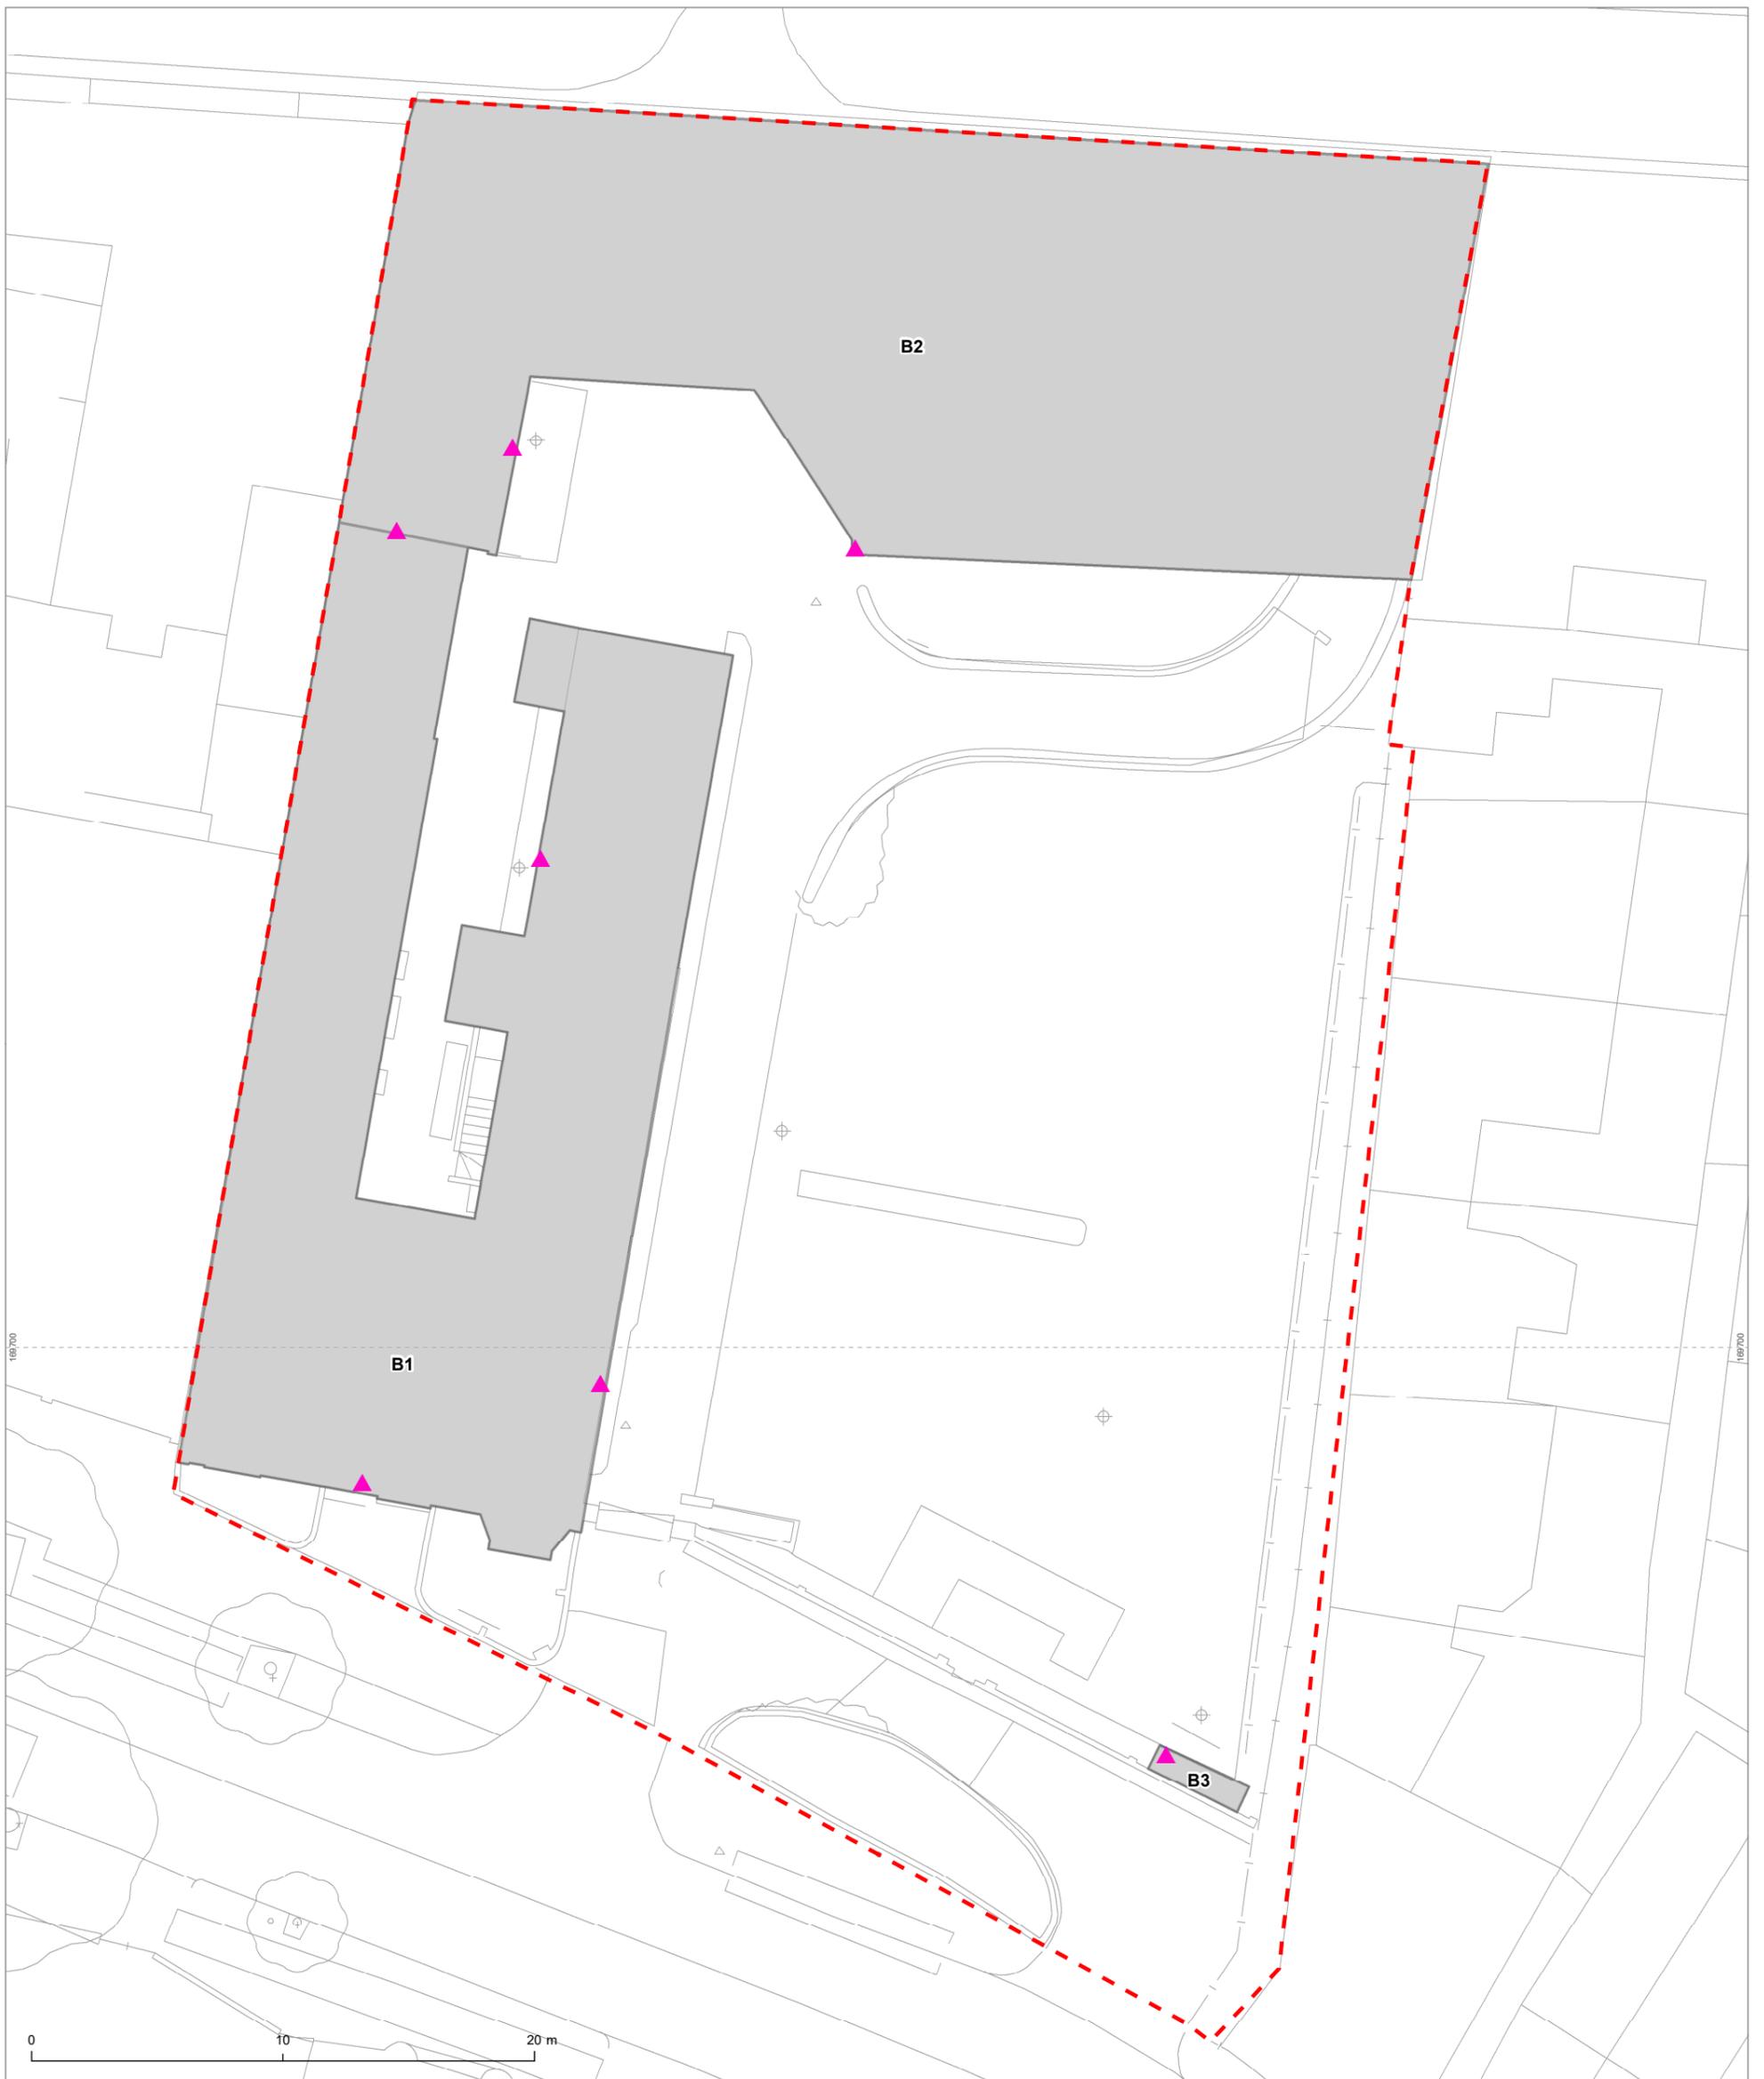
Drawing C150446-02-01 – Preliminary Bat Roost Assessment

The Preliminary Bat Roost Assessment was conducted on 1st August 2019 by Gemma Luckhurst (Ecological Project Officer) and Harry Stone (Ecological Project Officer). Drawing C150446-02-01 illustrating the layout of the buildings on site is provided in Chapter 6.
