75-81 George Street, Richmond

Pedestrian Environment Review System (PERS) Audit

A112323

November 2019

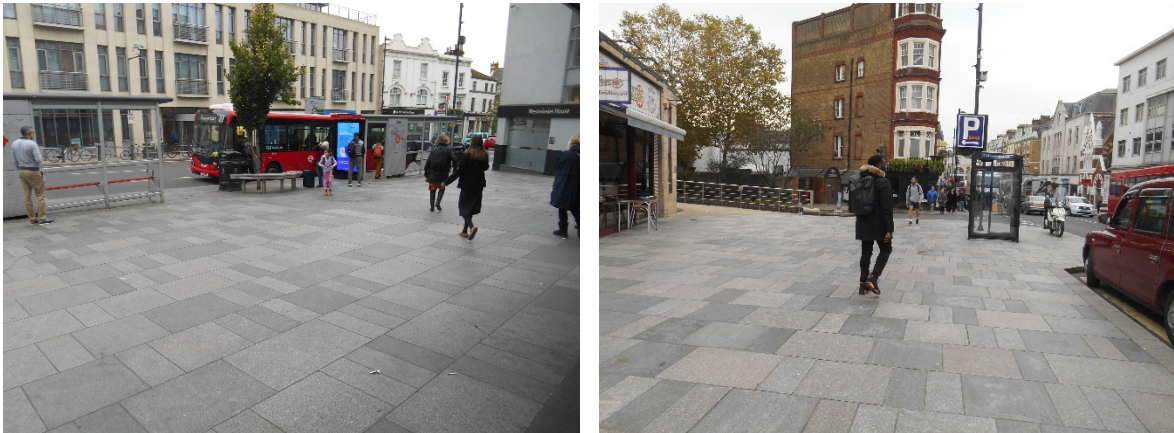
Figure 3.1 Link 1

3.3 Link 1 which is located adjacent to Richmond Rail and London Underground Station was characterised by good surface quality and scored highly on permeability, legibility and the overall quality of the environment was aesthetically pleasing, with plenty of space for pedestrians entering and exiting the main station entrance. The footway provision was very wide allowing separation away from traffic, as well as this, maintenance levels were shown to be good, with very few instances of litter or graffiti observed and a good provision of litter bins. Overall there was a high level of safety as there were CCTV cameras observed along this link, active frontages and a high footfall. A lower score was given for colour contrast, as it was observed that there was little variation in the surface colour between the Yorkstone paving and tactile paving.

Very wide footway provision on this pedestrian link particularly outside Richmond Rail and Underground Station, good separation from traffic and bus stops.

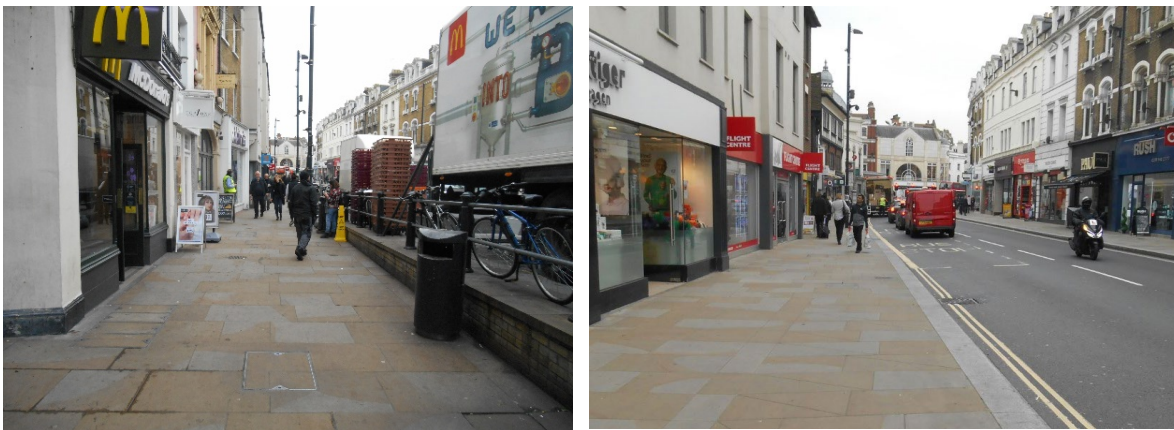
Figure 3.2 Links 2 and 3

3.5 Links 2 and 3 are located between Drummonds Place and The Quadrant to the south of Richmond Rail and Underground Station, with Link 2 comprising the eastern footway and Link 3 comprising the western footway. Links 2 and 3 are not dissimilar to Link 1 in terms of surface quality and footway materials. Link 2 was observed to be narrower adjacent to The Quadrant bus stops, increasing the likelihood of user conflict between bus passengers and pedestrians for which this link scored lower for user conflict. Links 2 and 3 scored highly in terms of tactile information, dropped kerbs, maintenance, cleanliness and overall quality of environment. High levels of personal security were observed along these links, with lots of passing activity along the footway as well as CCTV cameras present.

User conflict observed adjacent to bus stops, with narrower footway. Overall good quality of pedestrian environment observed.

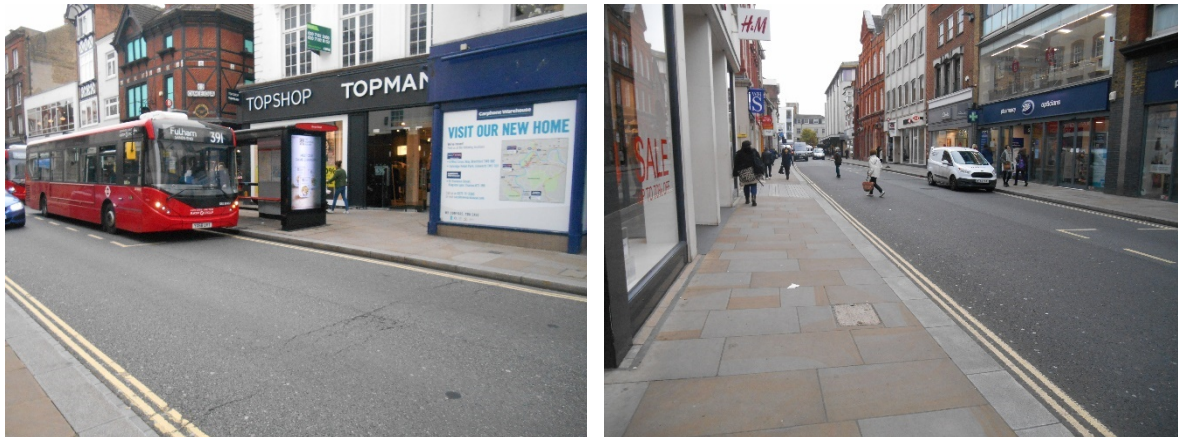
Figure 3.3 Links 4 and 5

- 3.7 Links 4 and 5 are located along George Street, with Link 4 comprising the western footway and Link 5 comprising the eastern footway. Links 4 and 5 generally scored highly in terms of dropped kerbs, tactile paving, maintenance, cleanliness, overall quality of environment and personal security. These links scored lower for user conflict due to the footway width being narrower in places, particularly adjacent to bus stops. The links also scored lower for colour contrast with little variation in colour between the Yorkstone paving and tactile paving provision.
- 3.8 Images of the pedestrian provision along Links 4 and 5 are shown in **Figure 3.3**.

Overall good quality of pedestrian environment, with provision of dropped kerbs and tactile information and high levels of cleanliness. Some user conflict adjacent to bus stops.

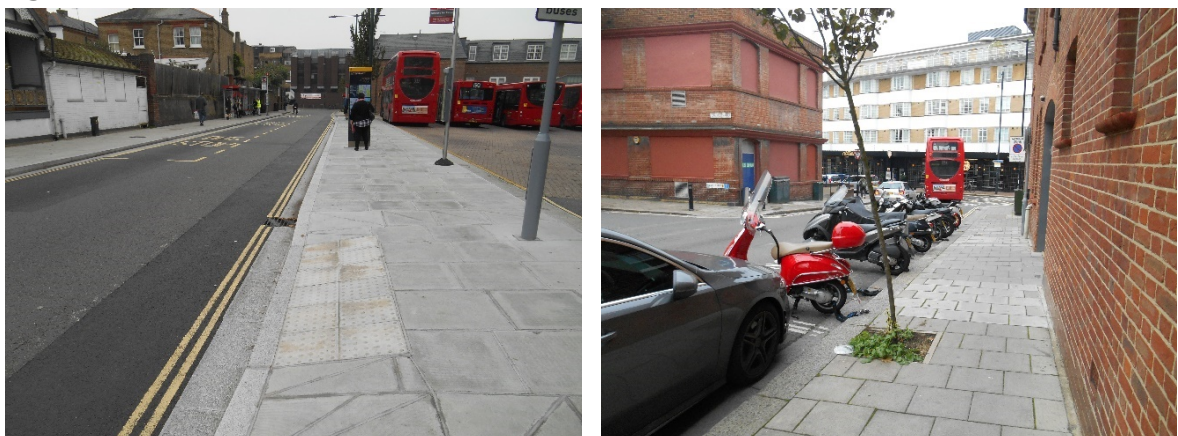
Figure 3.4 Link 6

- 3.9 Link 6 is located along Hill Street, Lewis Road and Wakefield Road between George Street and Richmond bus station. Link 6 scored higher in terms of effective width and dropped kerbs, however this link scored lower in most of the other parameters such as colour contrast, personal security, surface quality, user conflict and general maintenance. Footway provision is generally of better quality in the vicinity of the bus station, with evidence of tactile paving observed throughout.
- 3.10 Images of the pedestrian provision along Link 6 are presented in **Figure 3.4**.

Good quality footway provision within the vicinity of the bus station.

Along Lewis Road (shown above) the quality of the footway could be improved.

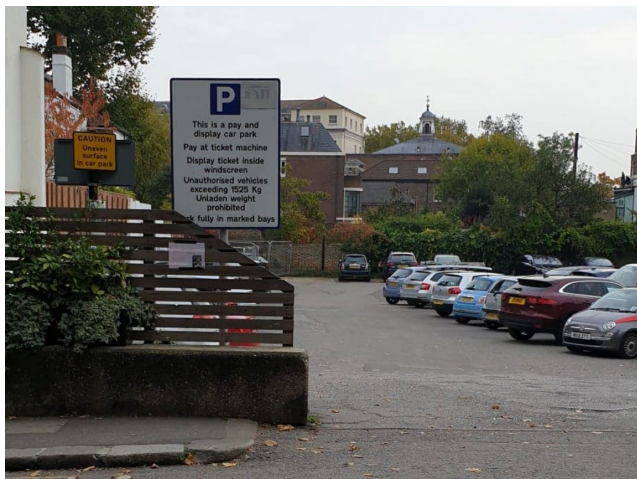
Figure 3.5 Link 7

- 3.11 Link 7 is located between George Street and Friar’s Lane car park, and is comprised of King Street, Old Palace Place and Friar’s Lane. Link 7 scored higher in terms of low evidence of obstructions, good legibility, good provision of street lighting, quality of environment and general maintenance. The link scored lower in parameters such as personal security, surface quality, tactile information, effective width, dropped kerbs and user conflict. For instance, these parameters were characterised by undulations in the footway, narrow footway width along King Street and Friar’s Lane, lack of CCTV, no provision of tactile paving. In the vicinity of the car park, the surface quality is inconsistent and uneven which presents a potential hazard for wheelchair users and partially sighted people. This link could be improved by widening the footways, providing tactile paving at crossing points and levelling out the uneven surface within the Friar’s Lane car park.

Road sign reads: "CAUTION: Uneven surface in car park".

- 4.2 Recommendations for improvements were identified, particularly along Link 7 which forms the majority of Route 4, between Friar's Lane car park and the site. These included the widening of footways and levelling out the uneven surface within the Friar's Lane car park. An improvement was also identified along Link 8 which could include greater provision of tactile paving. At Richmond Bus Station, it was noted that more seating could be provided for bus passengers.

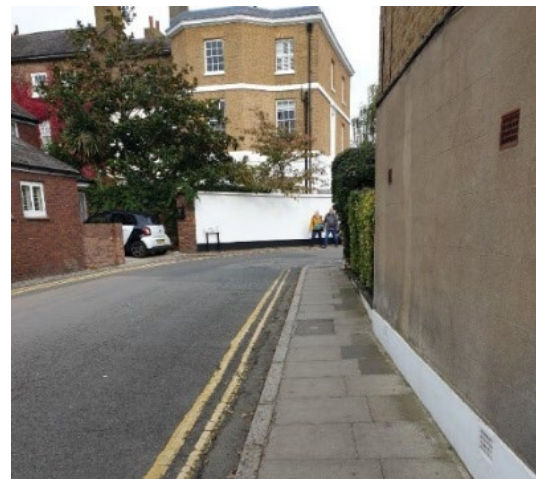
Narrow width of footways along King Street and Friar’s Lane.

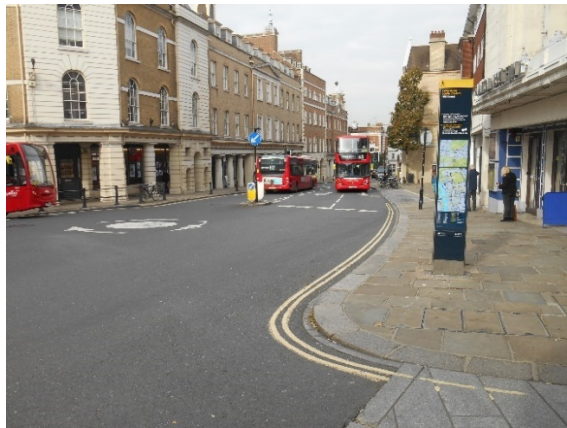
Figure 3.6 Links 8 and 9

- 3.13 Links 8 and 9 are located along Hill Street, between the junction of Red Lion Street / Hill Street to the north and the junction of Bridge Street / Hill Rise to the south. Links 8 and 9 scored highly in the majority of parameters, however Link 8 scores particularly low for tactile information. The high scores were characterised by wide footways, provision of dropped kerbs, high levels of cleanliness, good permeability with little or no obstructions, wayfinding information such as a local street map posts as well as good provision of street lighting. Link 8 could be improved with greater provision of tactile paving.
- 3.14 Images of the pedestrian provision along Links 8 and 9 are shown in **Figure 3.6**.

Wayfinding information (street map post).

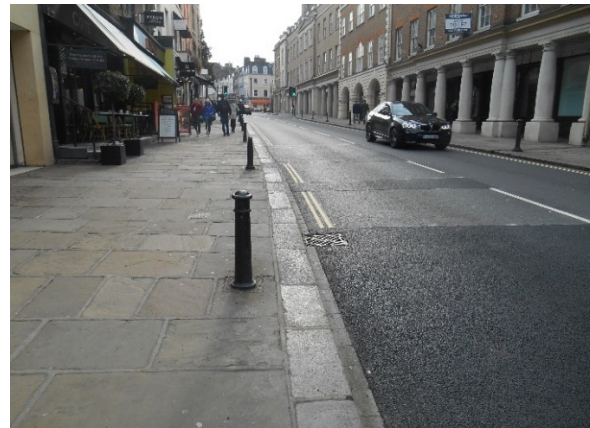
Wide footways with safety bollards.

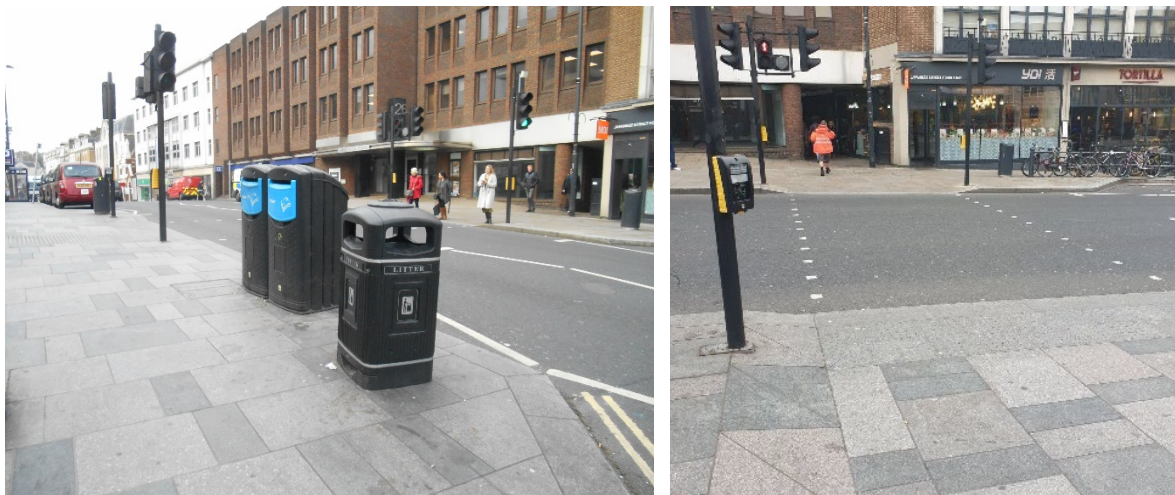
Figure 3.7 Crossing 1 (Pelican Crossing) – Richmond Railway Station

3.19 Crossing 1 is located adjacent to Richmond Rail and Underground Station, on The Quadrant, allowing pedestrians to cross to the western side of The Quadrant. Crossing 1 scored highly in all parameters as it comprises tactile paving, dropped kerbs, a good width for pedestrians to wait before using the crossing and good visibility/sightlines in both directions. Overall, the crossing was in a very good condition with litter bins provided nearby and high levels of cleanliness observed. The crossing also provides a direct route for pedestrians travelling to and from the station.

Litter bins adjacent to the crossing and wide width of crossing waiting area.

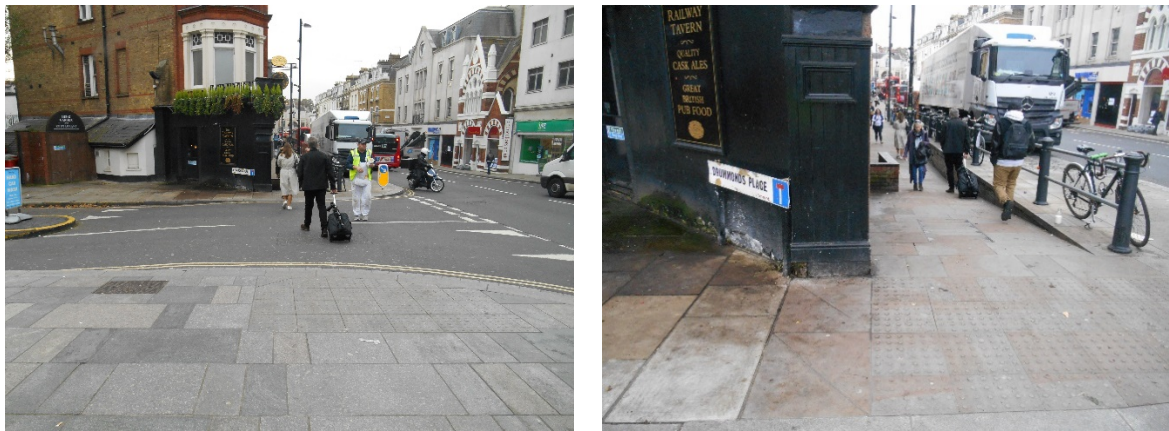
Figure 3.8 Crossing 2 (Informal Crossing) – Drummonds Place

3.21 Crossing 2 is located across Drummonds Place, approximately 70 metres to the south of Richmond Rail Station. It is an informal crossing comprising tactile paving and the footway surface is flush throughout. The crossing also comprises a raised table which reduces the speed of vehicles turning in and out of Drummonds Place. Crossing 2 scored highly in all parameters and is deemed suitable in the context of its location.

Tactile paving, flush footway surface and raised table provided.

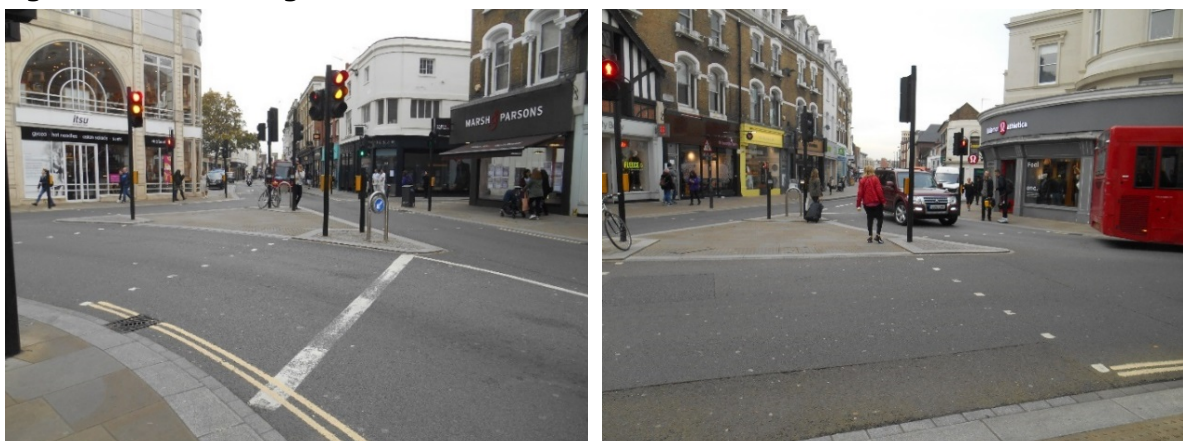
Figure 3.9 Crossing 3

3.23 Crossings 3, 4 and 5 are located at the junction between The Quadrant, The Square, Duke Street and George Street. Crossing 3 is a three-way pelican crossing, with a central pedestrian refuge island connecting all three crossings. Crossing 4 is a pelican crossing located across Duke Street, whilst Crossing 5 is a pelican crossing located across George Street, immediately to the south of the junction. The crossings scored highly in all parameters because they comprise tactile paving, a flush footway surface throughout, sufficient waiting space for pedestrians, good visibility/sightlines and the crossings are positioned in line with pedestrian desire lines, enabling pedestrians to cross easily in all directions (north, south, east and west). The crossings were in very good condition with high levels of cleanliness and maintenance observed.

Large pedestrian refuge island, tactile paving, flush footway surface and good visibility and sightlines.

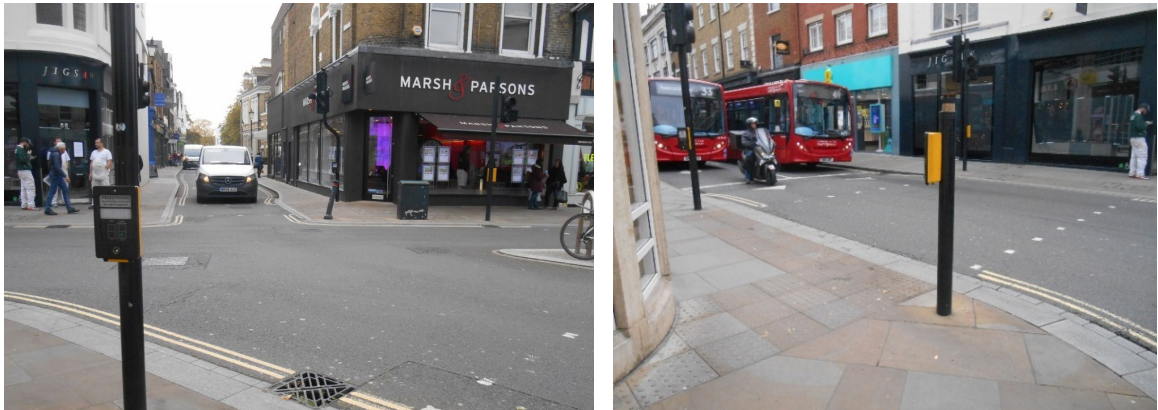
Figure 3.10 Crossings 4 and 5

Tactile paving, flush footway surface, sufficient pedestrian waiting space.

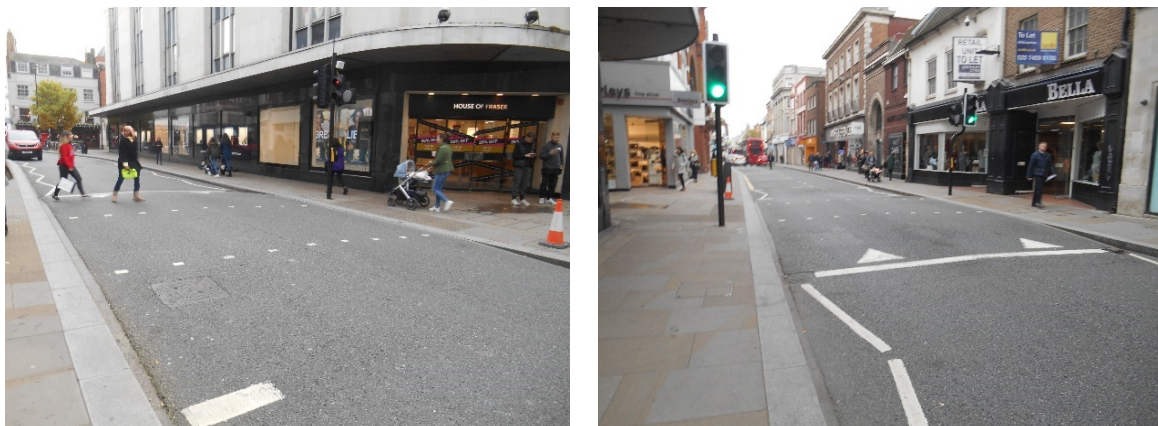
Figure 3.11 Crossing 6

- 3.25 Crossing 6 is located adjacent to the site frontage of the proposed development (currently a House of Fraser department store), on George Street. Crossing 6 is in the form of a pelican crossing and scored highly in all parameters. The main characteristics which informed the high scoring were a raised table, flush footway surface throughout, wide pedestrian waiting space, tactile paving, a countdown timer signal (indicates the amount of time pedestrians have left to cross before the traffic signal changes) and high levels of cleanliness and maintenance observed. The crossing is positioned in line with the pedestrian desire line for accessing the proposed development, situated adjacent to one of the main entrances to the building.

- 3.26 In terms of negative characteristics, there were some minor observations whereby the tactile paving consisted of the entire footway width which was due to the narrowing of the footway adjacent to the crossing. It is therefore noted that pedestrians waiting at the crossing have the potential to block passing pedestrians on the footway, however due to the nature of the street and proximity of building frontages in this area, there is unlikely to be scope to widen the footway and thus this should be considered as a minor observation.

Tactile paving, flush footway surface, raised table, sufficient pedestrian waiting space.

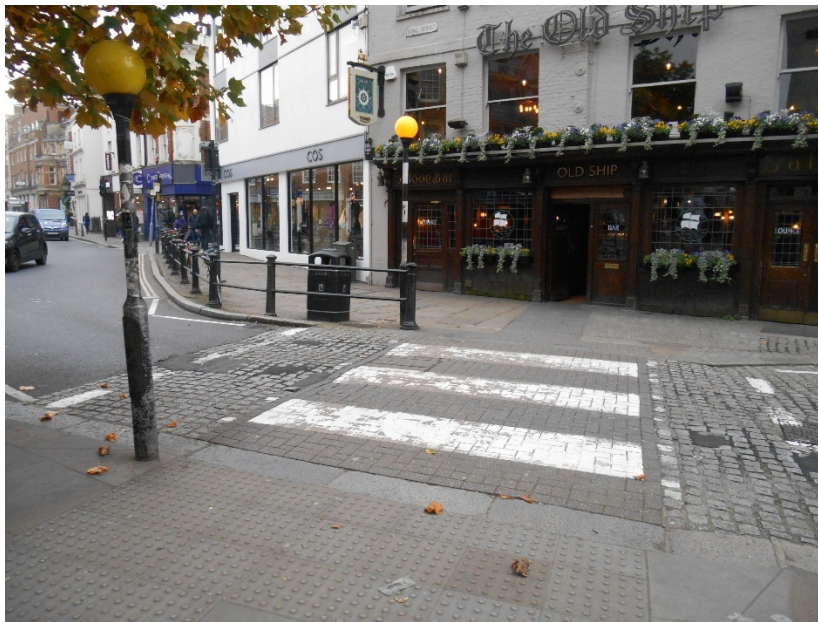
Figure 3.12 Crossing 7

- 3.28 Crossing 7 is located on King Street, adjacent to the proposed development. Crossing 7 is comprised of a raised table zebra crossing across King Street. The crossing scored highly in all parameters which included a raised table, flush footway surface, tactile paving and good pedestrian desire lines. The crossing is positioned adjacent to the southern entrance of the House of Fraser store, and thus provides an easy route for accessing the store from the south. In terms of improvements, it is recommended that the crossing could be repainted due to the fading of road markings.
- 3.29 An image of Crossing 7 is shown in **Figure 3.12**.

Tactile paving, flush footway surface and raised table.

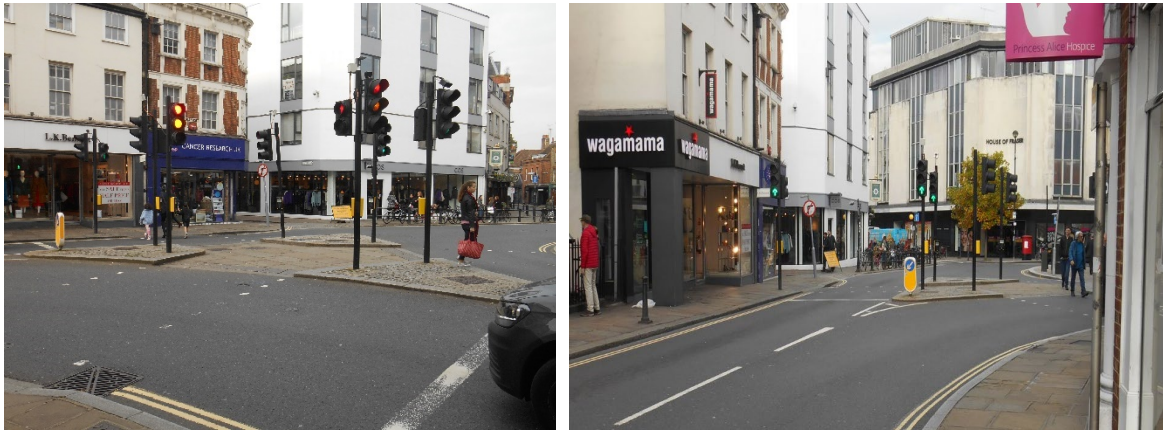
Figure 3.13 Crossing 8

- 3.30 Crossing 8 is located at the junction between Red Lion Street and Hill Street. Crossing 8 is a three-way pelican crossing with a central pedestrian refuge island, similar to the pedestrian provision at Crossing 3. This crossing scored highly in almost all parameters, except for crossing capacity and delay. It was observed that the width of the crossing was narrow in comparison to other crossings, which leaves a smaller waiting area for pedestrians and thus reduces crossing capacity. It was also noted that there was a relatively long wait time for pedestrians, however there is generally a short crossing distance for all three crossings. In general, there is good pedestrian provision including a flush footway surface, tactile paving, high levels of cleanliness and the crossing is well maintained.
- 3.31 Images of Crossing 8 are shown in **Figure 3.13**.

Tactile paving, flush footway surface and raised table.

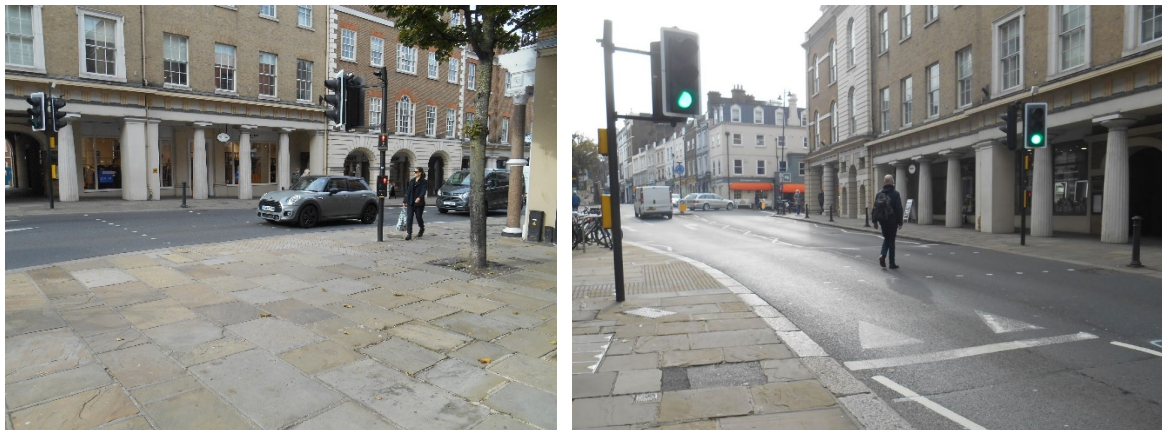
Figure 3.14 Crossing 9

3.32 Crossing 9 is located on Hill Street, approximately 30 metres to the north of Bridge Street and is in the form of a puffin crossing. The crossing scored highly in all parameters because it provides a raised table, flush footway surface throughout, tactile paving, sufficient pedestrian waiting space and good visibility/sightlines. The crossing is deemed suitable in the context of its location due to high levels of traffic along Hill Street.

Tactile paving, flush footway surface and a raised table.

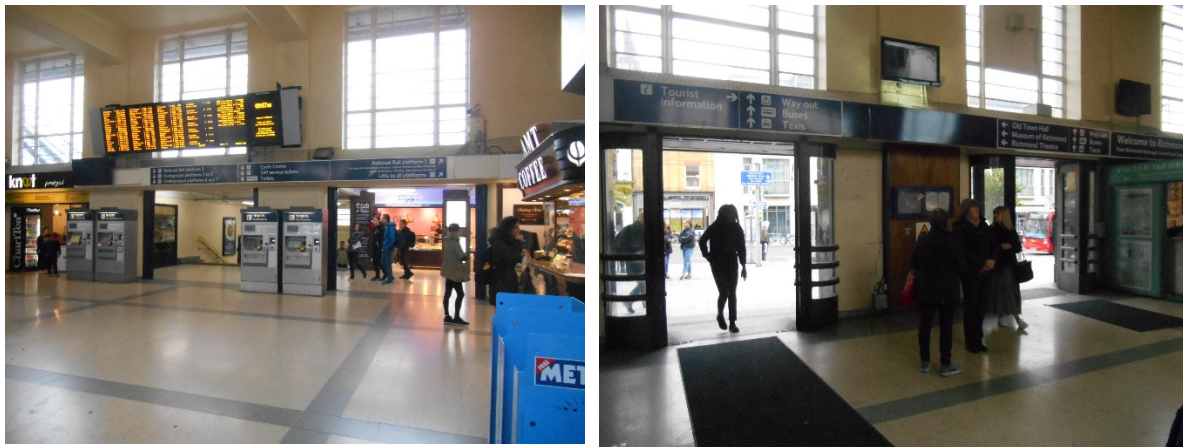
Figure 3.15 Richmond Railway Station

Overground services as well as London Underground services on the District Line. As a PTWA, the railway station scored highly in all parameters, for instance, within the main entrance hall at the station there was good provision of signage to all platforms, real-time information boards, ticket machines, a ticket office, coffee shops, retail units and step-free access to all platforms. High levels of security were also observed, with good CCTV coverage and lots of retail activity. In terms of cleanliness and maintenance, there were no signs of litter or neglect with litter bins provided outside the main station entrance. Overall, the station presented a good quality and safe environment. It was noted that no seating was provided within the main entrance hall, although seating is provided outside of the station on the adjacent footway.

Ticket machines, retail units, real-time information boards and wayfinding signage.

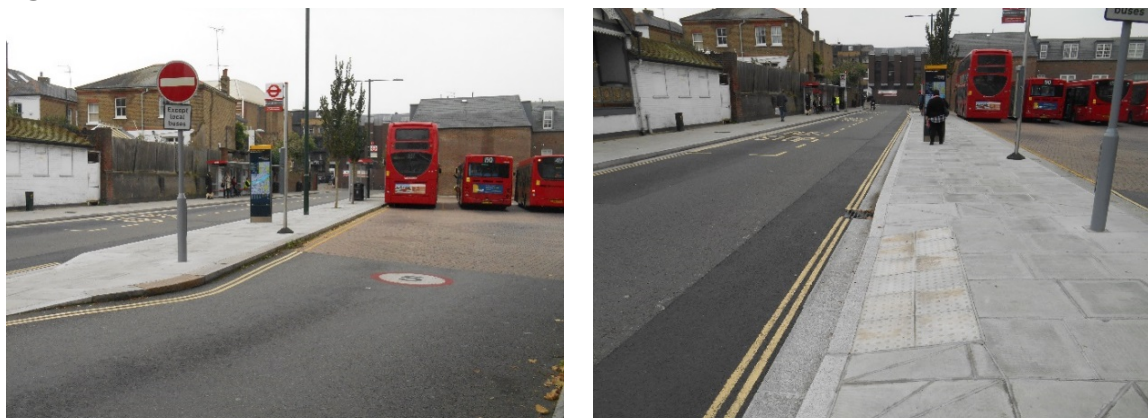
Figure 3.16 Richmond Bus Station

3.39 Richmond Bus Station is located on Wakefield Road and is served by the following bus routes; 33, 65, 371, 490, 493, 969, H22, H37, N22, N33, N65 and R68. The bus station generally scored highly in most PTWA parameters, but it scored lower in formal security measures. Good characteristics included wayfinding signage and information, real-time information boards, dropped kerbs where appropriate, high levels of cleanliness and a large passenger boarding/waiting area with seating and shelters provided. The lower scores in security measures were characterised by no instant response facility for emergencies and no clear evidence of CCTV coverage.

Real-time information boards, wayfinding signage, dropped kerbs, seating and shelter.

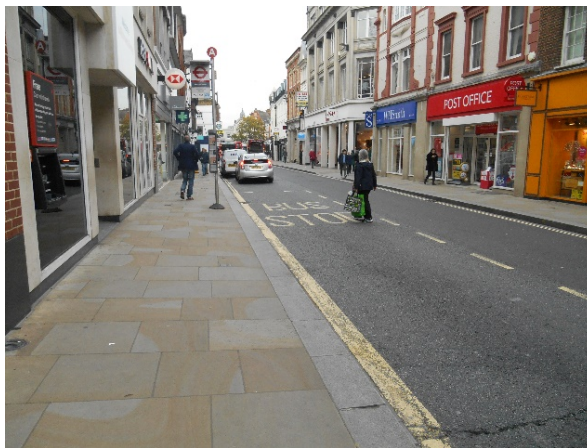
- 3.41 The bus stops on George Street are located approximately 70 metres to the north of the proposed development. These bus stops serve the following bus routes; 33, 337 and N33 for northbound services. Bus Stop A is comprised of a bus flag with timetable information, whilst Bus Stop B is comprised of a bus flag, timetable information, seating and a shelter. Both bus stops scored highly in terms of lighting, quality of environment and maintenance and cleanliness. Bus Stop B also scored highly in terms of information and infrastructure in the waiting area whereas Bus Stop A scored low in this area and also scored low on waiting area comfort. This was due to the narrow width of the waiting area, whereby waiting passengers conflict with passing pedestrians, and no seating or shelter is provided for passengers. It was also observed that the information at the waiting area did not include real-time information which warranted the lower score.

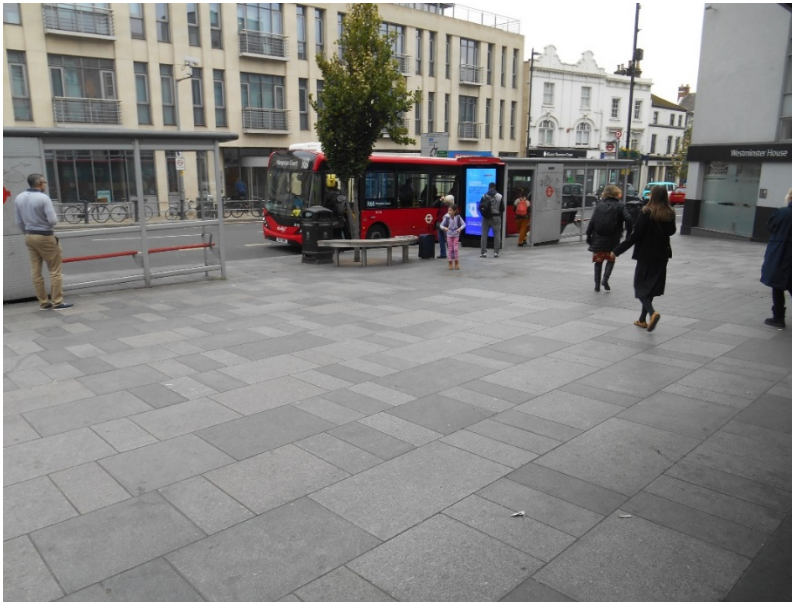
Figure 3.18 PTI Space – Richmond Rail and London Underground Station Forecourt

- 3.46 Richmond Rail and London Underground Station can be considered a PTI space as passengers are able to interchange between buses, National Rail, London Overground and Underground services. Richmond Rail and London Underground Station scored highly in all PTI parameters, with the main characteristics identified as good provision of wayfinding signage between modes, step-free access between modes, good levels of CCTV coverage, high levels of cleanliness with litter bins provided, seating and shelters provided at bus stops and a high quality footway approximately 10 metres in width. The wide footway outside of Richmond Rail and London Underground Station allows pedestrians to interchange comfortably between modes and allows space for passing pedestrians.
- 3.47 Images of the PTI spaces at Richmond Rail and London Underground Station is shown in **Figure 3.18**.

Seating, bus shelters, benches and a wide footway.
