BOWMER AND KIRKLAND

A feasibility study for the construction of a new playing field for Turing House Free School.

5th April 2018 [REVISION 2 – 14th February 2020]

TGMS REF: 0865.24

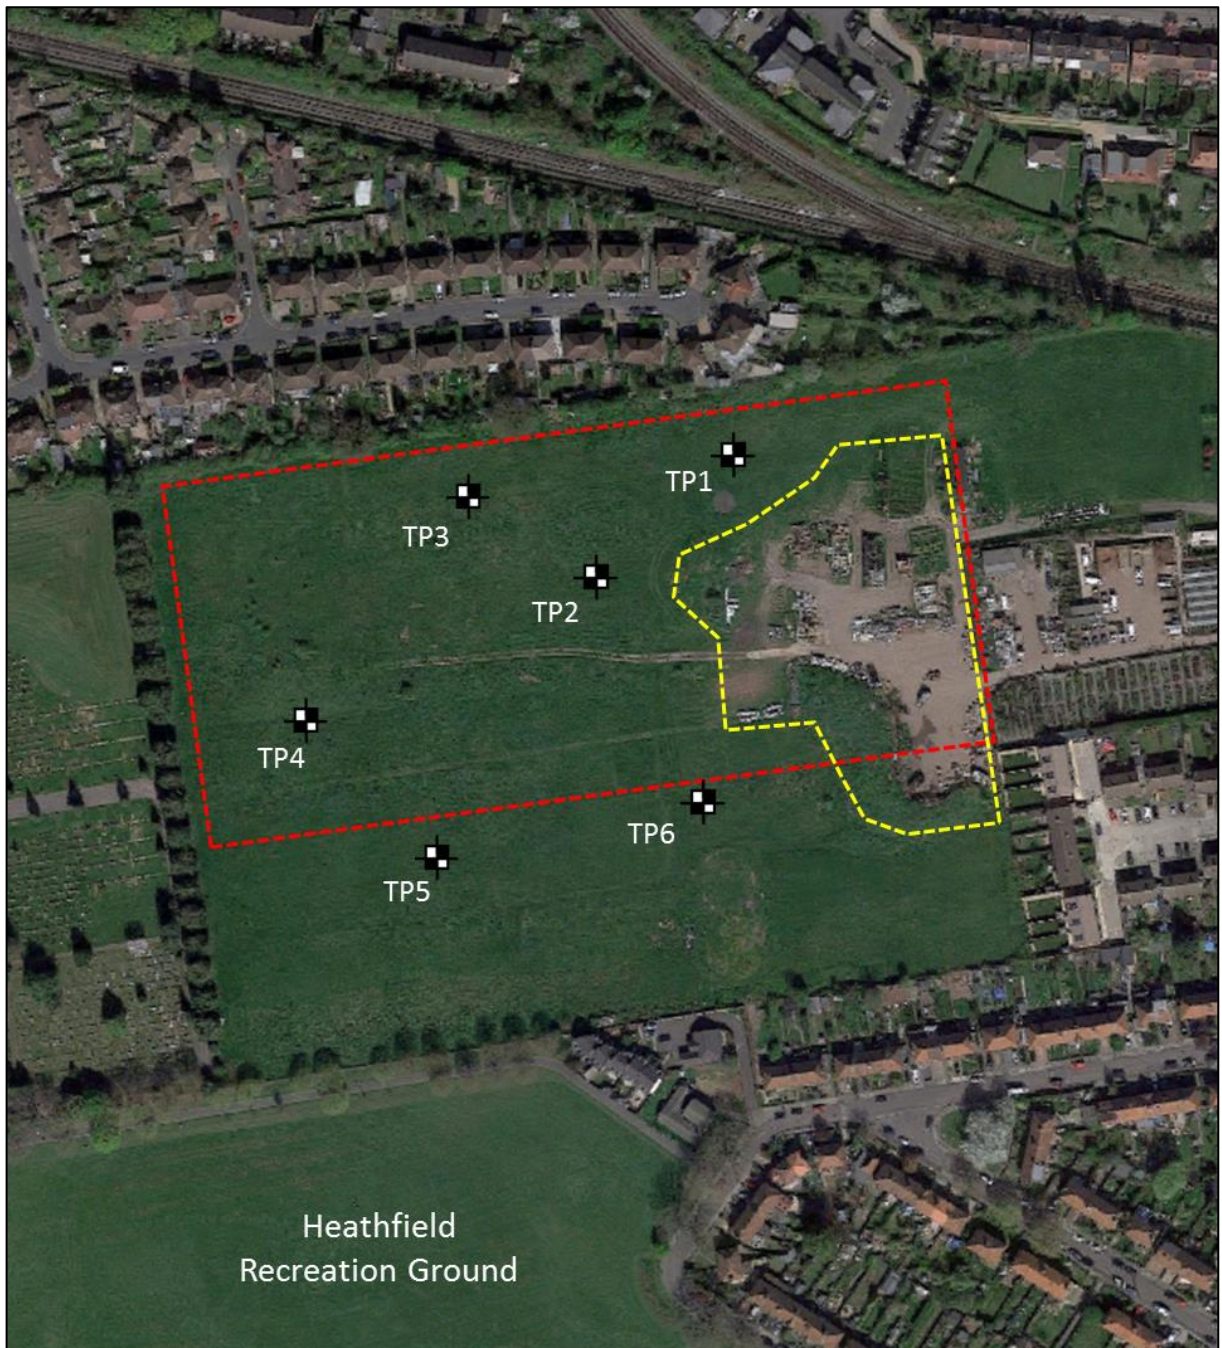
Figure 1. Aerial view of site showing the indicative locations of the soil test pits (TP1 to TP6). The dashed red line demarcates the proposed development area for sports pitches (indicative, do not scale). The dashed yellow line demarcates land currently used by the nursery which was not investigated during the site visit.

To evaluate soil type/structure further for the sports pitch development, six soil test pits (TP) were excavated at targeted locations (Figure 1). Soil samples were removed for laboratory analysis to determine soil texture and basic nutrient status.

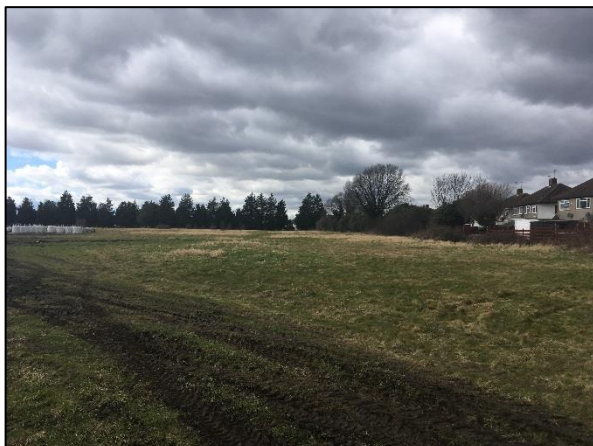
Figure 2. General view of site looking west.

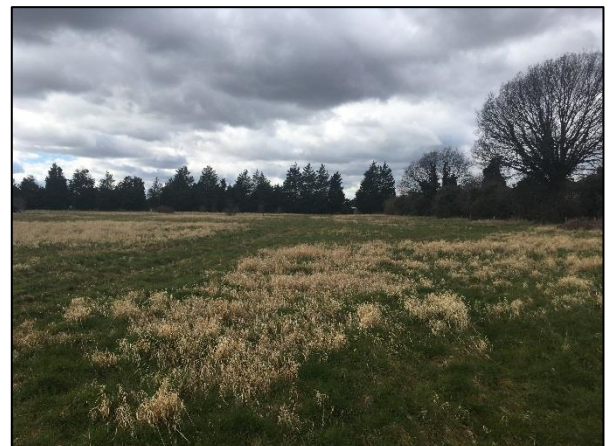
Figure 3. General view of site looking north-west.

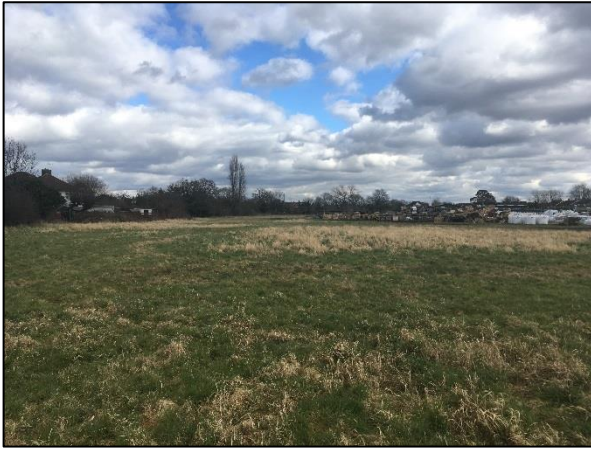
Figure 4. General view of site looking east.

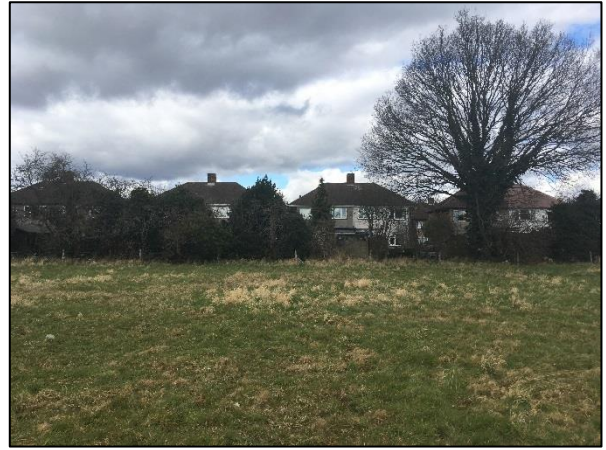
Figure 5. General view looking north towards residential properties.

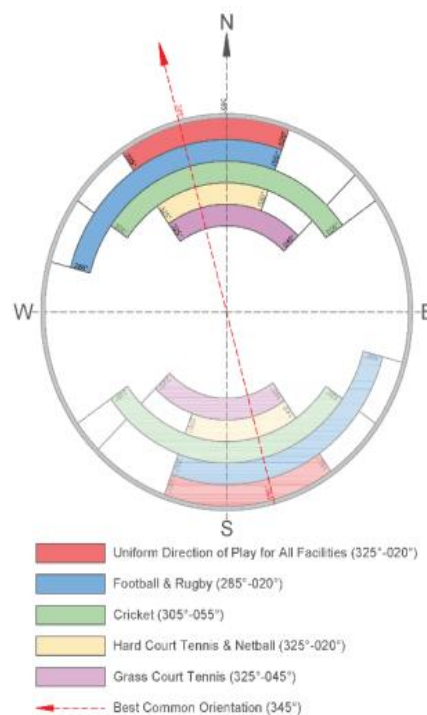
Figure 7. Optimum pitch orientation (Sport England).

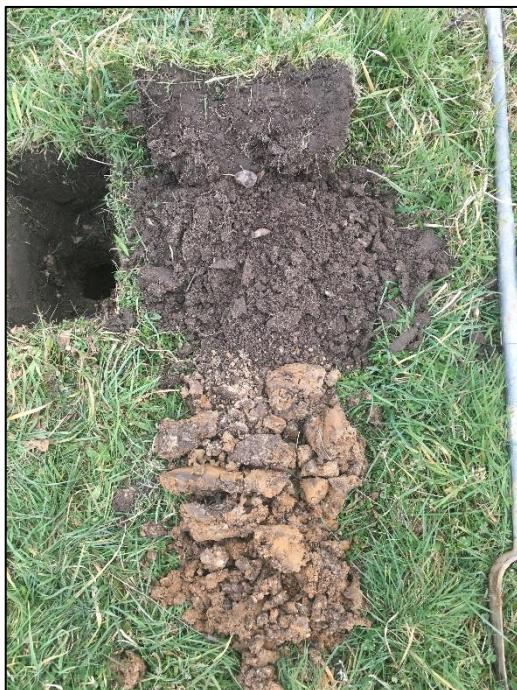
TP1

Topsoil depth	280 mm	300 mm	320 mm
Topsoil texture	Reasonably structured, dark brown sandy silt loam	Reasonably structured, dark brown sandy silt loam	Reasonably structured, dark brown sandy silt loam
Stones	Occasional stones in topsoil	Occasional stones in topsoil	Occasional stones in topsoil
Thatch content	10 mm	8 mm	10 mm
Subsoil texture and depth	Well structured, orange, moist sandy loam to 600 mm	Well structured, brown and orange, moist sandy silt loam to 500 mm	Well structured, dark orange, very moist loamy sand to 700 mm
Groundwater	None encountered	None encountered	None encountered

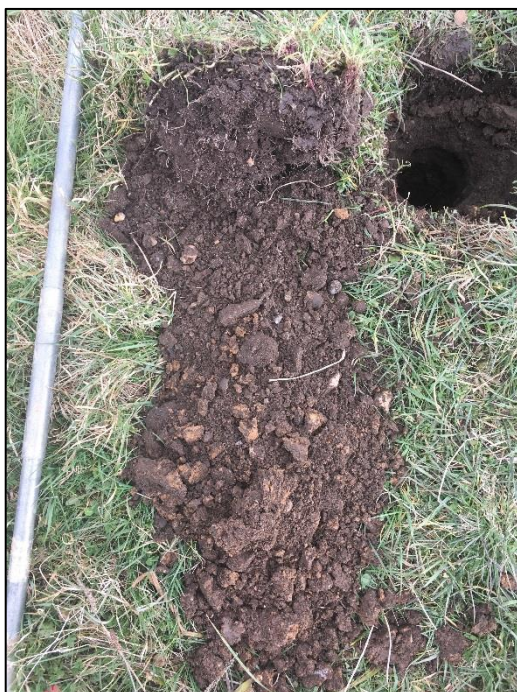
TP4

Topsoil depth	300 mm	300 mm	300 mm
Topsoil texture	Reasonably structured, dark brown sandy silt loam	Well structured, dark brown sandy silt loam	Reasonably structured, dark brown sandy silt loam
Stones	None	Occasional stones in topsoil	Occasional stones in topsoil
Thatch content	8 mm	10 mm	8 mm
Subsoil texture and depth	Well structured, brown and orange, moist sandy silt loam to 500 mm	Well structured, brown, moist sandy silt loam to 500 mm	Well structured, brown and orange, moist sandy loam to 600 mm
Groundwater	None encountered	None encountered	None encountered

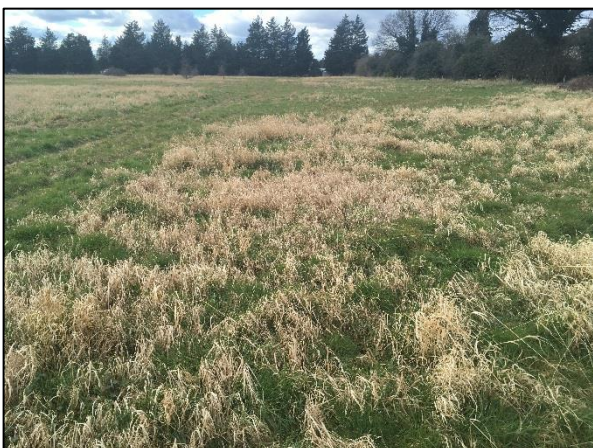
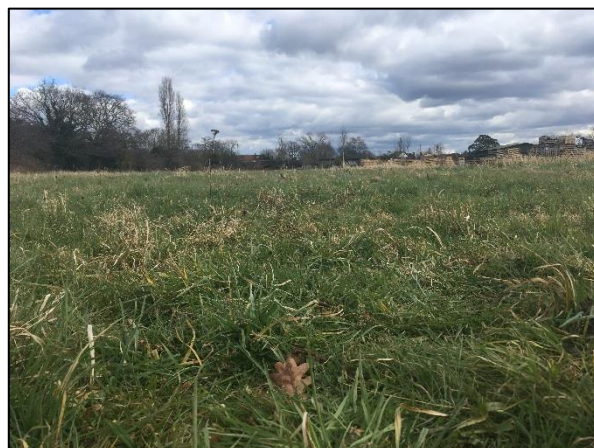
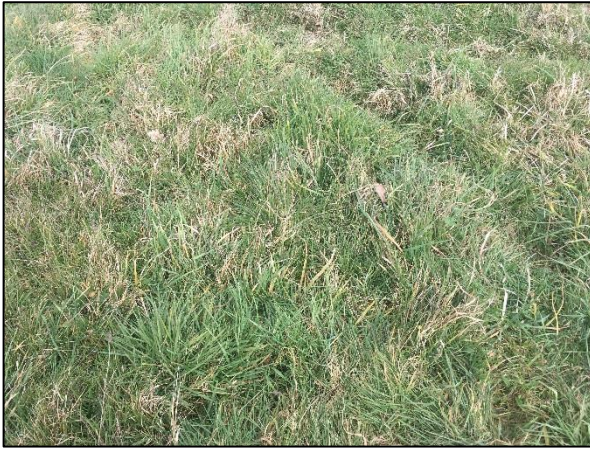
Ground cover was at 90% and consisted of low-grade grassland containing a mix of pasture grasses (Figures 10, 11 & 12). The broad-leaved weed population within this cover occupied less than 5% which is very good, however grass height was long and ranged from 50 to 300 mm in areas.

Figure 10. General view of ground cover.

Figure 11. Close-up of ground cover.

Figure 12. Example of 100% ground cover.

Surface cultivations will be required to address minor undulations across the site and so it is recommended that the site is sprayed with glyphosate prior to cultivations; a flail mower operation should also be budgeted for.

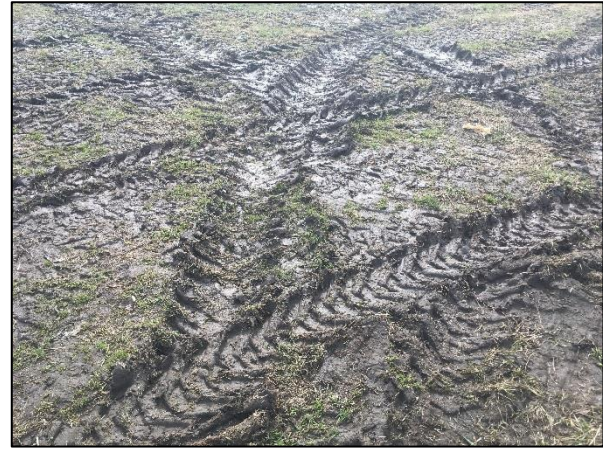
There was also evidence of localised rutting caused by vehicles transporting supplies around the nursey (Figure 13). These areas highlighted the detrimental effects of soil compaction on the indigenous soils and the need for drainage as surface water ponding was evident.

Figure 13. Example of vehicular ruts.
