**Desk Study, Site  
Investigation & Risk  
Assessment Report**

**Project Name:** 1 St James Road, Hampton

**Project ID:** J14219

**Report Date:** 6<sup>th</sup> May 2020

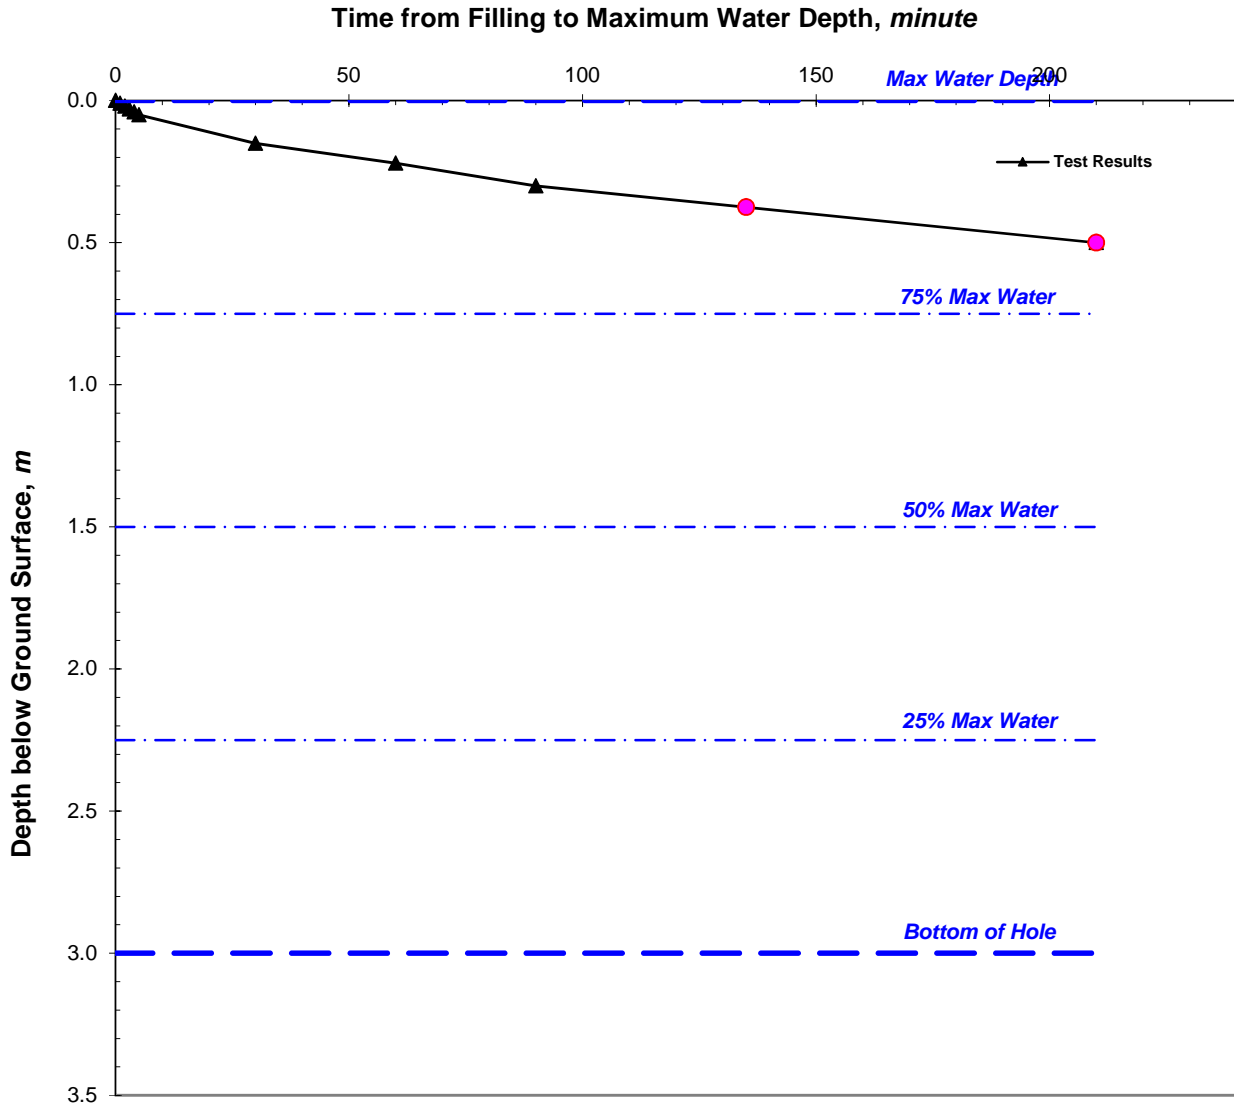
**Test Hole No:** WLS1  
**Test No:** Test No 1 (Initial)

Diameter of Borehole, m	0.100	Depth to Water at Start of Test, m	0.000
Depth to End of Borehole Casing, m		Max Water Dropdown during Test, m	0.500
Depth to Borehole Base, m	3.000	Total Soakage Test Time, min	210.0
Depth to Top of Permeable Soils, m		Mean Internal Discharge Area, m <sup>2</sup>	0.813
Depth to Groundwater Surface, m		Discharge Rate, litre/min	0.013
Depth to Top of Granular Fill, m		Soakage Rate, litre/m <sup>2</sup> /min	<b>0.016</b>
Voids Assumed within Borehole, %	100%	BRE Soil Infiltration Rate, m/sec	<b>2.68E-07</b>

Soakage testing was carried out in one of the windowless sample boreholes (WLS1) The small scale falling head soakage test indicated little or no infiltration. The result of the test can be found in Appendix B.

On the basis of these test results and given the soil types present, the site is not considered suitable for shallow soakaway drainage. We would therefore recommend a positive drainage system be considered for all surface water disposal.

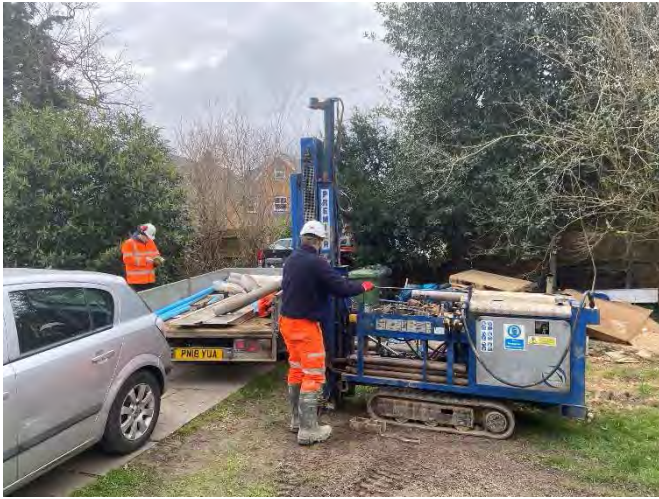
Drilling WLS1 looking east.

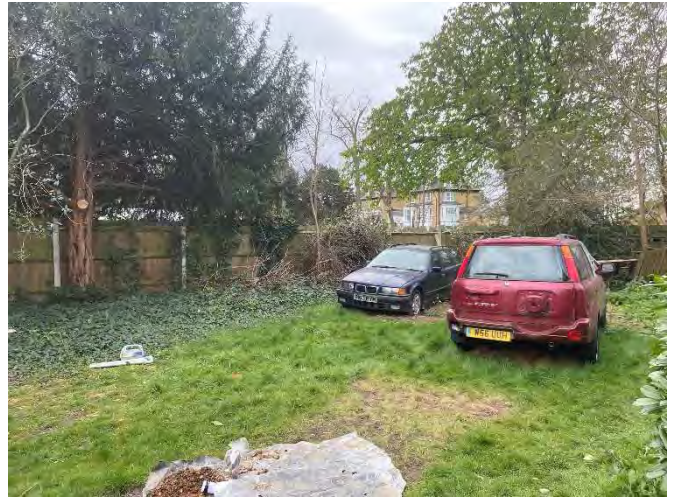
Parked cars in the front garden looking south east.

There is a potential to encounter shallow Made Ground on site and the materials found within this pose the greatest risk to the site. The parked cars identified on site during the walkover present a risk of localised fuel spills.

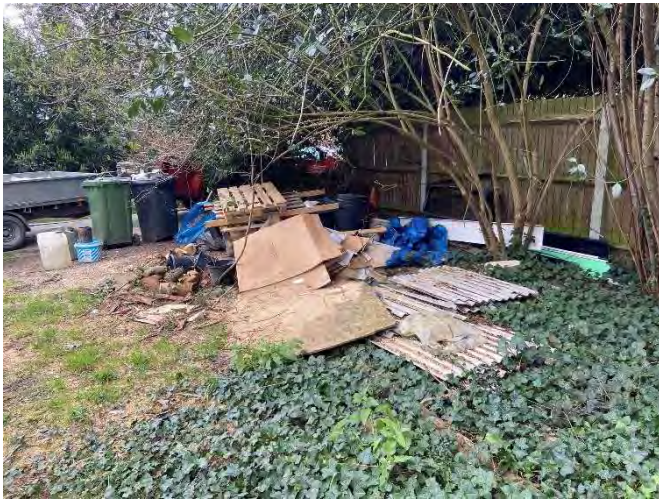
Rubbish including cardboards wood and possibly asbestos cement sheet roofing near entrance to site.

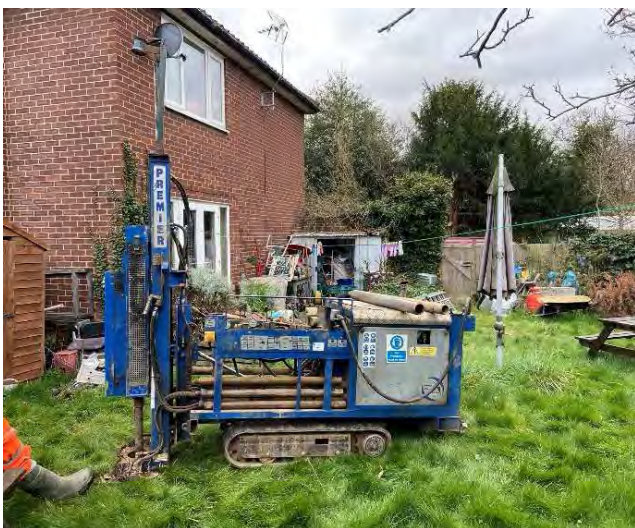
Drilling WLS3 looking east.
