# Manor Road / Richmond

## Geoenvironmental & Geotechnical Preliminary Risk Assessment

**PROJECT TITLE:** Manor Road, Richmond

**REPORT TITLE:** Geo-Environmental and Geotechnical Preliminary Risk Assessment

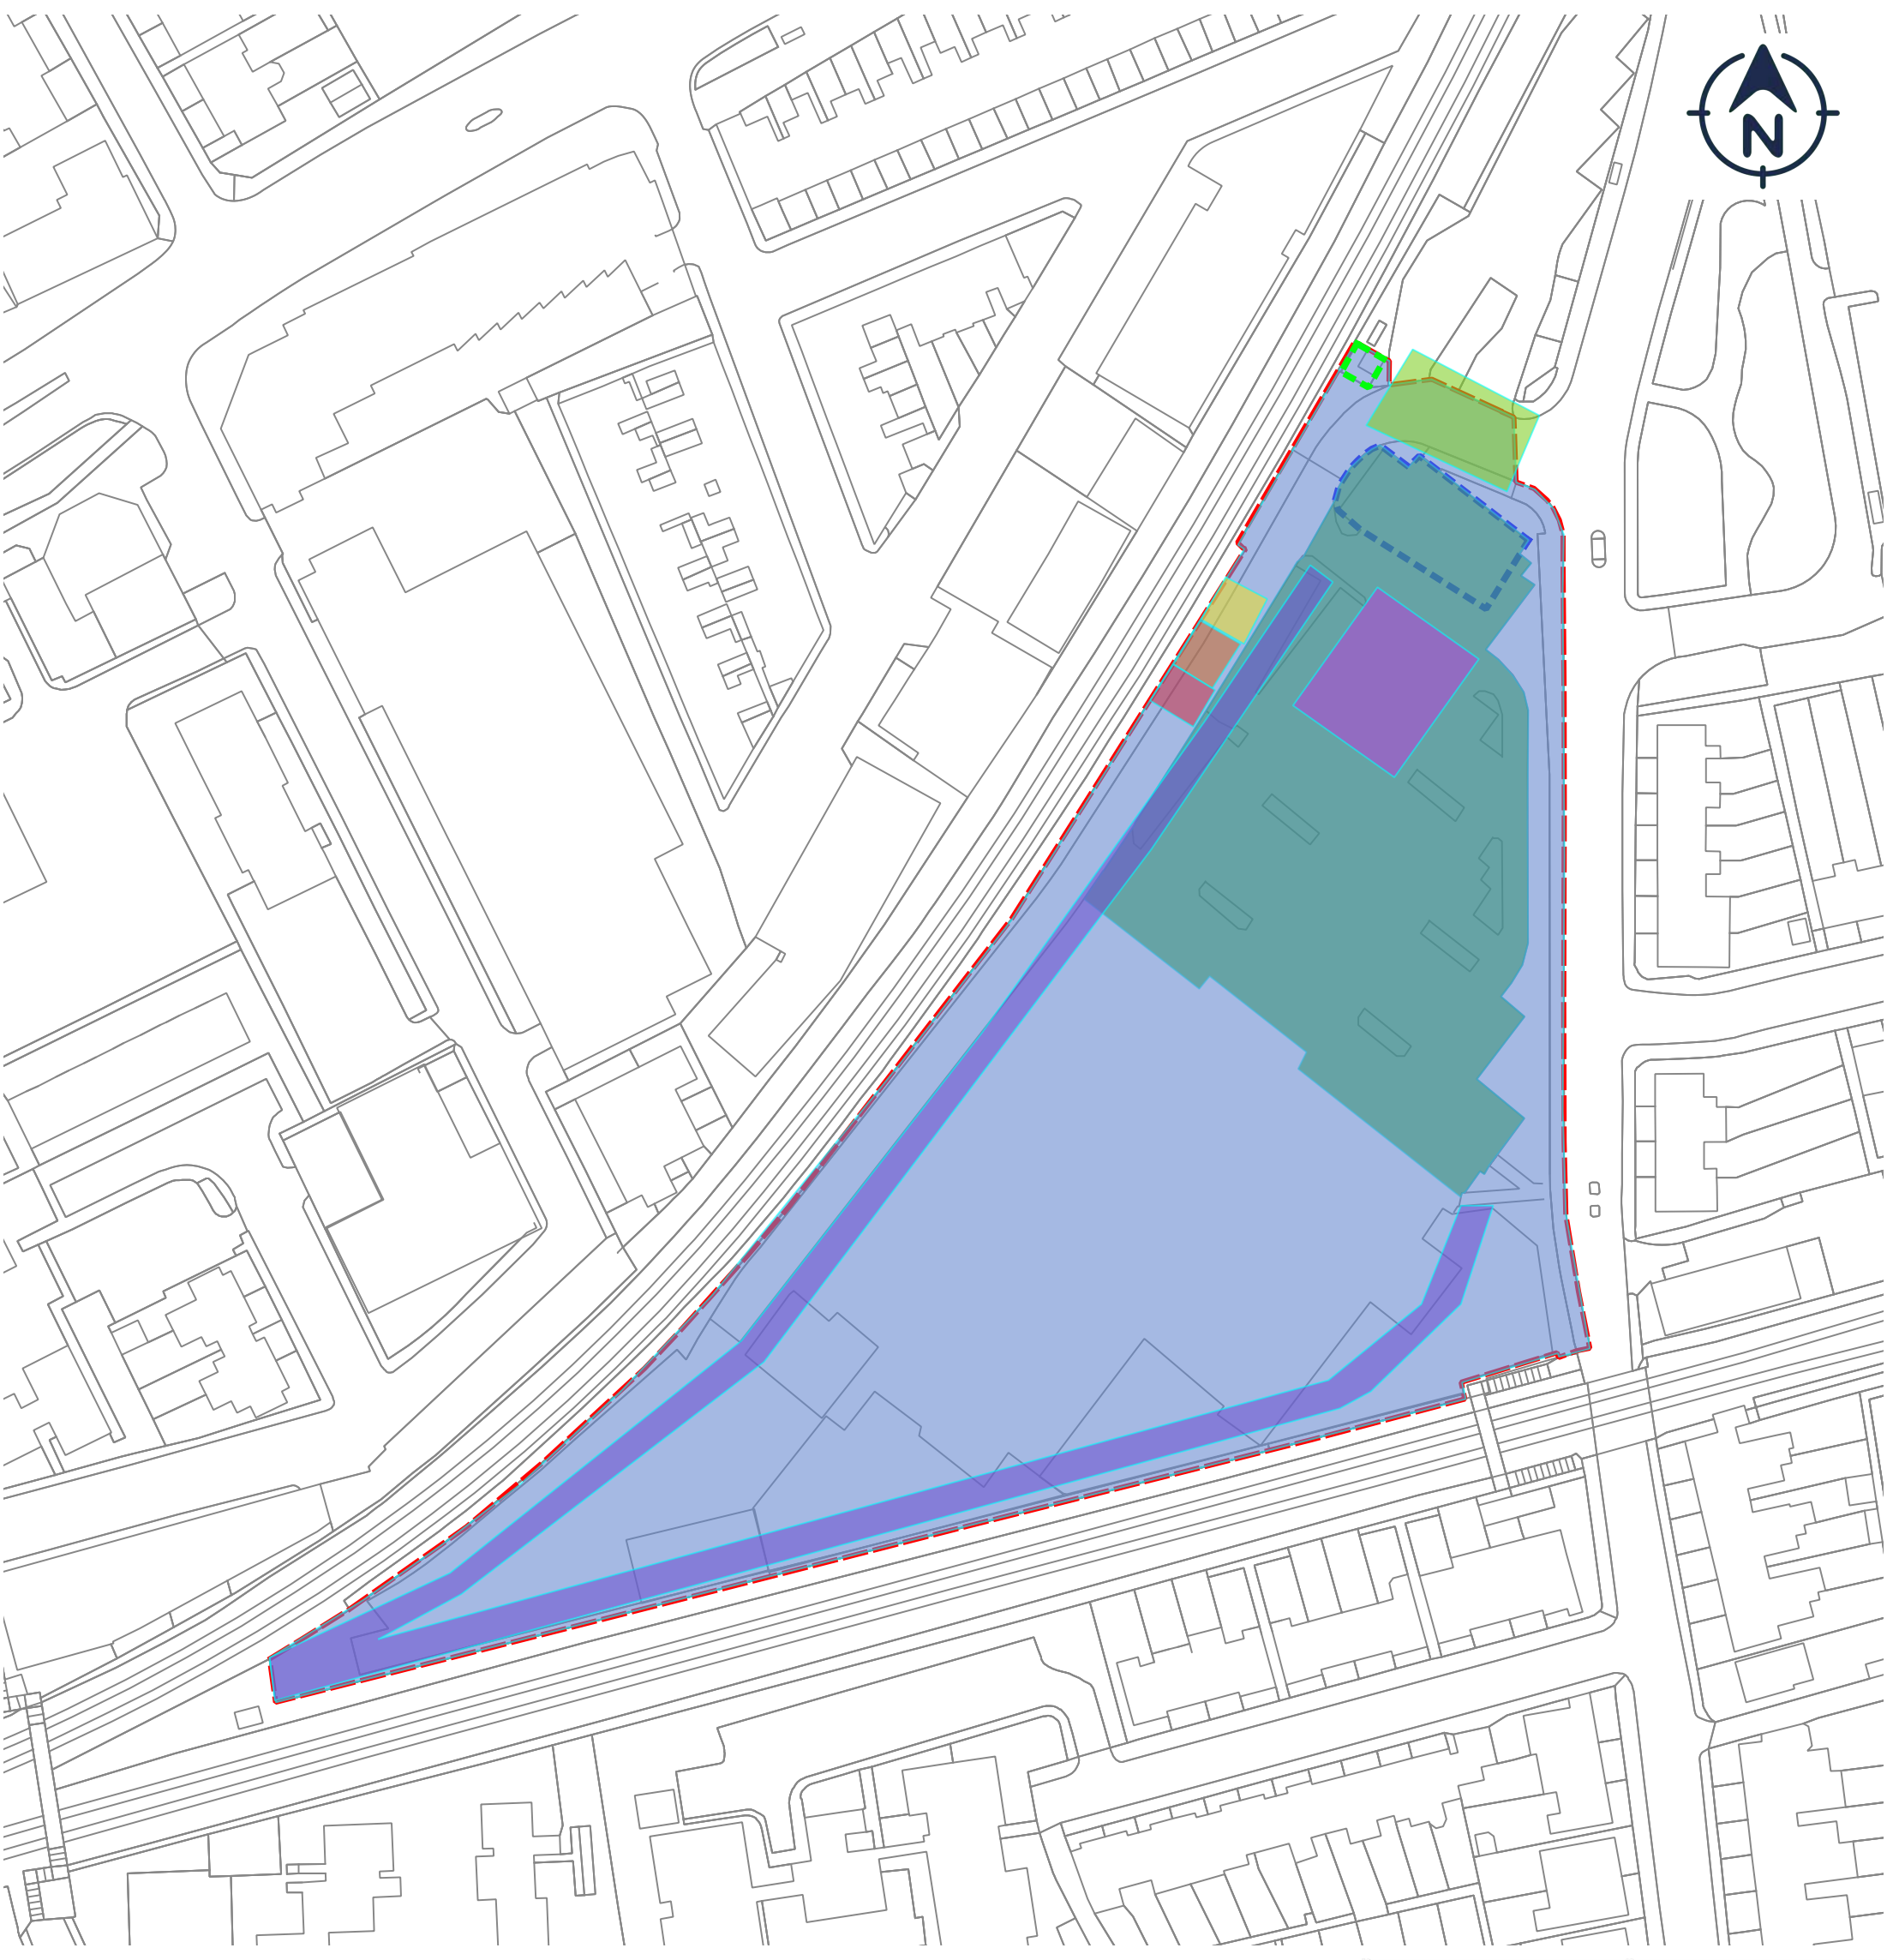
Figure 2  
Potential Sources of Contamination

FIGURE 2A – POTENTIAL SOURCES OF CONTAMINATION ON-SITE

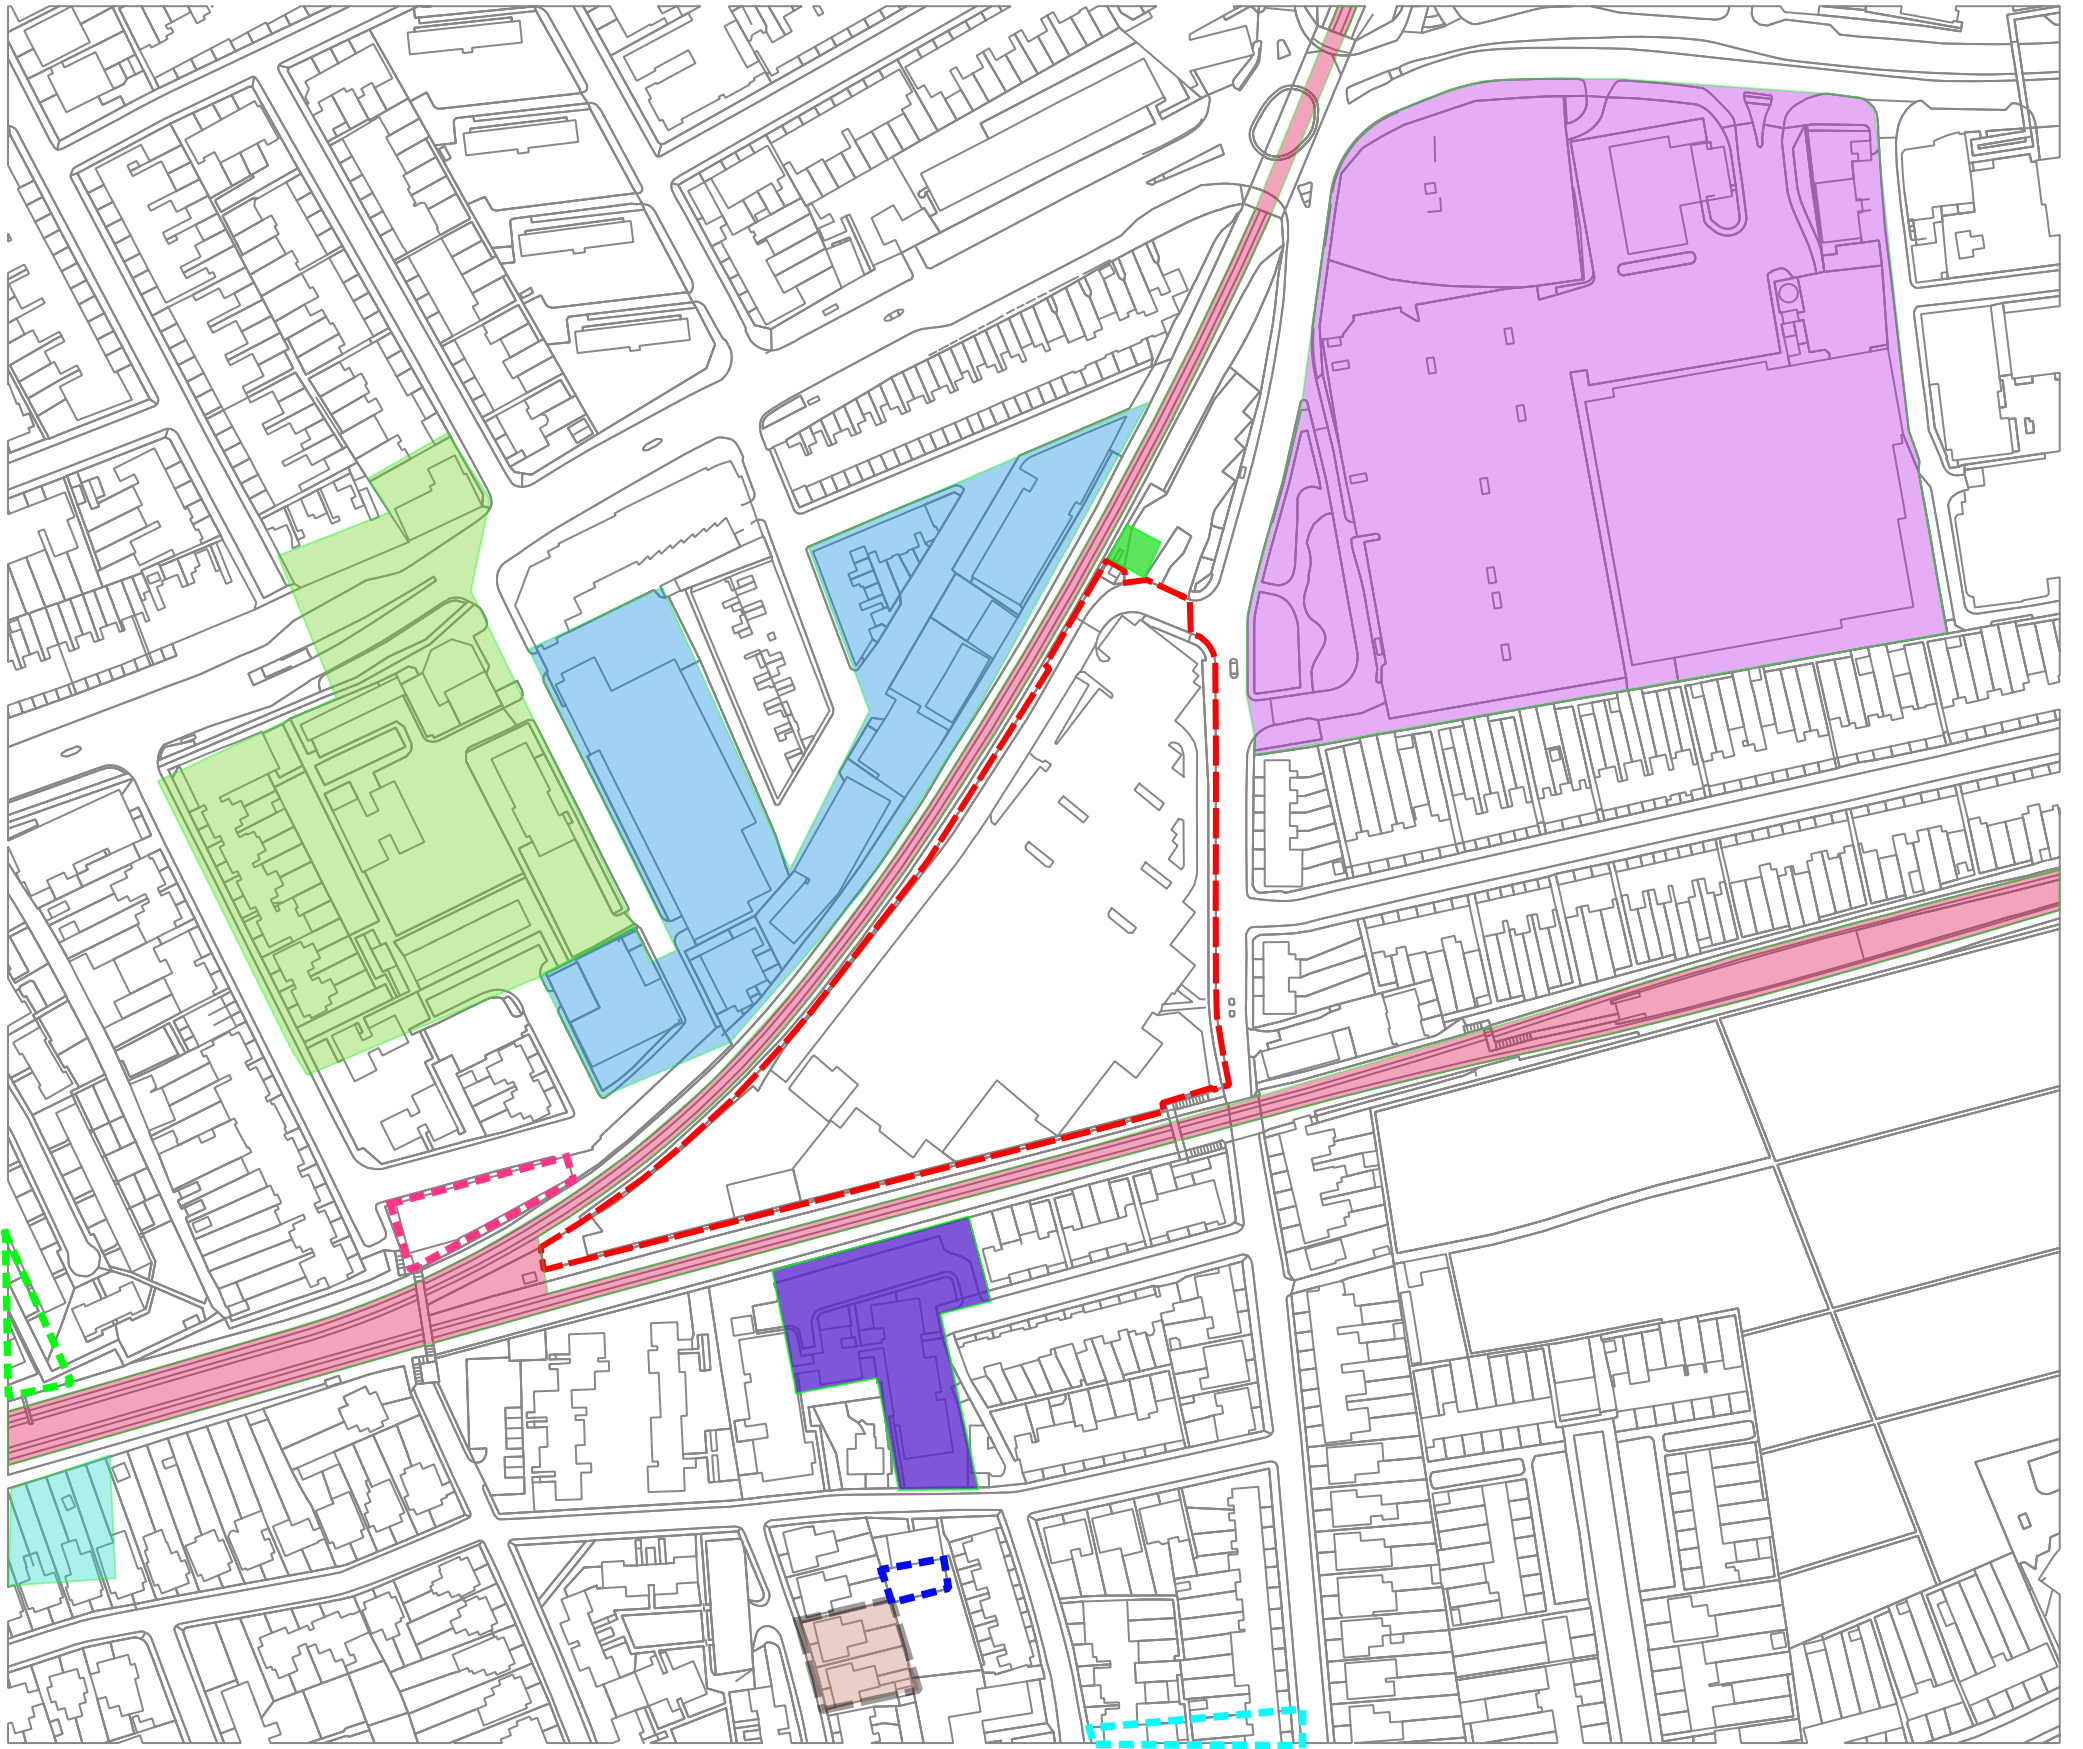
FIGURE 2B – POTENTIAL SOURCES OF CONTAMINATION OFF-SITE

- ⋮ Corporation & Goods Depots and Coach Repair Works
- ⋮ Electrical Substation
- ⋮ Former 3no Garages
- Former Coal Hoppers
- Former Laundry
- Former Light Industrial Warehouse
- Former Nursery
- Former Richmond Gas Works
- Former Warehouses, Works, Electrical Substation, Builders Yard, Tank and Various CTDE
- ⋮ Former Works, Builders Merchant, Distribution Services & Carpet Cleaners
- Railway Lines
- Various CTDE
- Site Boundary
