# Remediation Strategy

Turing House Free School, Hospital Bridge Road, Twickenham

Presented to **Bowmer and Kirkland**

Delta-Simons Project No. 18-0170.08

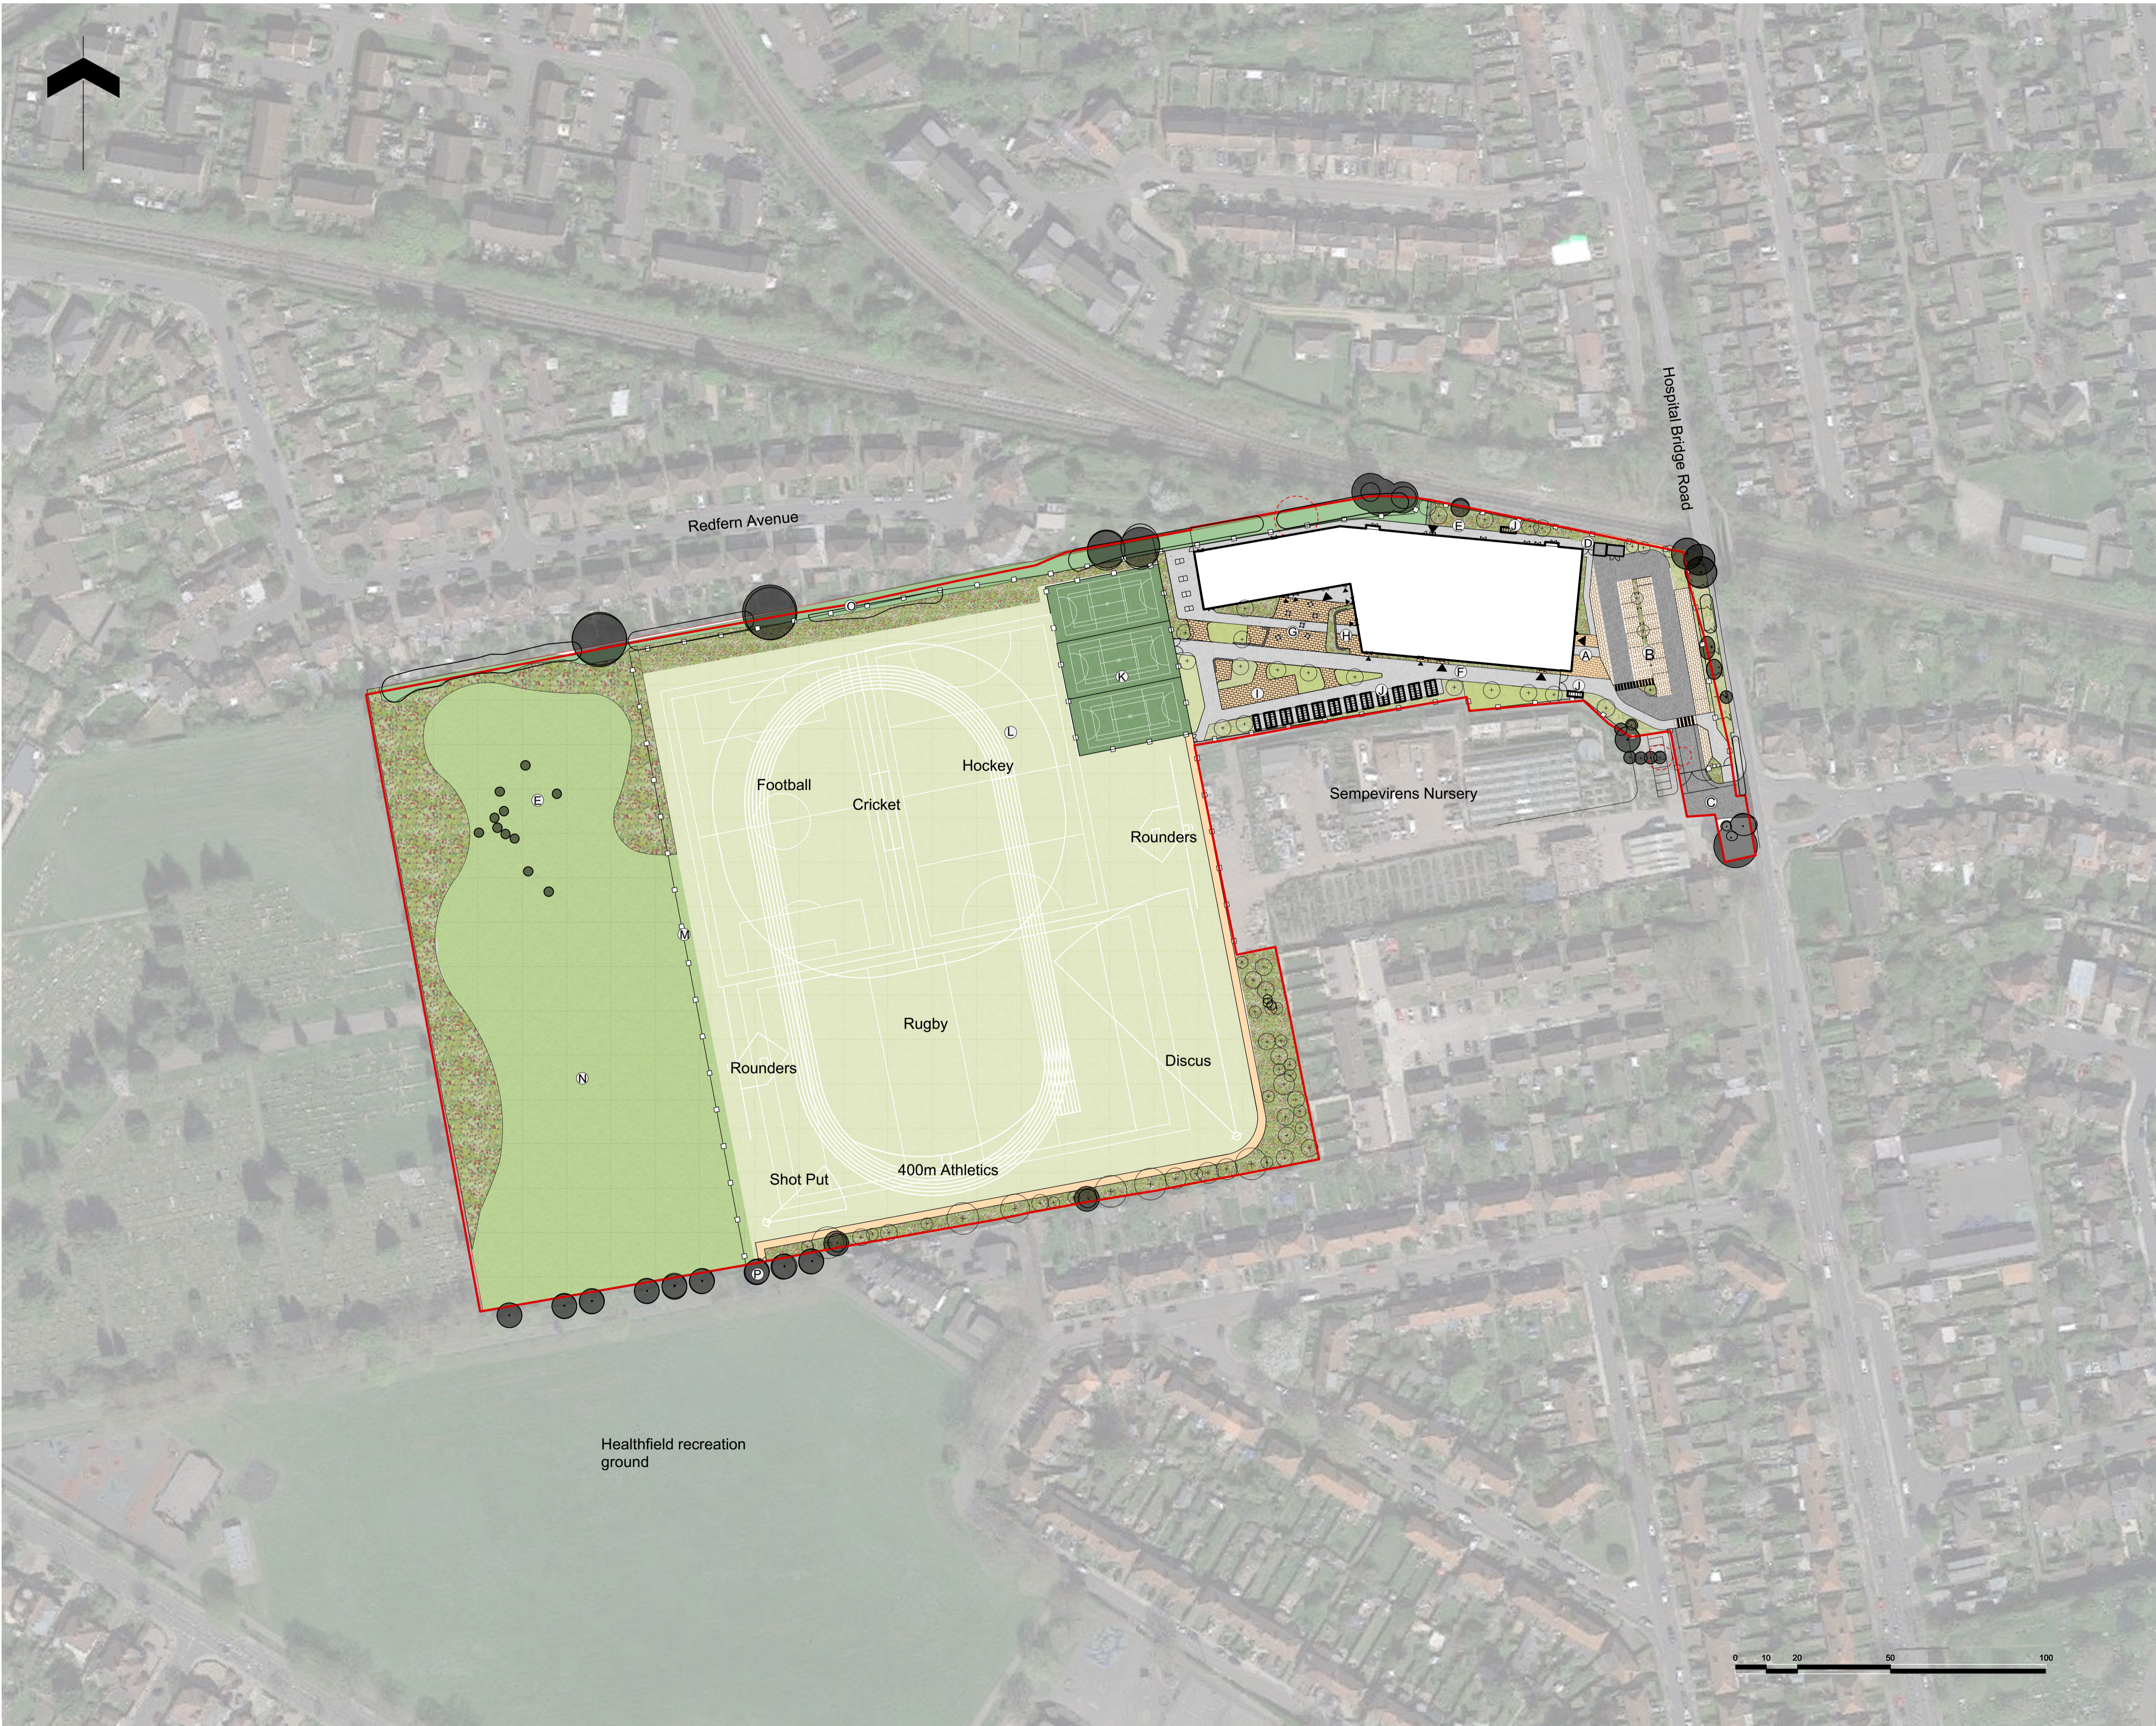
# Drawing 1 – Proposed Development Plan - EFATH-ALA-00- XX-DR-L-0003

- KEY**
- (A) Entrance Plaza**  
40no. Total Spaces
  - (B) Car Parking**  
3 Disabled Bays  
10 Active Electric Charging Points  
10 Passive Electric Charging Points  
Deliveries / Coach Bay

- (C) New Site Entrance**
  - (D) Deliveries and Maintenance Gate**
  - (E) Habitat Area**  
Planting species designed to encourage insect and bird habitats and enhance the ecological corridor. Indicative design intent shown for illustrative purposes only.

- (F) Pedestrian Boulevard**
  - (G) Hard Informal Social Area**
  - (H) 6th Form External Social Space**
  - (I) External Canopy**
  - (J) Cycle Parking**  
136no. Pupil Spaces  
10no. Visitor Spaces  
10no. Staff Spaces

- (K) 3 Court MUGA**
  - (L) Playing/Sports Field**  
A Space design to maximise the amount of sports played by the school. The North/South orientation results in 3no. pitches

- (M) Boundary Fence**  
a 2.4m boundary fence with hedge planting to provide screening
  - (N) Grassland & Habitat Creation**  
Area seeded with species rich grass and planting with trees to create habitat zones and habitat creation. Indicative design intent shown for illustrative purposes only

- (O) Habitat Corridor**  
The existing avenue of trees retained and grassland managed to reinforce the habitat corridor, providing habitat corridor between the rail line, cemetery and retained fallow land

- (P) Pupil Access**  
Proposed pupil access from Heathfield Recreation Ground. A low lit self bind gravel path weaving through the habitat area to the school.

It is understood the Site is proposed for the construction of a new secondary school with associated vehicle car parking and hard and soft landscaping. The Proposed Development Plan is included as Drawing 1.
