The Former Stag Brewery, Mortlake

Protected Species Report

May 2020

Waterman Infrastructure & Environment Limited

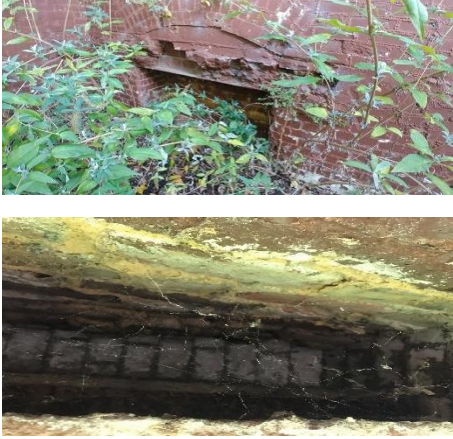
Description	Building Photographs	Bat Roost Rating
<p><u>PRF 4 (Site Side)</u></p> <p>Feature present on the Site side of the wall with 4 of these features present in close succession. The features are fully bricked up on the river side, with various heights of bricking up on the Site side, creating a cavities between approximately 40-80cm high. During the inspection no signs of roosting bats were recorded.</p>

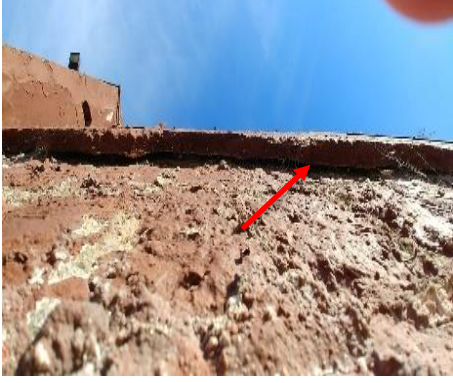
<p>Moderate</p>
<p><u>PRF 5 (Site Side)</u></p> <p>Feature present on the Site side of the wall. An area of render has broken away from the wall and has created a linear gap between the render and the wall. The gap is 1cm wide at its greatest extent and protrudes up between 2 to 6cm. It is arguable if the cavity present is wide enough to provide an entrance point for bats, however spider webs are present both in the cavity and at the entrance. During the inspection no signs of roosting bats were recorded.</p>

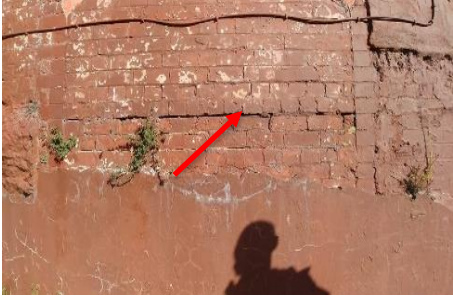
<p><u>PRF 6 (Site Side)</u></p> <p>Feature present on the Site side of the wall. Linear gaps are present in the wall where mortar is missing, in the vicinity of PRF 5. The gaps are 1 to 1.5cm tall, 4cm at their widest and protrude into the wall 3-5cm. The gaps contain debris from the mortar and spider webs are present. During the inspection no signs of roosting bats were recorded.</p>

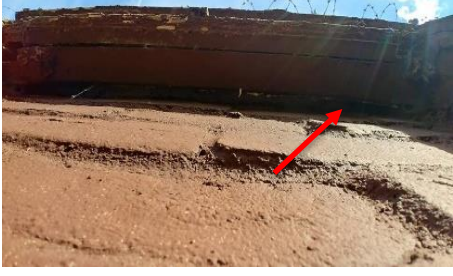
<p>Moderate</p>
<p><u>PRF 7 (Site Side)</u></p> <p>Feature present on the Site side of the wall. An open gap is present around the window frame with 3 of these features present in close succession. The gap is 3 to 4cm wide and 5cm deep. Spider webs are present. During the inspection no signs of roosting bats were recorded.</p>

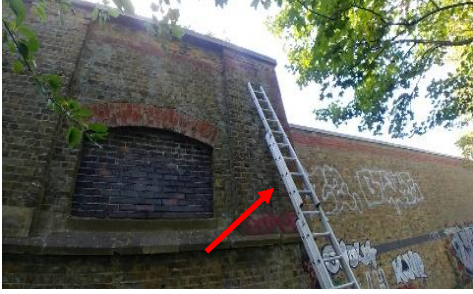
Description	Building Photographs	Bat Roost Rating
<p><u>PRF 8 (River Side)</u></p> <p>Feature present on the riverside of the wall. A crack is present in the wall running up the brickwork from 1m to 3m above ground level. The crack is assessed to be superficial and is 2cm at its widest and contains snails, woodlice and spider webs. The crack is 6cm at its deepest. During the inspection no signs of roosting bats were recorded.</p>

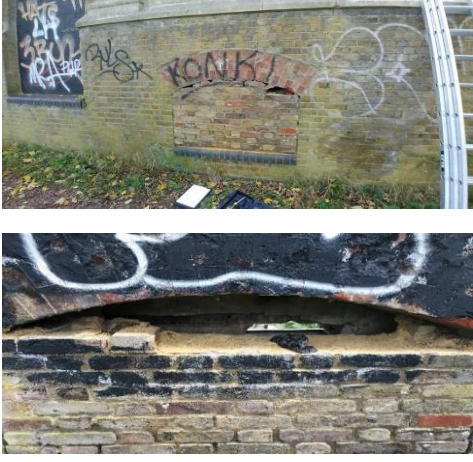
<p>Low</p>
<p><u>PRF 9 (River Side)</u></p> <p>Previously a moderate PRF (top photo) located on the river side of the wall and is one of the river side features of PRF 4.</p> <p>However, this feature has now been vandalised (bottom photo) and is considered too large exposed to support roosting bats.</p>

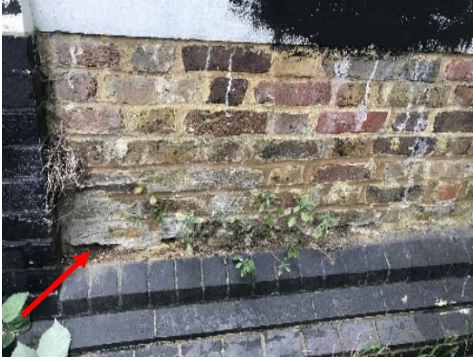
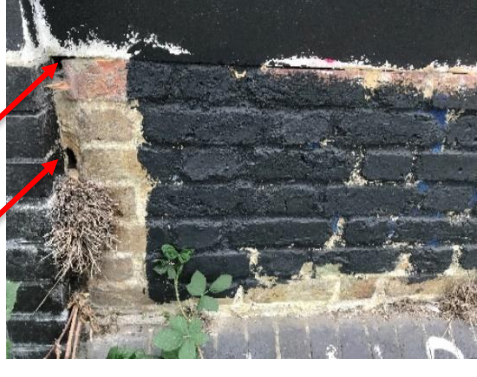
<p>Negligible</p>
<p><u>PRF 10a and 10b (River Side)</u></p> <p>Both features are present on the river side of the wall and again are river side features of PRF 4. The features are the same except that 10a comprises a horizontal access point in the bottom left hand corner and 10b comprises 2 no. vertical access points down the left-hand side.</p> <p>The features are present at between 0.5 and 1m above ground level. Where previous bricking up works were undertaken the resulting cavity has been filled with debris.</p> <p>Where external mortar has been lost, internal debris which filled the cavity has also been lost, creating small cavities behind.</p> <p>The access points are 2 to 3cm high and 2 to 7cm long, with the internally cavities protruding between 5 and 10cm back and 5 to 7cm across.</p>

Description	Building Photographs	Bat Roost Rating
<p>Old spider webs are present within the cavities and during the inspection no signs of roosting bats were recorded.</p>

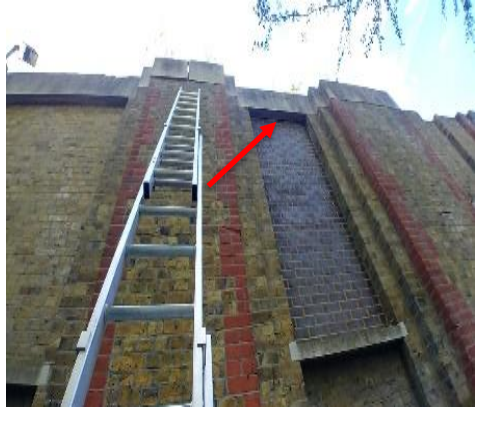
<p><u>PRF 11 (River Side)</u></p> <p>Feature present on the riverside of the wall.</p> <p>A gap is present between the top of a 'new' wall (constructed from darker brick work as part of previous bricking up work) and a concrete lintel above. The gap is 5cm wide (2cm wide during previous survey) and goes up 2cm and back the width of a brick. No internal cavity is present behind.</p> <p>During the inspection no signs of roosting bats were recorded.</p>

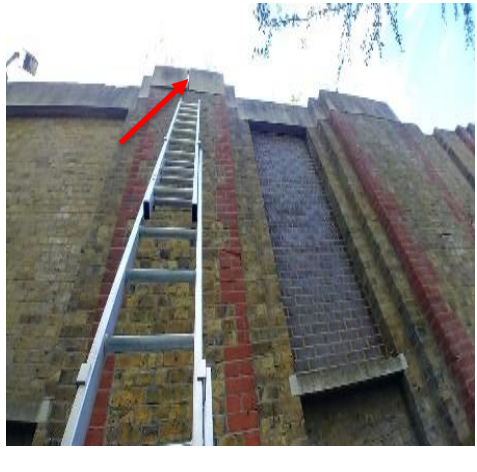
<p>Low</p>
<p><u>PRF 12 (River Side)</u></p> <p>Feature present on the riverside of the wall. A large crack is present at the stone lintel at the top of the wall (above ladder). The crack has split the stonework in two and has expanded in width to 5-6cm at its widest.</p> <p>The cavity is therefore open to the elements and leaf litter and spider webs are present and it is considered that the gap is now too open and exposed to be of value to roosting bats. During the inspection no signs of roosting bats were recorded.</p>

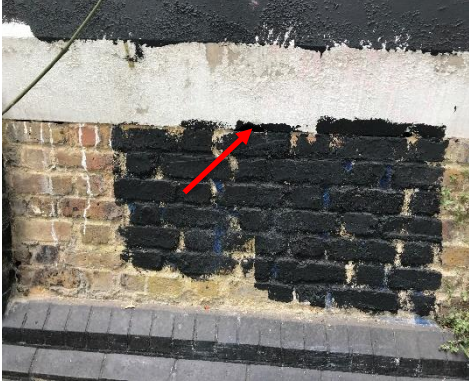
Description	Building Photographs	Bat Roost Rating
<p><u>PRF 13 (River Side)</u></p> <p>Feature present on the river side of the wall and is a river side feature of PRF 4. The feature is present at 1.5m above ground level and is assessed to have formed due to bricking up work. The access point (created as a result of missing mortar) is 3 to 4cm high and 7 to 8cm wide and leads into a confined internal cavity. The cavity runs 1m along the top of the brick work and is 10cm wide but also drops down by 5cm on the site side of the wall. The cavity contains debris from the brick work including mortar and spider webs are present.</p> <p>During the inspection no signs of roosting bats were recorded, however a mouse was observed inside.</p>

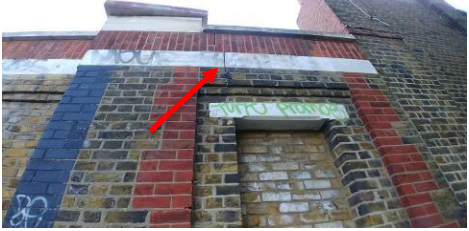
<p>Moderate</p>
<p><u>PRF 14 (River Side)</u></p> <p>Feature present on the riverside of the wall. A crack is present above the bricked-up window. The crack is 1.5cm at its widest with spider webs and woodlice present.</p> <p>During the inspection no signs of roosting bats were recorded.</p>

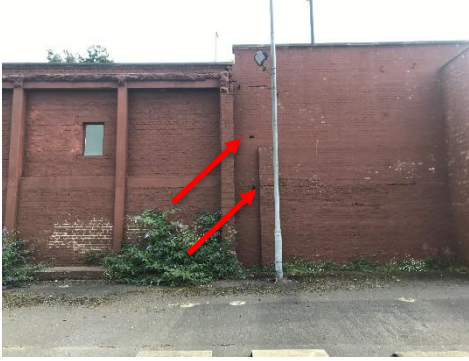
<p><u>PRF 15 (Site Side)</u></p> <p>Several areas of missing brick work within the south-eastern corner of the Site.</p> <p>The missing brick work has created cavities approximately 10cm in height, 15cm in width and 10-15cm in depth. At the higher feather there is also a crack in its top approximately 1cm in width and 1-cm deep.</p> <p>During the inspection spider webs were present with no signs of roosting bats recorded.</p>

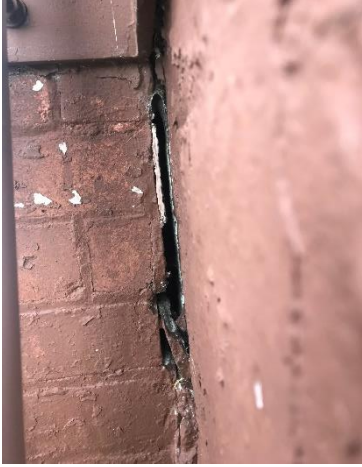
Description	Building Photographs	Bat Roost Rating
<p><u>PRF 15 (Site Side)</u></p> <p>Gaps in brick work between the wall and a buttress within the south-eastern corner of the Site.</p> <p>The gap is approximately 1.5cm wide at its widest and 20-25cm in height. No enclosed cavity is present with the gap running through to the other side of the buttress.</p> <p>During the inspection spider webs were present with no signs of roosting bats recorded.</p>

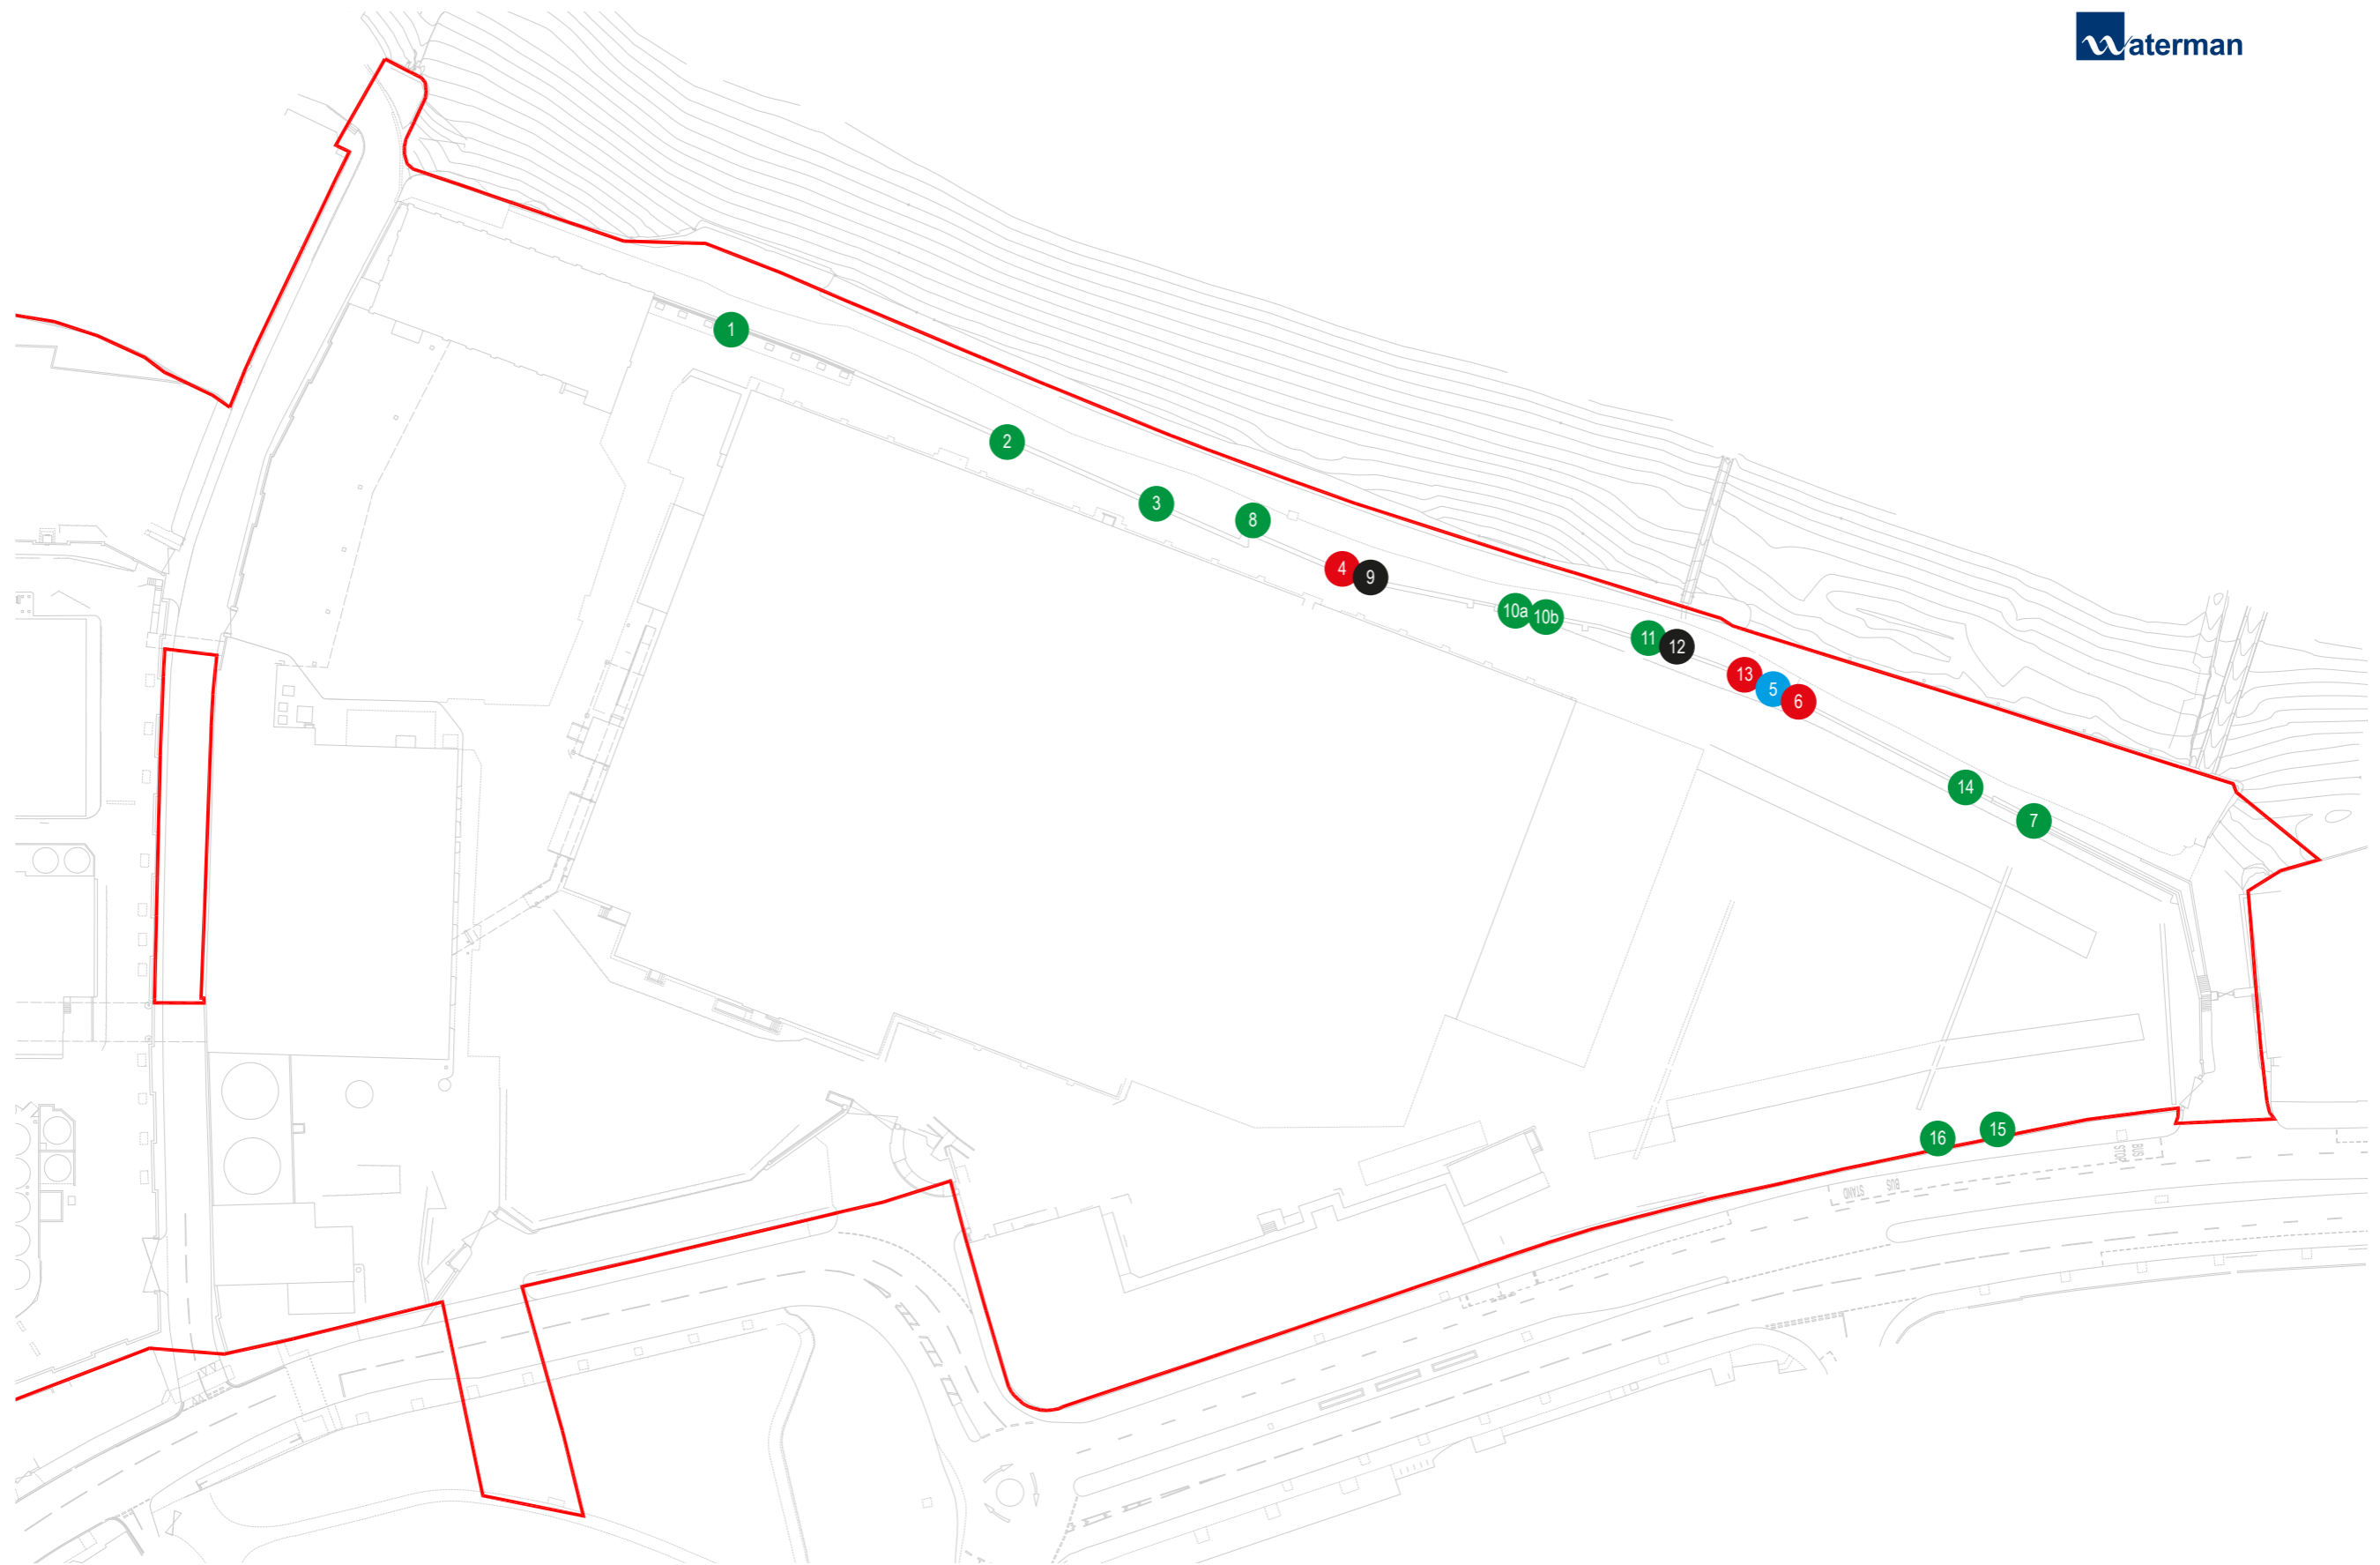
Project Details	WIE15582-102: Stag Brewery
Figure Title	Figure 3: Bat Activity Survey Transect & SM2 Location
Figure Ref	WIE15582-102_GR_EC_3A
Date	2019
File Location	\\s-incs\wiel\projects\wiel15582\102\graphics\ec\issued figures

Bat Activity Transect

- 2.8. The two evening activity surveys commenced from sunset to until two hours thereafter, with the dawn activity survey commencing two hours before, and continuing until, sunrise. A pair of surveyors, using a full spectrum BatLogger M detector, followed a pre-determined transect route (**Figure 3**).

- 2.10. To supplement the activity surveys, a single static automated bat detector (SM2BAT+) was deployed at the Site based on current best practice guidelines. The static detector was positioned beneath the Budweiser Sign (**Figure 3**) on the wall adjacent to the River Thames.
- 2.11. The static detector recorded for five consecutive nights in July, August and September 2019. The detector was programmed to record from 30 minutes before sunset until 30 minutes after sunrise. **Table 3** below provides a summary of the bat survey parameters³ for each deployment session.
